Pierce Transit Facilities Condition Assessment Report

Prepared for

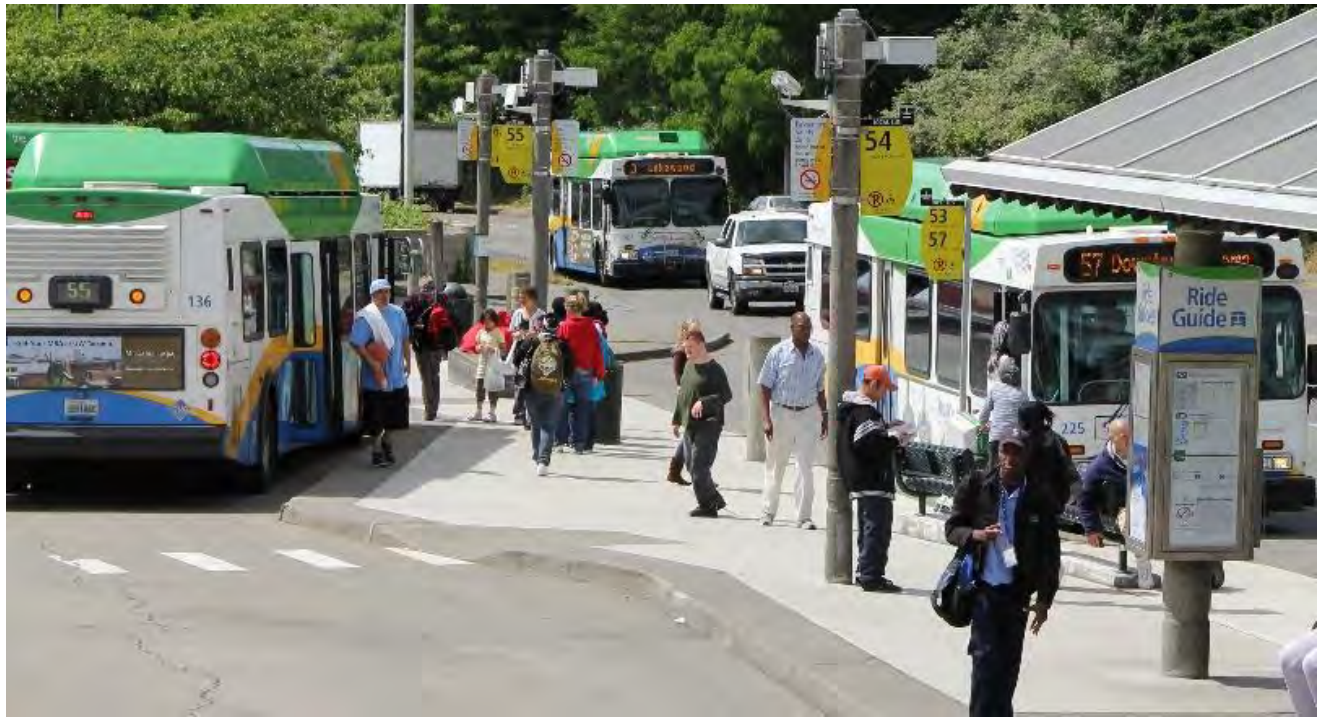
ES-4: Summary of Parking Facility Condition Ratings

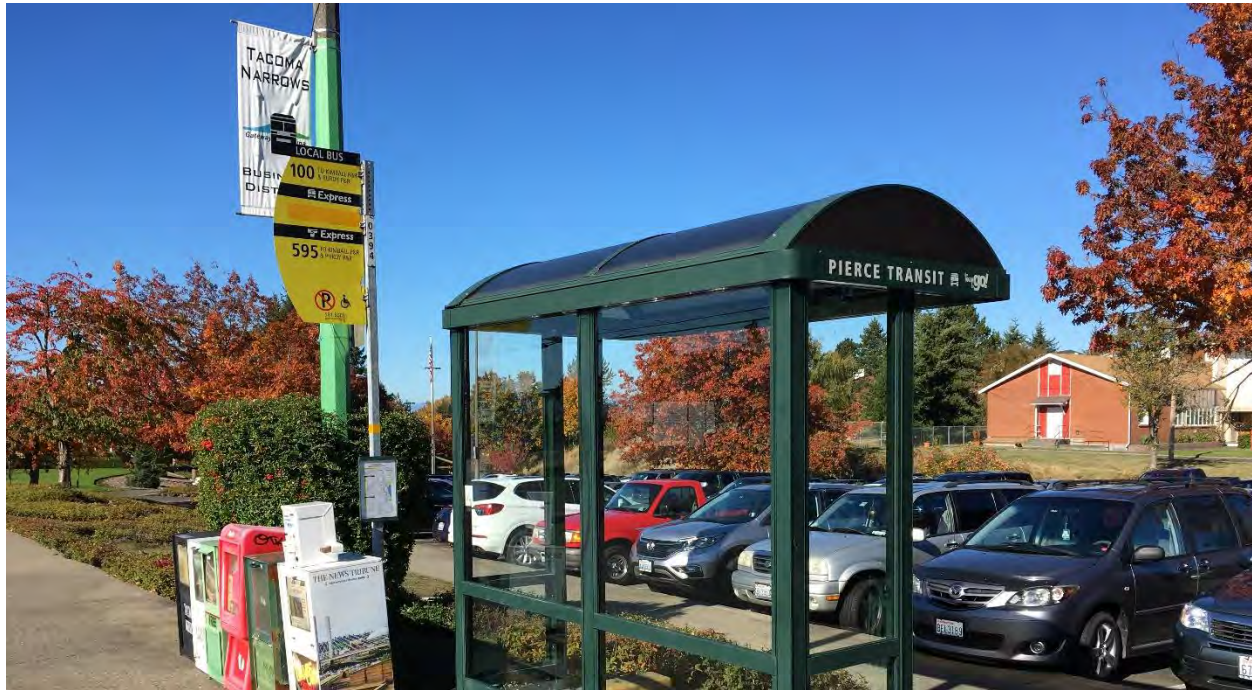
Kimball Drive	Narrows/ Skyline	North Purdy	Point Defiance	WA SR 512
Substructure	4.0	4.0	4.0	4.0	4.0
Shell	3.8	4.0	3.0	3.3	2.5
Interiors	3.1	N/A	N/A	N/A	3.0
Conveyance	N/A	N/A	N/A	N/A	N/A
Plumbing	3.5	3.3	4.0	N/A	3.2
HVAC	3.8	N/A	N/A	N/A	3.1
Fire Protection	N/A	N/A	N/A	N/A	N/A
Electrical	3.5	3.2	4.0	3.5	3.8
Fare Collection	N/A	N/A	N/A	N/A	N/A
Site	2.8	3.2	3.2	3.8	2.2
FACILITY	3.0	3.3	3.3	3.5	2.4
Total Cost for Recommended Actions	\$10,100	\$20,100	\$23,500	\$13,000	\$364,250
Total Cost for all Parking Facilities: \$430,950

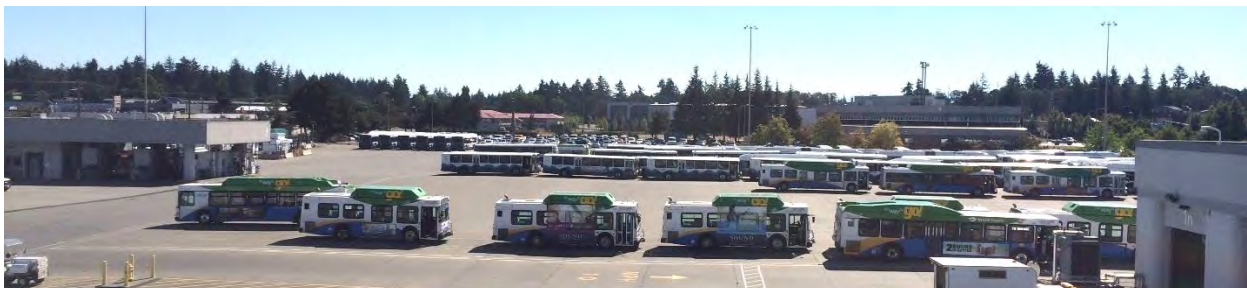
In addition to AIM reporting, the TAM rule requires asset inventory and condition assessments at a level of detail sufficient to monitor and predict the performance of assets and to inform investment prioritization in the TAM Plan. Facility condition assessments must be conducted by assessing the condition of and assigning a rating for facility assets using FTA’s Transit Economic Requirements Model (TERM) Local Investment Tool Edition (Lite) scale. TERM is the capital needs analysis tool used by FTA to provide analysis of transit investment scenarios at a national level and is an extensive database of industry assets. TERM Lite is a similar tool developed specifically for local agencies for use in long-range capital planning and budgeting.

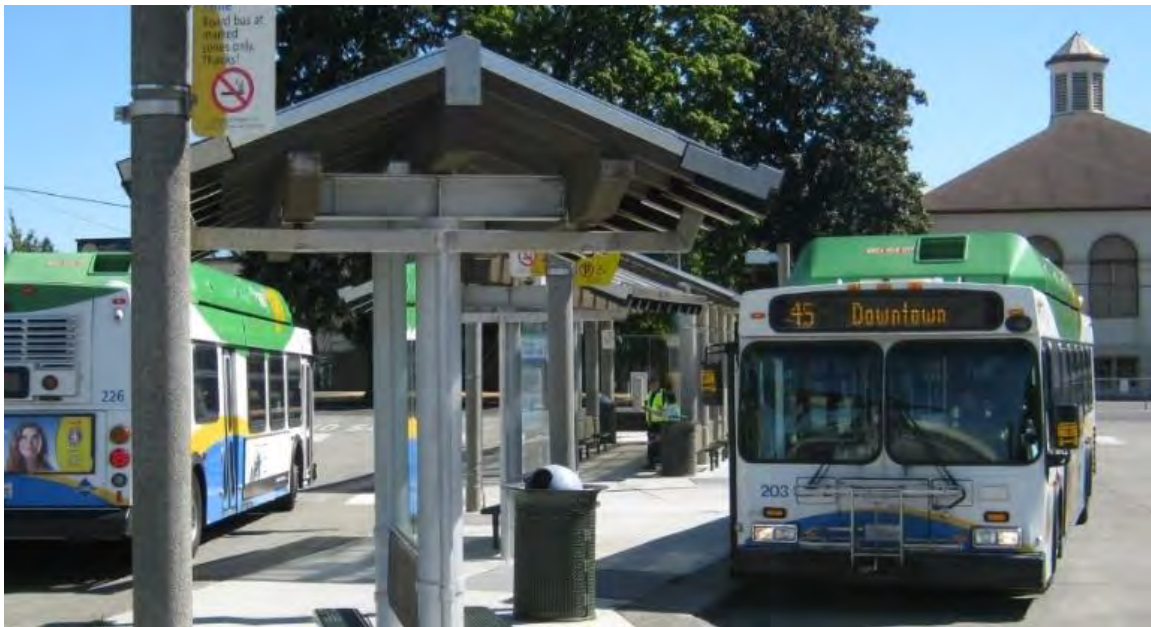
⁶ Since 2011, Pierce Transit has used VFA.facility to manage facility condition information. VFA.facility is a web-based database tool designed to help the agency gather and maintain accurate information about facilities condition requirements and is used to aid in capital planning and budgeting.

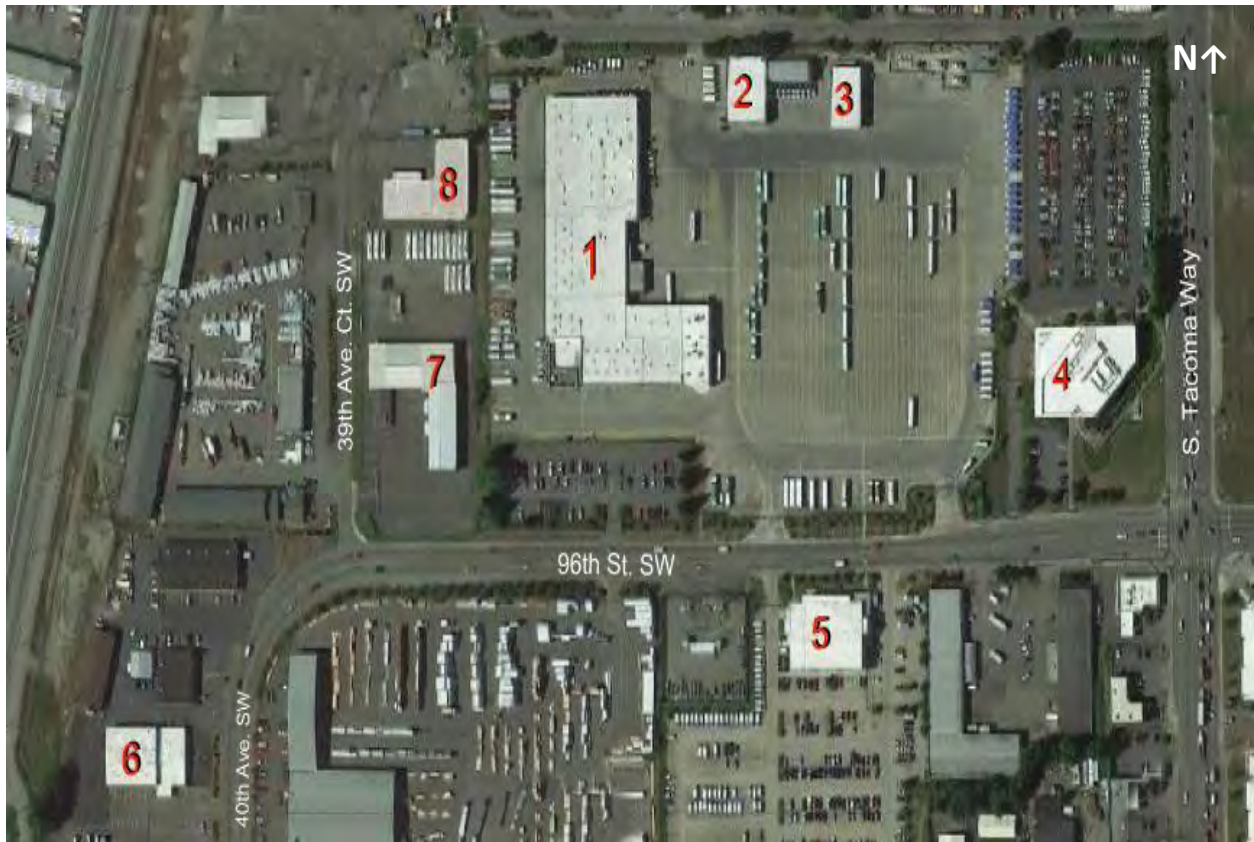
Figure 1. Pierce Transit Administrative and Maintenance Facility Building Locations

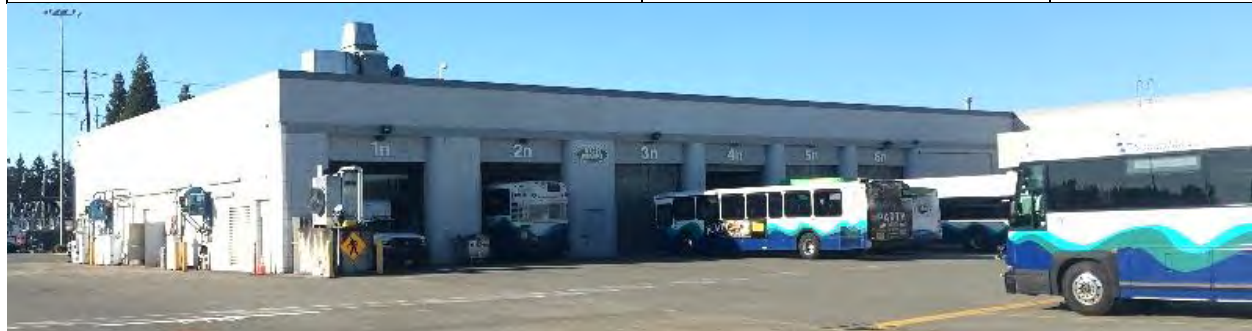
3.1.2 Building 2 – Facilities and Bus Wash

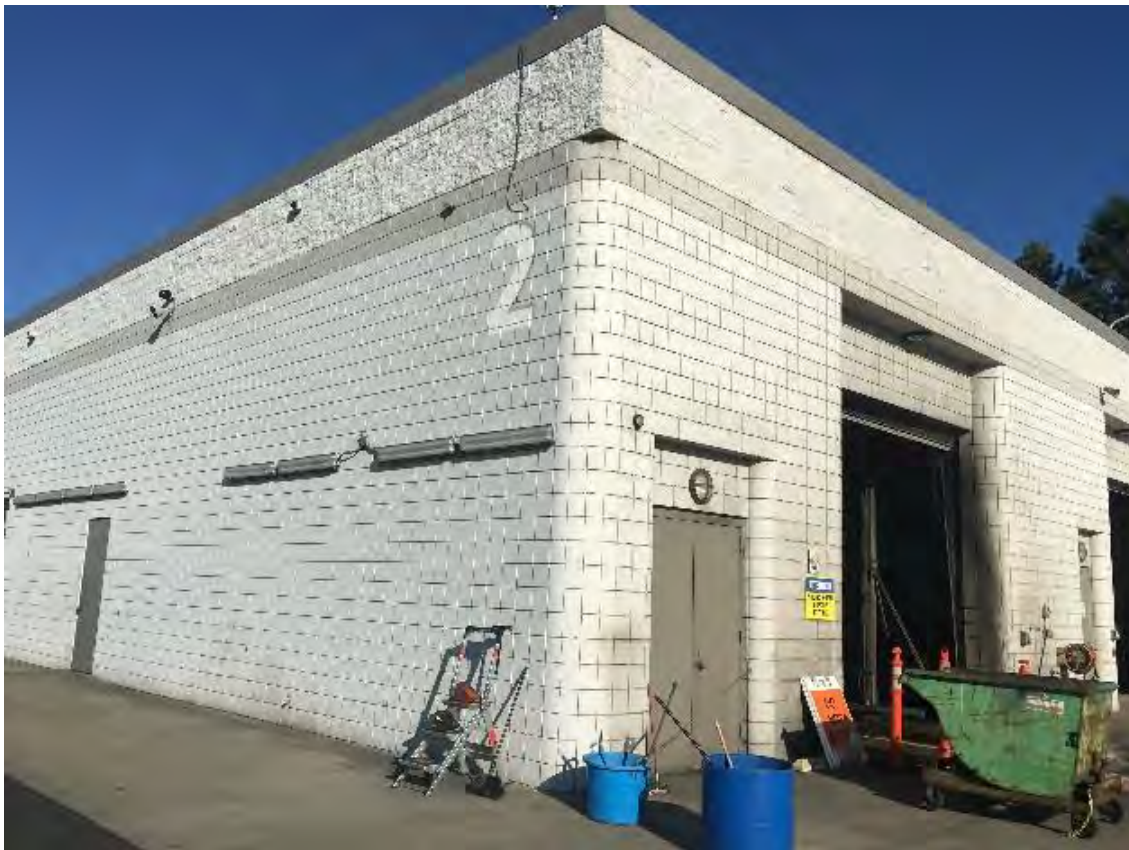
3.1.3 Building 3 – Fuel House

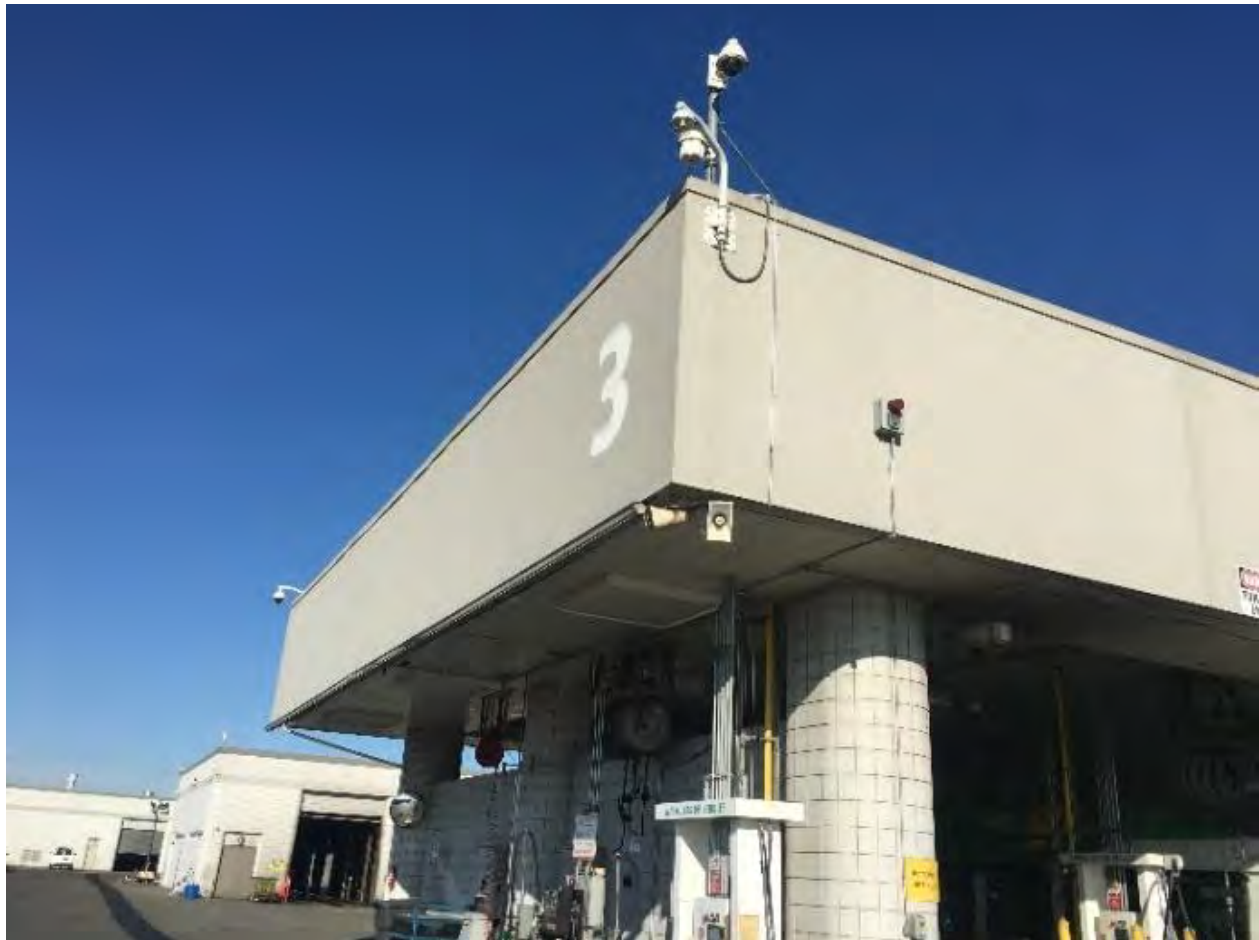
3.1.4 Building 4 – Administration

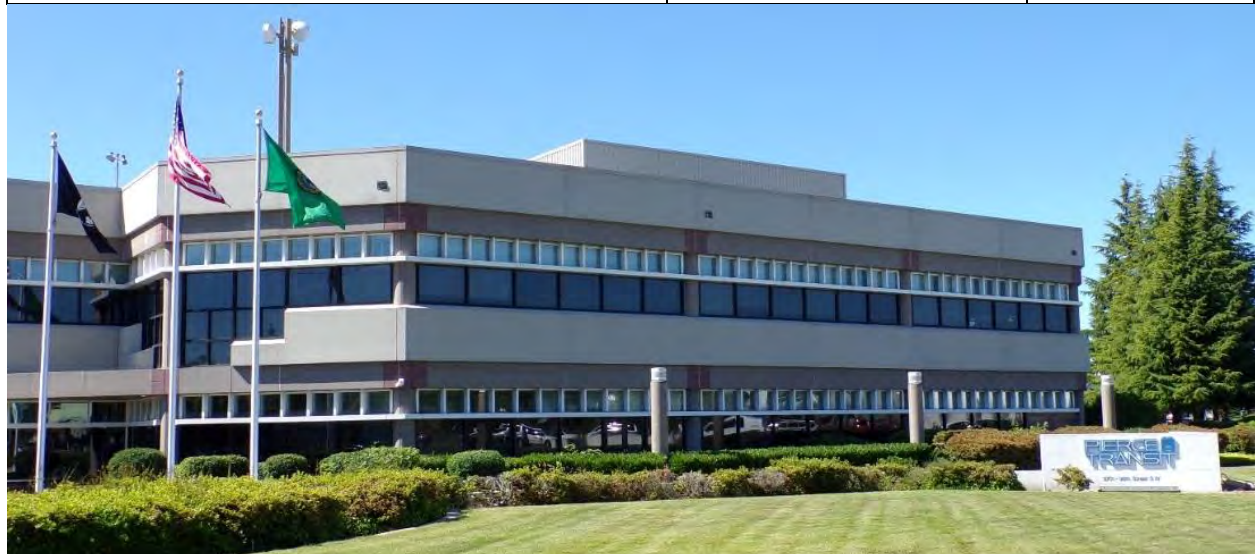
3.1.5 Building 5 –Training Center

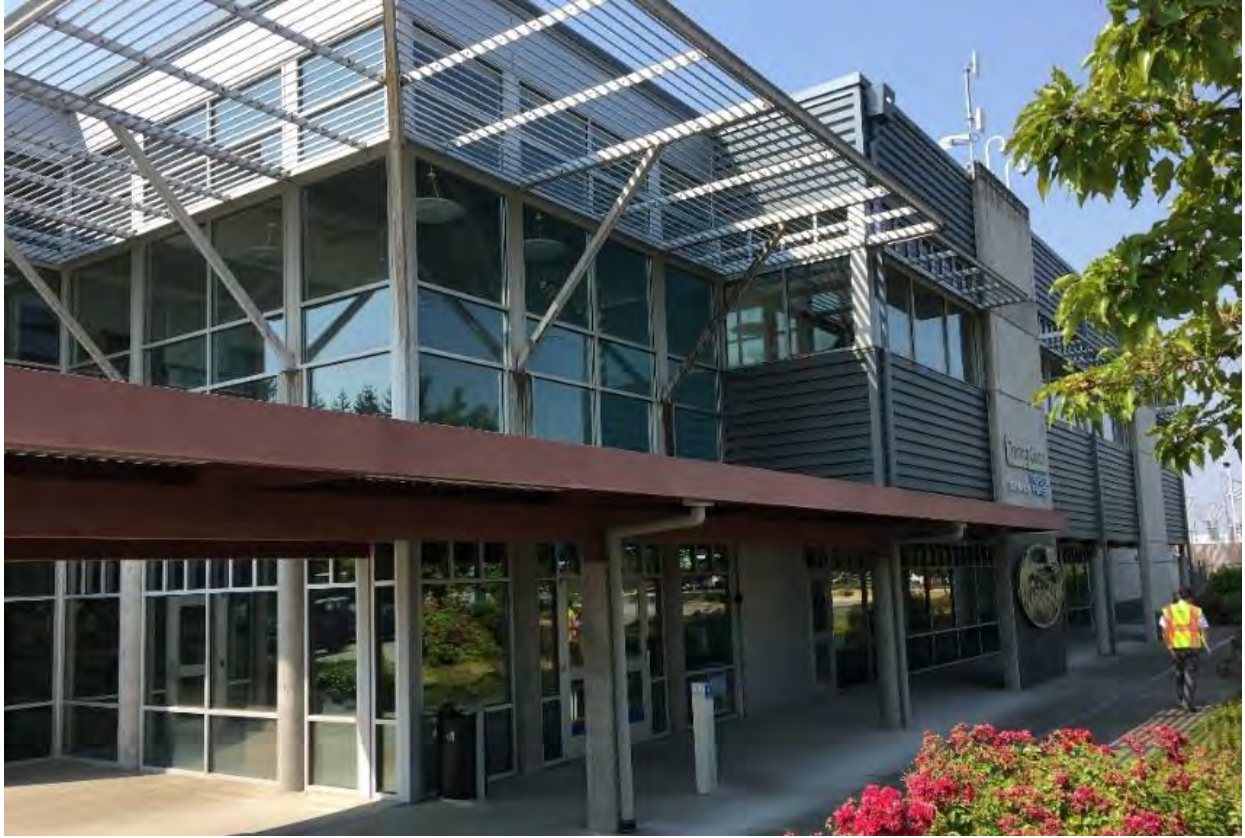
3.1.6 Building 6 – (Agency’s Occupant or Purpose to be Determined)

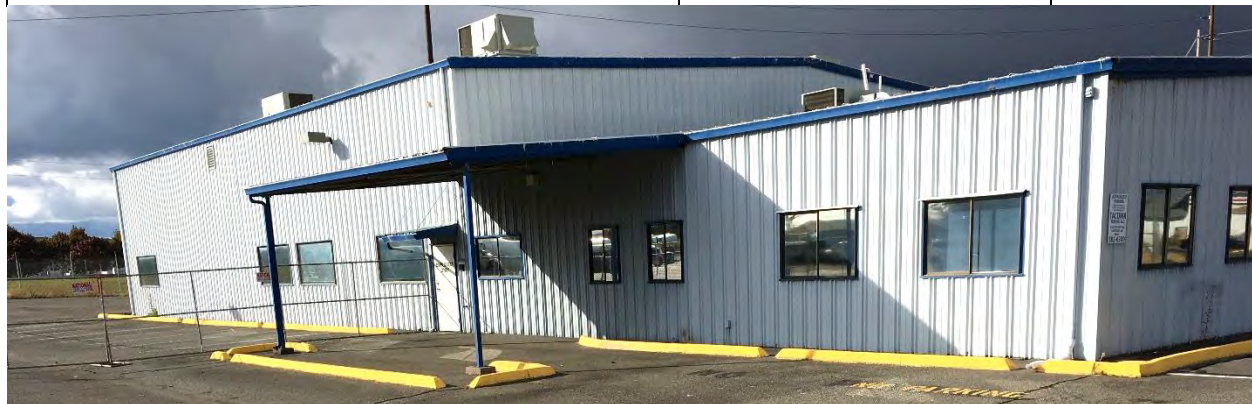
3.1.7 Building 7 – Radio and Service Supervisors Building

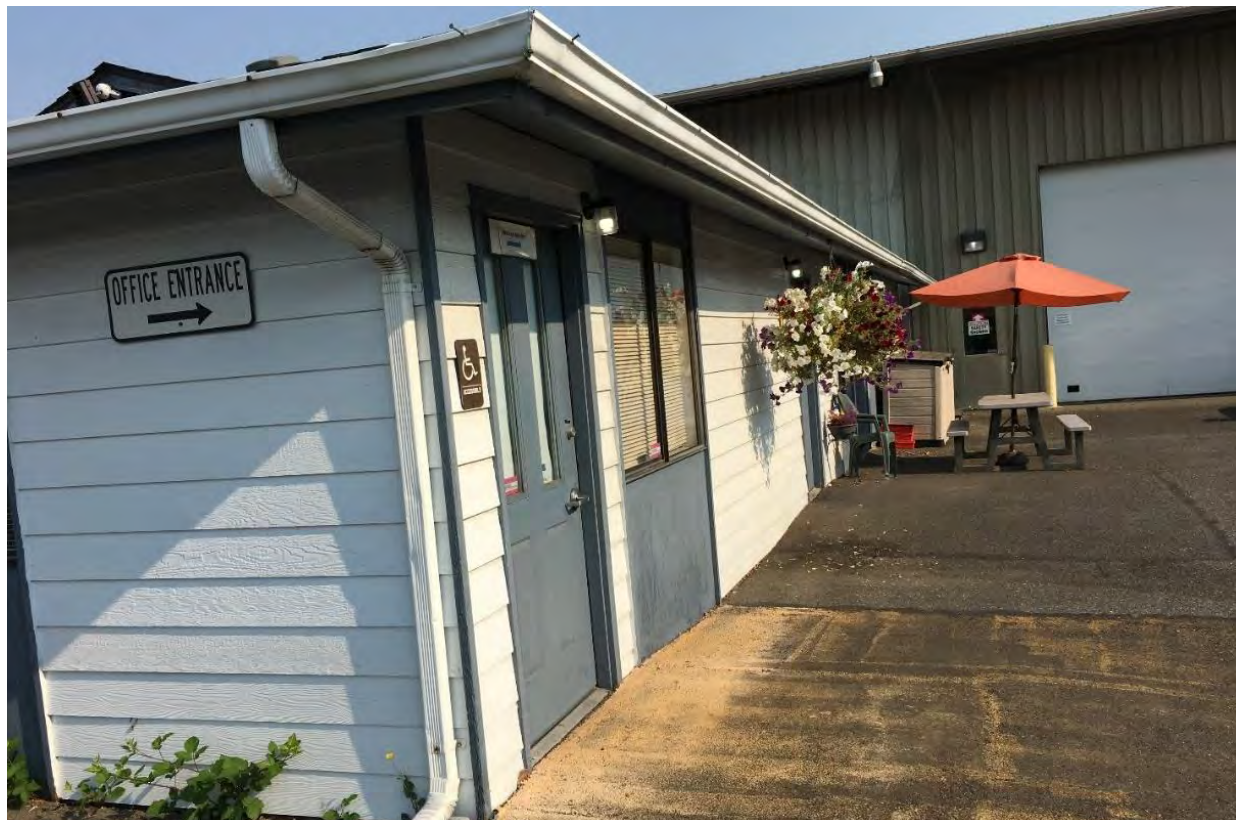
3.1.8 Building 8 – Screaming Eagle Warehouse

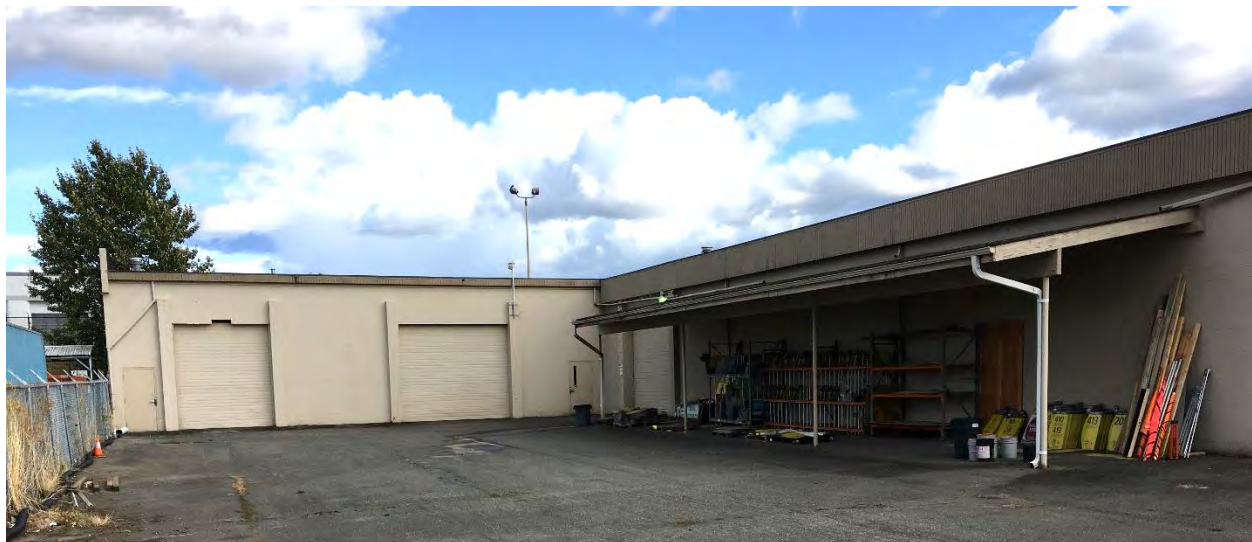
4. PASSENGER AND PARKING FACILITY CONDITION RATINGS

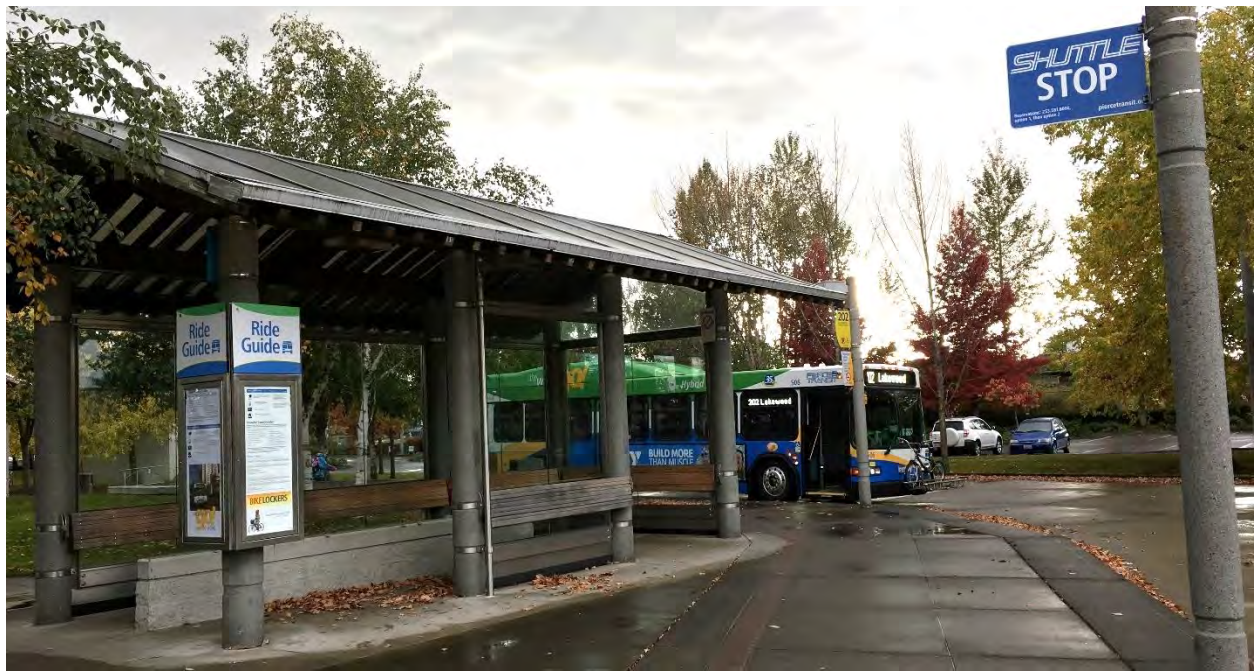
4.2.2 Commerce Street Transfer Center

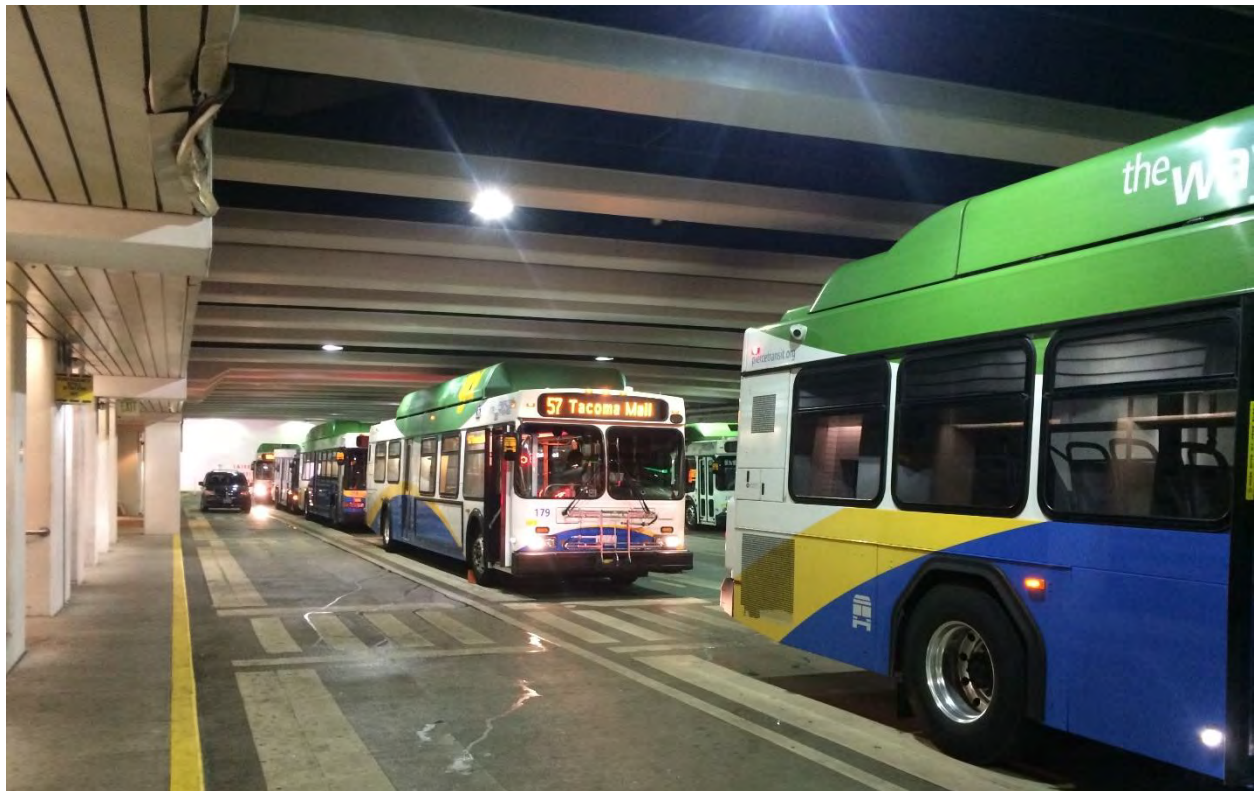
4.2.3 Lakewood Towne Center Transit Center

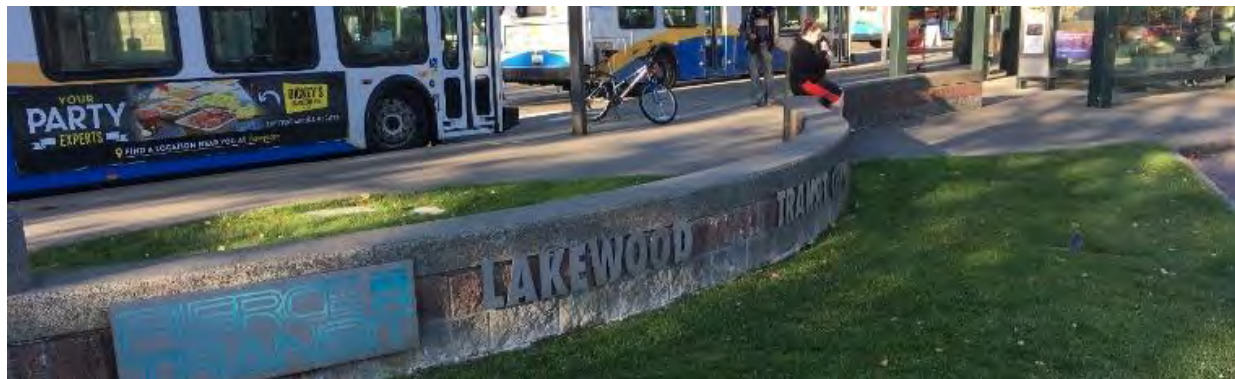
4.2.4 Parkland Transit Center

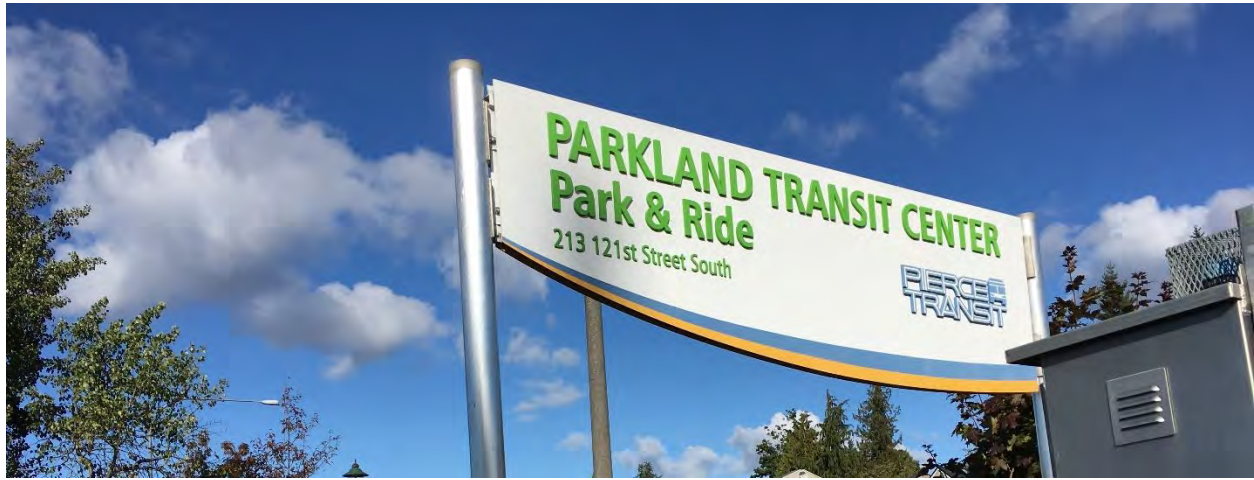
4.2.5 South Hill Mall Transit Center

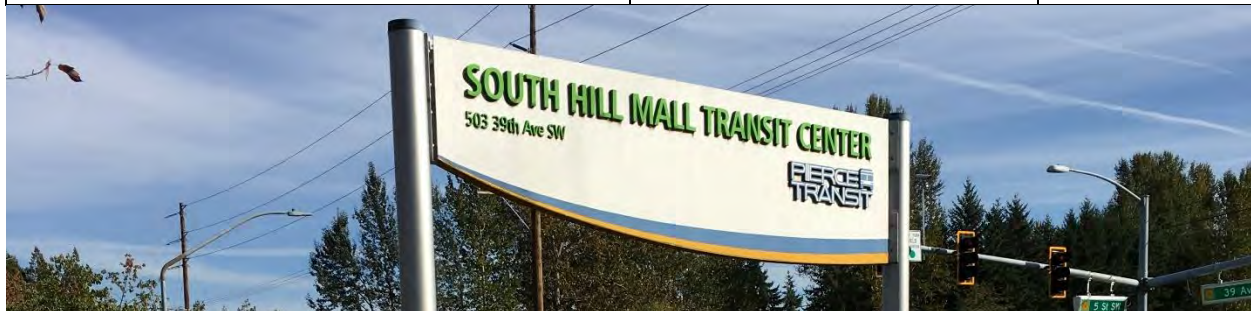
4.2.6 Tacoma Community College Transit Center

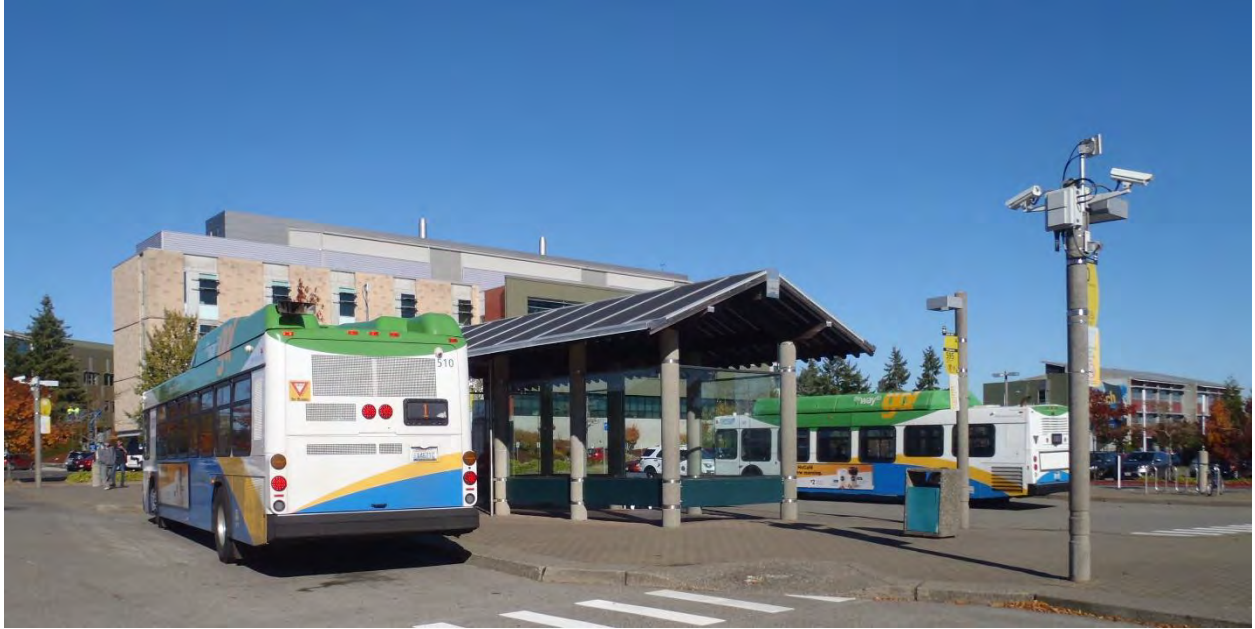
4.2.7 Tacoma Dome Station

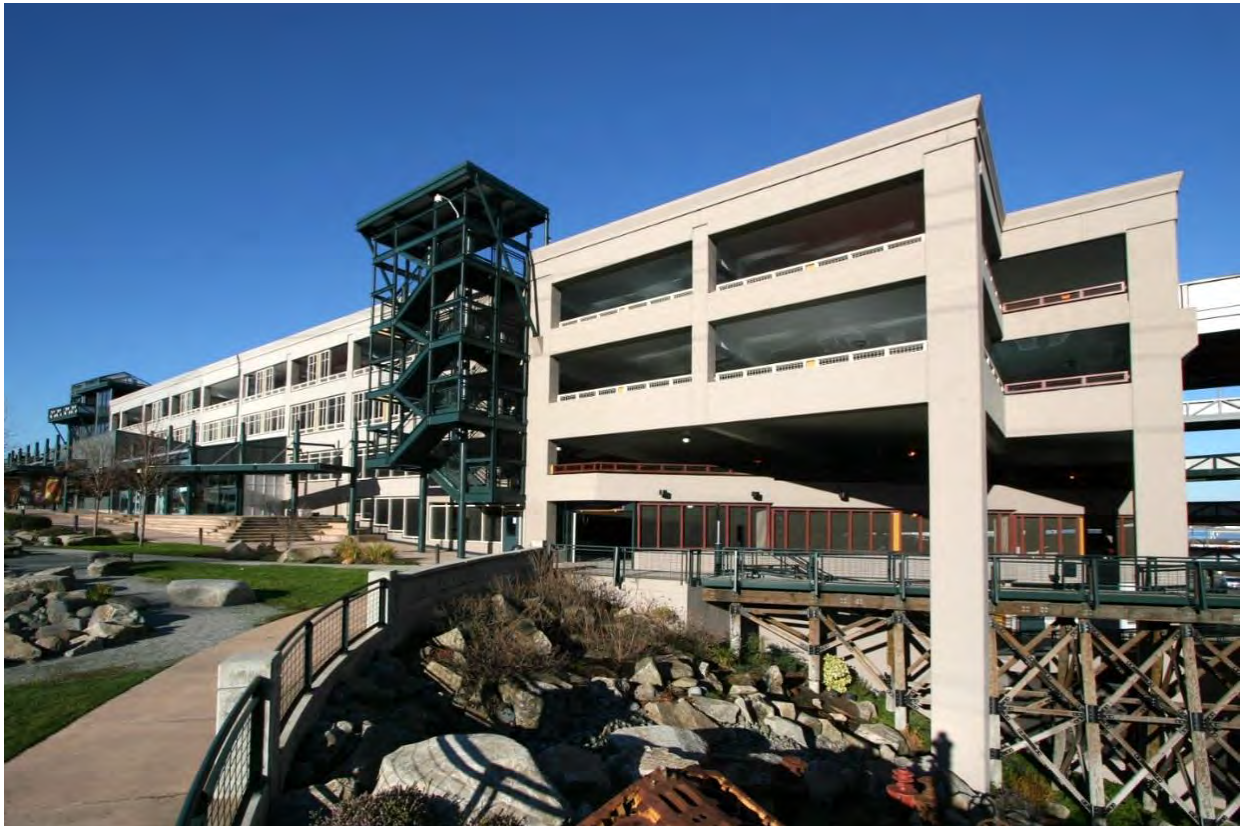
4.2.8 Tacoma Mall Transit Center

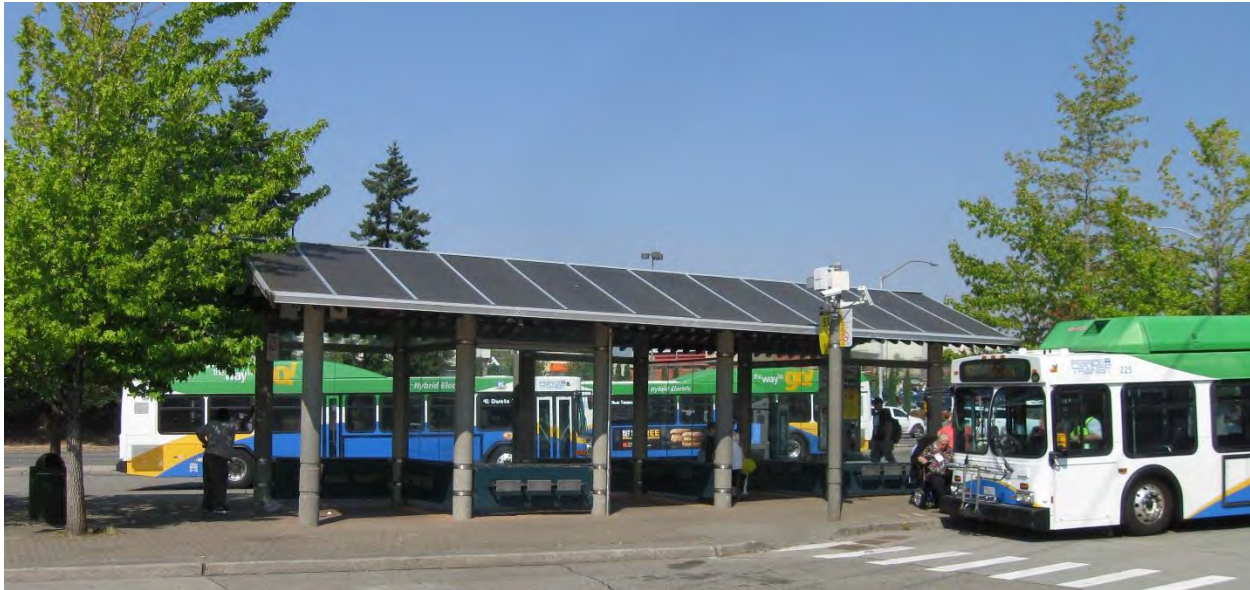
4.3 Parking Facility Condition Ratings

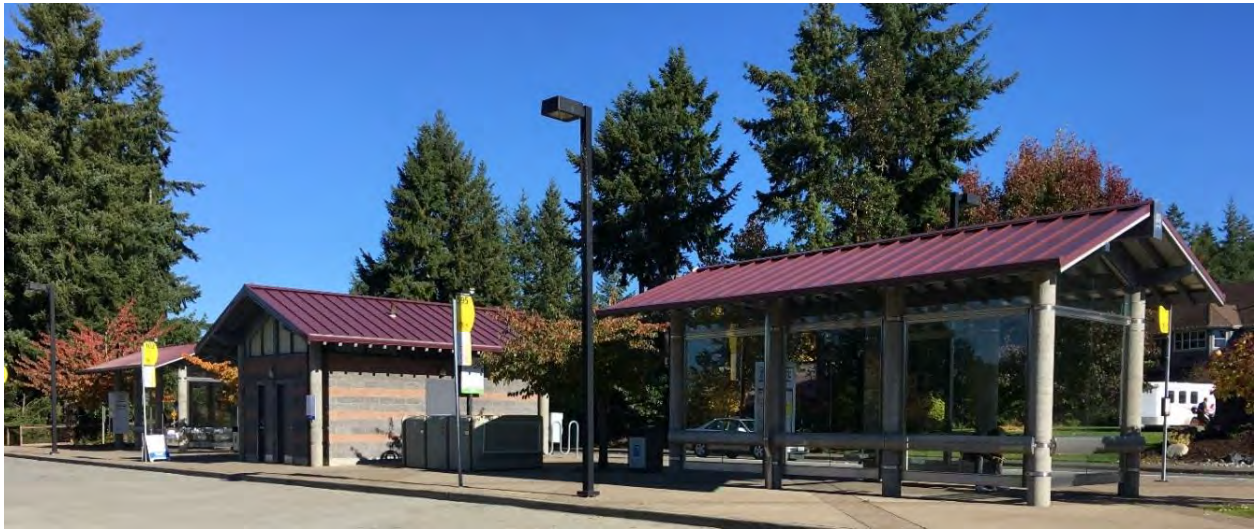
4.3.2 Narrows/Skyline Park-and-Ride

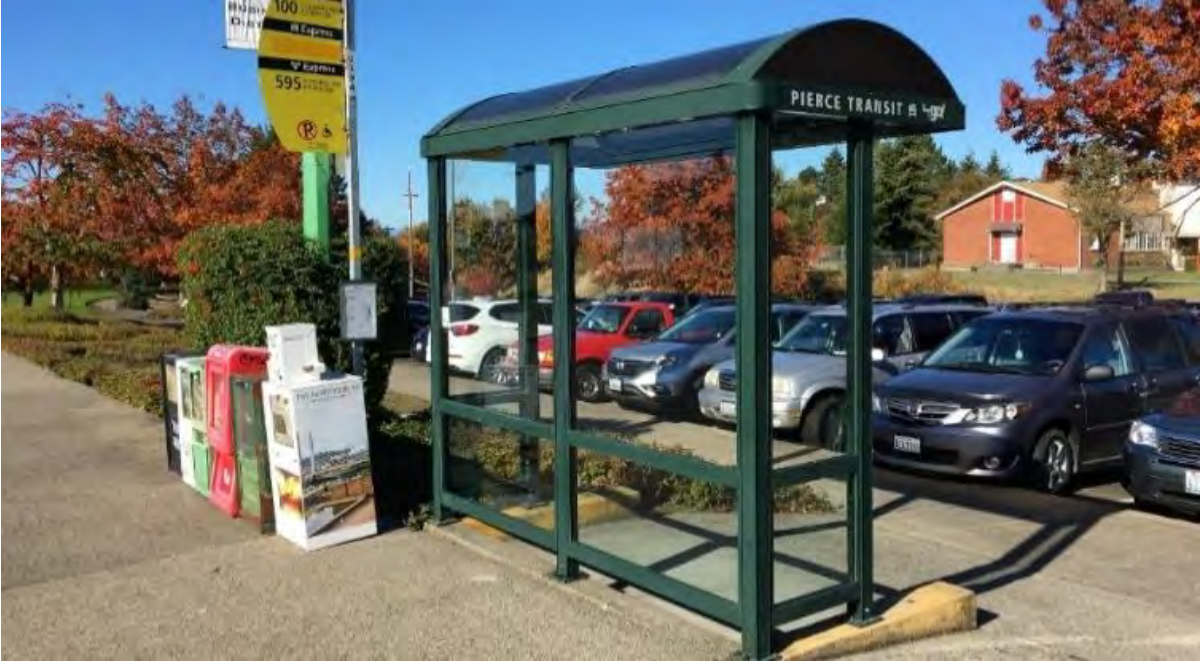
4.3.3 North Purdy Park-and-Ride

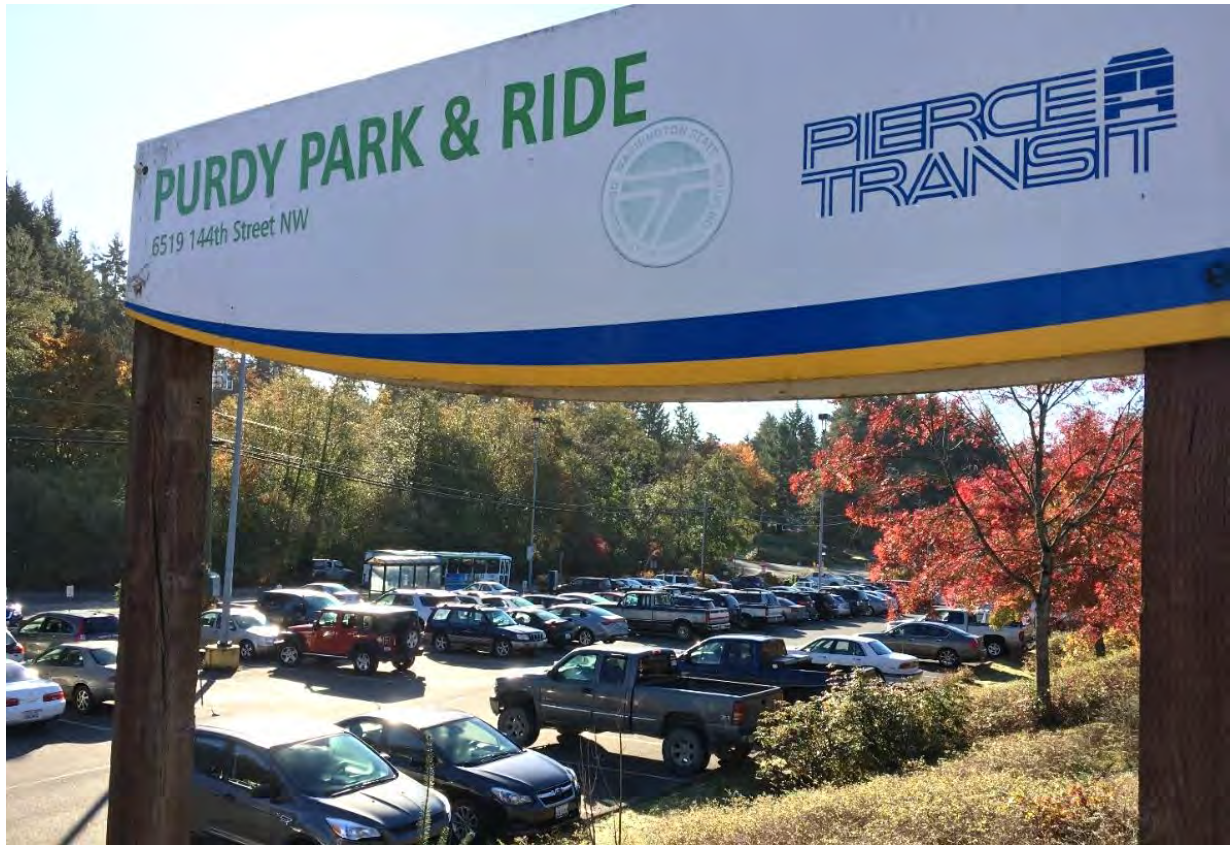
4.3.4 Point Defiance Bus Layover Facility

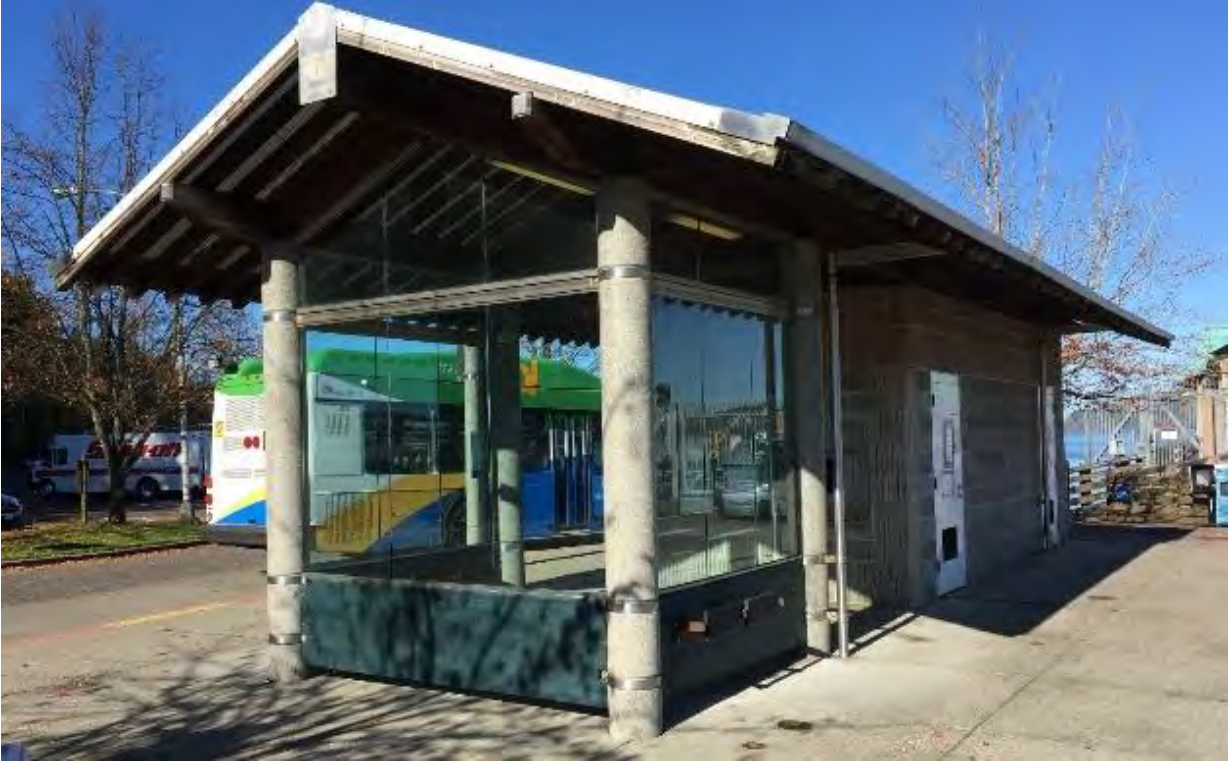
4.3.5 WA State Route 512 Park-and-Ride

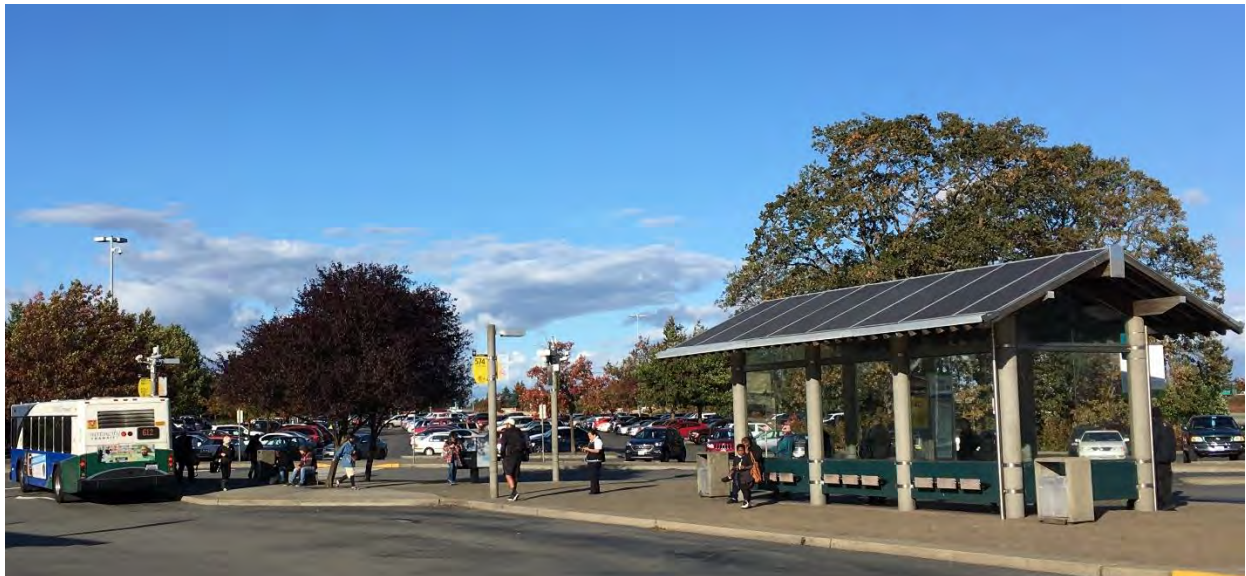
5. FACILITY GROUP PERFORMANCE MEASURES

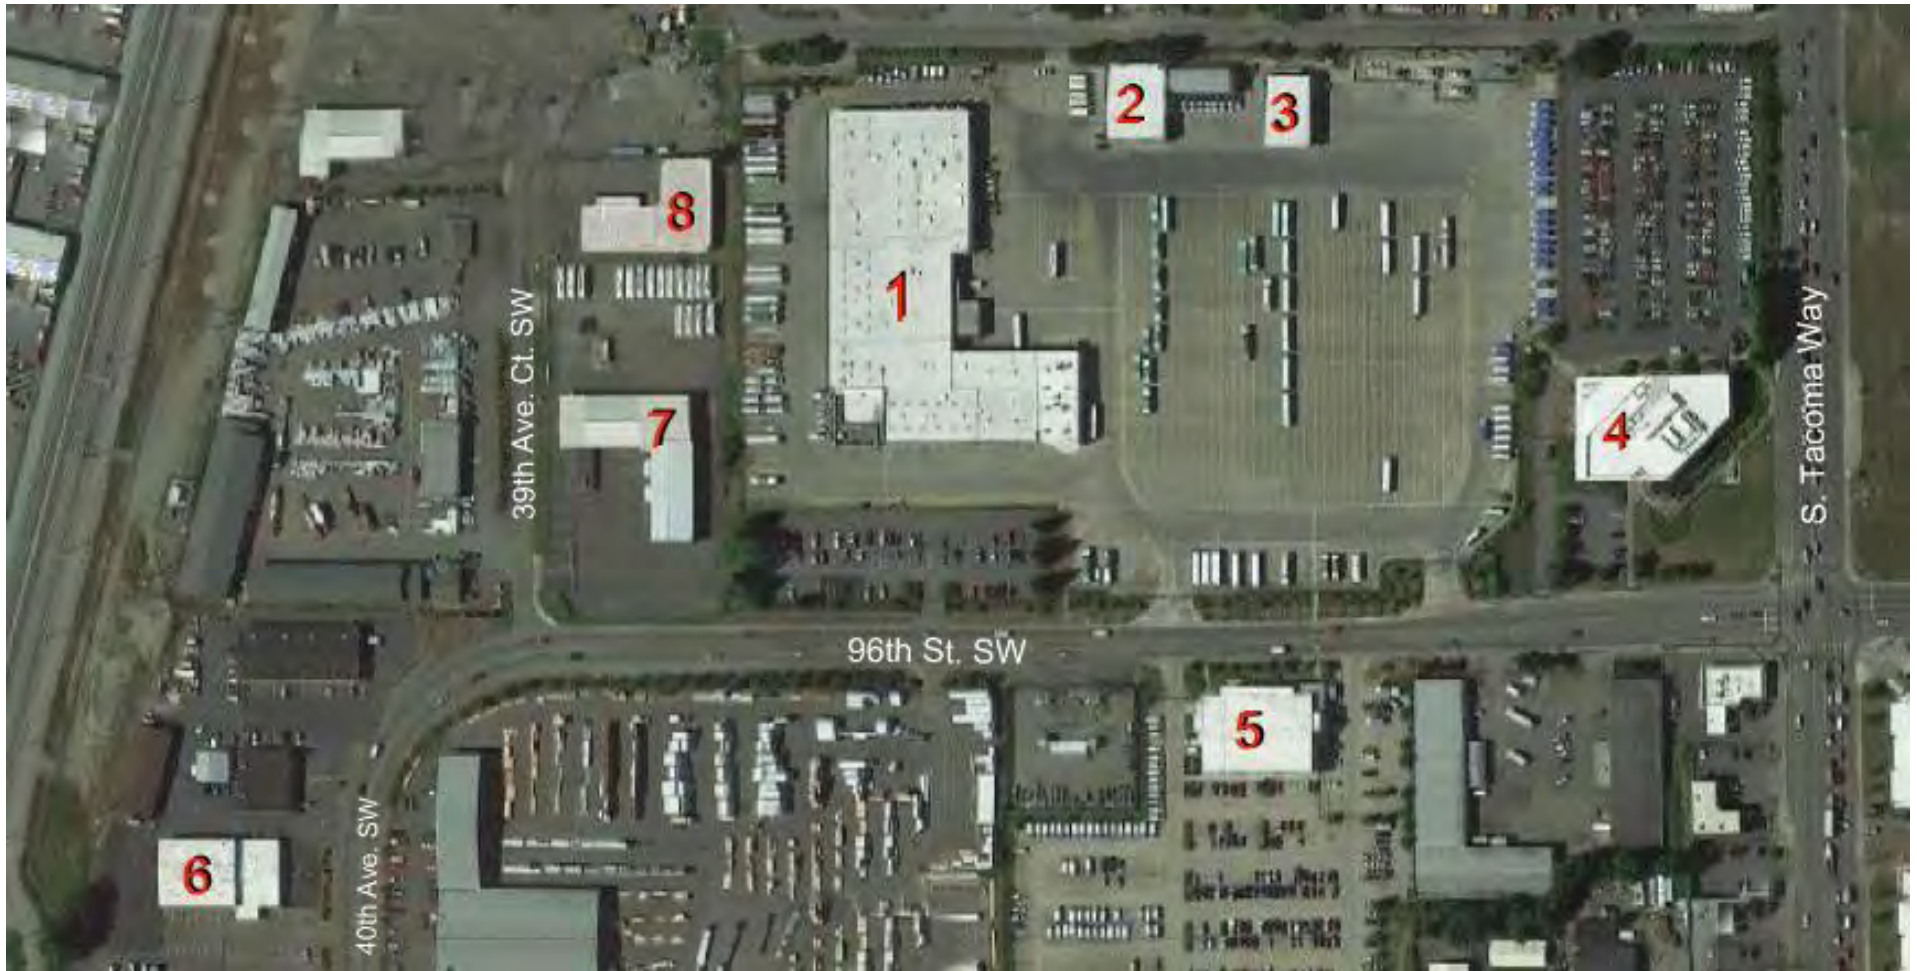
Facility Condition Assessment

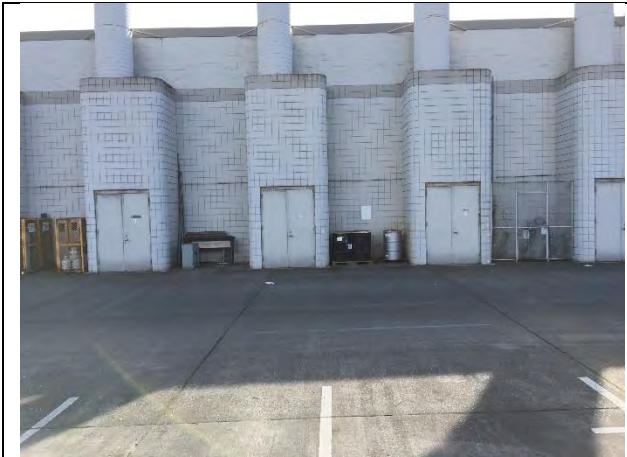
Shell appurtenances	Balconies, fire escapes, gutters, downspouts.	All exterior shell appurtenances are in functional and in good condition.	4.2	None	N/A
