Pierce Transit Facilities Condition Assessment Report

Prepared for

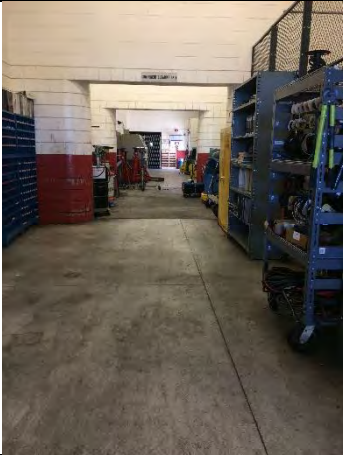
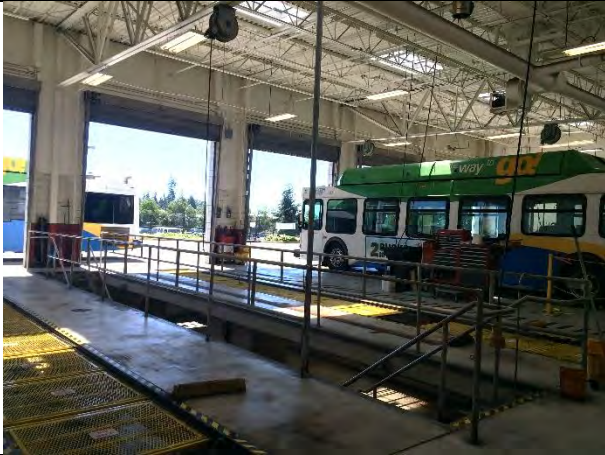
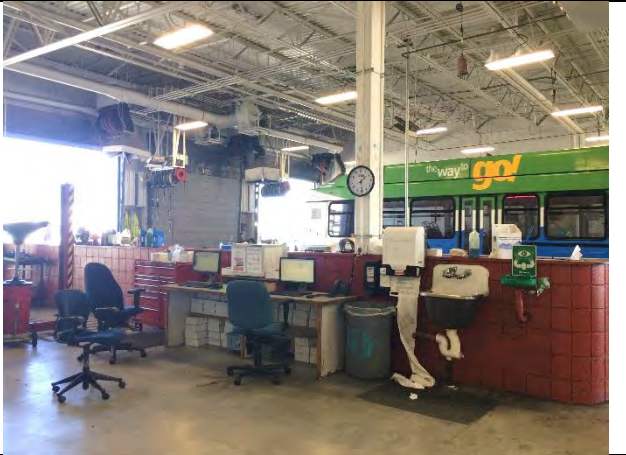
Building interior		Building interior		Building interior

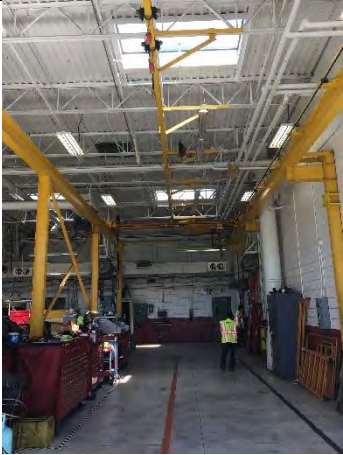
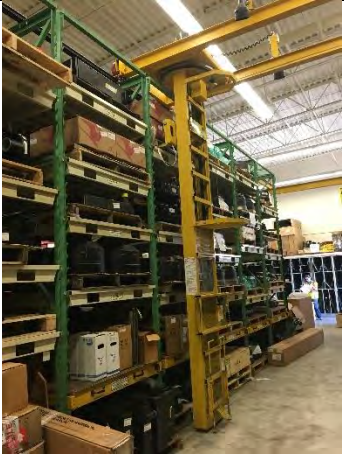
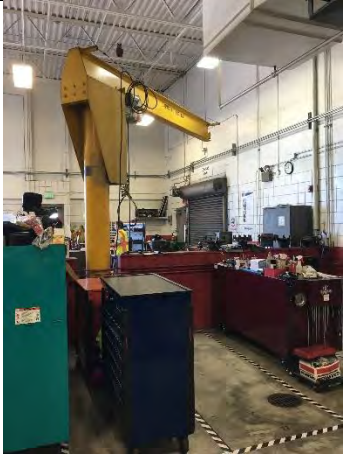
Running Repairs Service Bay - 1 ton bridge crane		Warehouse - 1 ton Stanley Vidmar STAK adjustable racking system		Main Service Bay - ½ ton jib crane

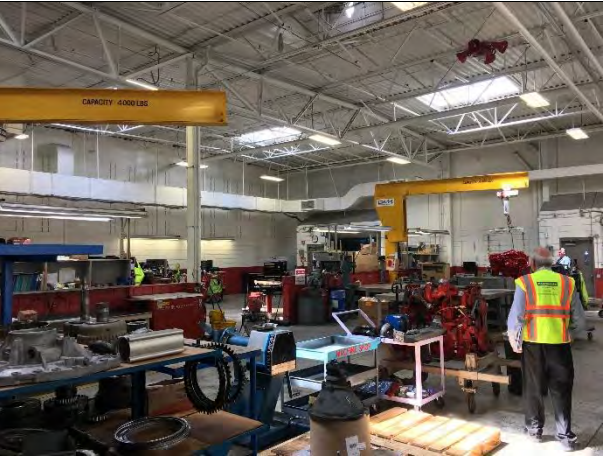
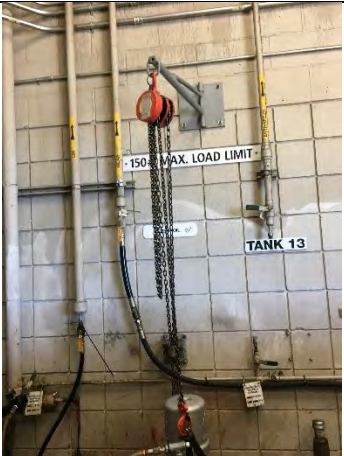
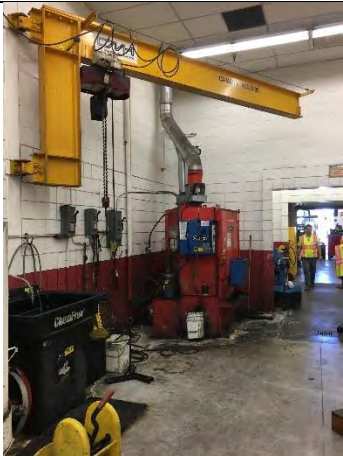
Component Rebuild Room - One 1 ton and three 2 ton jib cranes		Lube/Compressor Room - 150 pound manual chain hoist		Wash Room - 2 ton wall mounted jib crane

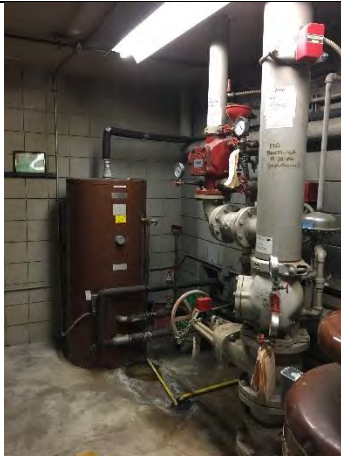
Hot water tank has exceeded expected typical lifespan

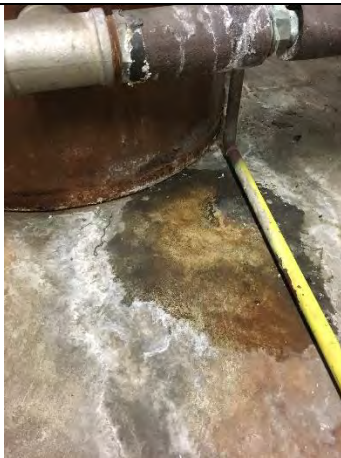
Slow leak near the larger water heater in the mechanical room

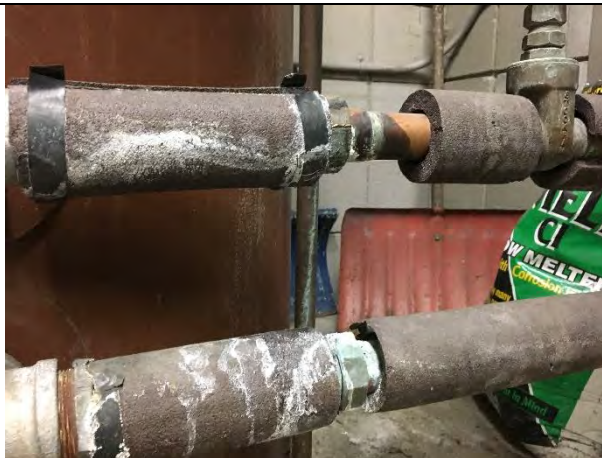
Slow leak near the larger water heater in the mechanical room

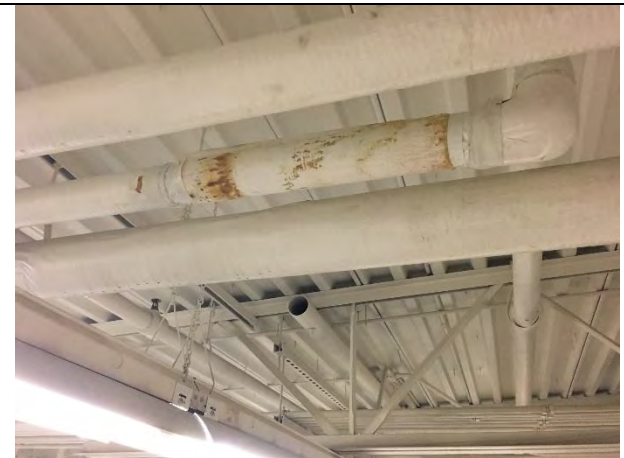
Evidence of repaired water distribution piping from small leaks

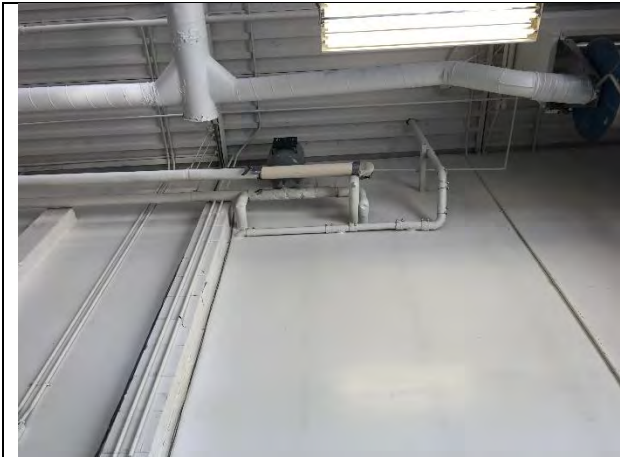
Evidence of repaired water distribution piping from small leaks

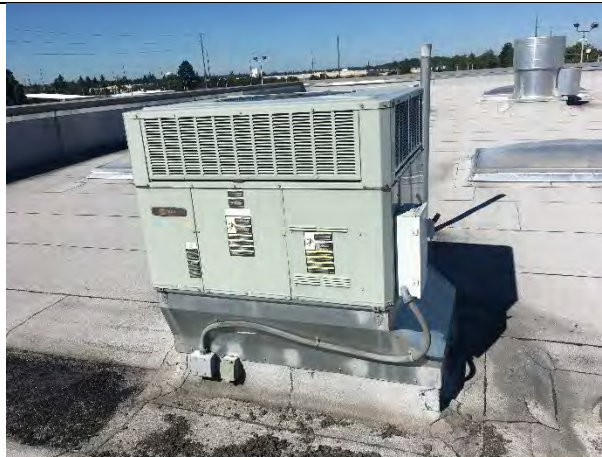
Evidence of low area on roof that collects water and debris from not draining properly

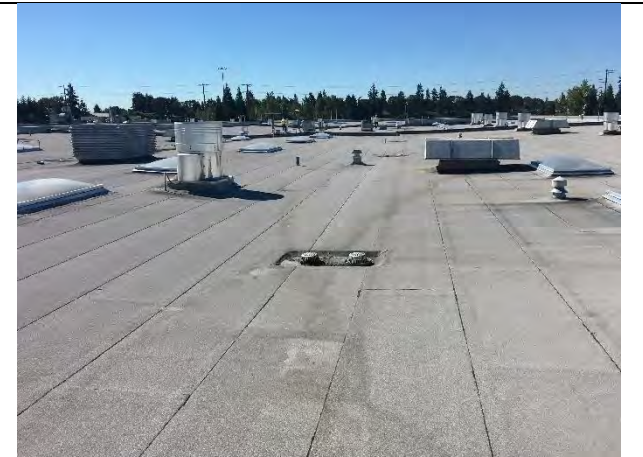
Most of the roof area drains properly

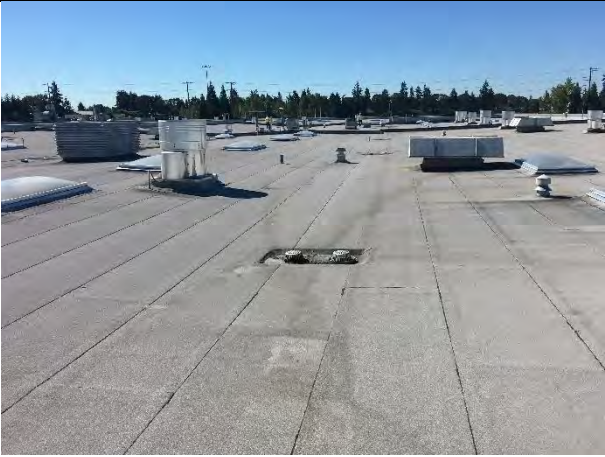
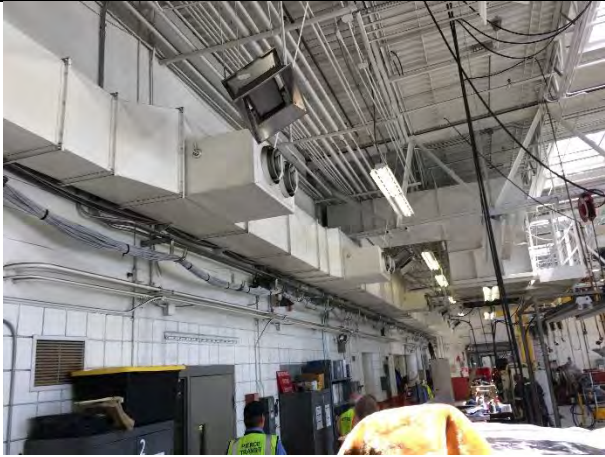
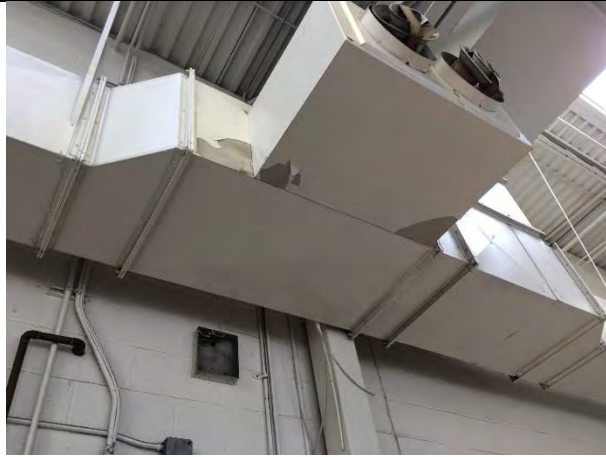
Roof mounted cooling units and exhaust fans		Radiant heaters no longer in use		Paint peeling off the ducts in the support vehicle shop

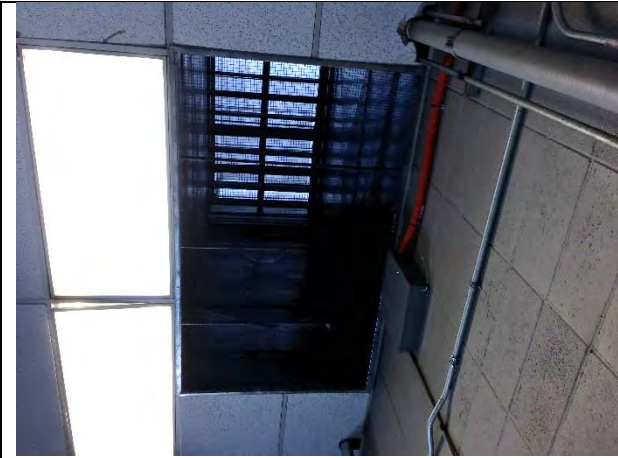
Generator intake vent

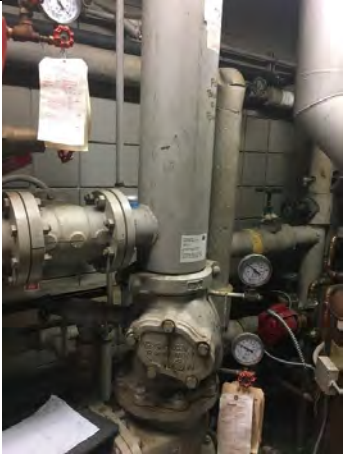
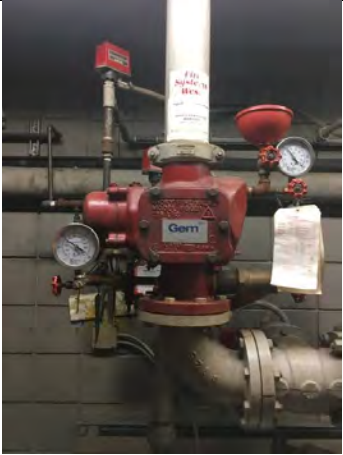
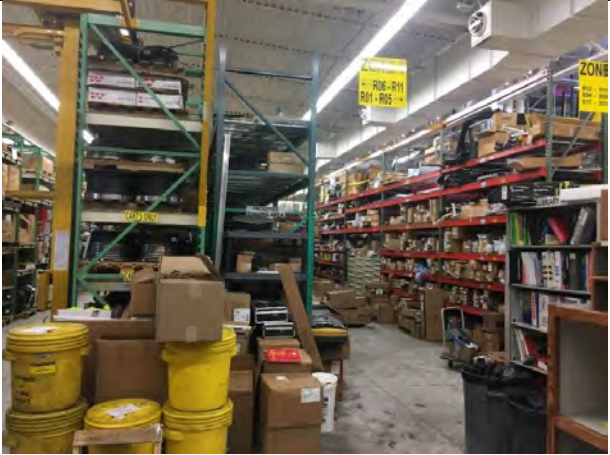
Fire riser #1 (Wet System)		Fire riser #1 (Dry System)		Shelf storage

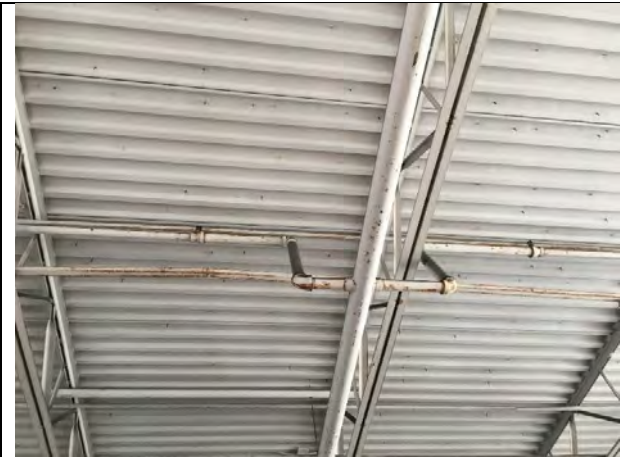
Rusted exterior dry system piping

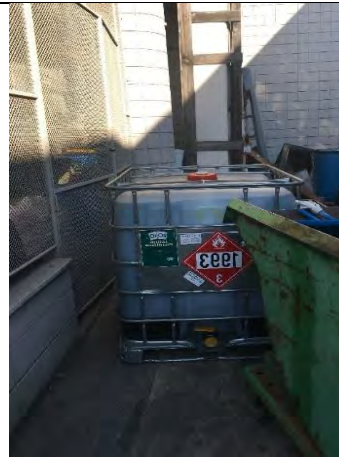
Windshield wiper fluid

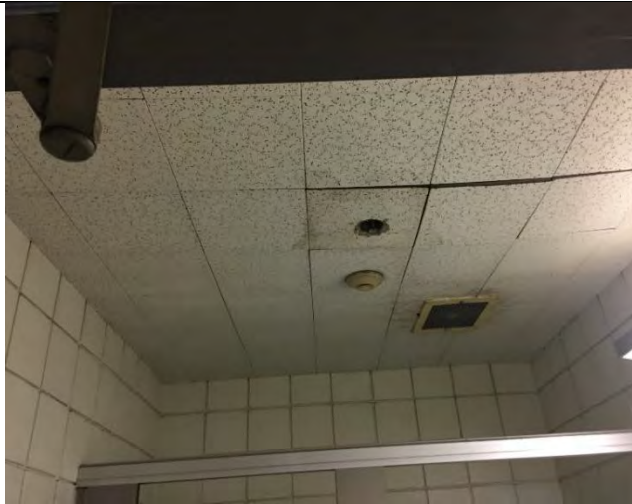
Paint area restroom sprinkler head

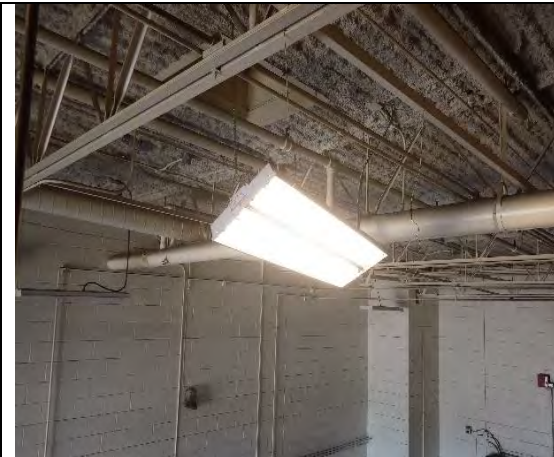
One light in tire shop

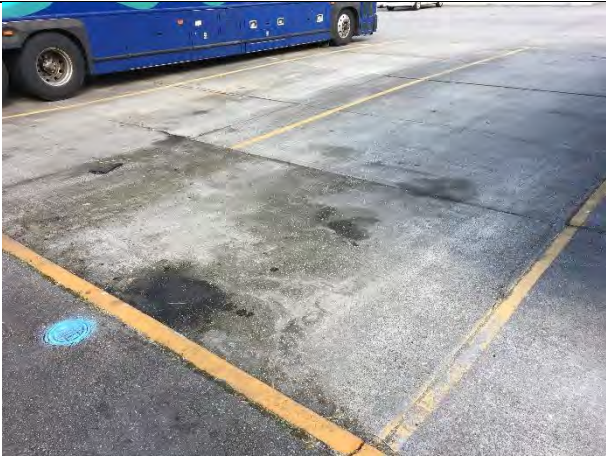
Low spot in concrete and sidewalk on southwest side of building that has settled

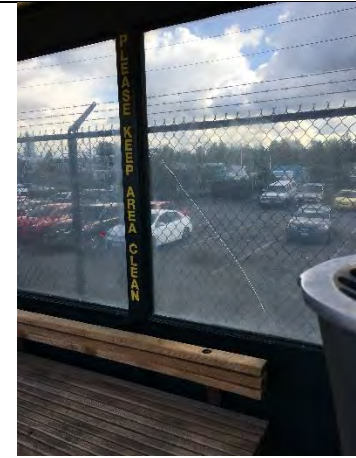
Smoking shelter window is cracked

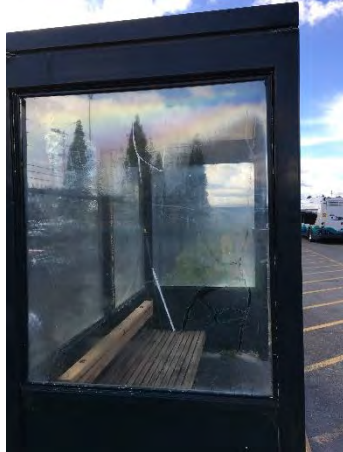
Smoking shelter window tint is splitting

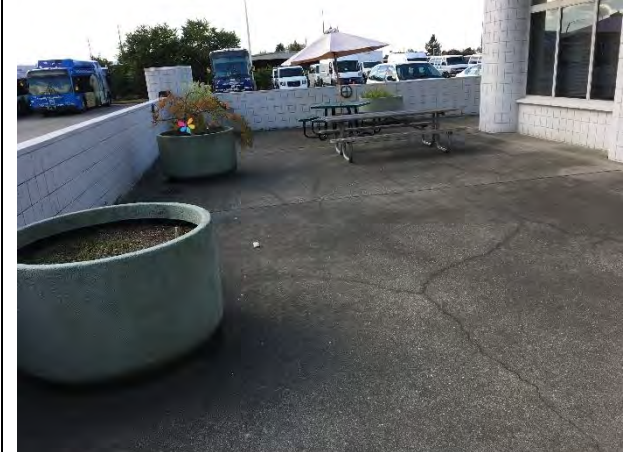
Cracked concrete slab on patio, outside lunch room

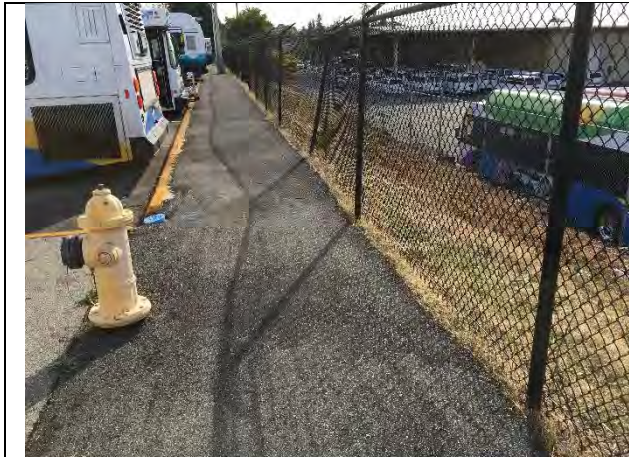
Vertical fence posts are bowed out and the top rail has been bent.

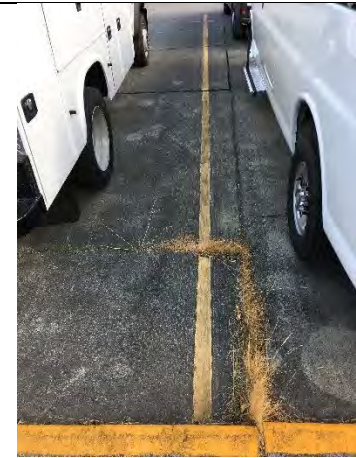
Cracks in panels on the southwest side of the building

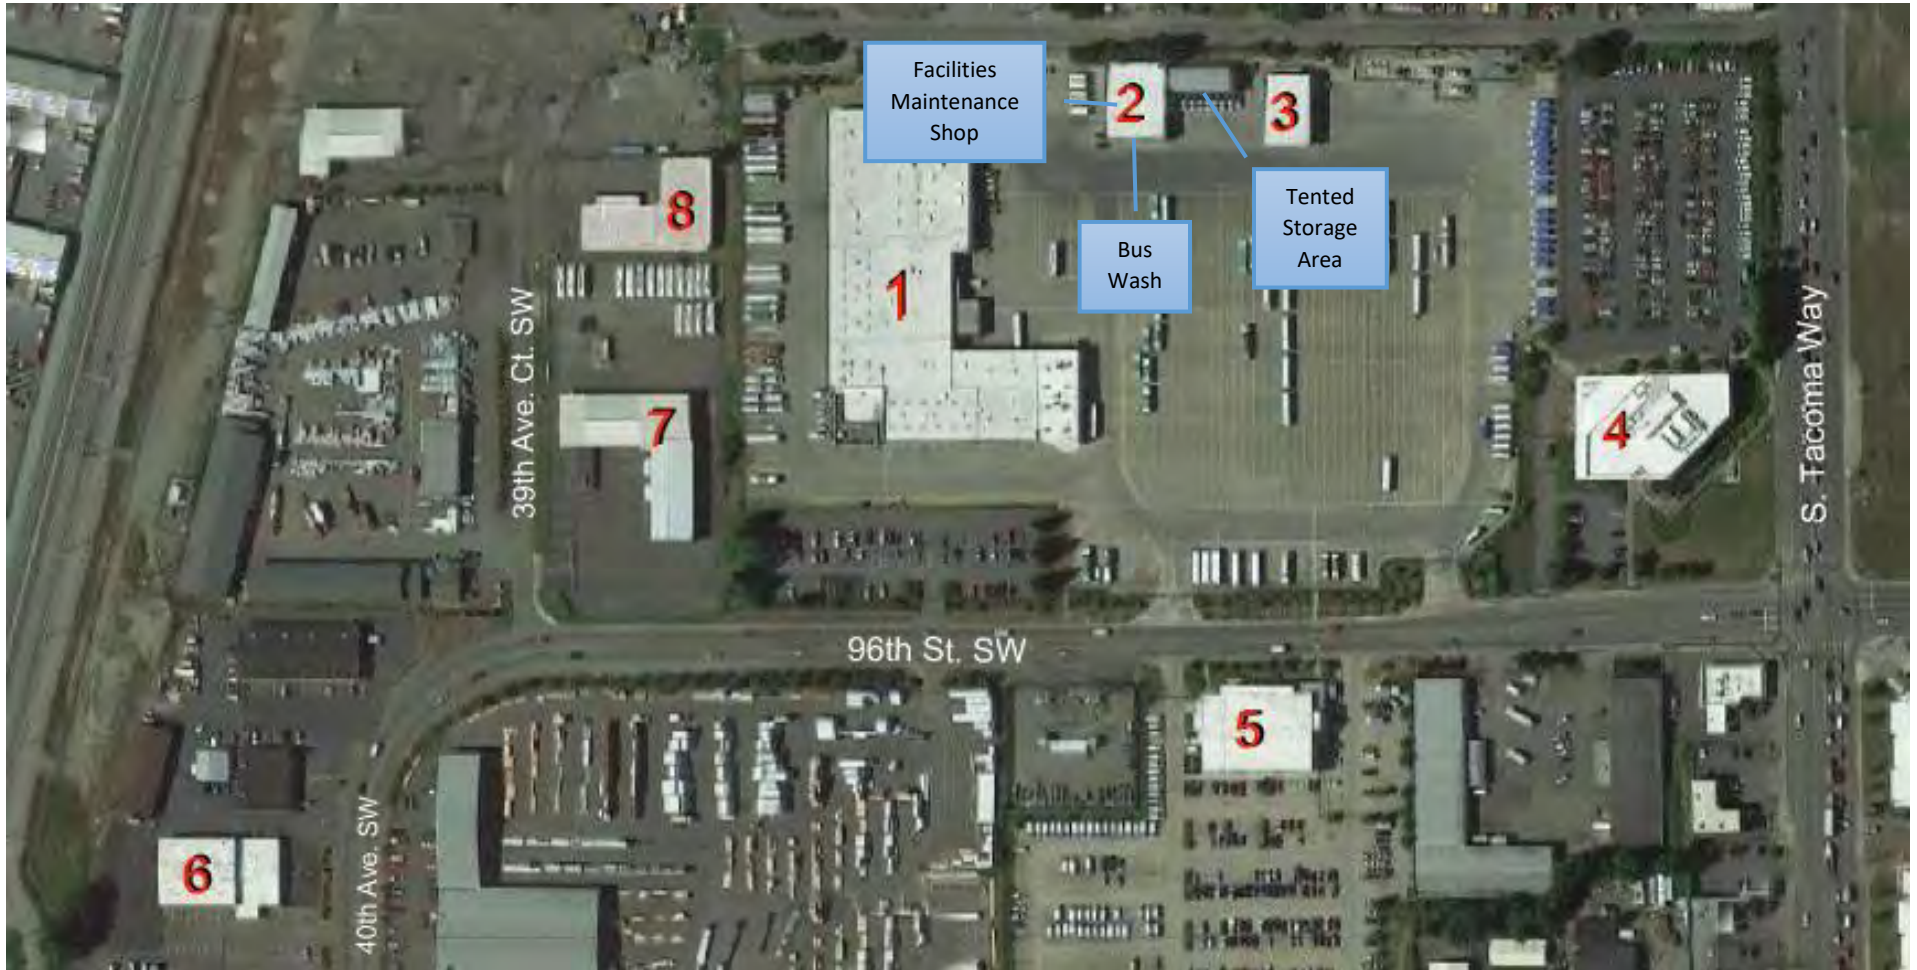
Facility Condition Assessment

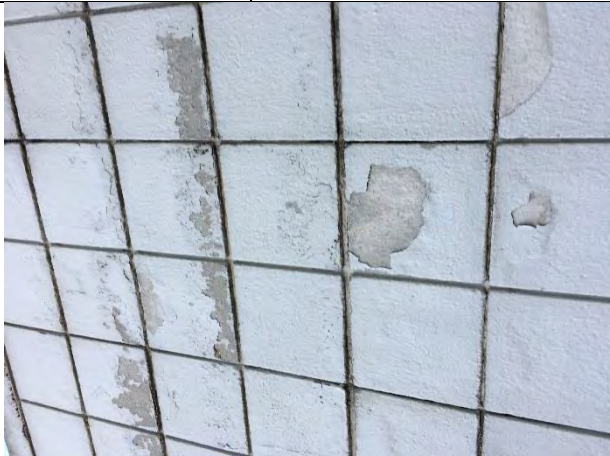
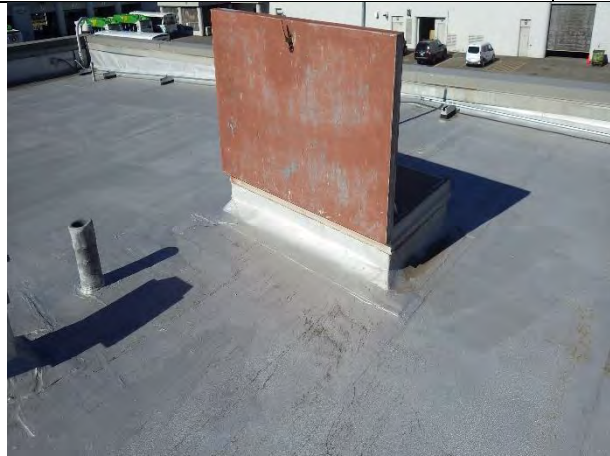
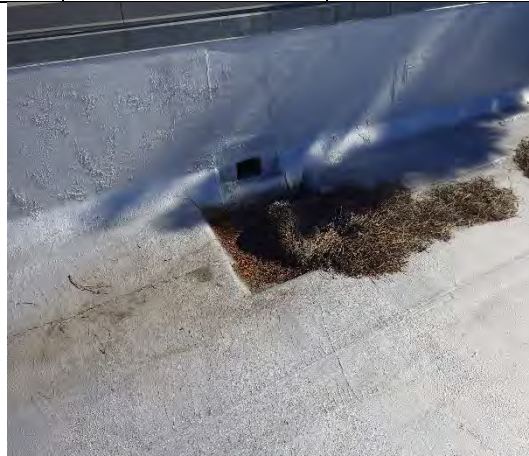
Peeled and chipped paint on north and south walls		Some alligatoring on roof coating		Drain on roof that is partially clogged with pine needles

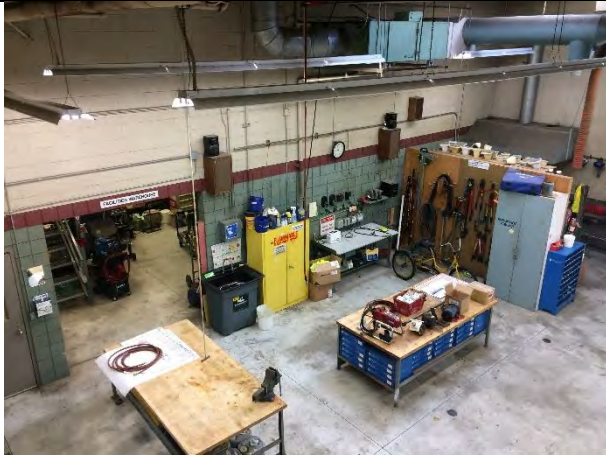
Interior of shop, looking northeast

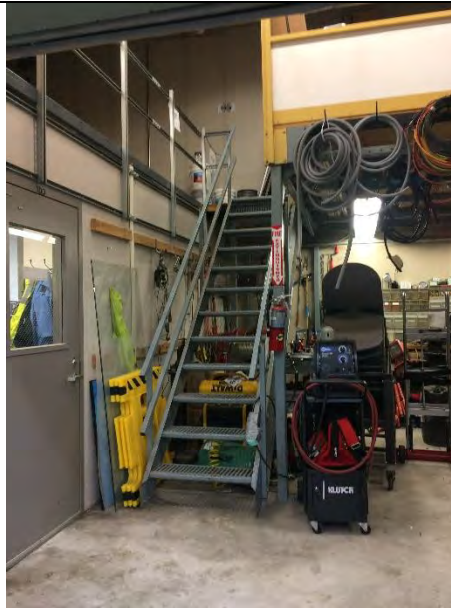
Stairs to the mezzanine in north storeroom

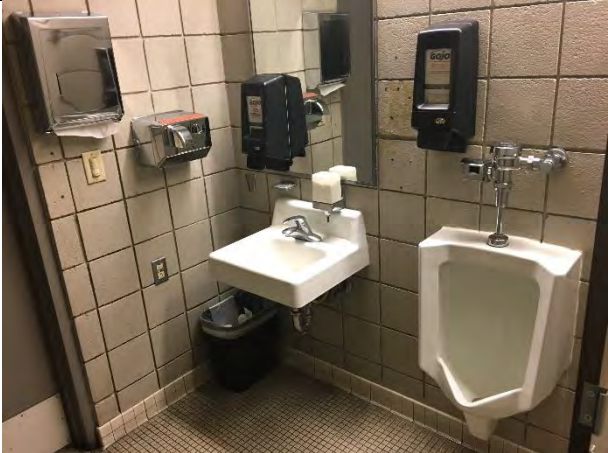
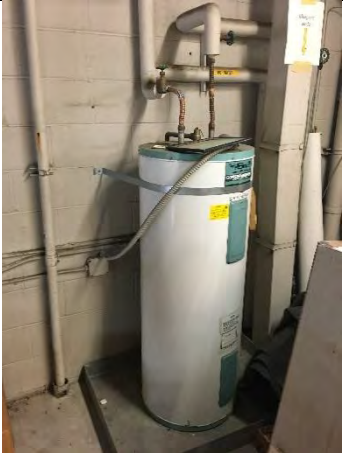
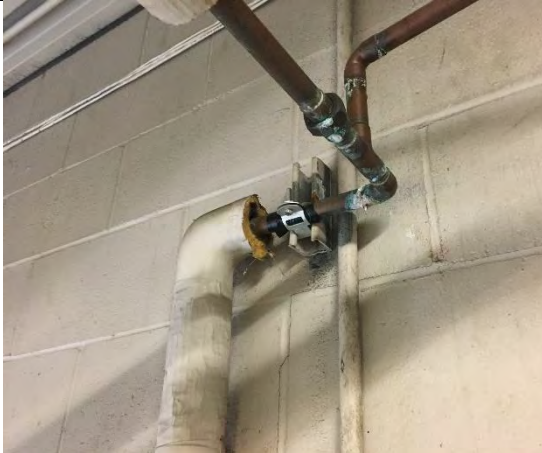
Fixtures in restroom are working and in adequate condition		Hot water tank on second floor		Visible leak on second floor on cold water piping

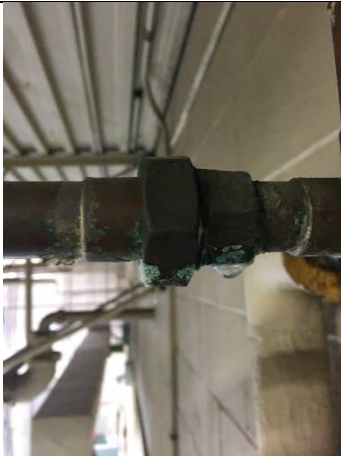
Close up view of cold water piping leak

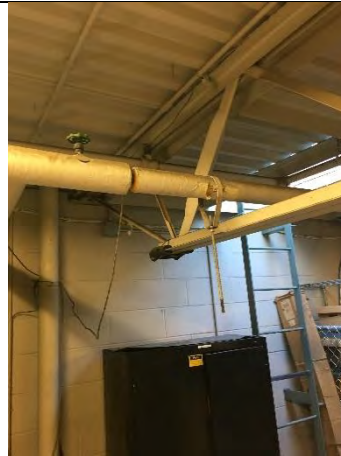
Pipe hanger on second floor is broken

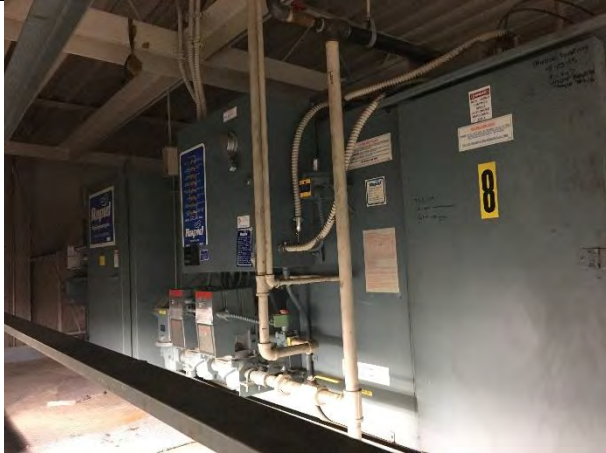
Heating and cooling systems provided for building is natural gas

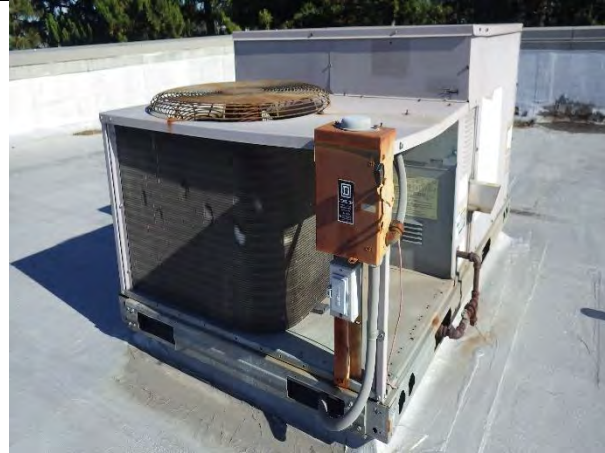
Roof mounted unit is aging and shows signs of surface rust

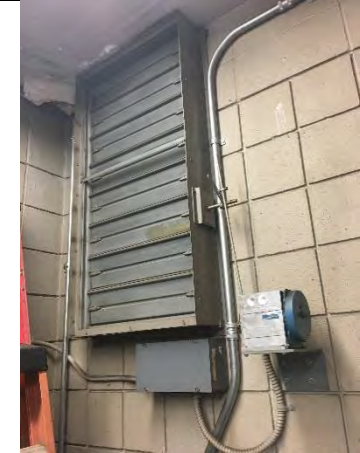
Intake and exhaust louvers located in mechanical room

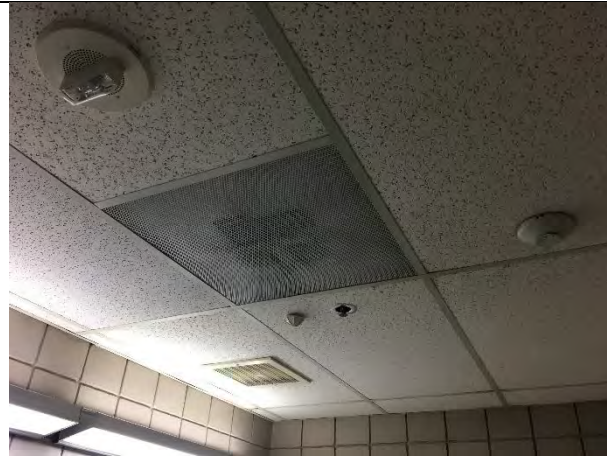
Exhaust fan in restroom functional

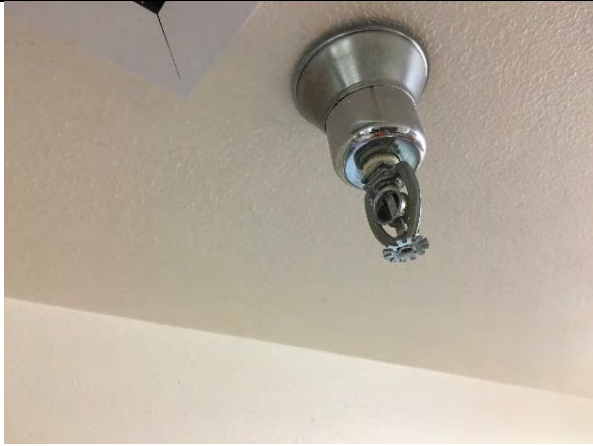
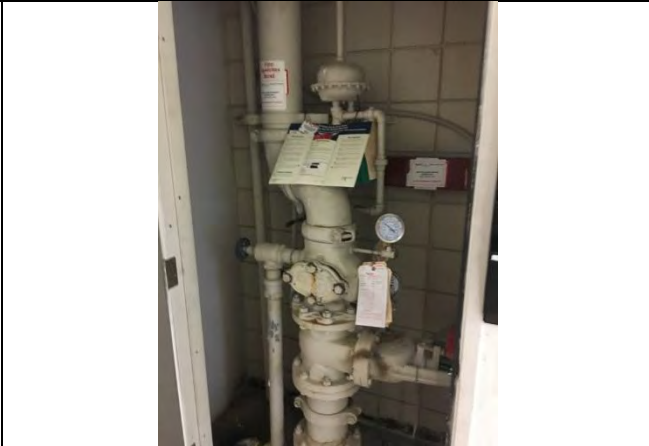
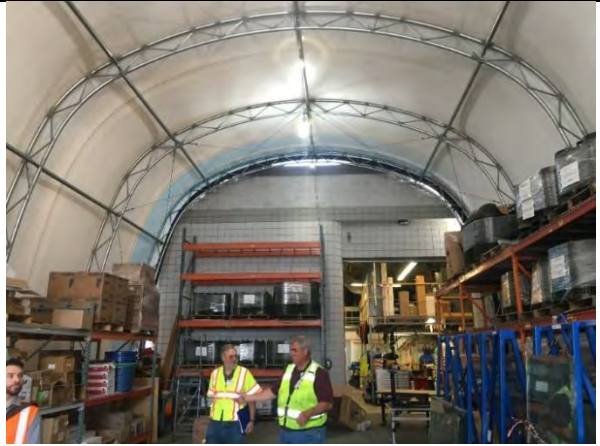
Fire sprinkler head		Fire Riser		Tented area east of Building 2

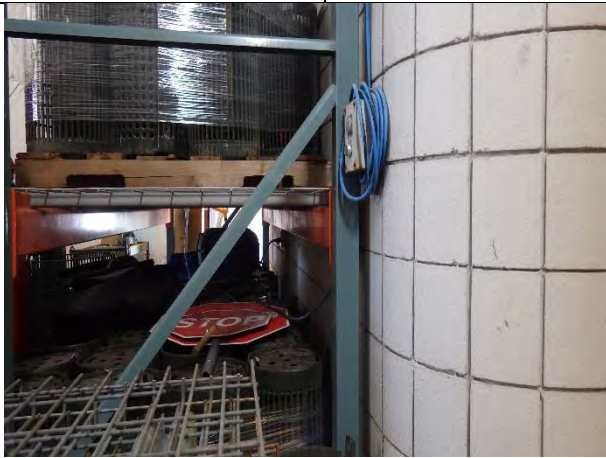
Overhead lighting in tent storage fed by extension cord

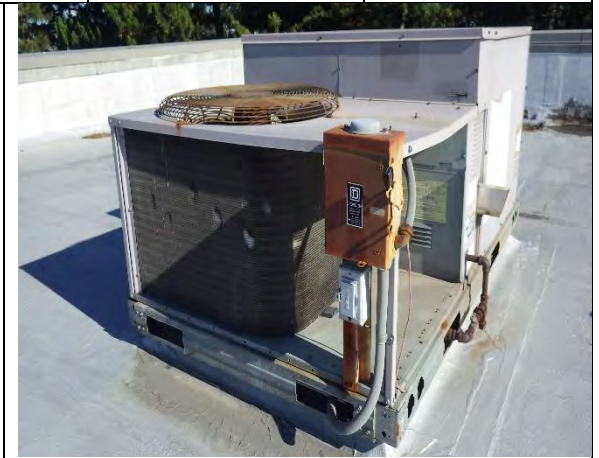
Rooftop electrical disconnect protective coating has exceeded useful life

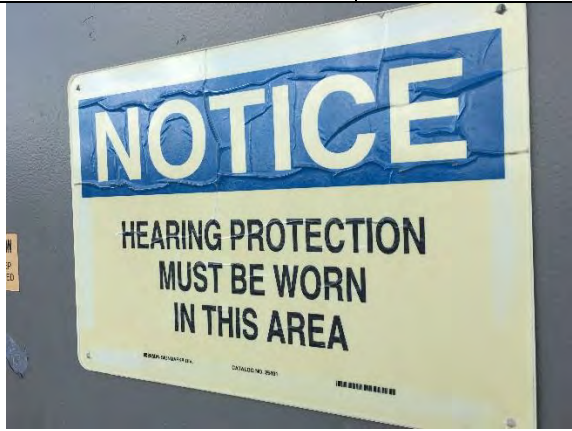
Sign on building facing south

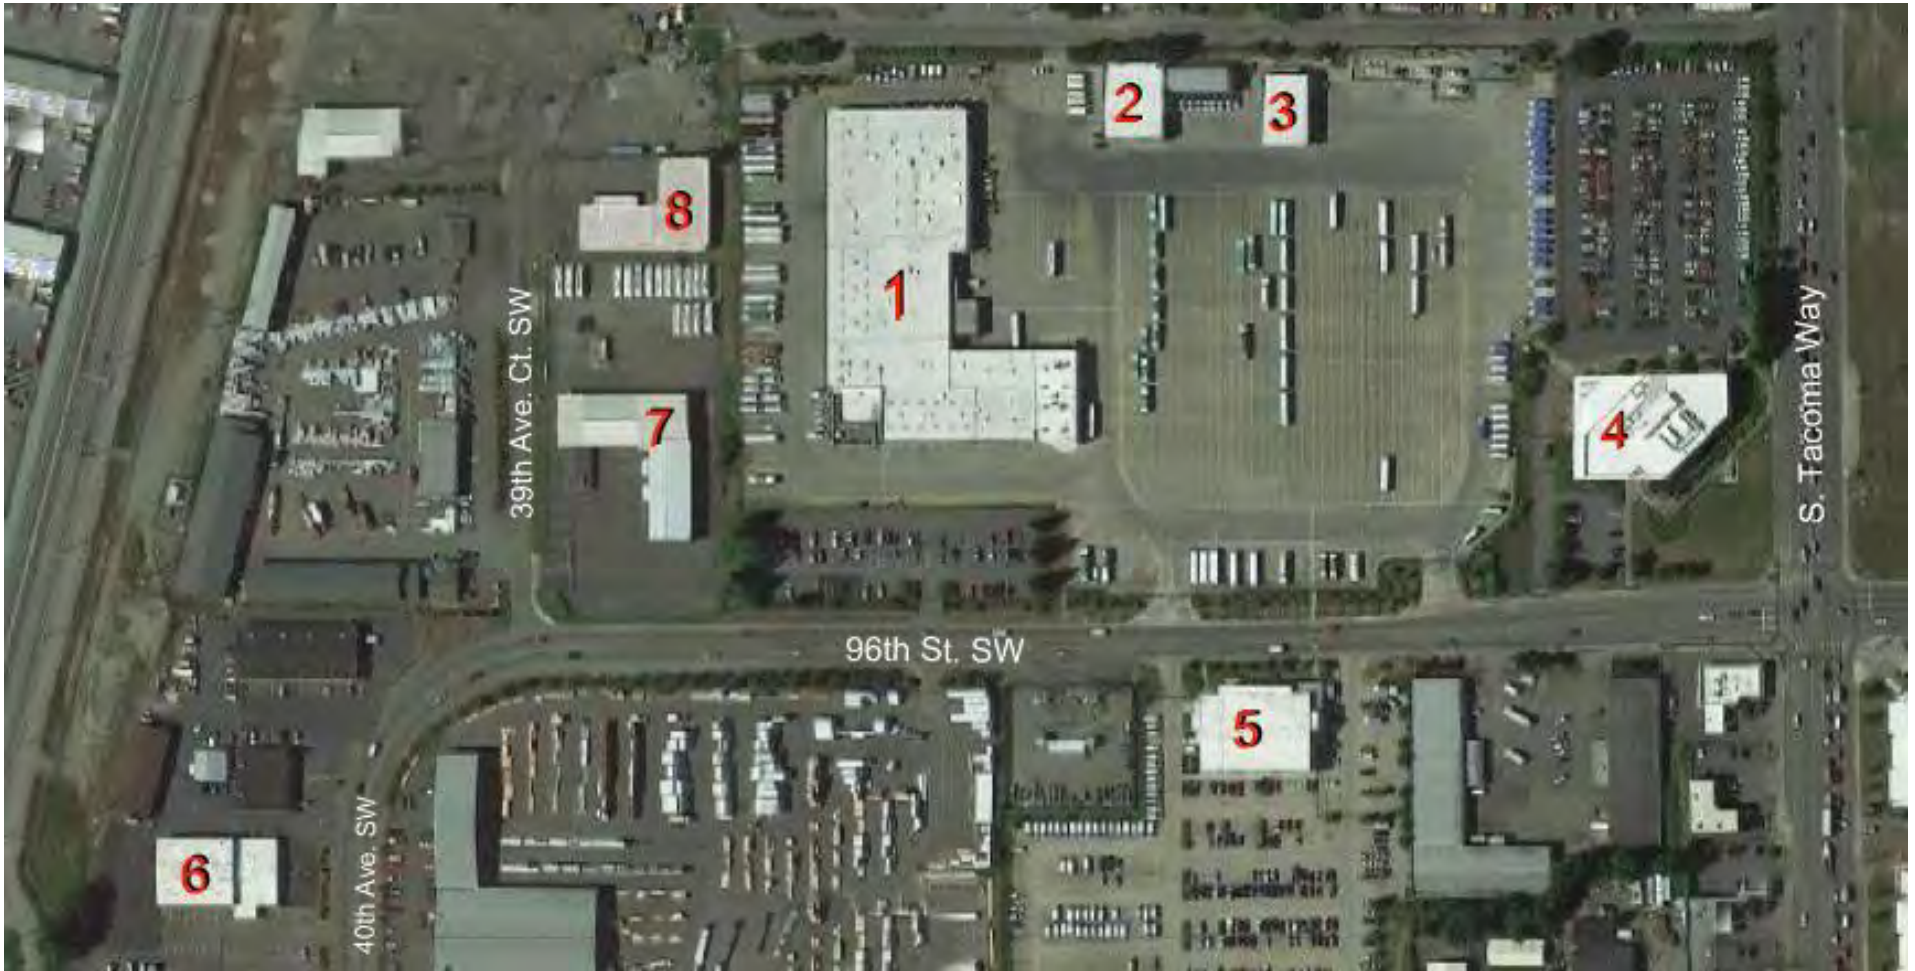
Facility Condition Assessment

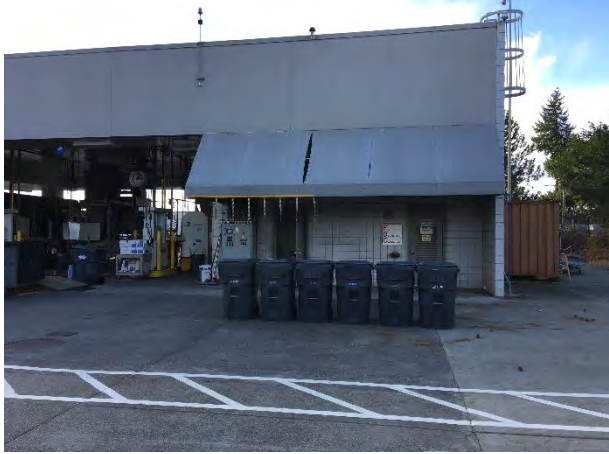
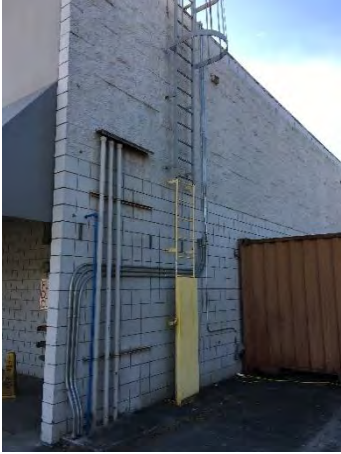
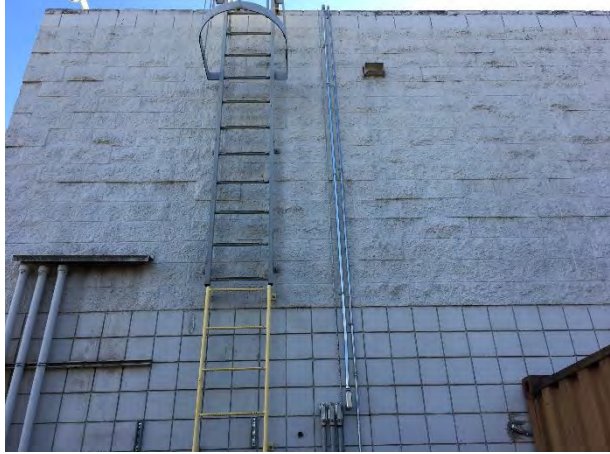
Awning roof on east side is ripped and worn		Roof access ladder with locked ladder guard	Rust on metal at top of ladder

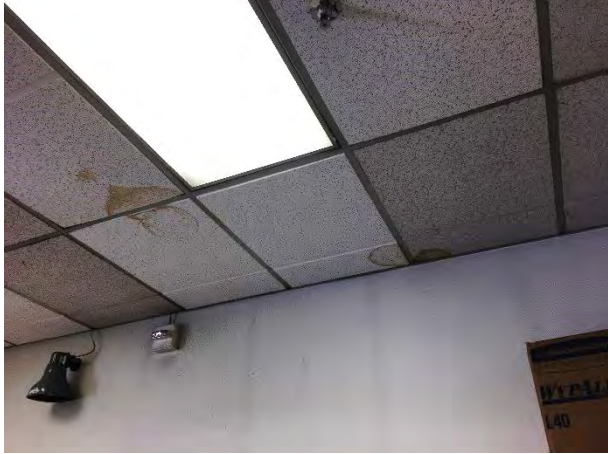
Water leak stains on north wall of fare counting room

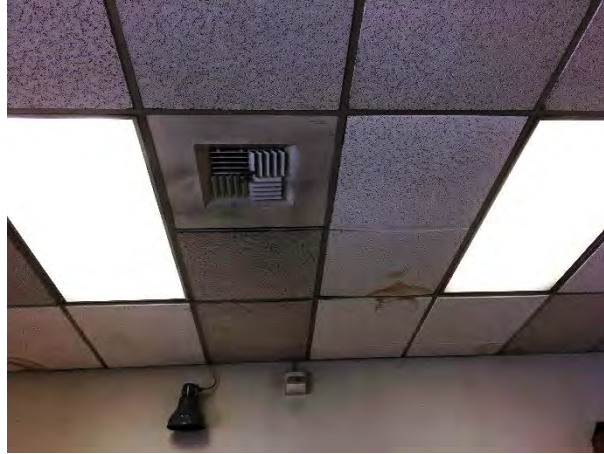
Water leak stains on north wall of fare counting room

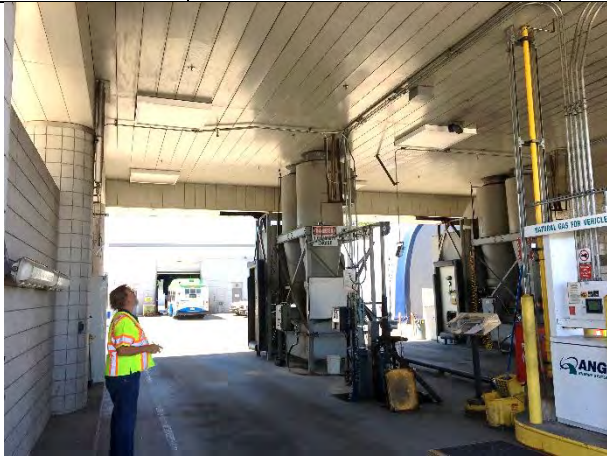
Small air leak in compressed air piping at fuel island #2

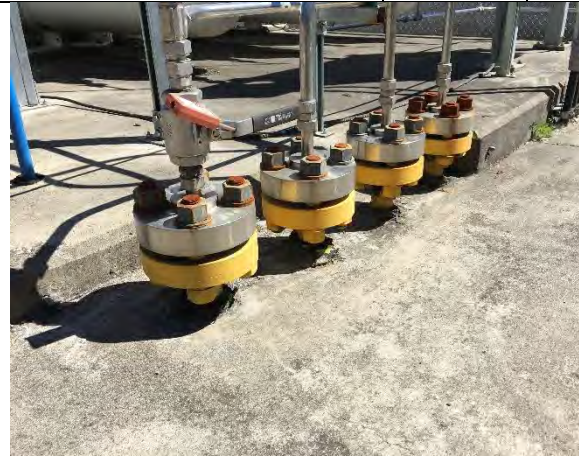
Rusty bolts on compressed natural gas flanges

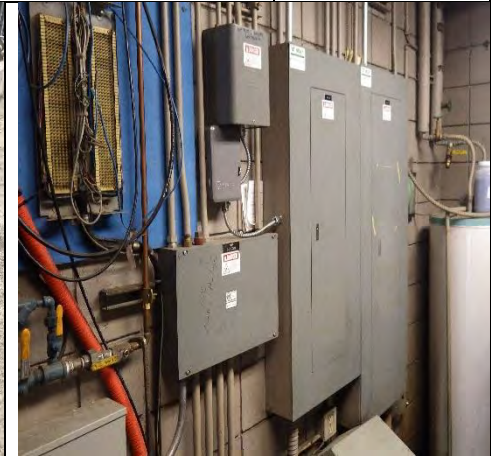
Water heater needs to be seismically restrained

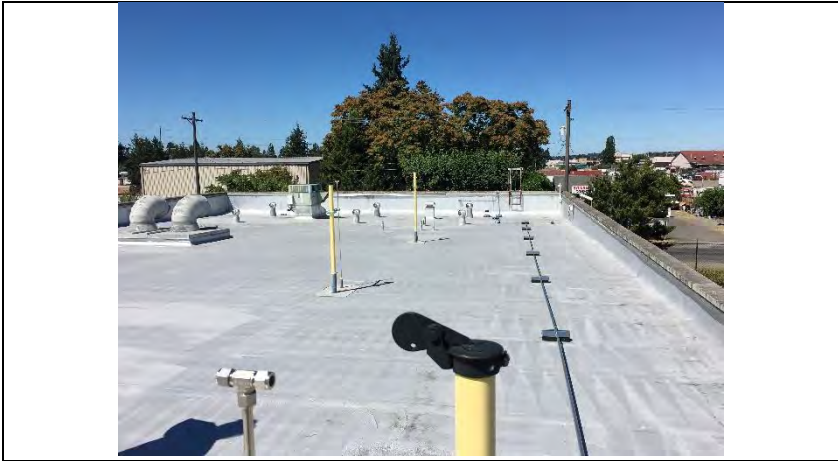
Roof appears to be properly sloped and drainage is functioning properly

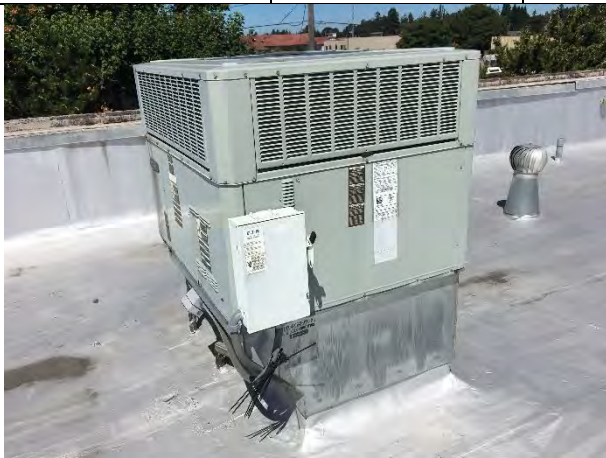
Roof mounted heating and cooling unit

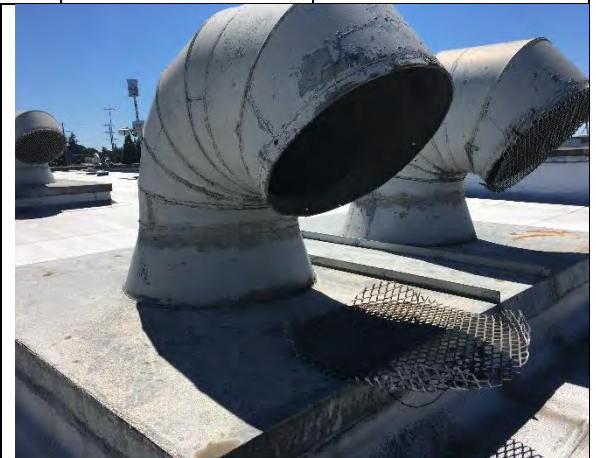
Screen for fuel island exhaust vent has fallen off

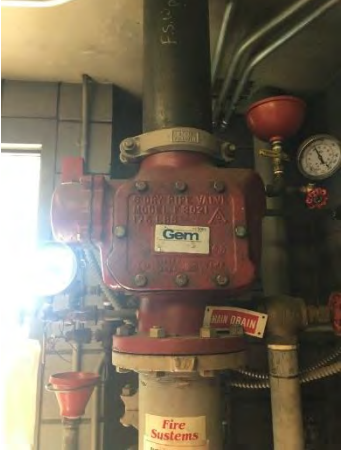
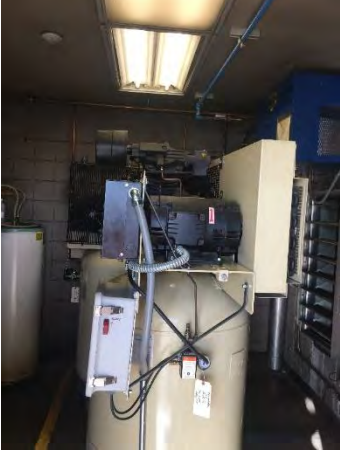
Fire Riser (Dry System)				Air Compressor for Dry Sprinkler System

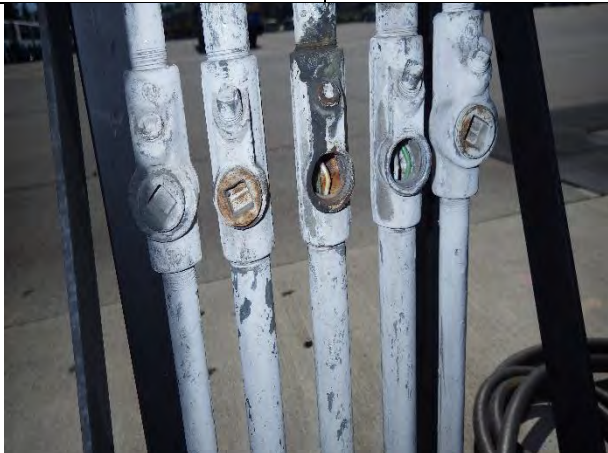
Conduit seal fittings at fuel island 1 not filled with sealing compound or plug fitting

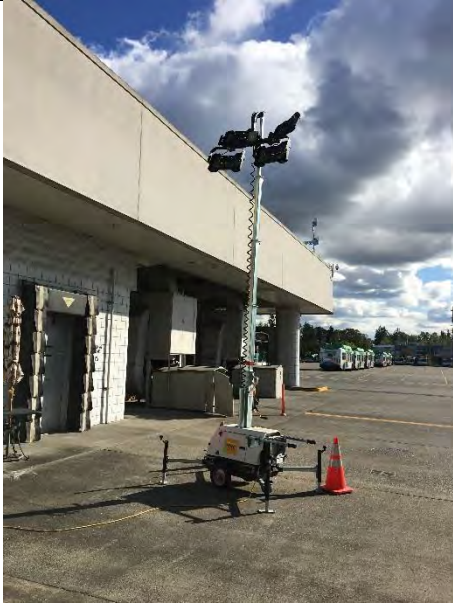
Temporary lighting on west side of building

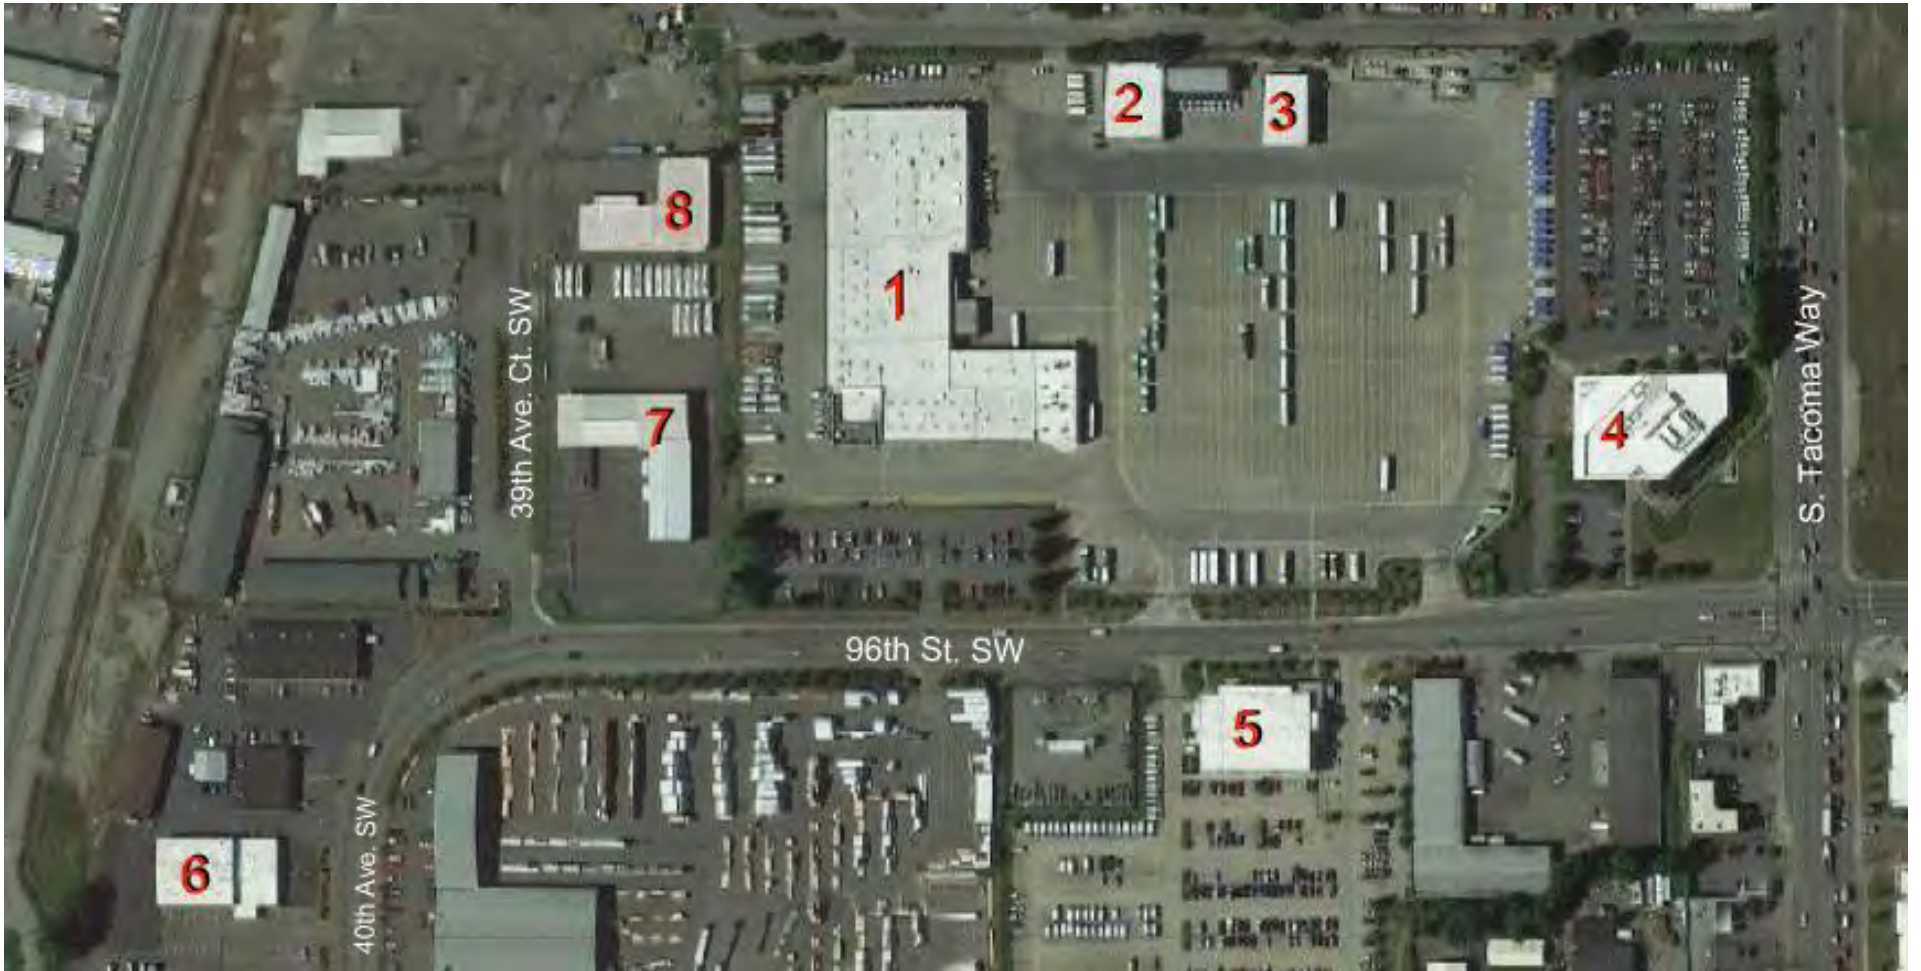
Facility Condition Assessment
