Pierce Transit Facilities Condition Assessment Report

Prepared for

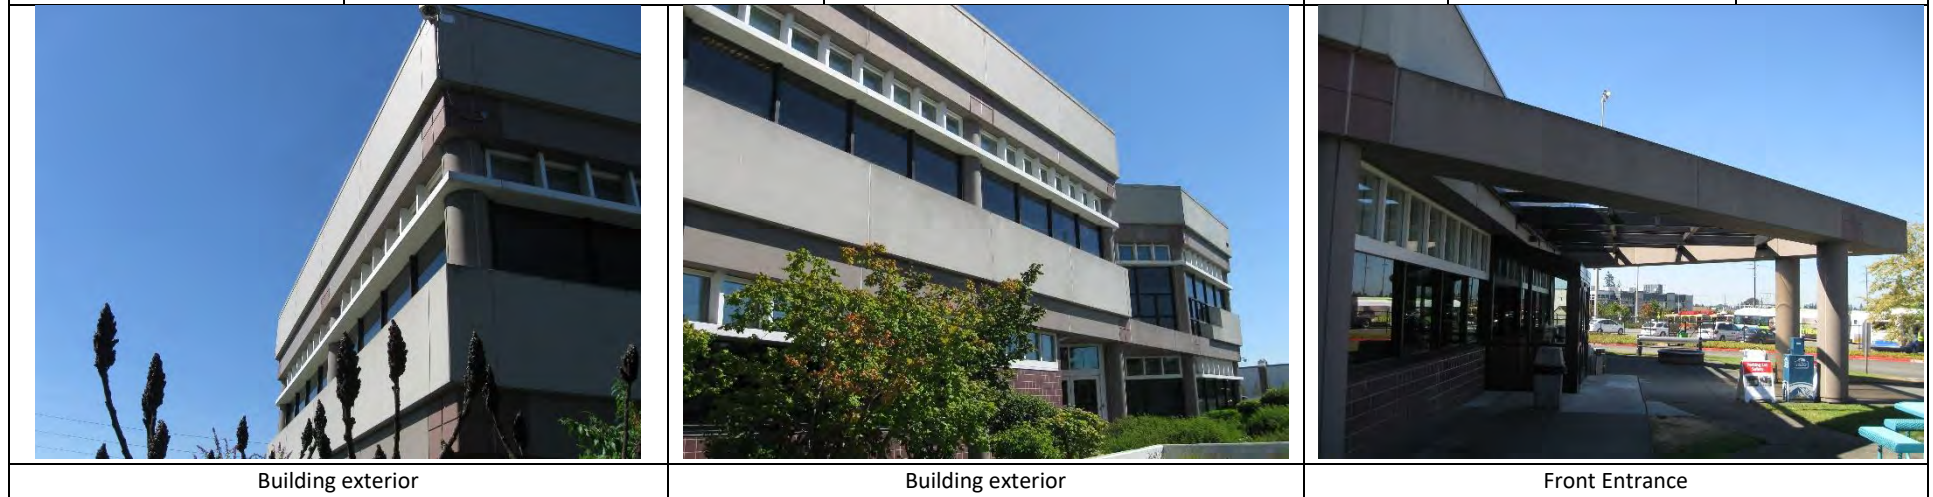
Exterior	Windows, exterior doors, exterior paint.	Windows and doors functioning and in good condition. Windows, window sills and siding are dirty. Paint is in adequate conditions, there is peeling paint on south side of penthouse indicating moisture in wall.	3.5	Clean windows and window sills. Pressure wash penthouse wall to remove loose paint. Treat with sealer and repaint.	\$5,000

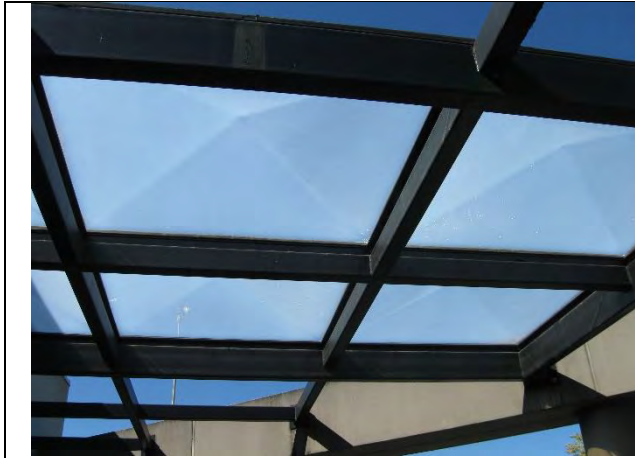
Skylight at entry has dirt in valleys between units

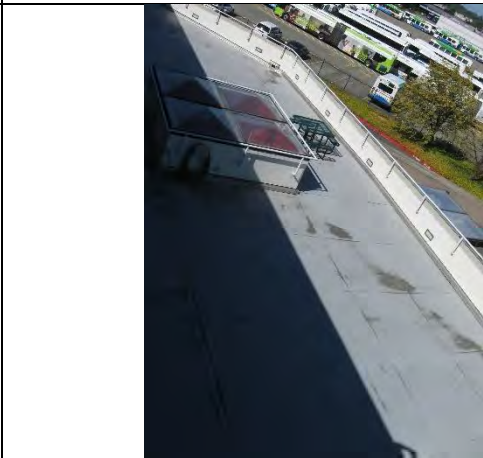
Lower roof used as outdoor patio

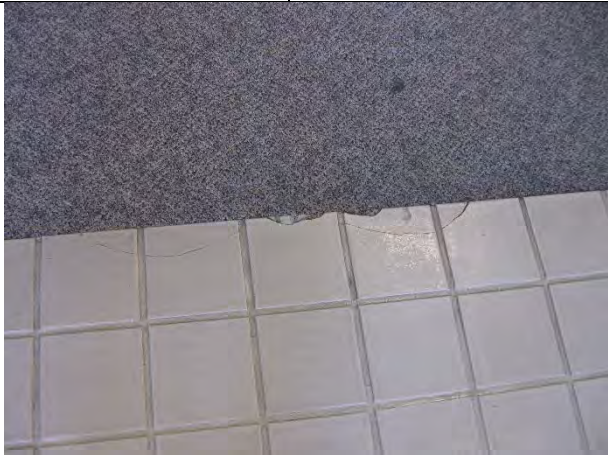
Tile breakage at main entry at door sill and tile to carpet transition

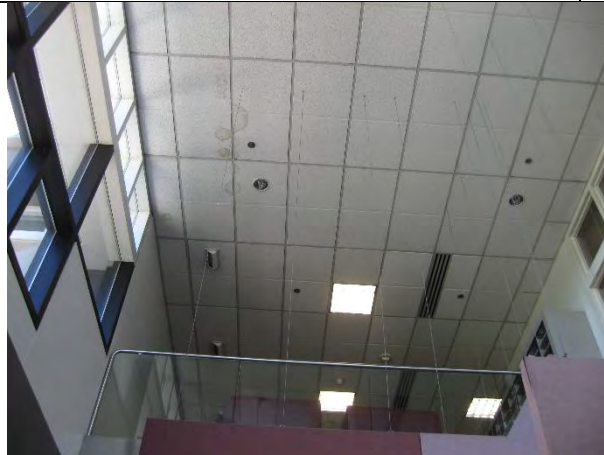
Water stains at high ceiling over main entry

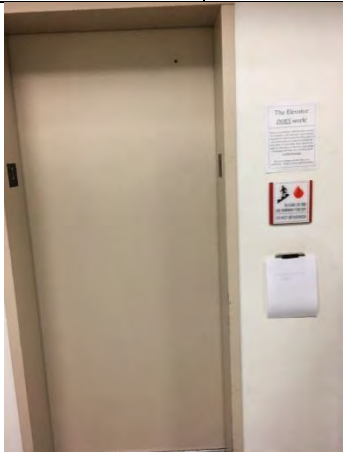
Secondary Level	Description	Current Condition	TERM Lite Rating	Recommended Corrective Action	Estimated Cost
Primary Level D. Conveyance					
Elevators	Building elevator.	Elevator was not working at the time of the site visit. A note over the operating buttons indicated that it was "Out of Service". An additional note indicates there are issues with the elevator if the door is held open for too long and that it may make beeping noises. Staff was aware of the elevator issues. Pierce Transit notified assessment team that elevator had been fixed as of December 2017.	3.0	None	N/A

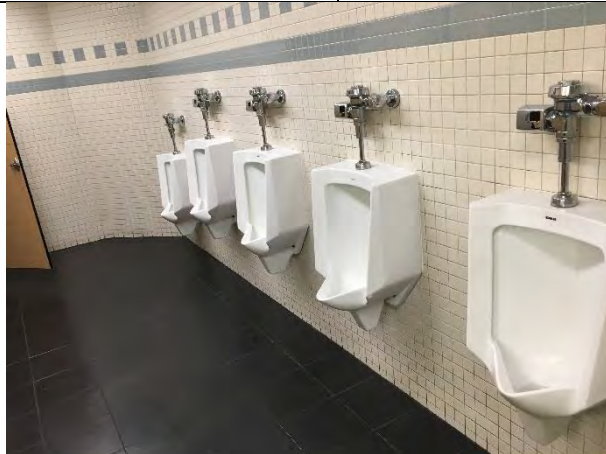
Fixtures in bathrooms are working and in adequate condition

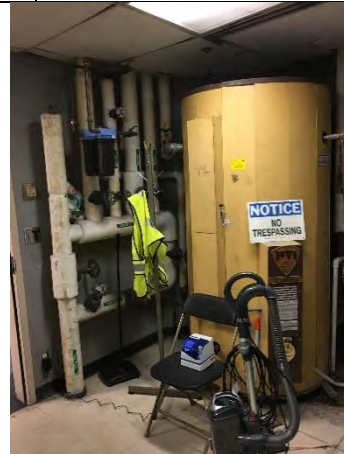
Water heater in utility room across from quiet room

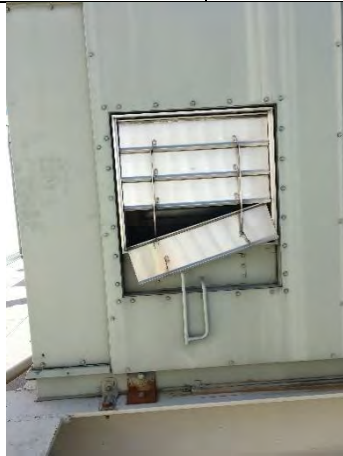
Roof mounted HVAC units gravity damper blade

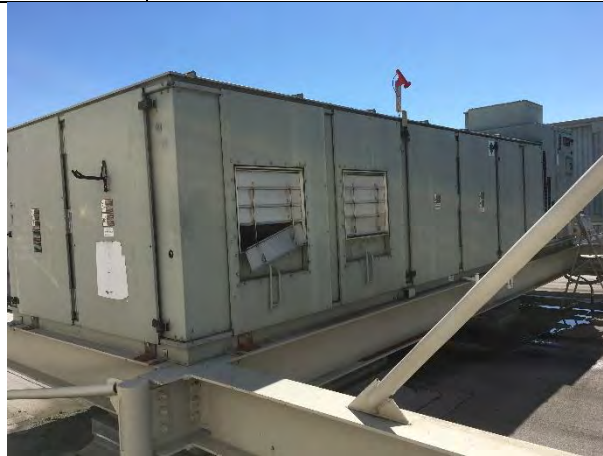
Two largest HVAC units on the roof

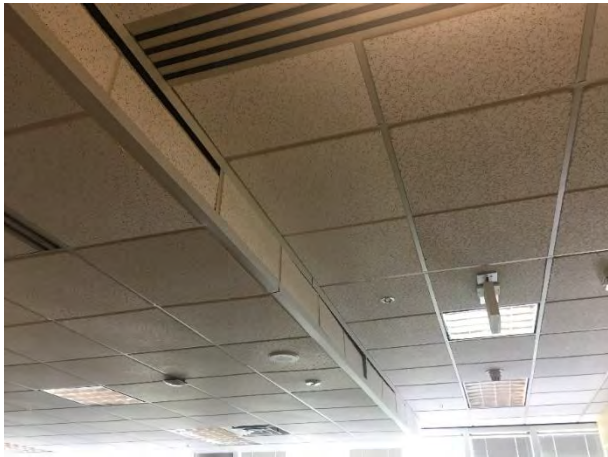
Sprinkler heads near soffit

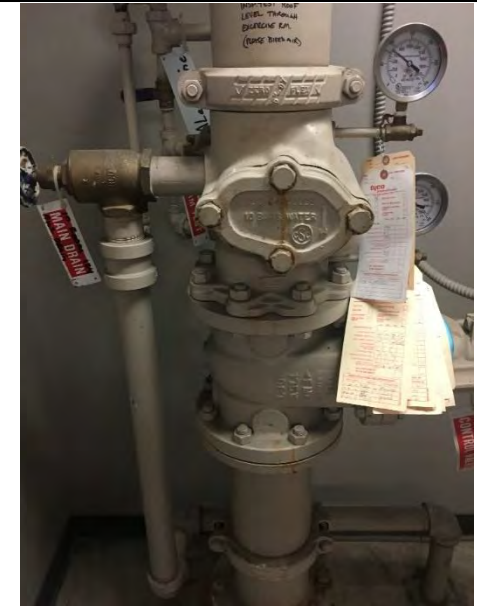
Standpipe in stairway with no hose connections

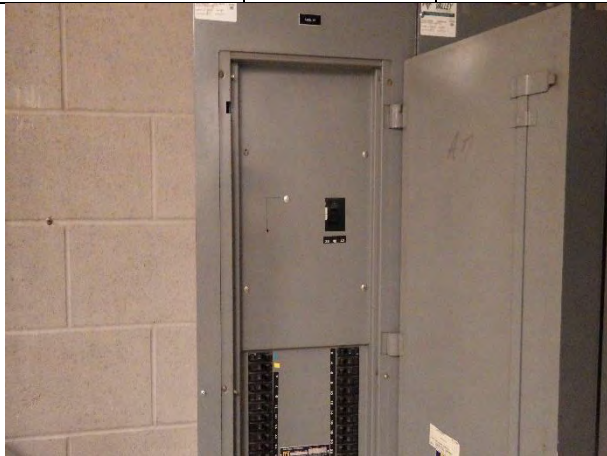
Electrical panel A7 on the first floor

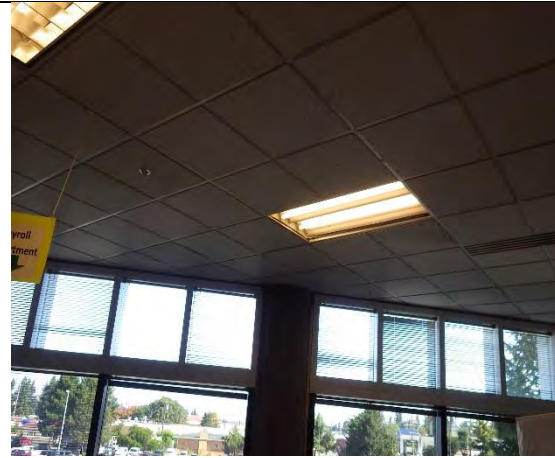
Payroll Office light is missing diffuser

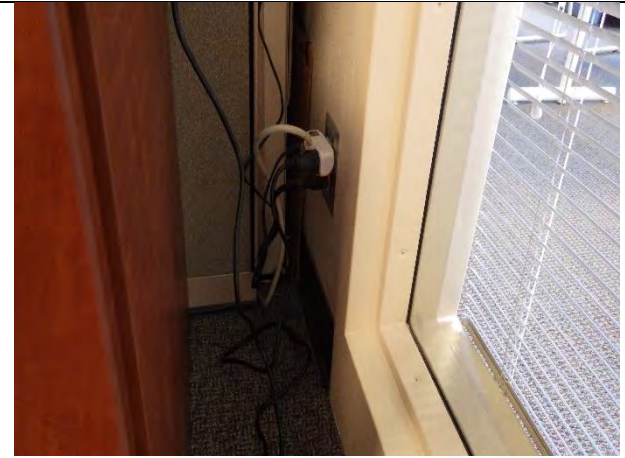
Executive Office cubicle work stations located in old second floor lobby area currently have power strips plugged into power strips or other means of temporarily adding receptacles

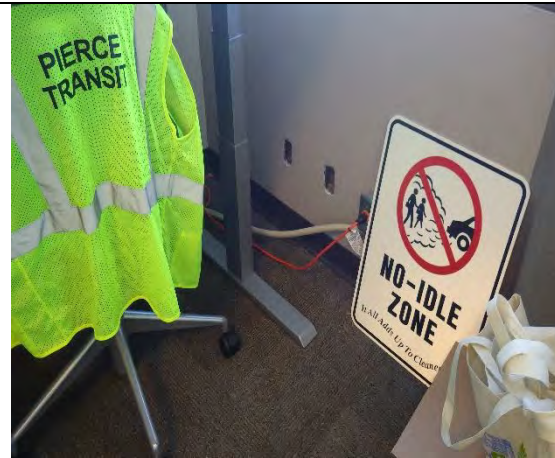
Executive Office cubicle work station missing electrical cover plates

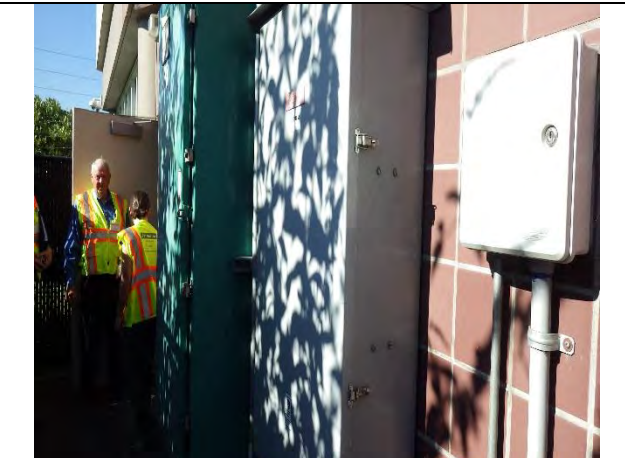
Broken Generator Panel enclosure latch

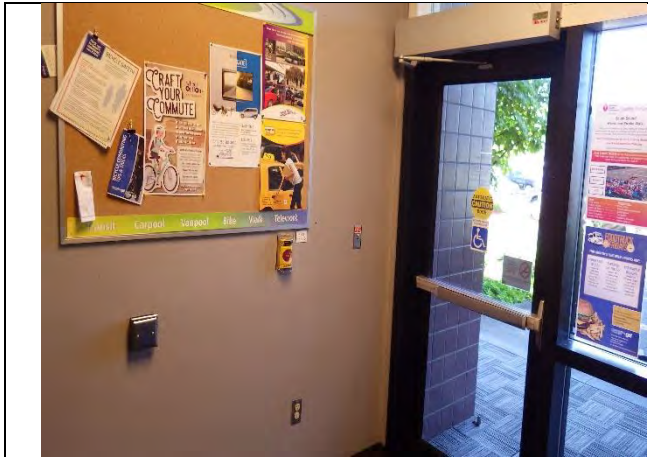
Single exterior door on north side of building with ADA opener does not function properly

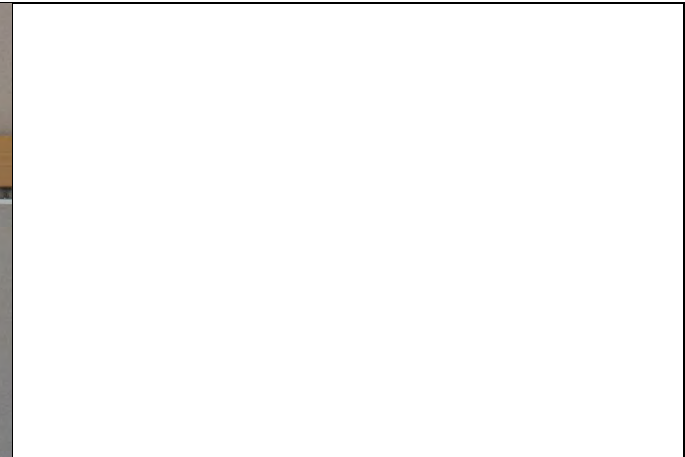
Fire alarm horn is obstructed by display in Alder Conference Room

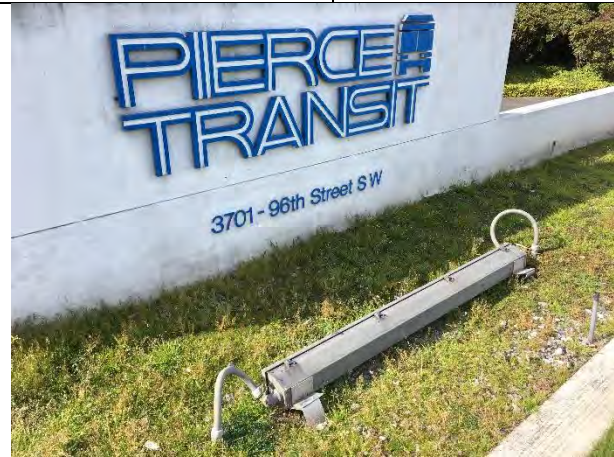
The bracket for positioning the lighting on the east side of the large, street facing Pierce Transit sign is broken

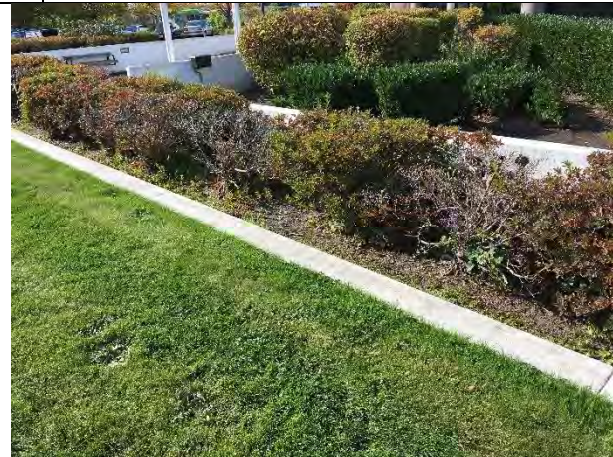
Landscaping is dying in several areas around building including by the front sign, on both sides of the vehicle entrance/exit gate, and by the backup generator

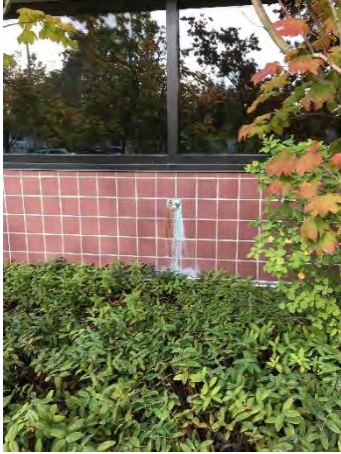
A hose bib on the front of the building appears to have a very slow leak and has caused a scale buildup down the side of the building

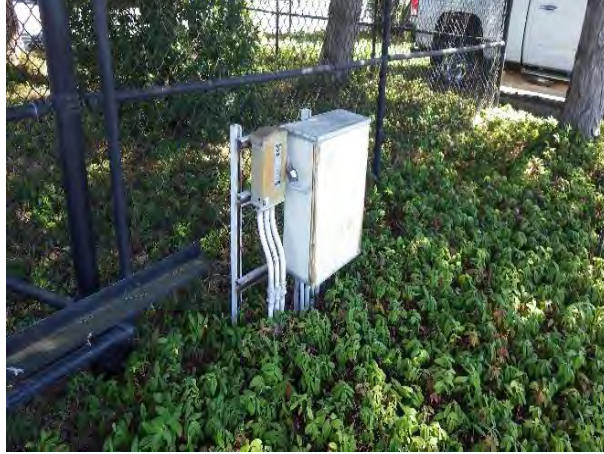
Non-functional gate opener on north side of employee parking lot

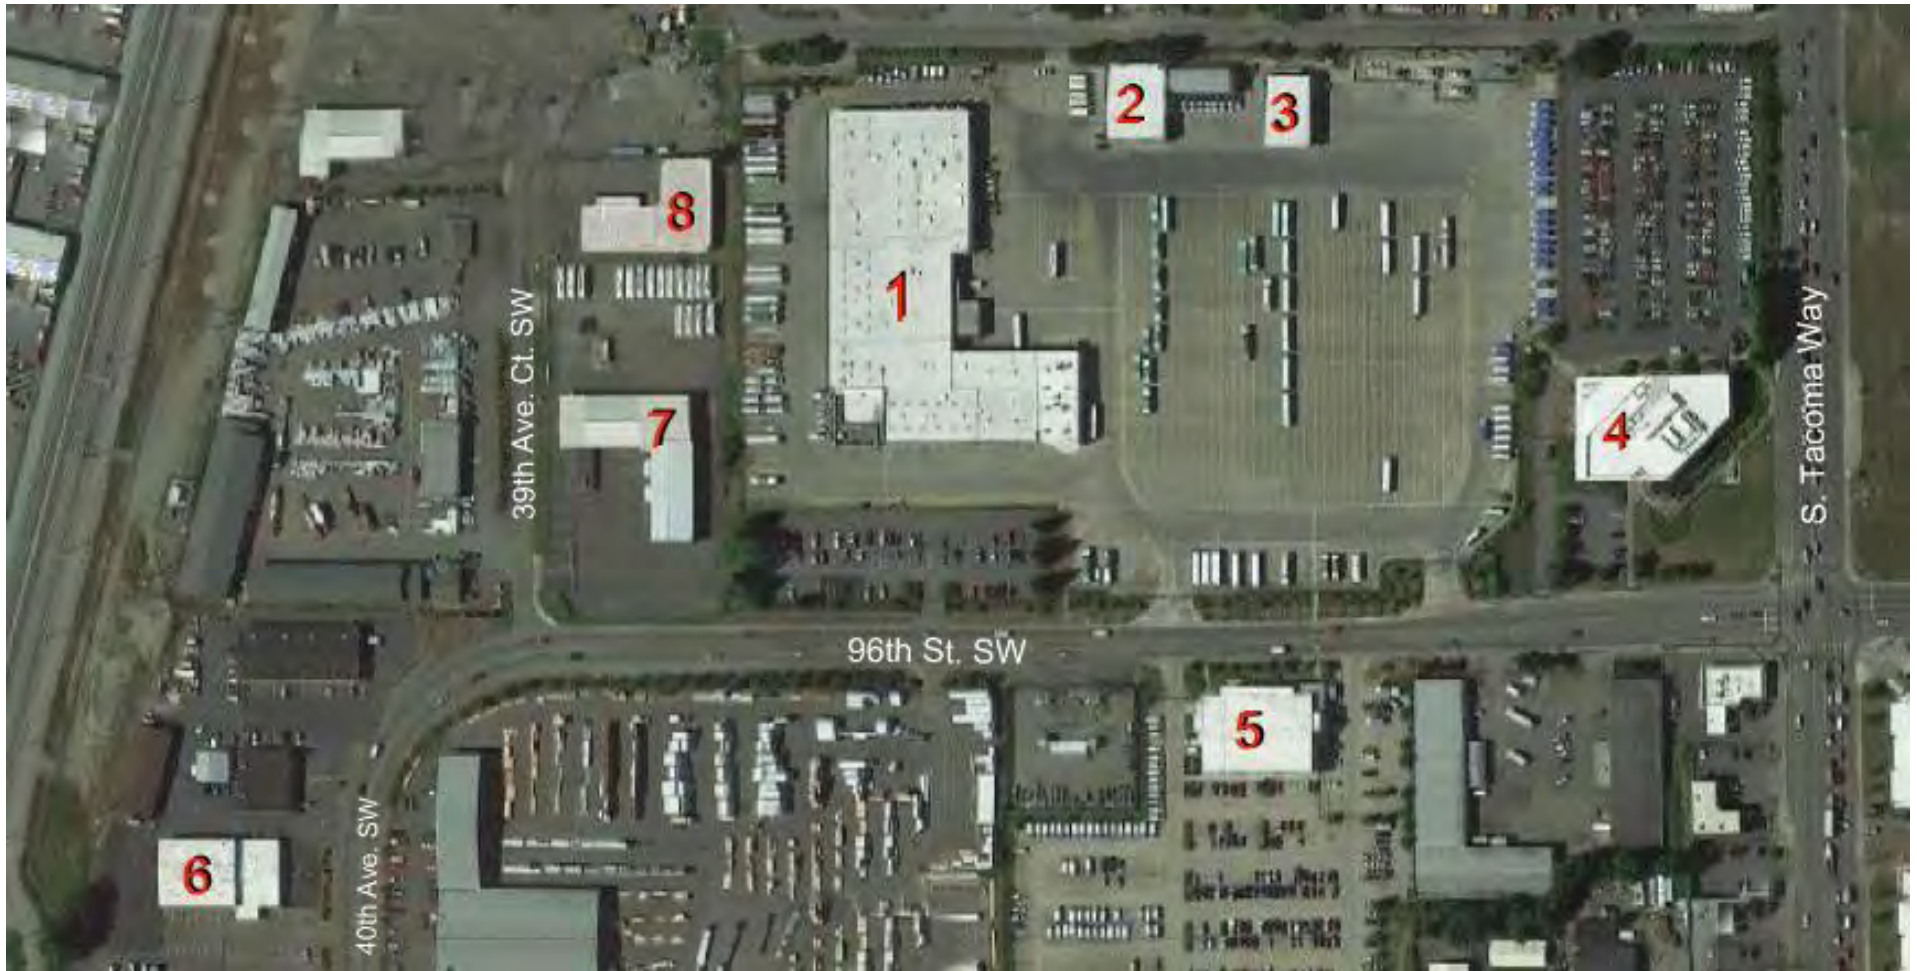
Facility Condition Assessment

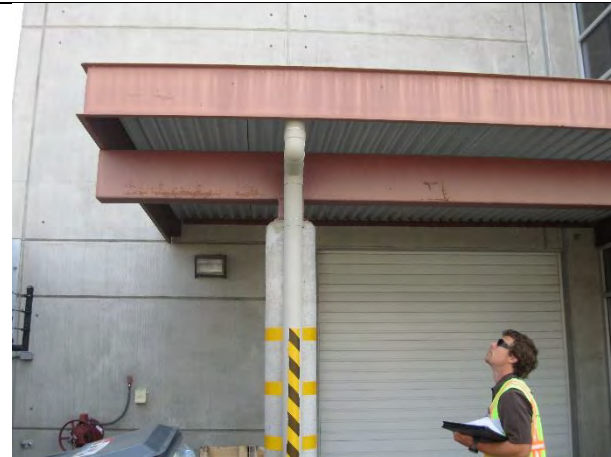
Steel beams at loading dock, northwest corner. Beams have some rust appearing

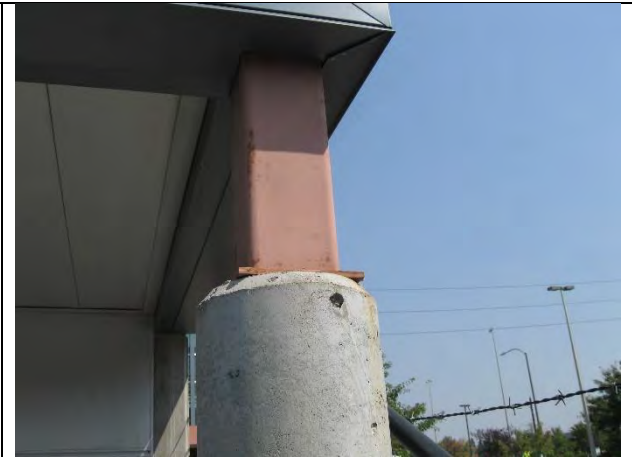
Steel beams and concrete column

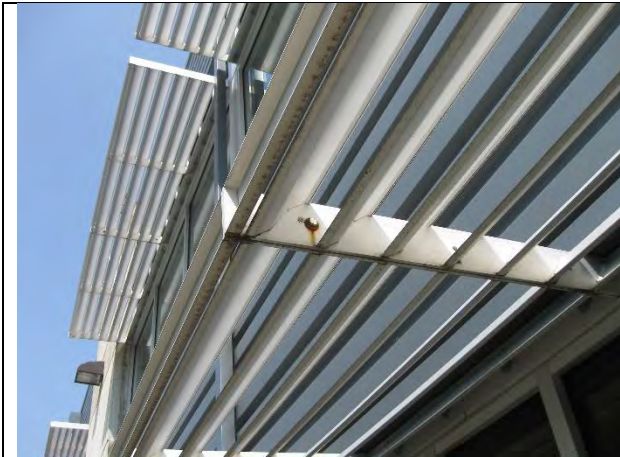
Exterior canopy framing, note rusted bolt/washer

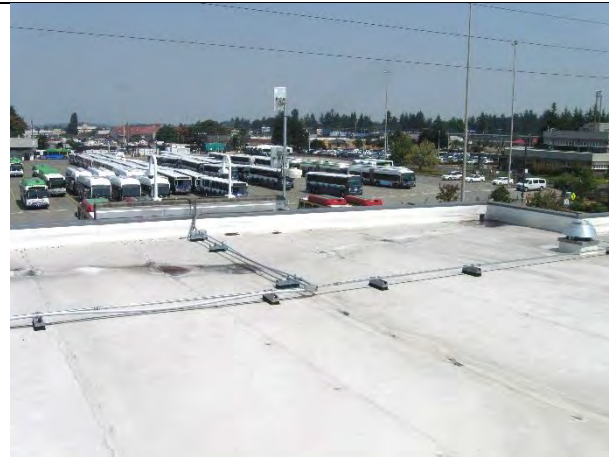
View of roof looking north, showing some low spots with debris and roof mounted conduit runs

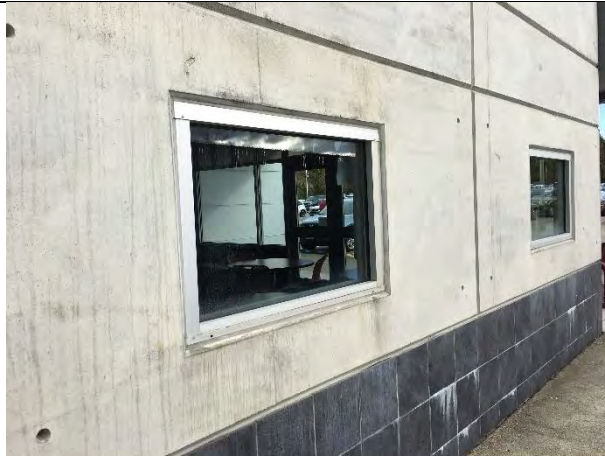
West wall of building, showing lunchroom windows and stains at wall tile joints

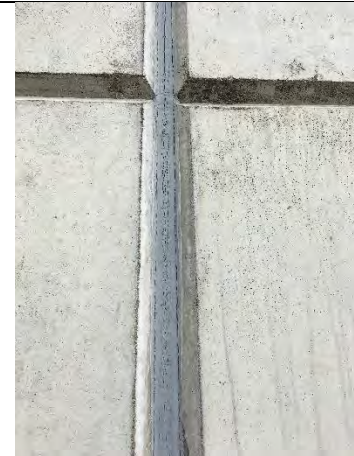
West wall of building showing caulk joint between precast concrete panels

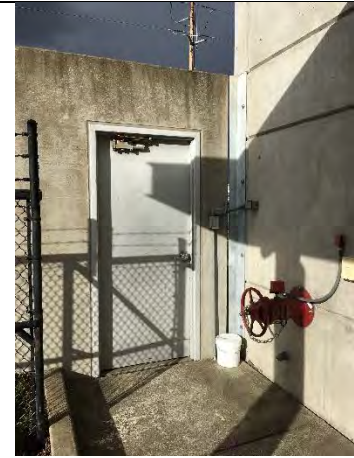
Northwest corner of building, showing door through enclosure wall and sprinkler valve

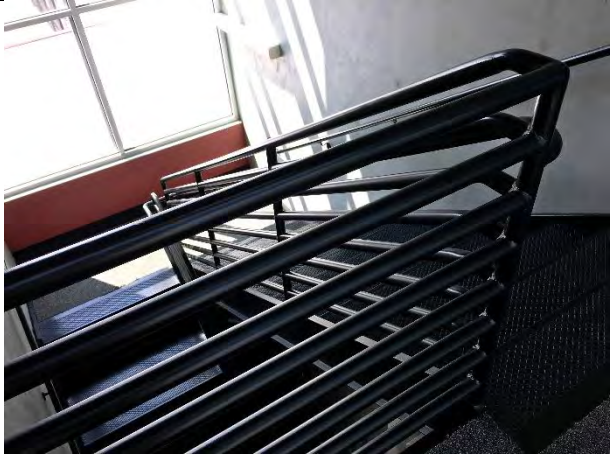
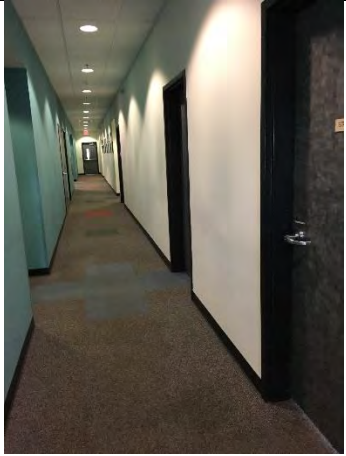
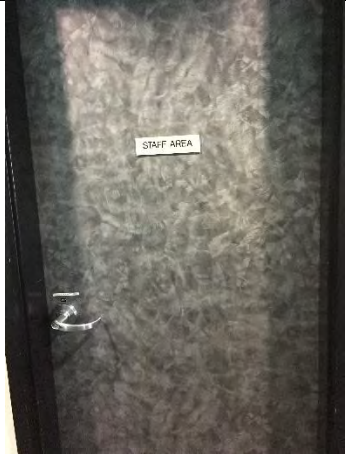
Stairwell		Carpet in hallway		Interior door

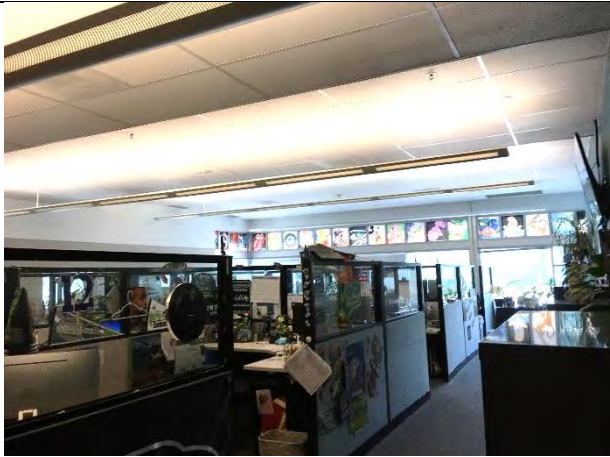
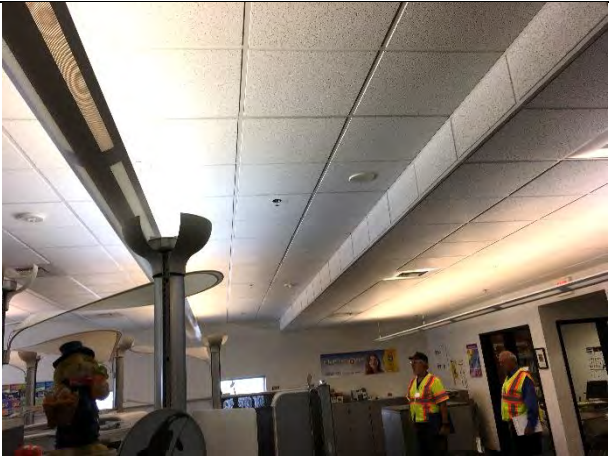
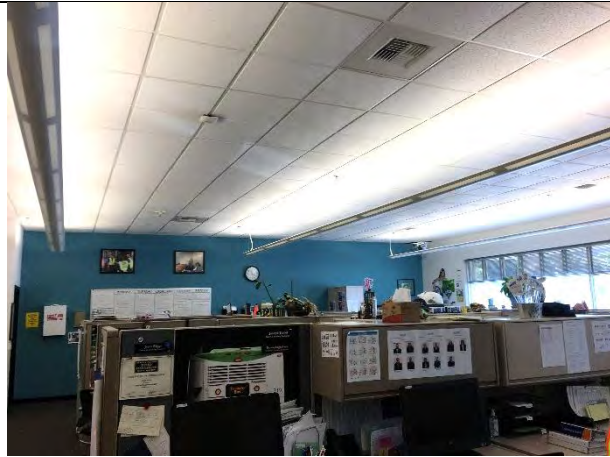
Interior ceiling and workstations		Interior walls, ceiling and lighting		Interior walls, ceiling, and workstations

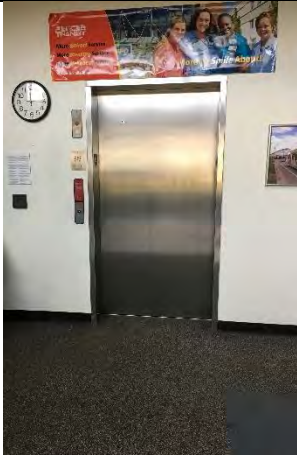
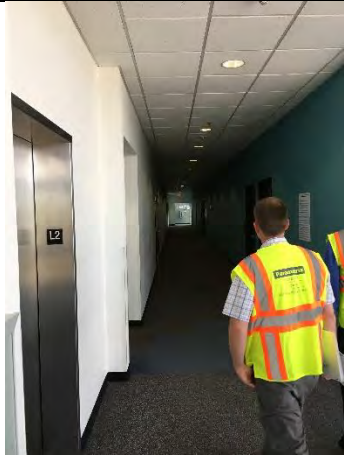
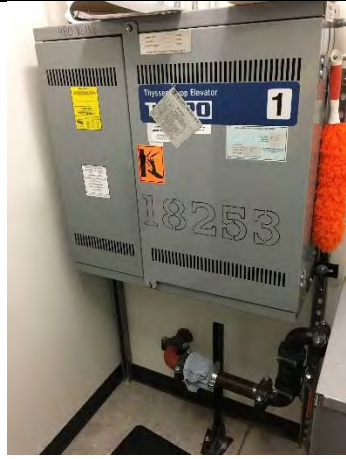
Elevator first floor		Elevator second floor		Equipment in elevator room

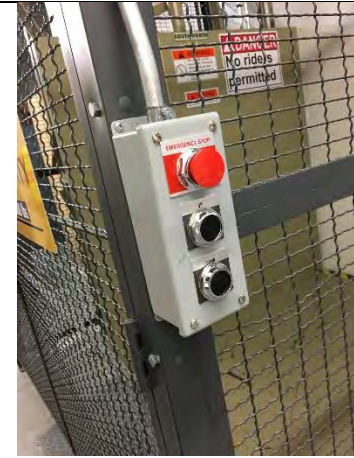
Maintenance lift operating buttons with emergency stop

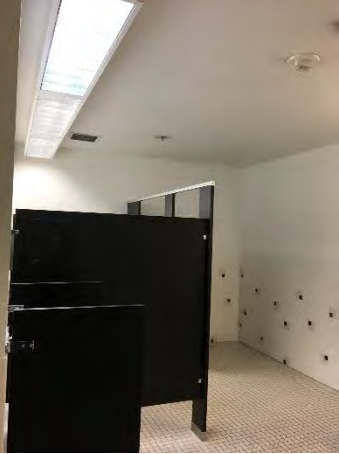
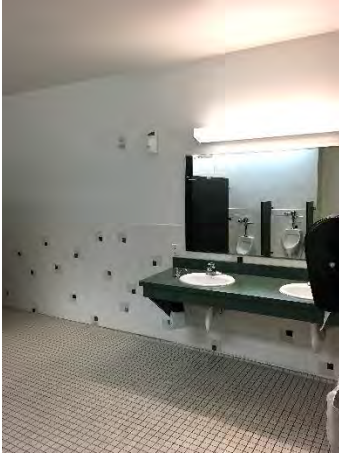
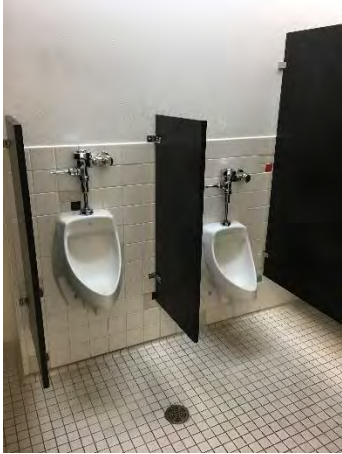
Men's restroom partitions		Men's restroom sinks		Men's restroom urinals

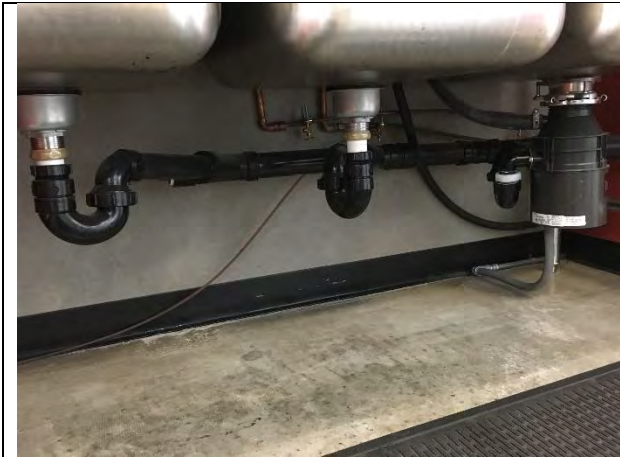
Plumbing under kitchen sink in good working condition

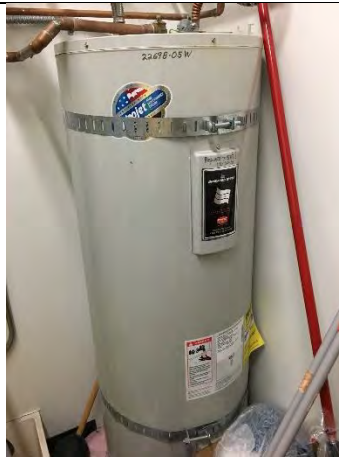
Water heater in utility room

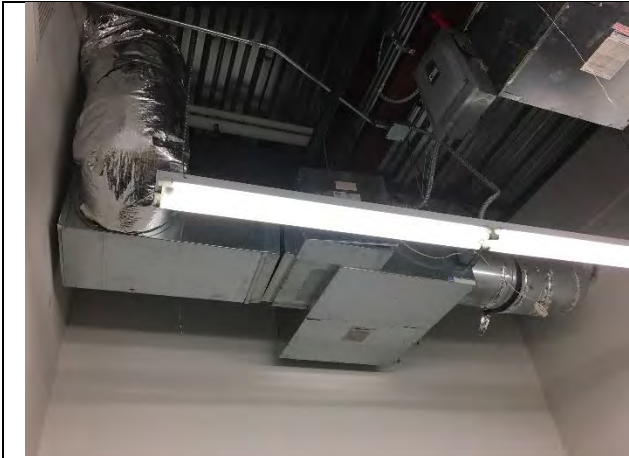
HVAC ducts in storage room

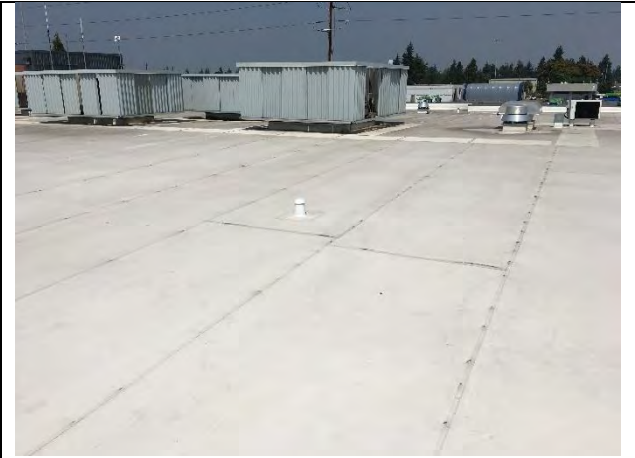
Roof, showing screening at roof mounted HVAC equipment

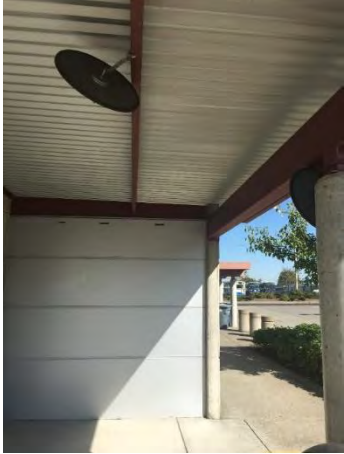
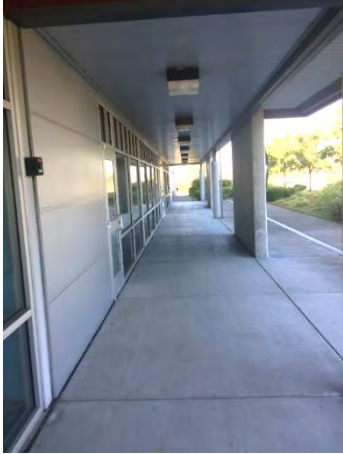
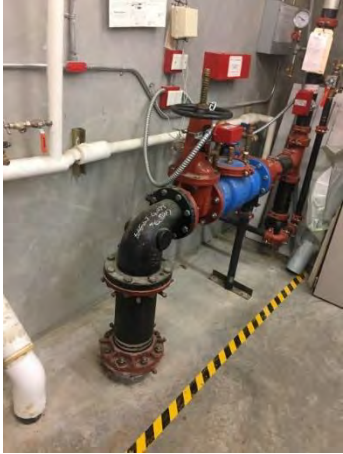
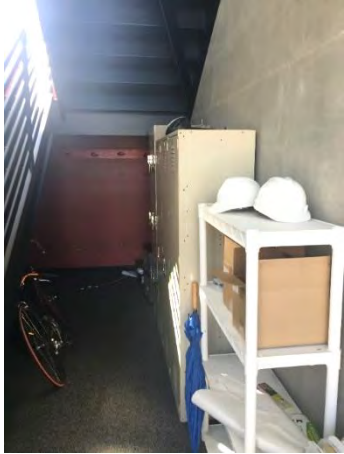
Exterior awning with no fire sprinklers (east side of building)	Exterior awning with no fire sprinklers (north side of building)	Fire riser	Storage under stairs

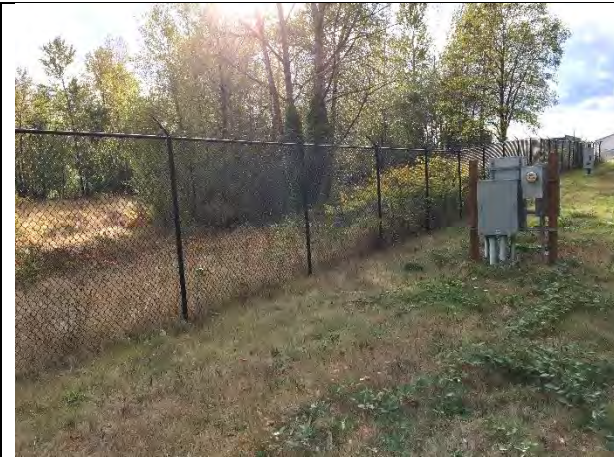
Modular Office electrical service

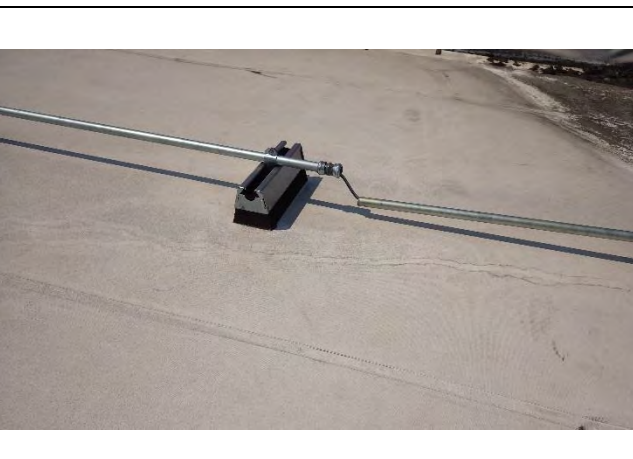
Conduit separated on roof to be repaired

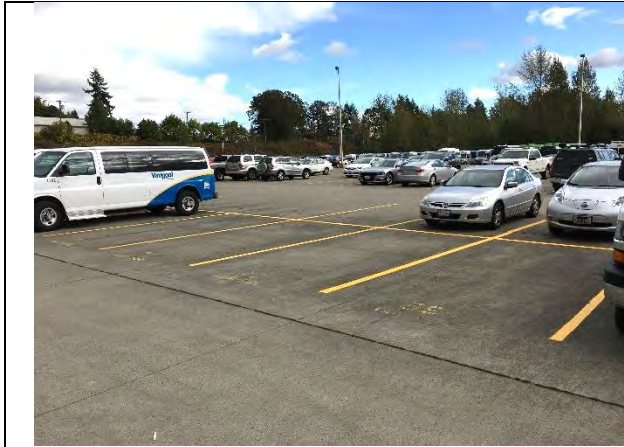
Painted numbers on parking stalls fading

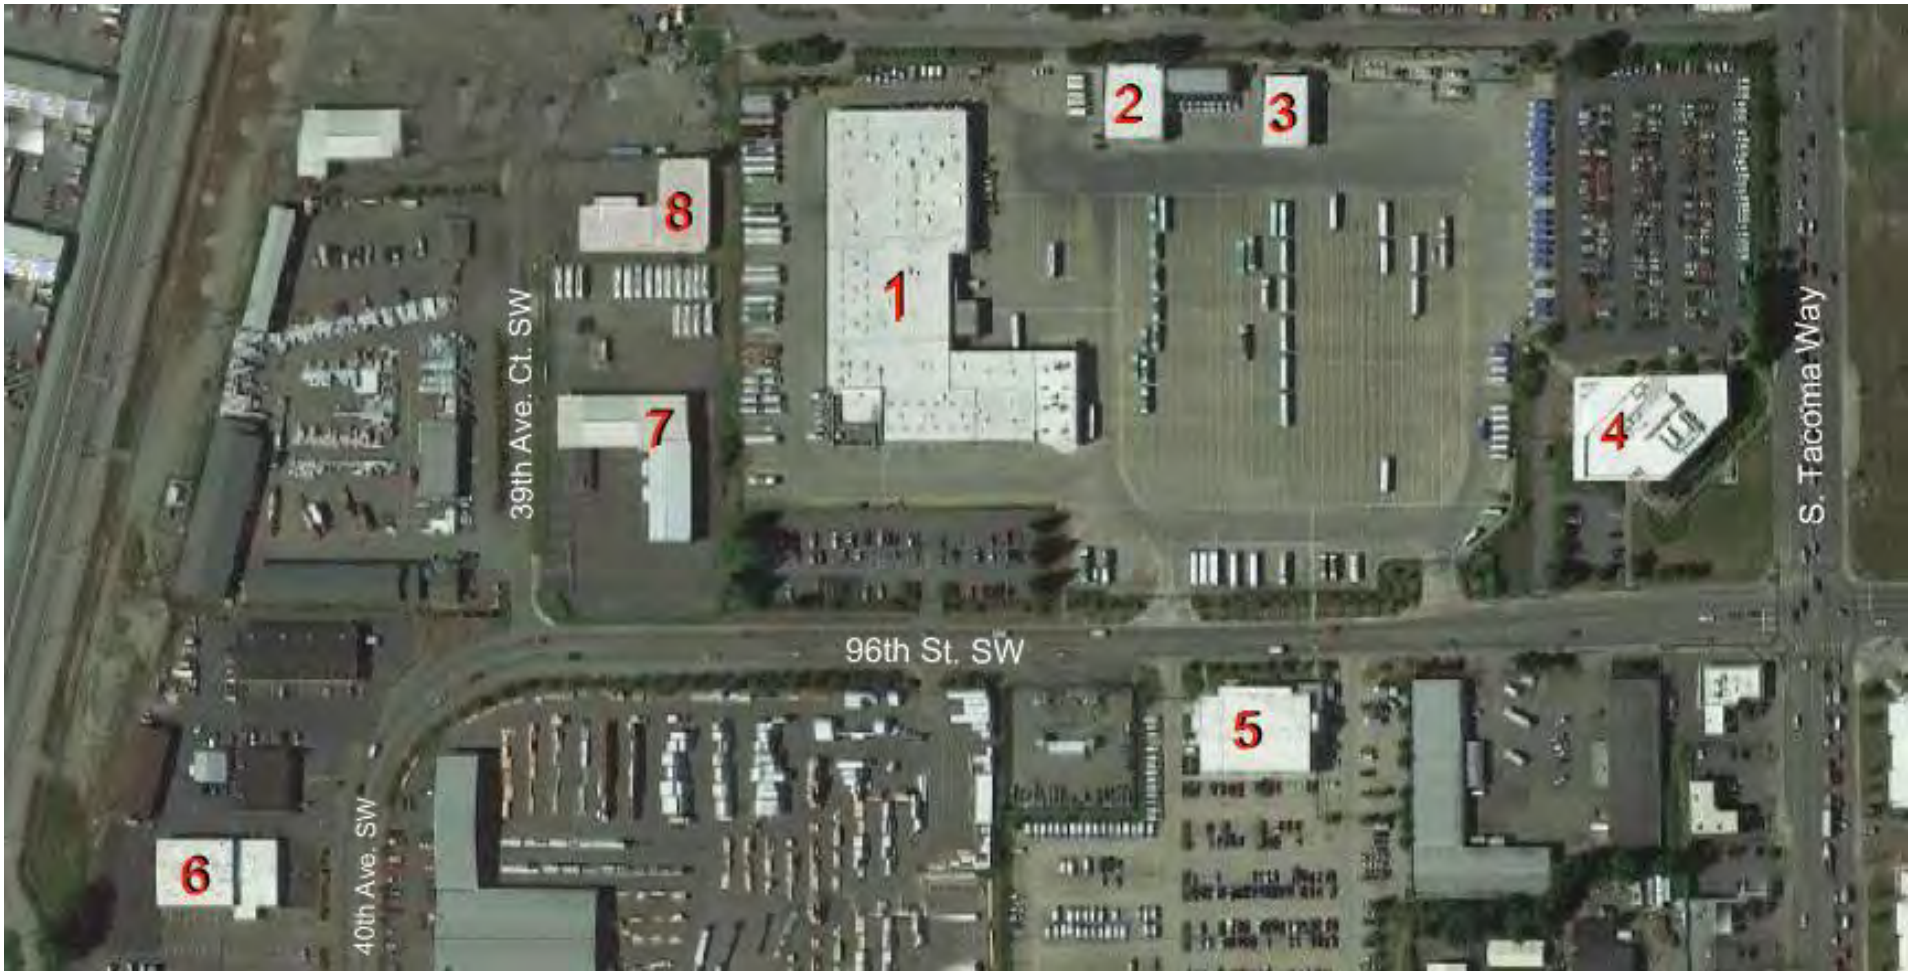
Facility Condition Assessment

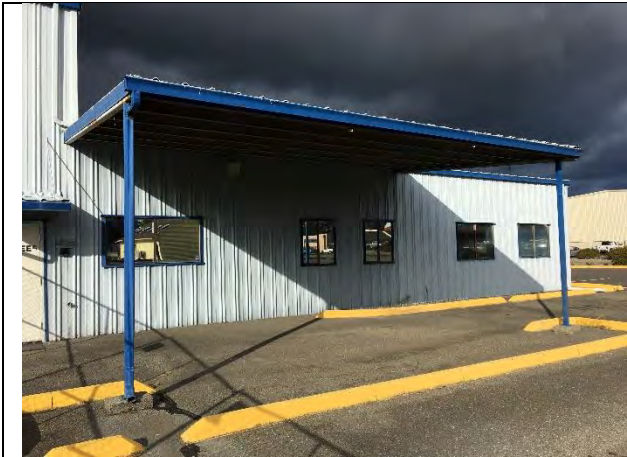
Shed roof carport on south side of building, employee entrance at left edge of photo

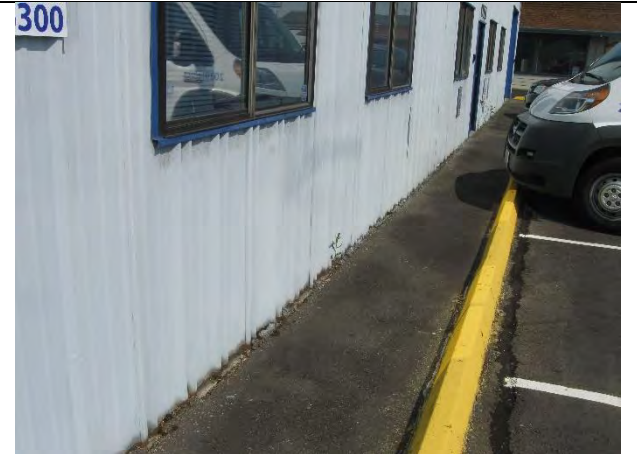
East wall of building, showing rusted siding at bottom edge

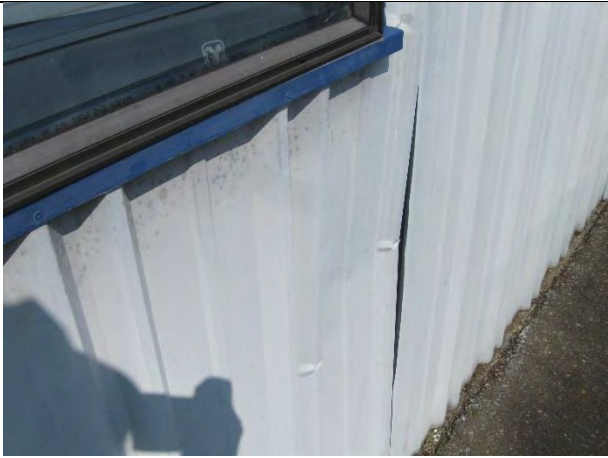
Dents in metal siding at east wall

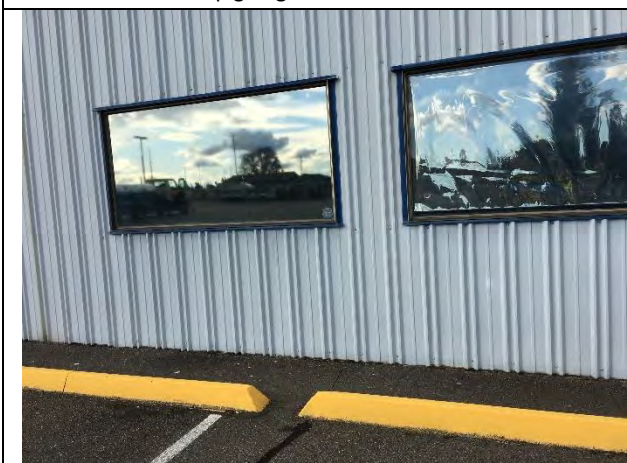
Exterior windows, south wall

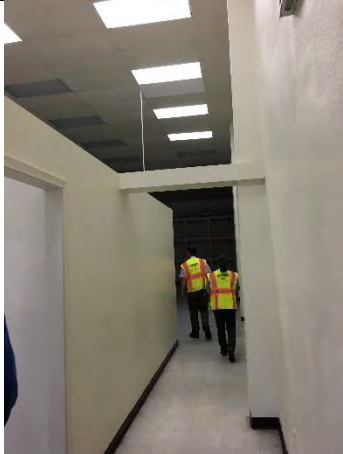
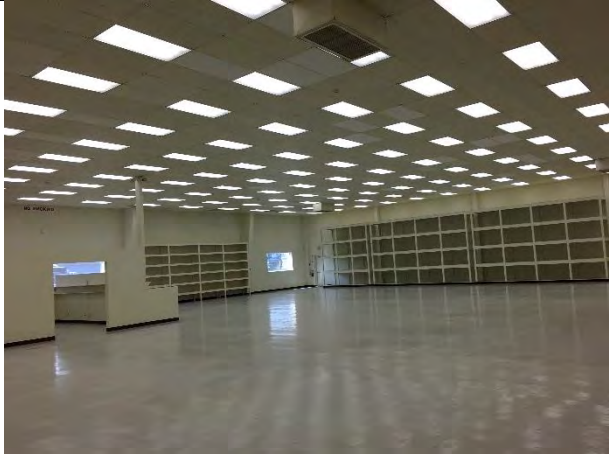
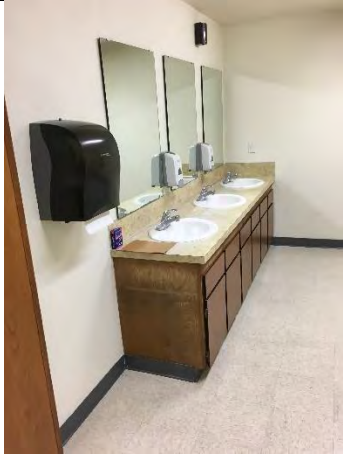
Interior walls in good condition		Linoleum flooring and suspended ceiling in large work-room		Women's restroom sinks

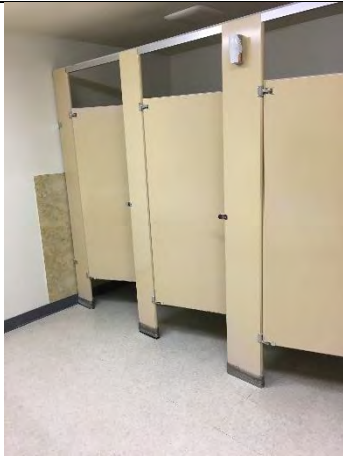
Women's restroom partition walls

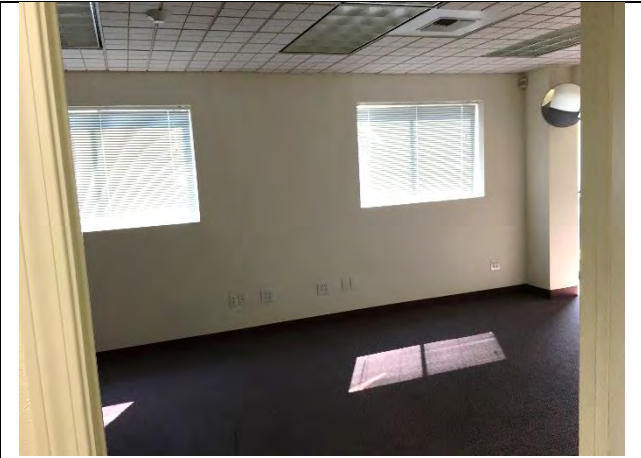
Interior of building in large work-room

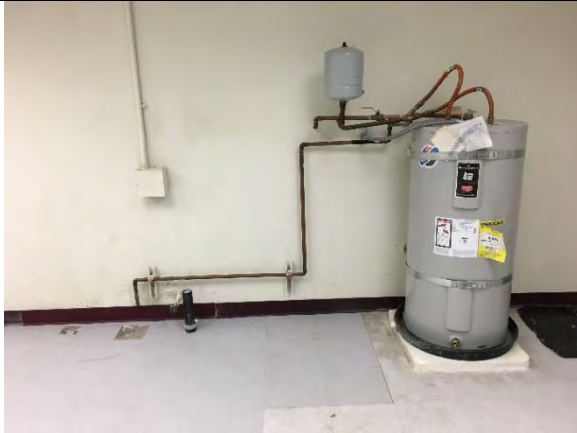
Secondary Level	Description	Current Condition	TERM Lite Rating	Recommended Corrective Action	Estimated Cost
Primary Level E. Plumbing			4.0		
Fixtures	Bathroom fixtures and water heater.	Fixtures in bathrooms are working and in adequate condition. Water heater in kitchen area in adequate condition and is braced properly but nearing the end of its typical useful life.	3.5	None	N/A
Water distribution	Water distribution system.	Water distribution system is working and functional. No leaks were observed.	4.0	None	N/A
Sanitary waste	Sanitary waste system.	Sanitary waste system is working and functional. No leaks were observed.	4.0	None	N/A

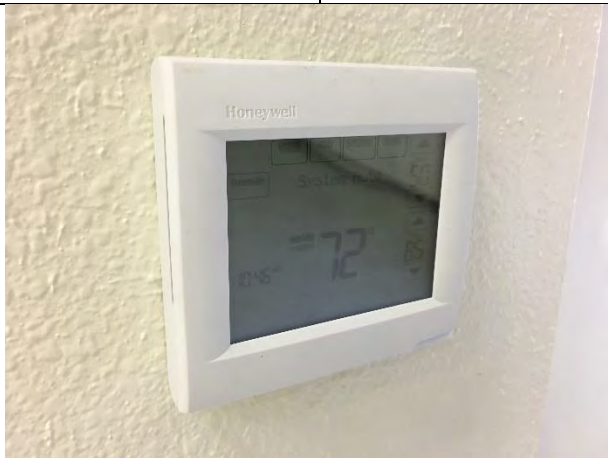
Honeywell Thermostat

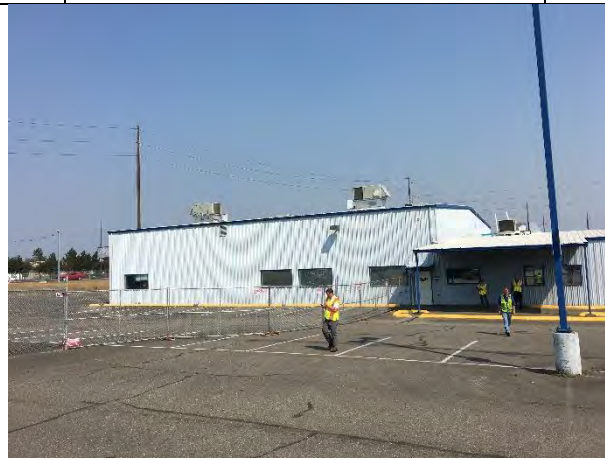
Roof mounted HVAC units

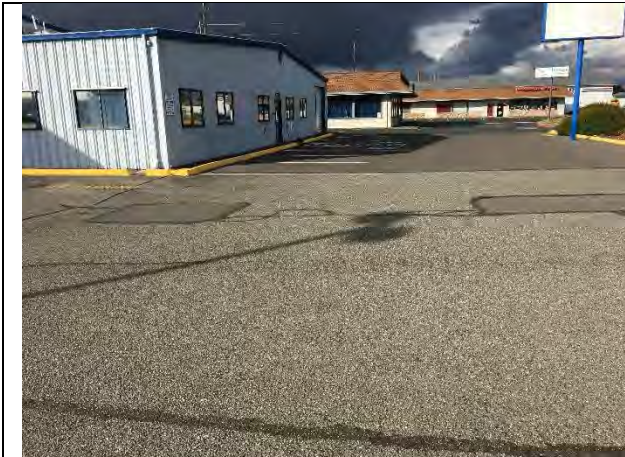
Asphalt cracks have been sealed

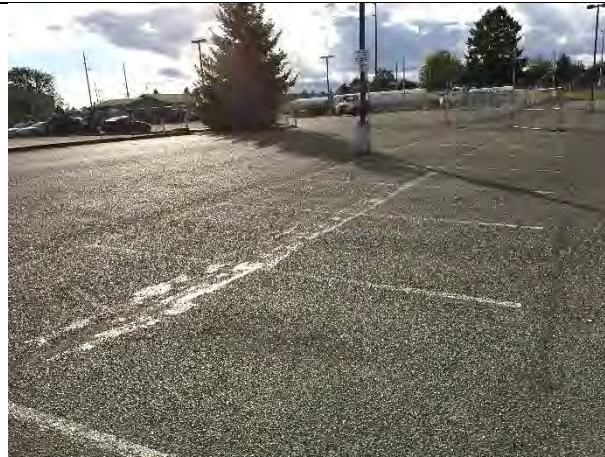
Parking lot striping is faded, but adequate

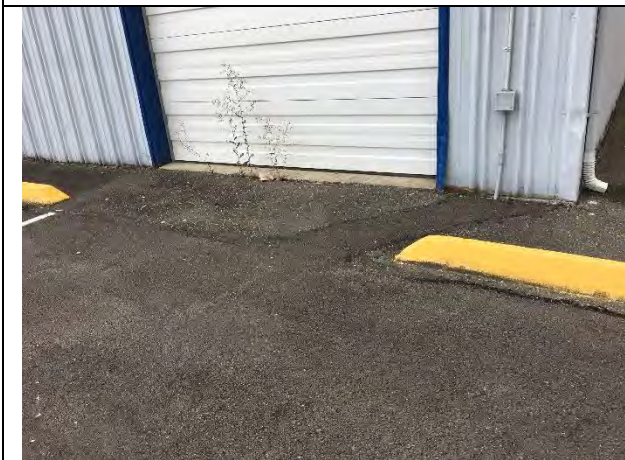
Weeds in the cracks between the asphalt and foundation

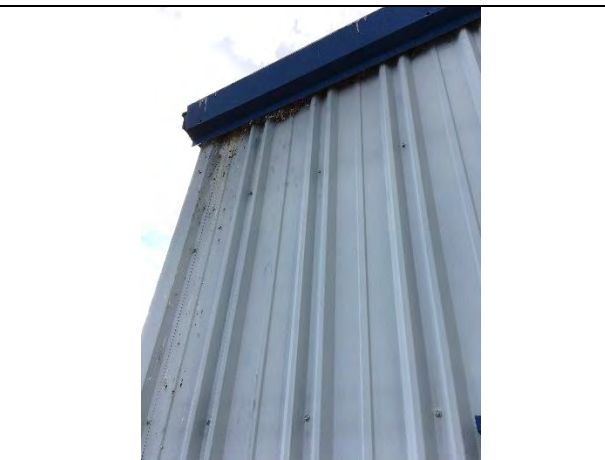
Birds nest located in southwest corner of building
