Pierce Transit Facilities Condition Assessment Report

Prepared for

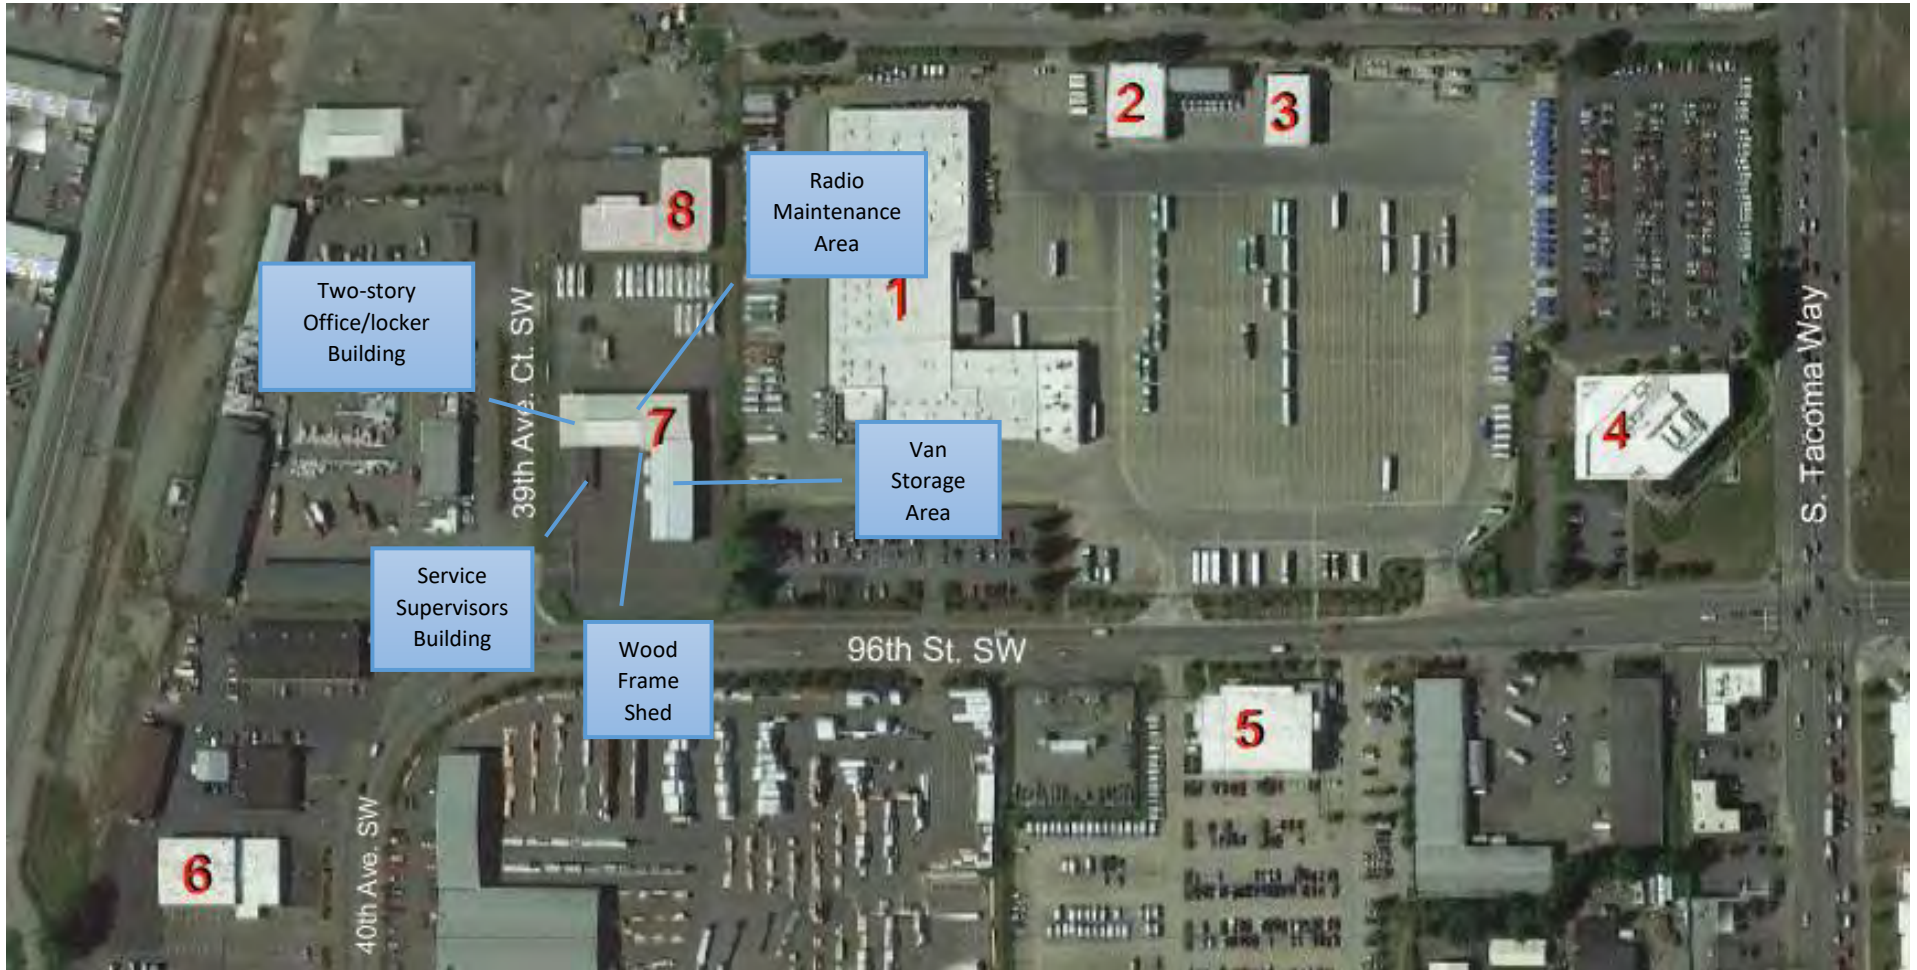
Facility Condition Assessment

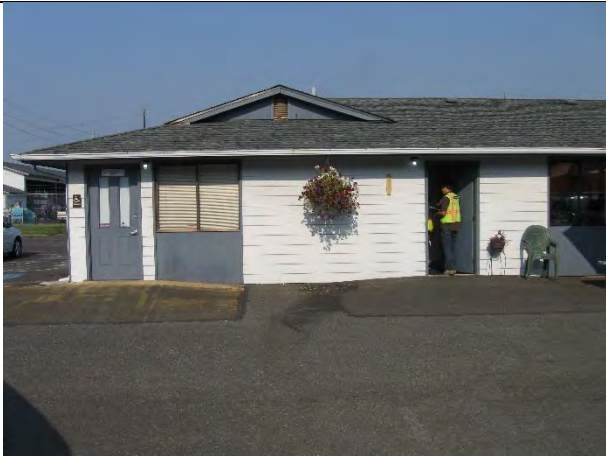
East wall entry of service supervisors building

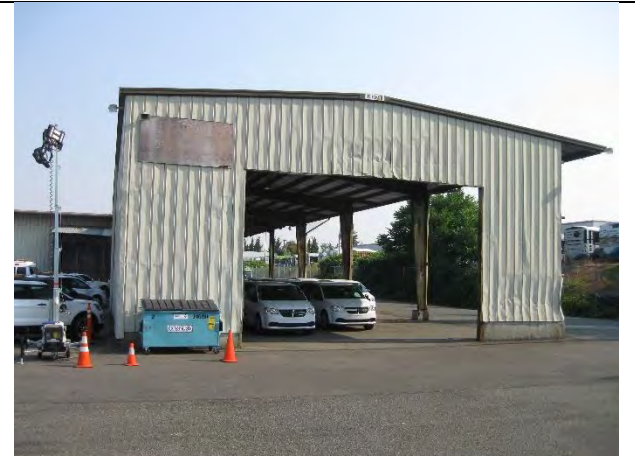
South wall of "L", showing damaged siding

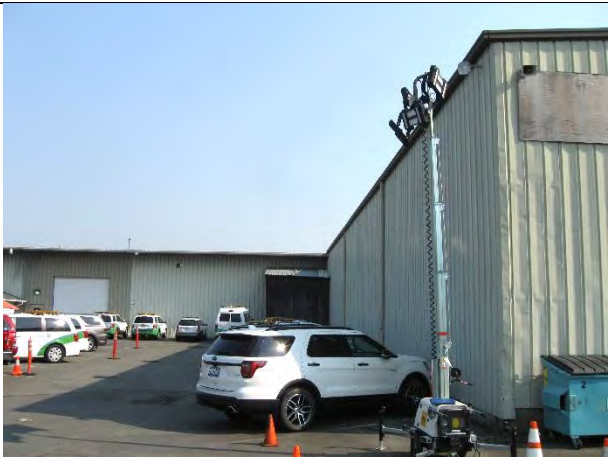
Southwest corner of "L", south wall of radio maintenance area

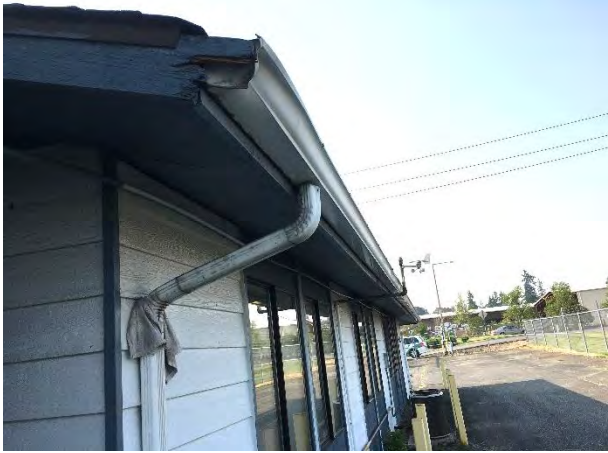
Northwest corner of service supervisors building showing damaged gutter

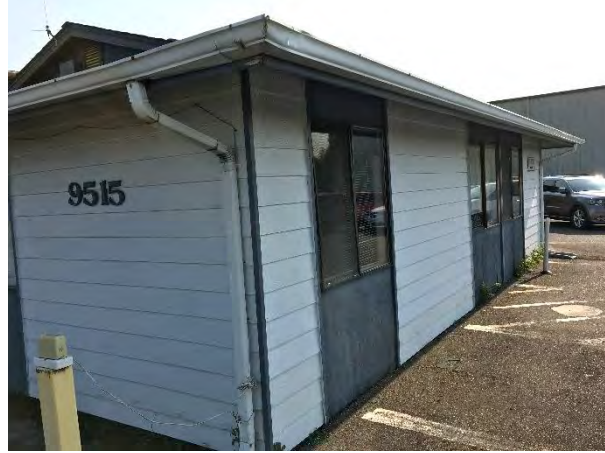
Southwest corner of service supervisors building

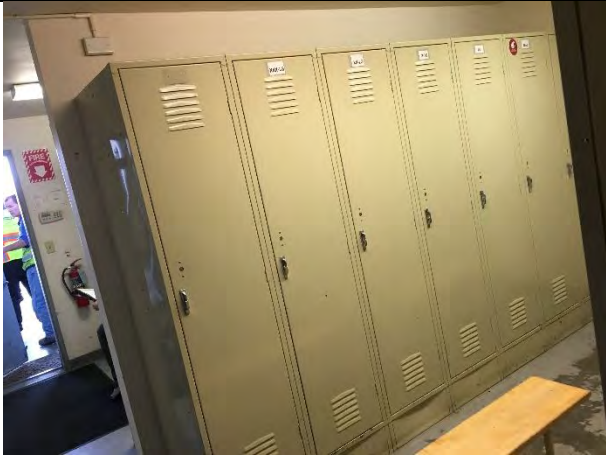
Office/locker building interior

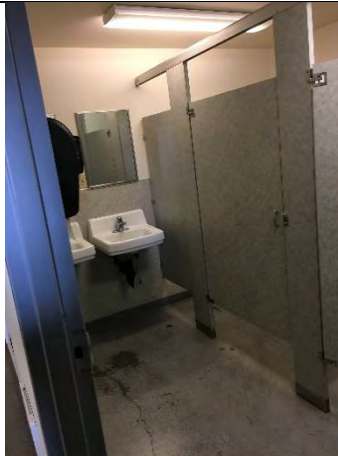
Men's restroom partitions

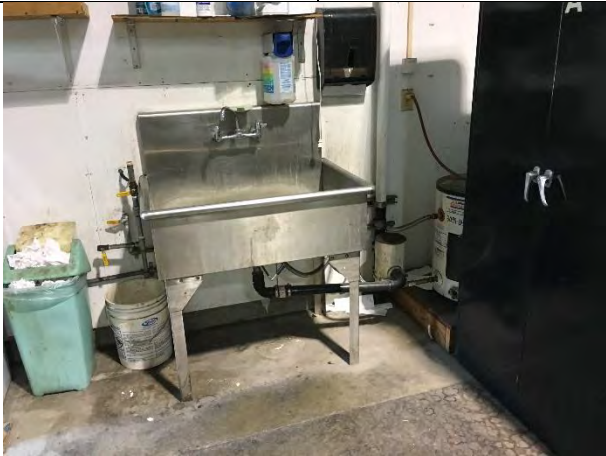
Sink in radio maintenance area

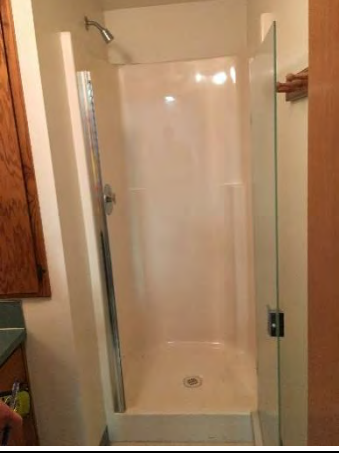
<p>Office/locker building shower on second floor</p>

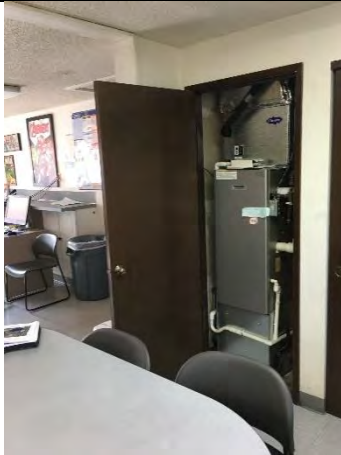
Interior of HVAC system for service supervisors building

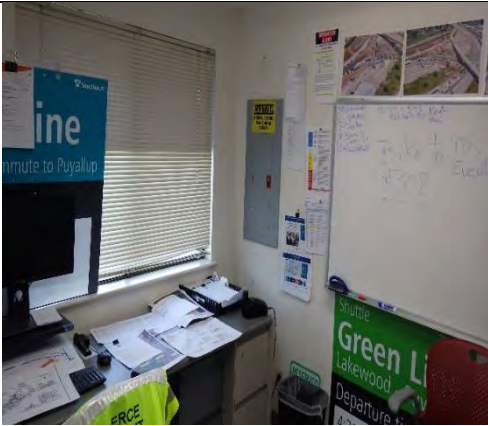
Electrical panel in service supervisor office

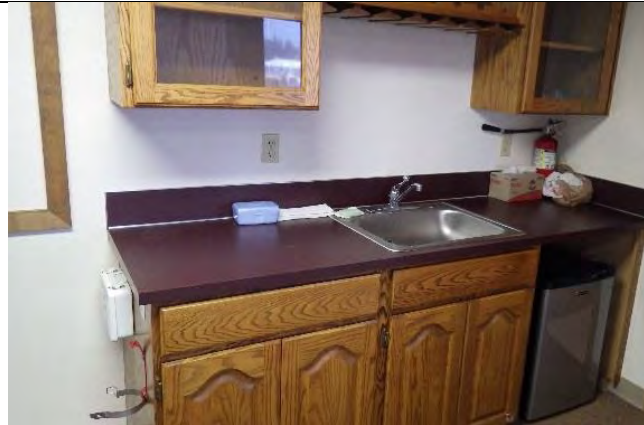
Replace receptacles with GFCI protection

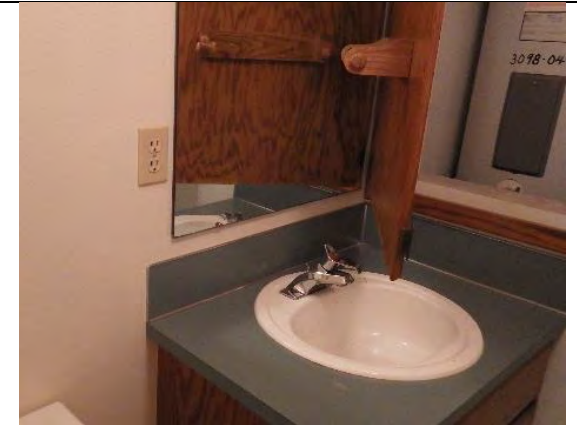
Replace receptacles with GFCI protection

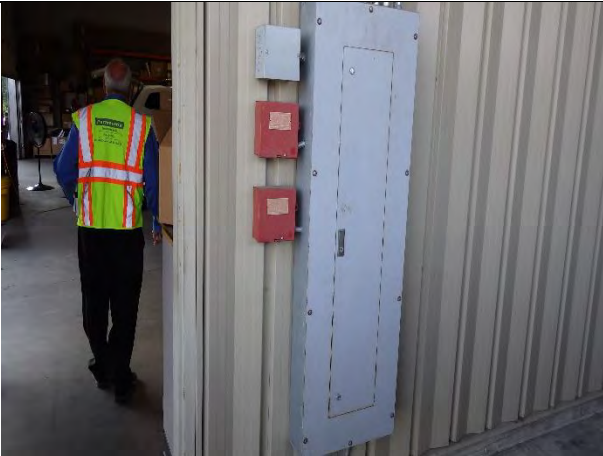
Restore protective coating on panel enclosure

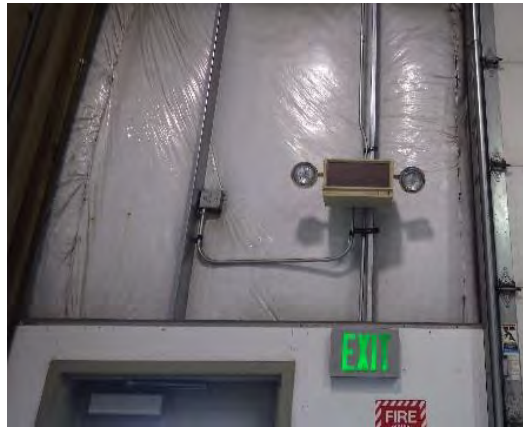
Non-functioning egress light

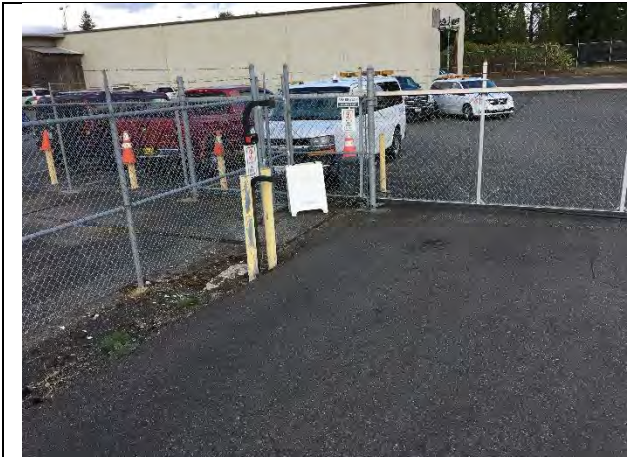
Electric entry gate on southwest corner of property

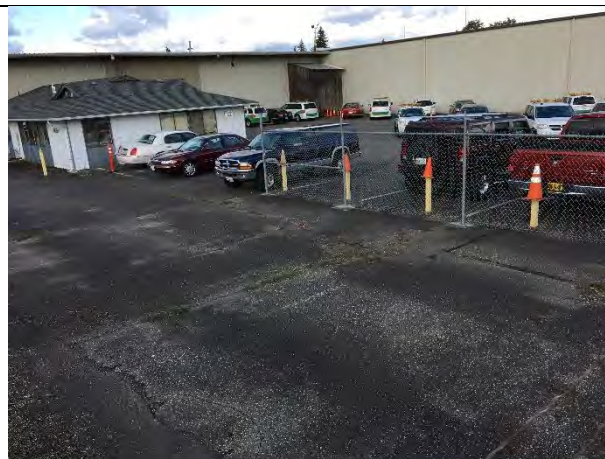
Cracks in asphalt where grass and weeds are growing through

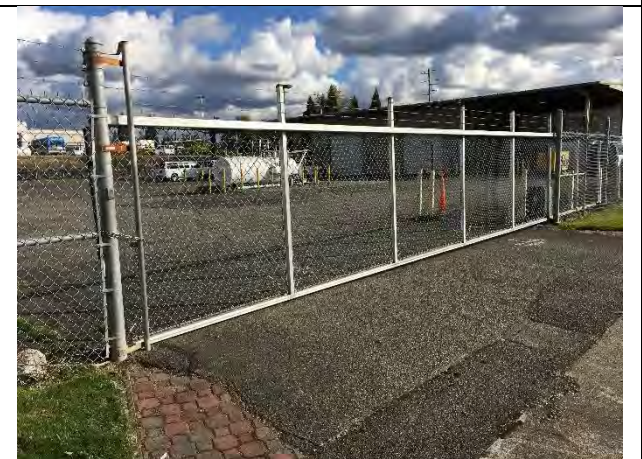
Chained manual gate on northwest corner of property

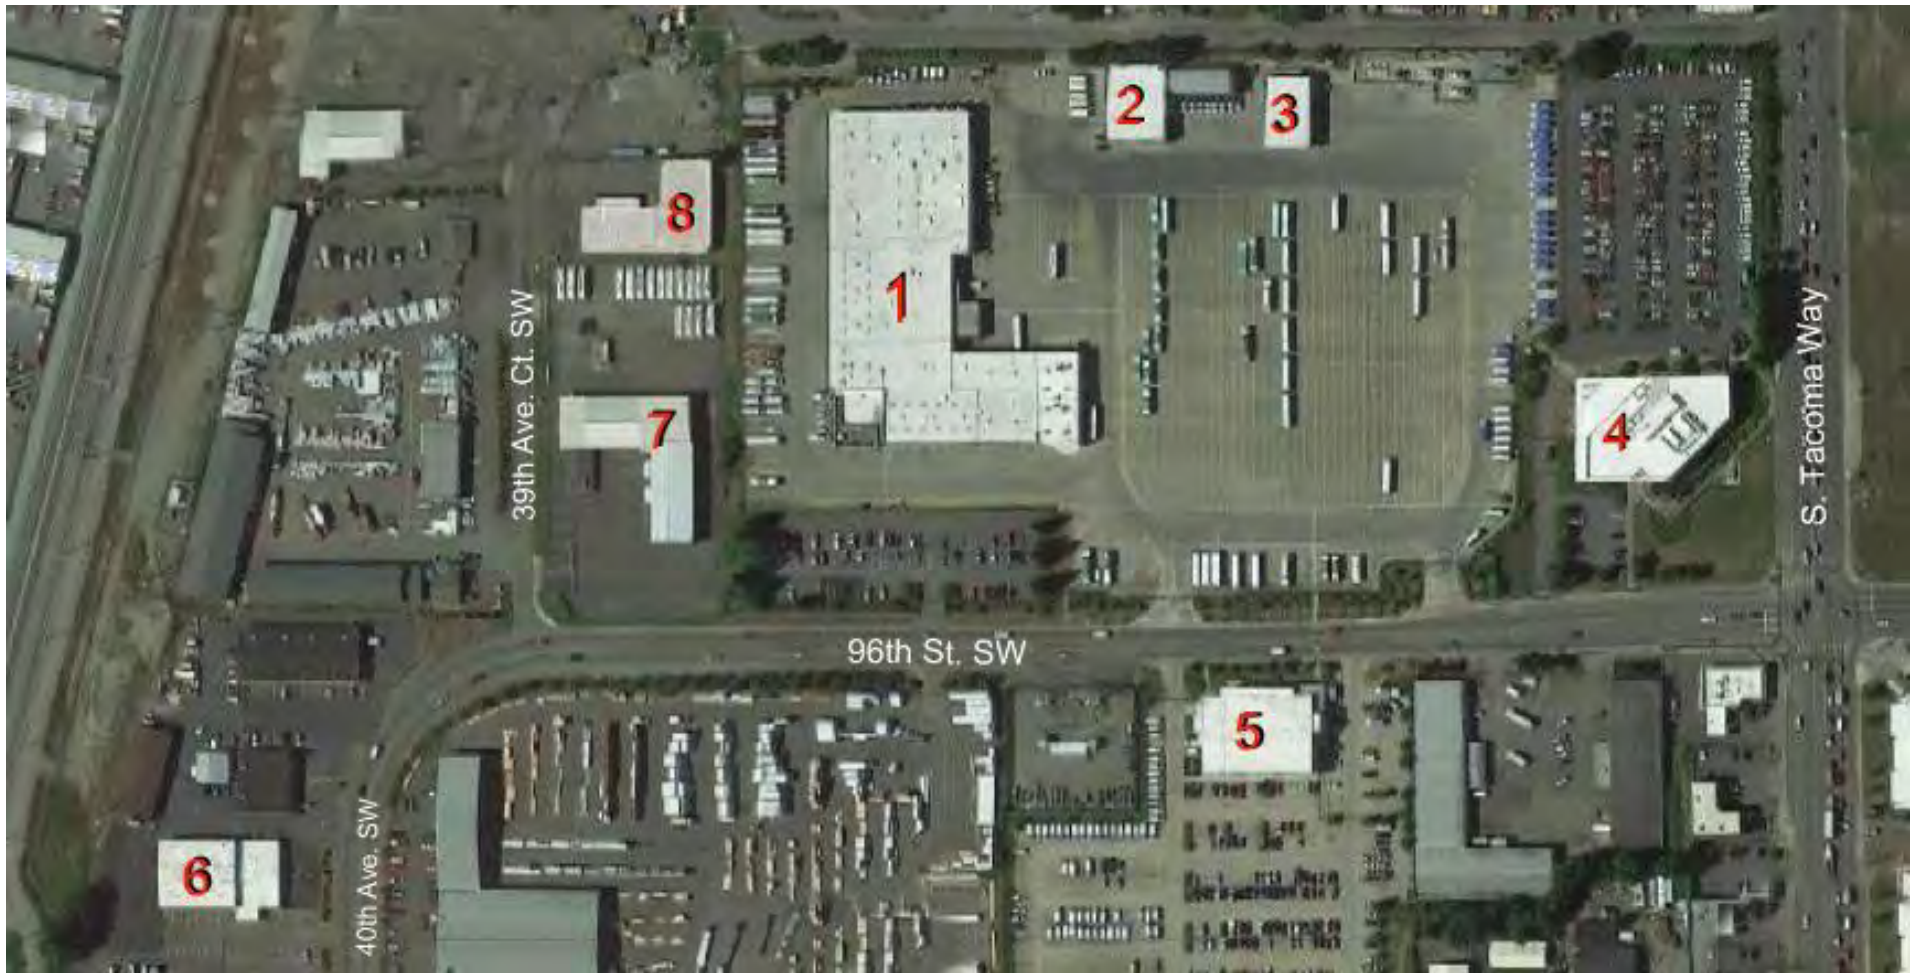
Facility Condition Assessment

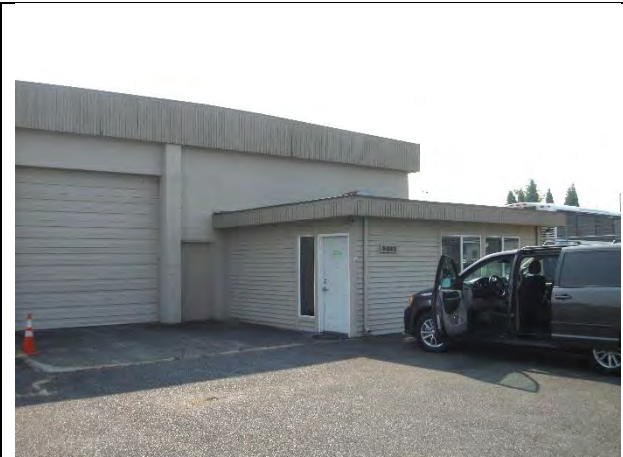
Office space add-on on west side

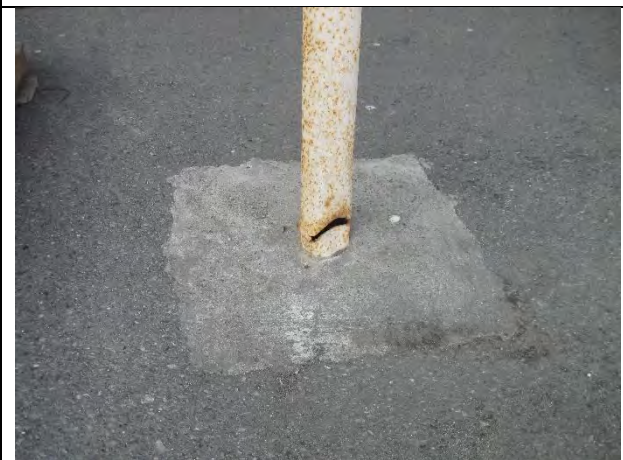
Warehouse exterior under shed roof on north side

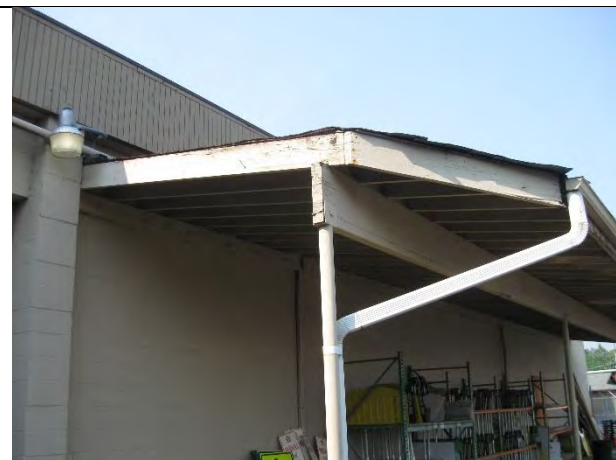
Exterior gutters and downspouts

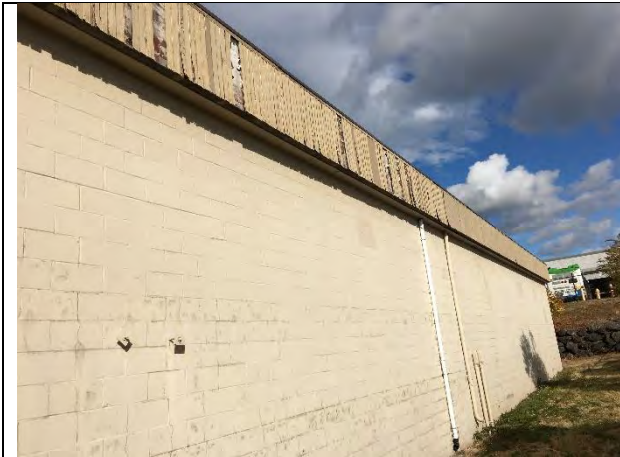
Door header cut out at north door on west wall

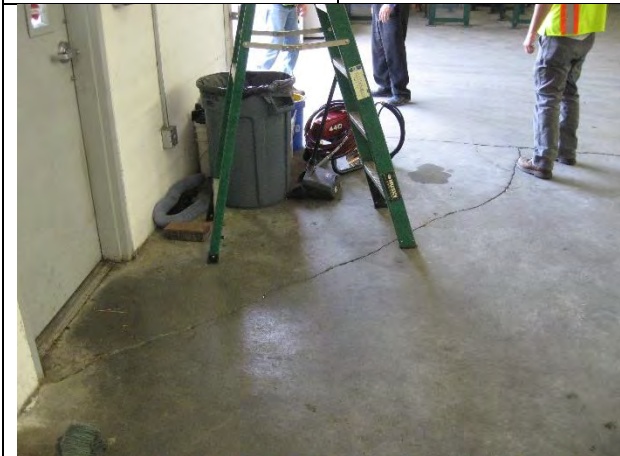
Secondary Level	Description	Current Condition	TERM Lite Rating	Recommended Corrective Action	Estimated Cost
Primary Level C. Interiors			3.5		
Partitions	Interior framed rooms.	Appear to be functional and in good condition.	4.0	None	N/A
Finishes	Warehouse floors.	Were done in single pour and shrinkage cracks are visible, however does not affect functionality.	3.5	None	N/A

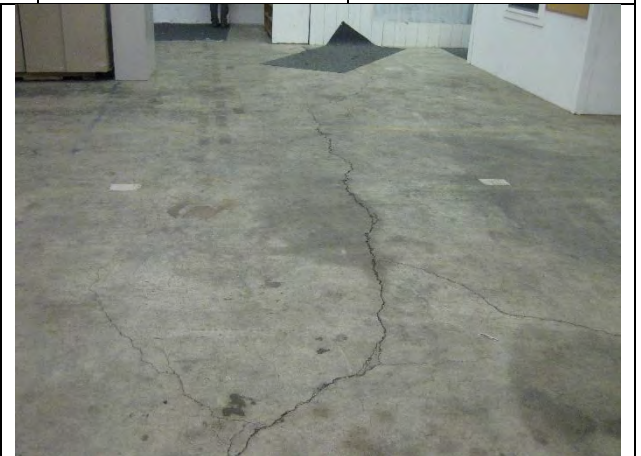
Warehouse floors and interior office space

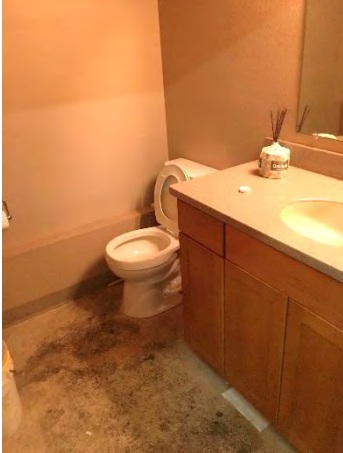
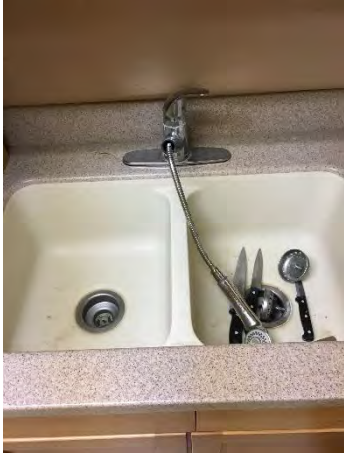
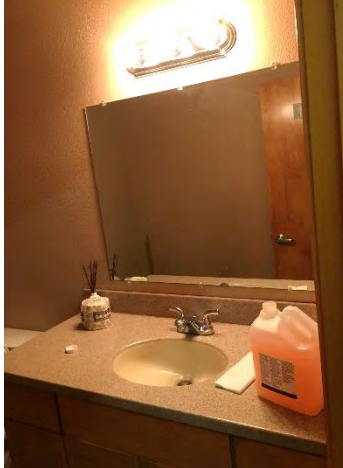
Bathroom fixtures in adequate condition	Kitchen fixtures		Women's restroom sink

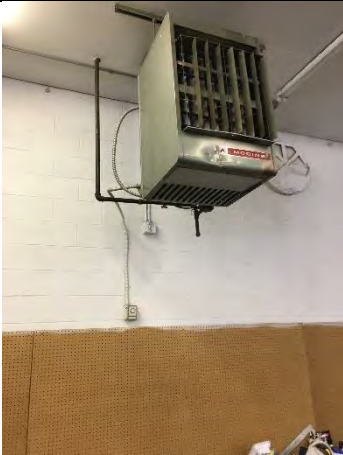
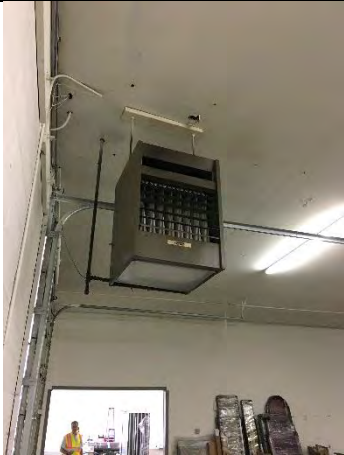
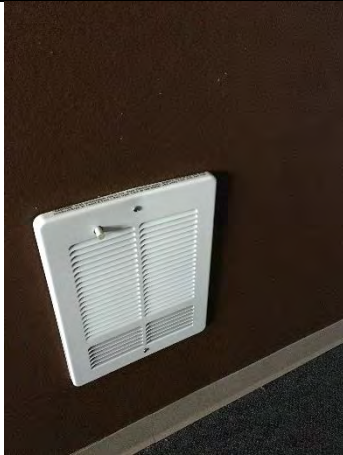
Gas powered heater hanging from ceiling in warehouse		Gas powered heater hanging from ceiling in warehouse		Wall mounted unit heaters in office spaces

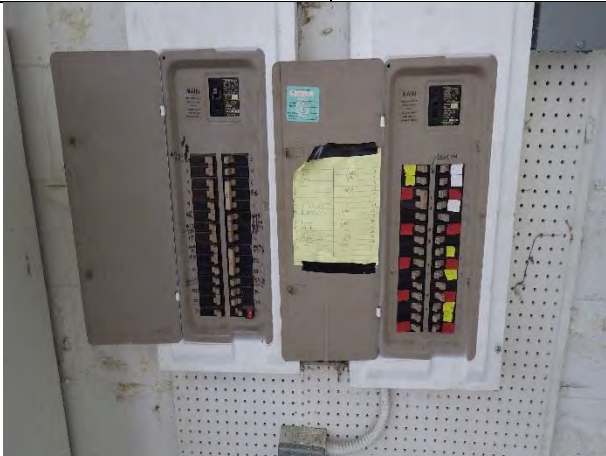
Electrical service in working order

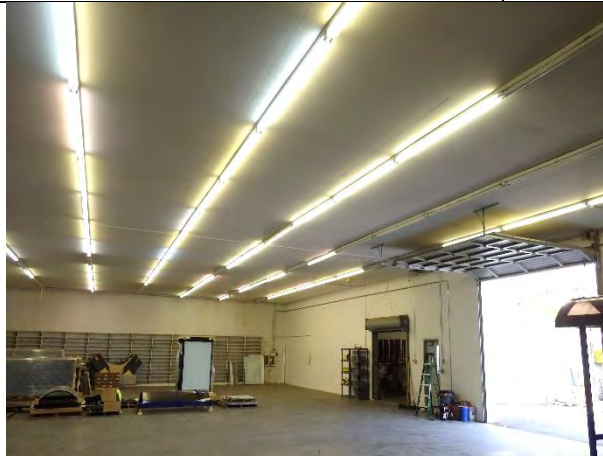
Lighting in main bus shelter work area

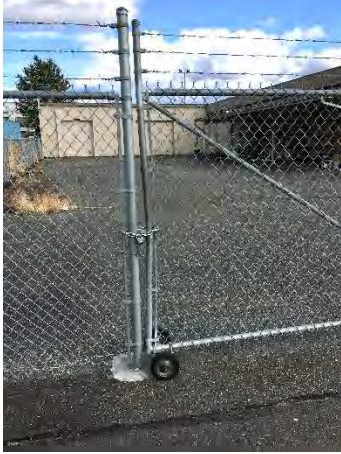
Rolling entrance gate on west side of property

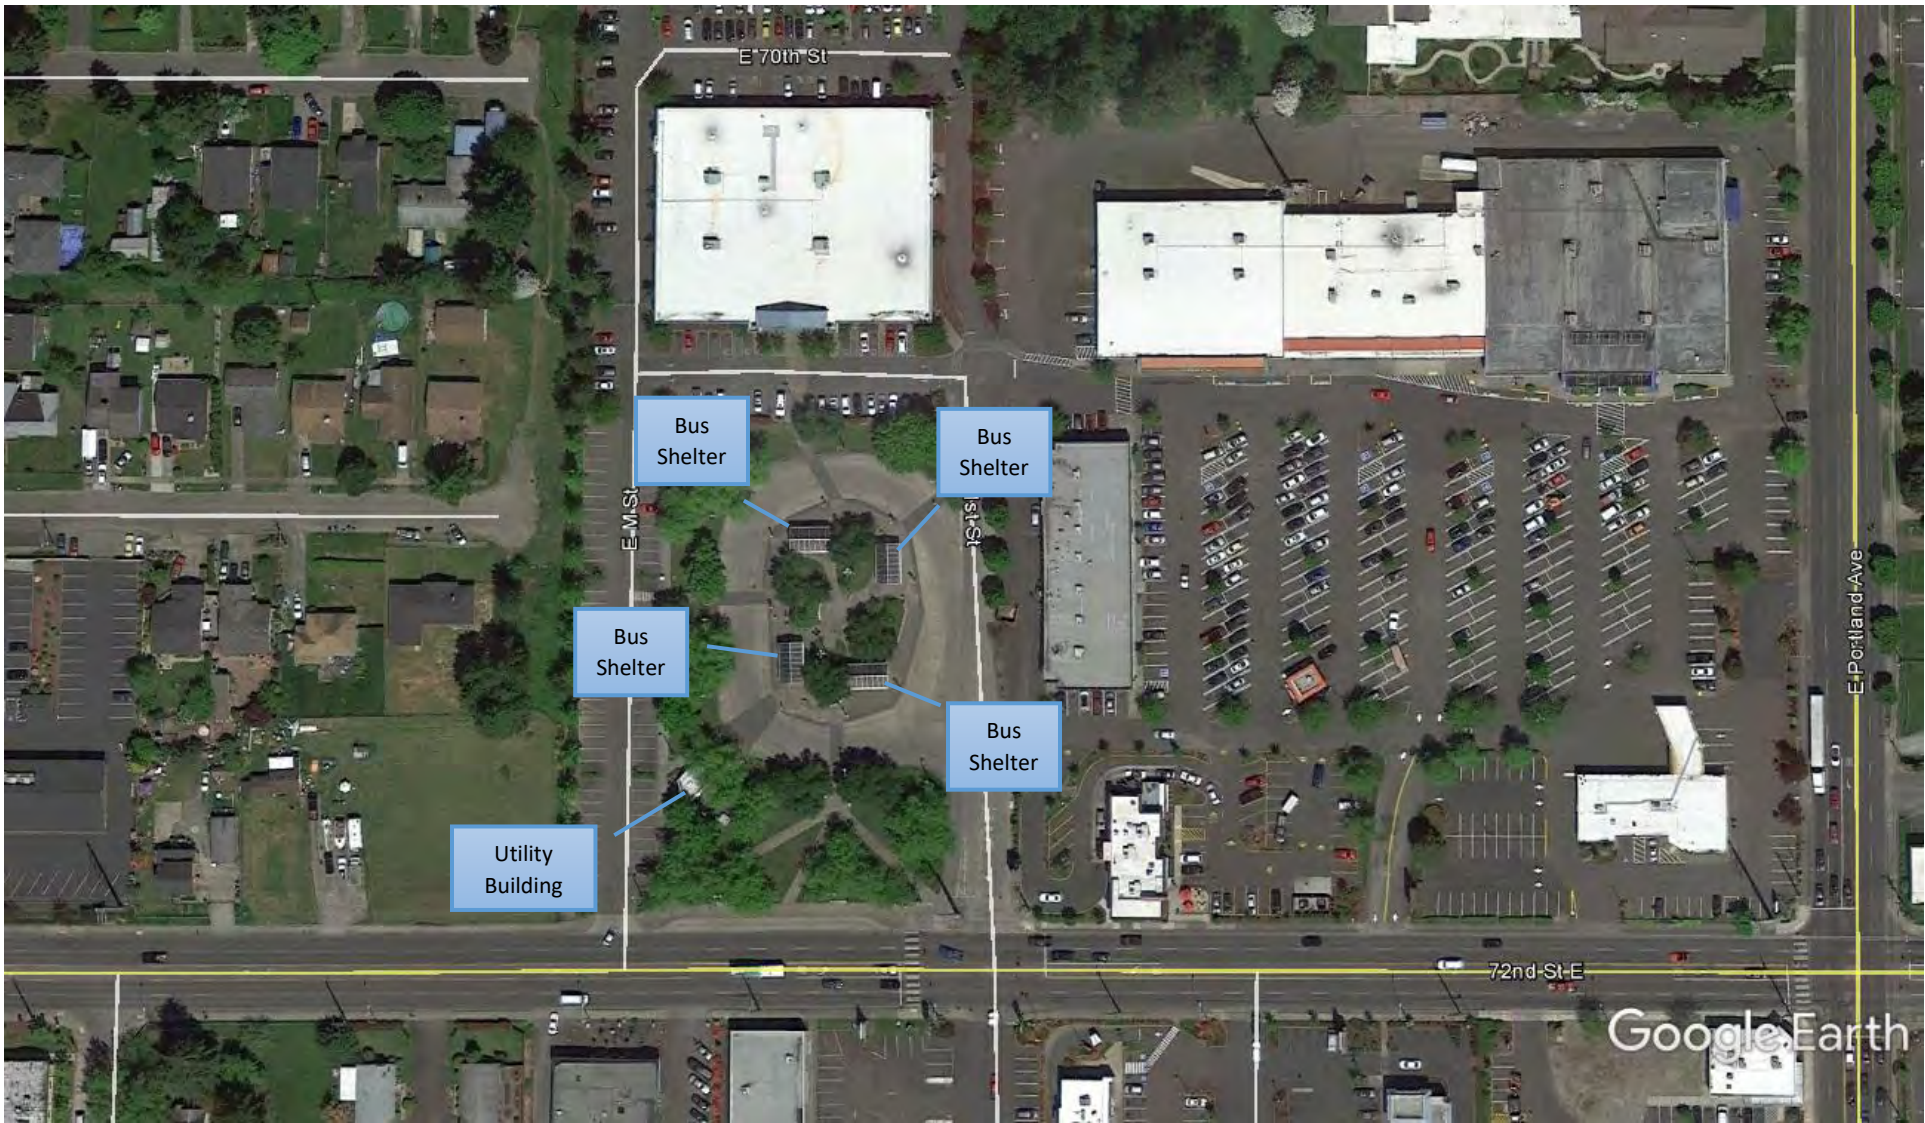
Facility Condition Assessment

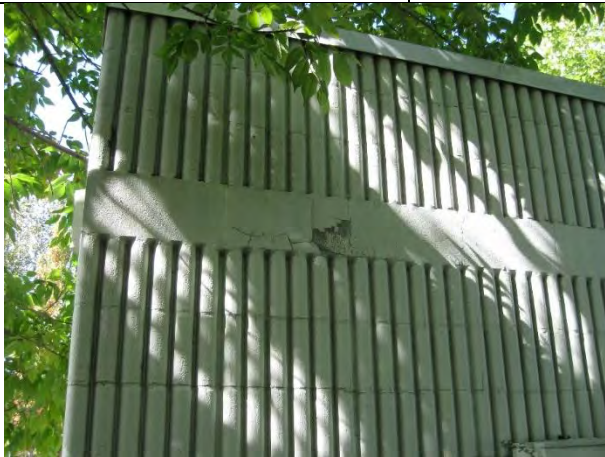
CMU damage on utility building

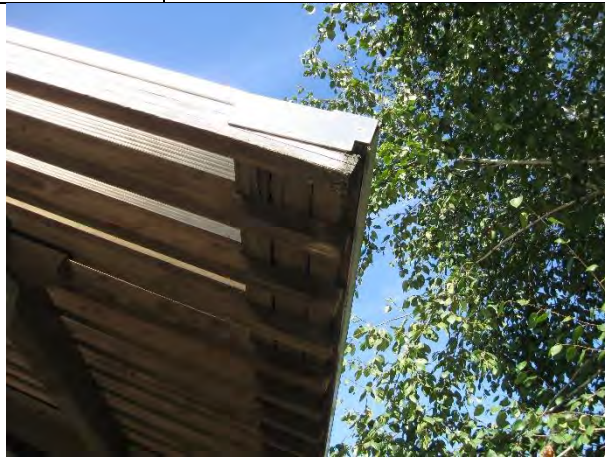
Bus shelter gable end roof rafters rotted

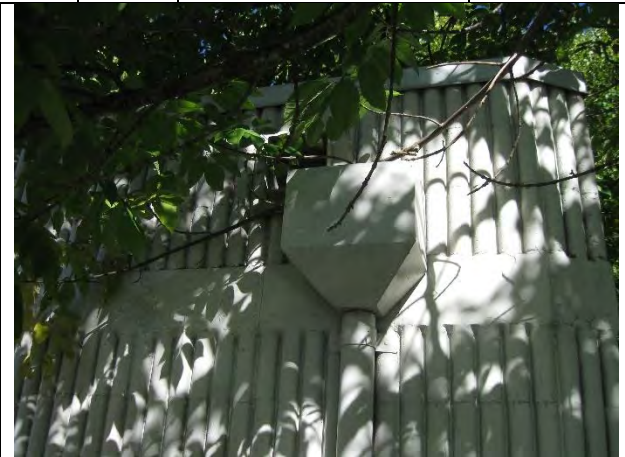
Utility building downspout collector box.

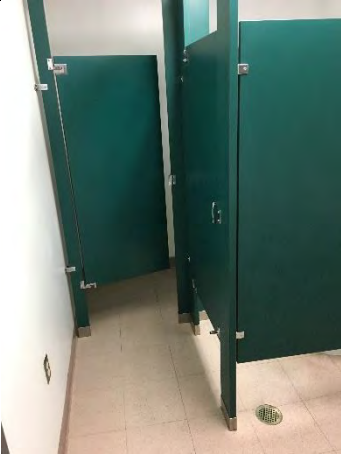
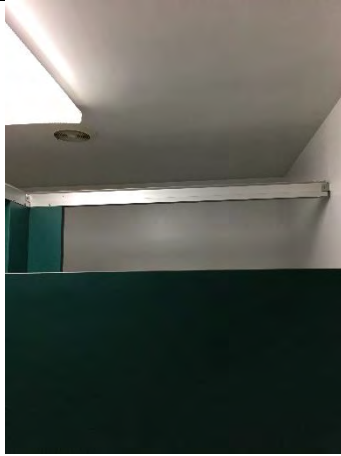
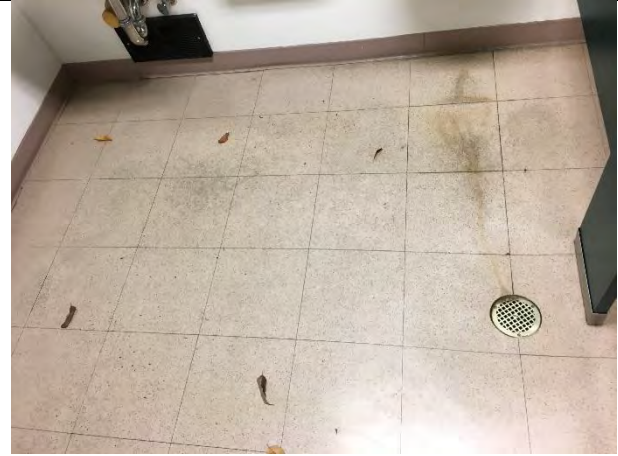
Bathroom partitions		Interior restroom walls		Flooring in men's restroom

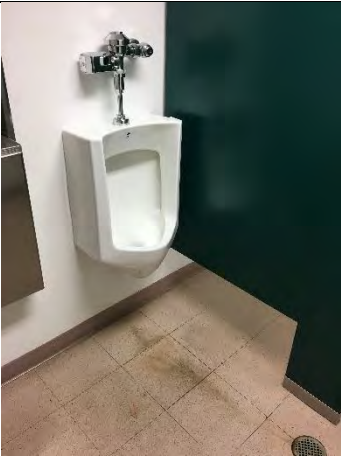
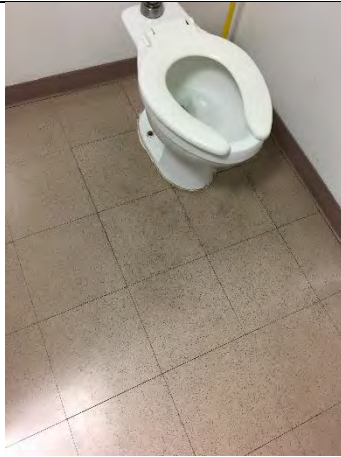
Tile flooring in men's restroom		Tile flooring in women's restroom

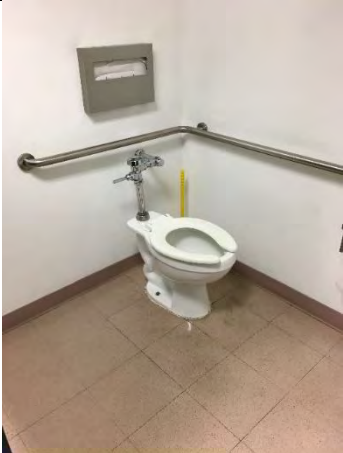
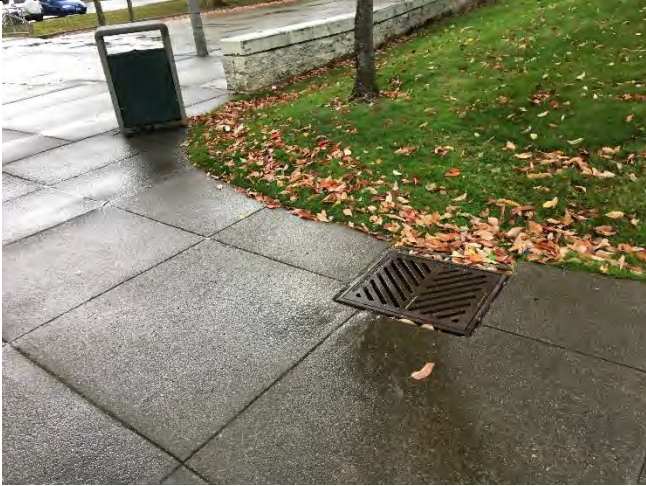
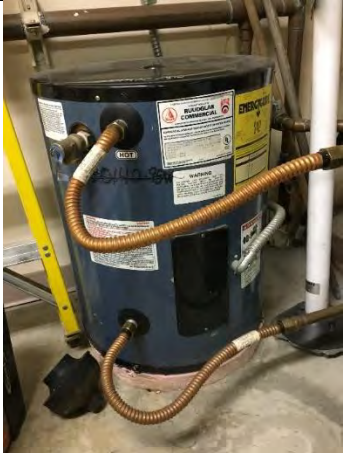
Restroom fixtures are in good condition	Storm drains throughout site provide sufficient drainage	Hot water tank in utility room

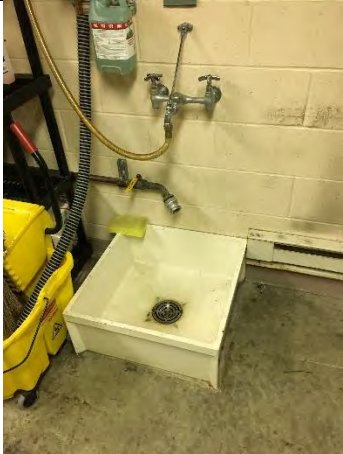
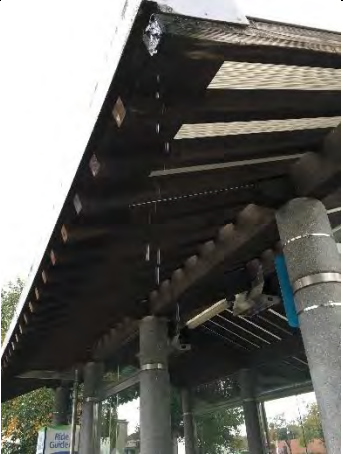
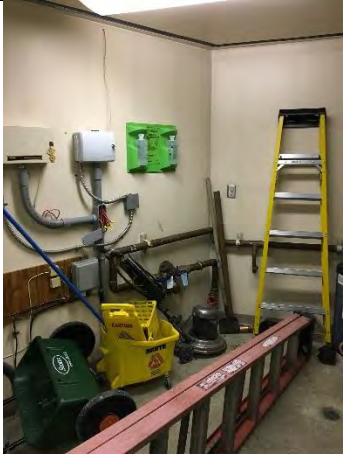
Mop sink	Leaking gutter at bus shelter	Miscellaneous storage in utility room

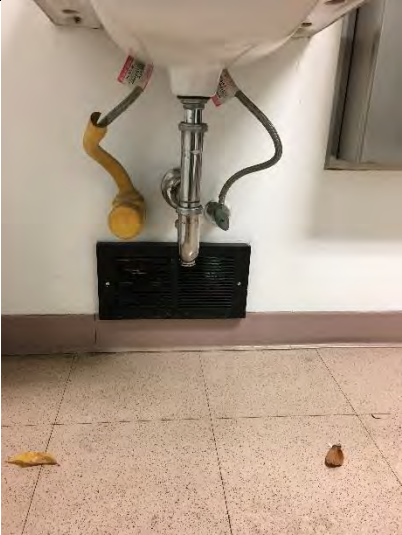
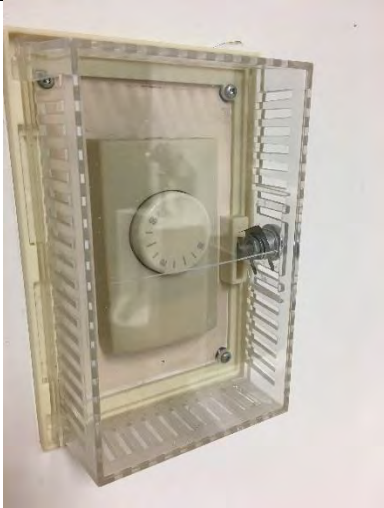
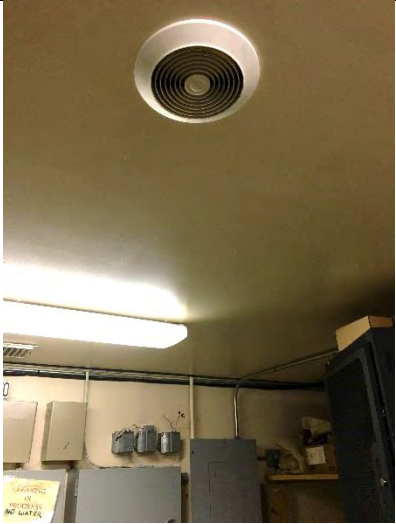
Restroom heaters located under sinks		Remote thermostat with locked cover		Utility room ceiling exhaust fan

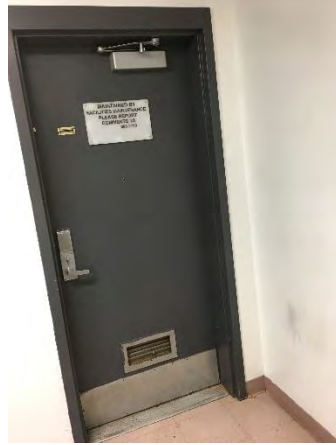
Utility room baseboard heater

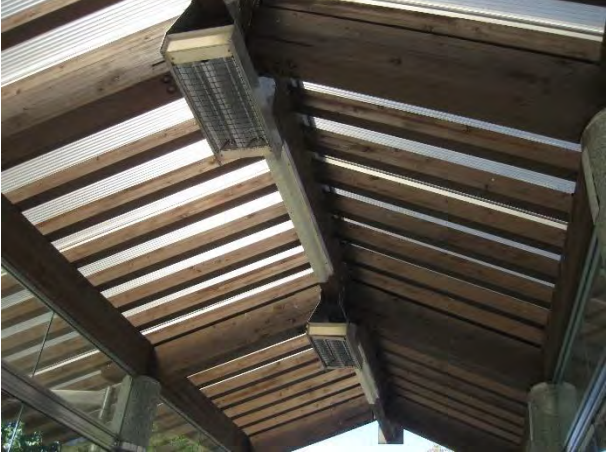
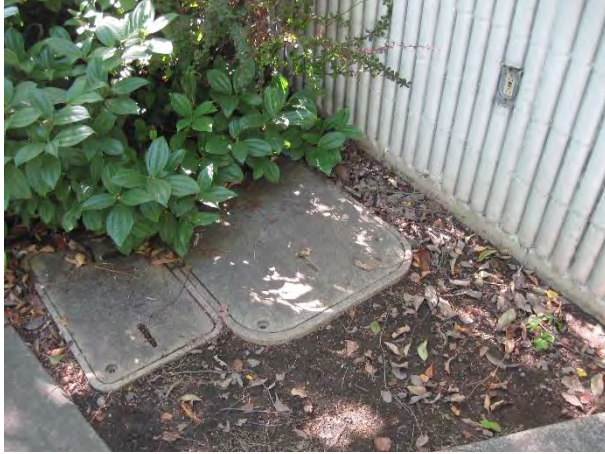
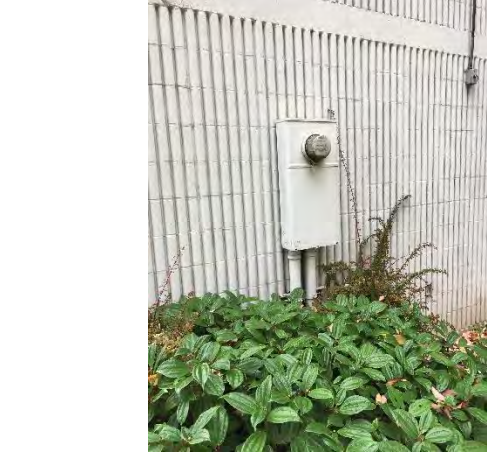
Bus shelter flourescent fixtures installed on center beam	South wall of utility building, cover missing on outside electrical receptacle	Meter on side of utility building

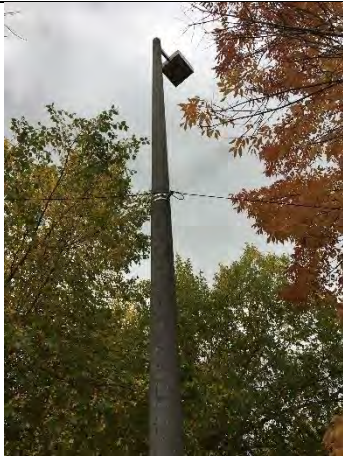
Lighting near utility building

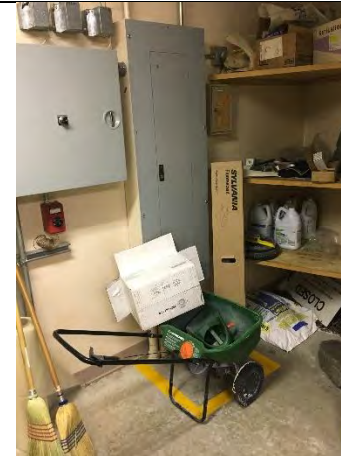
Relocate items located in front of electrical panel

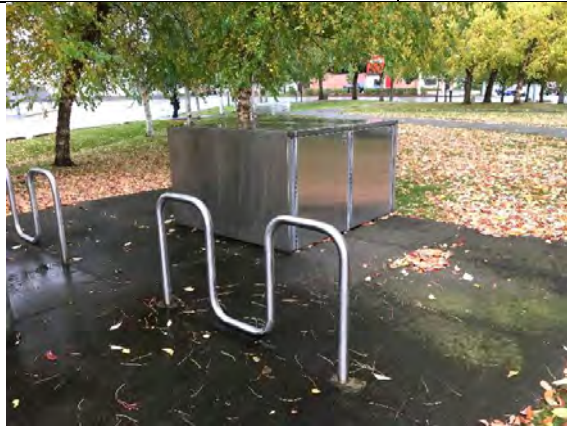
Bike locker and stands are in good condition

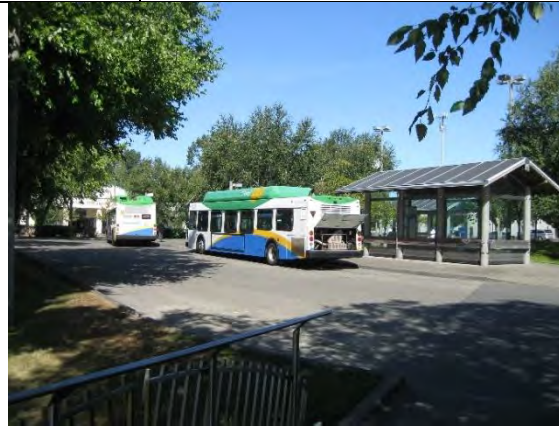
Concrete panels are in adequate condition

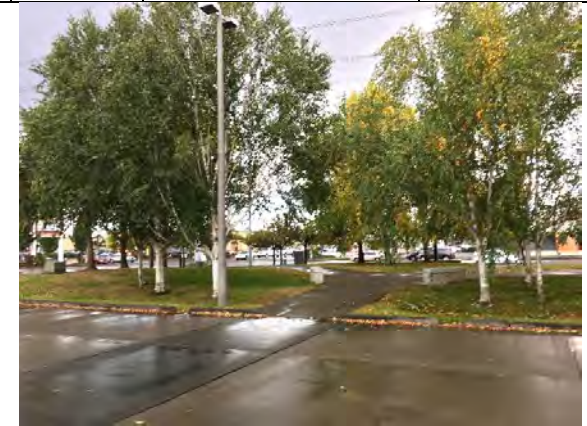
Pedestrian crossing not as visible when surface is wet

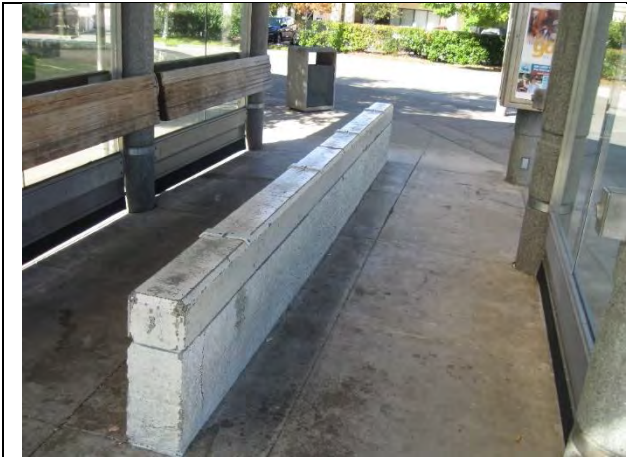
CMU seating in bus shelter – paint is worn

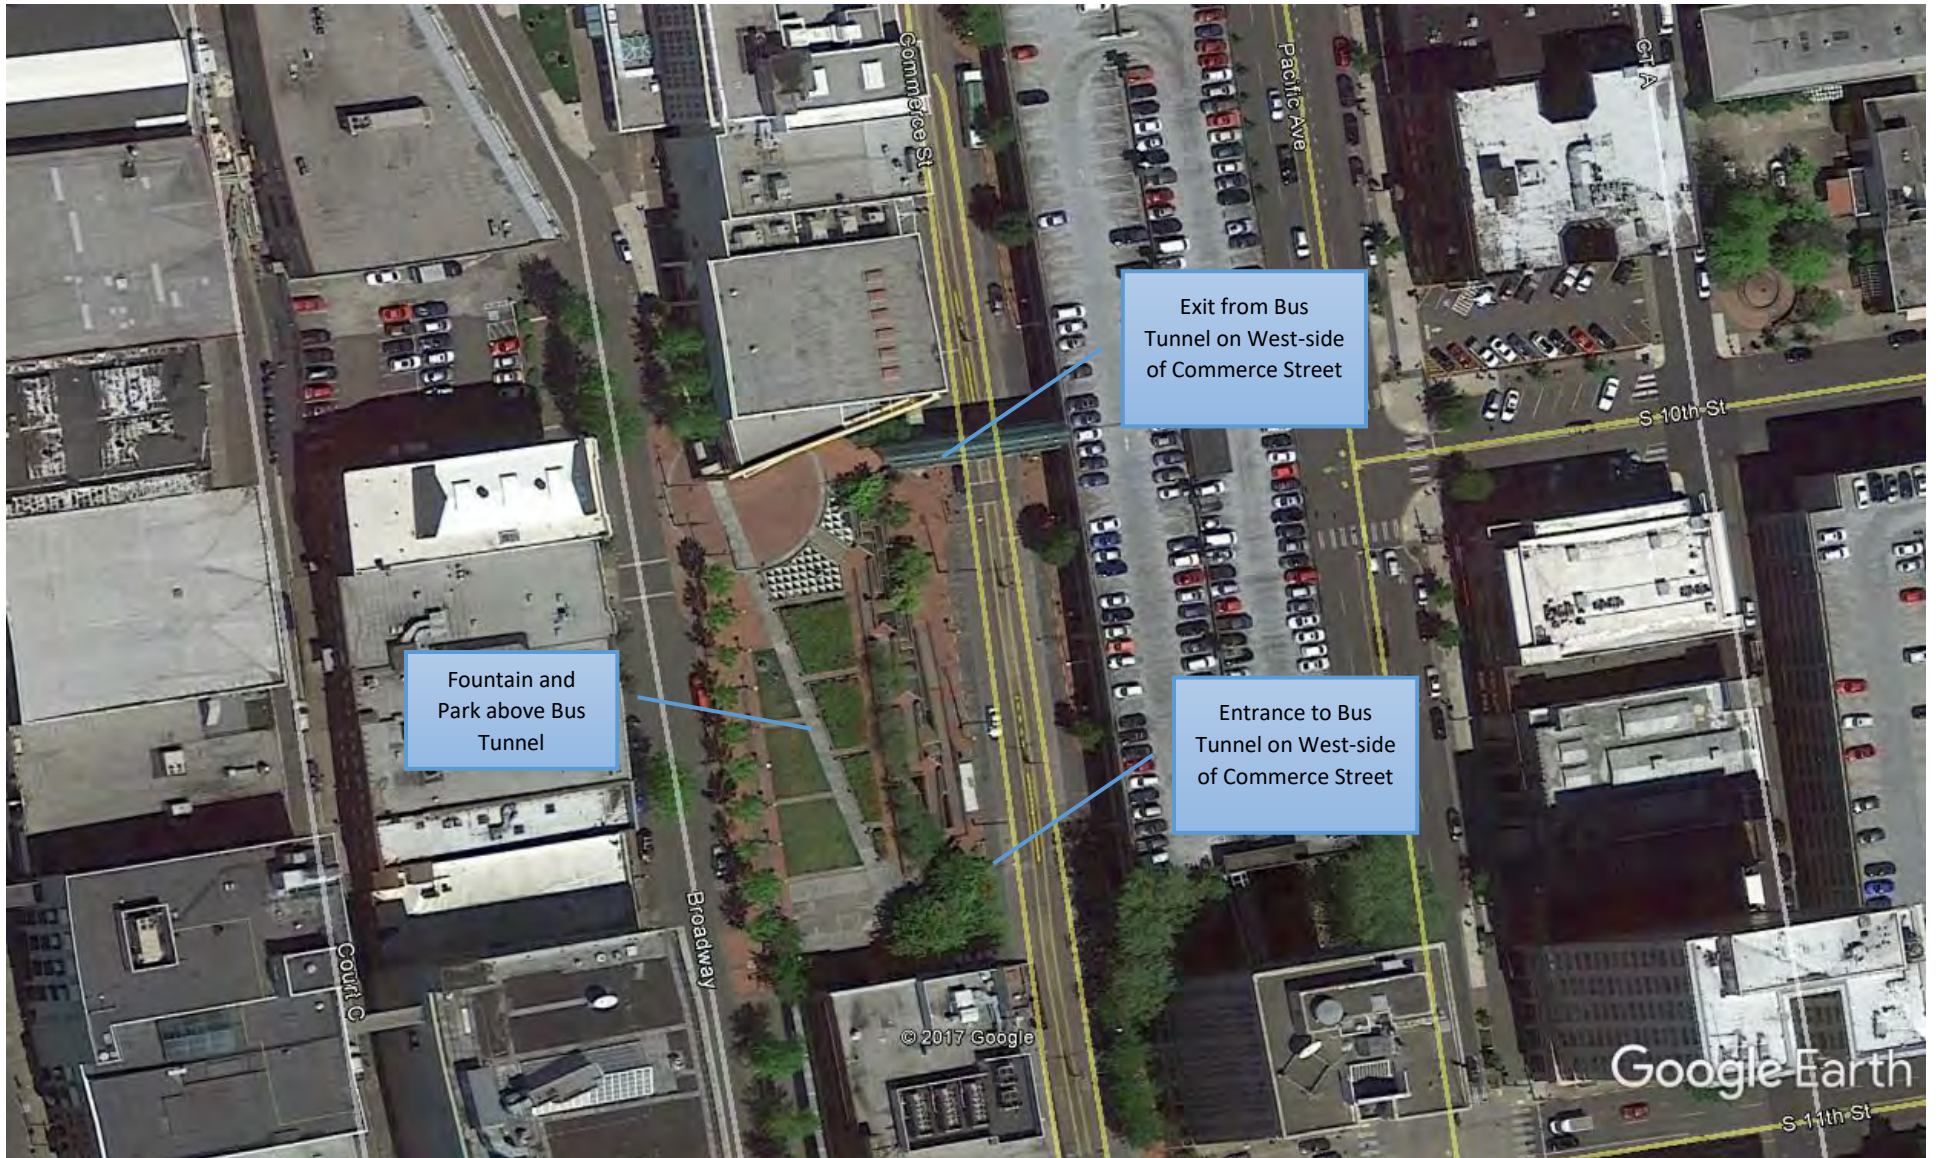
Facility Condition Assessment

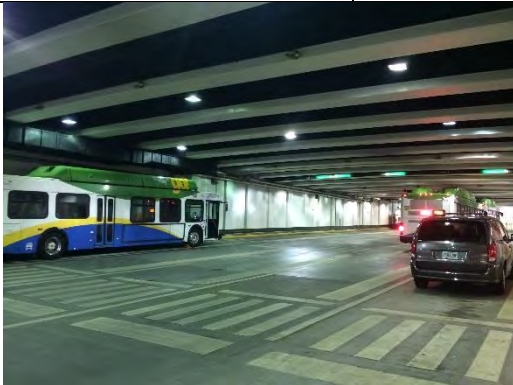
Underground retaining walls
