Pierce Transit Facilities Condition Assessment Report

Prepared for

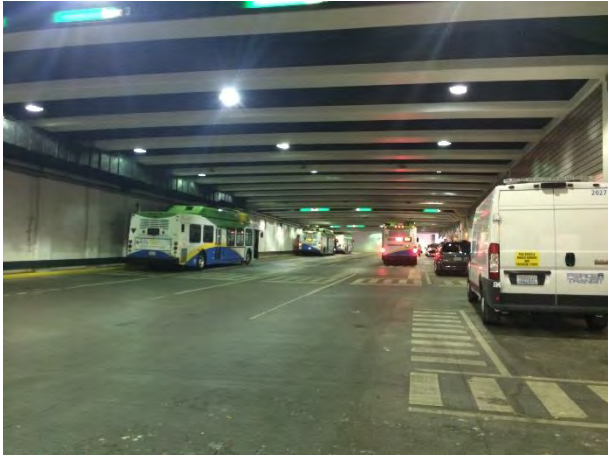
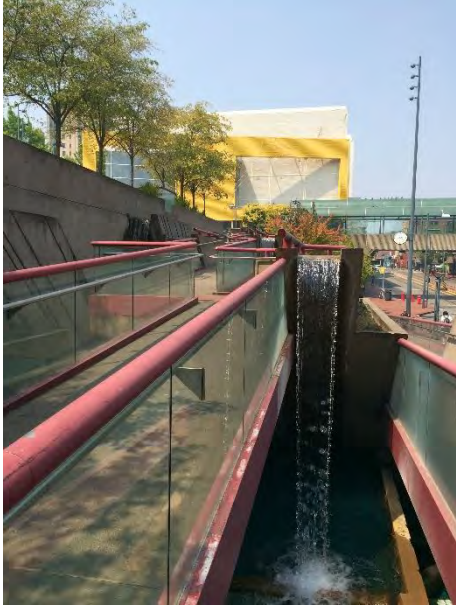
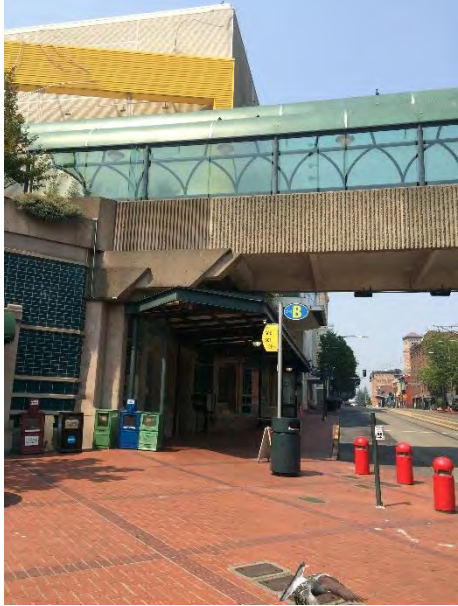
Concrete pre-stress beams spanning bus bay		Fountains on roof surface		Exterior of bus shop area

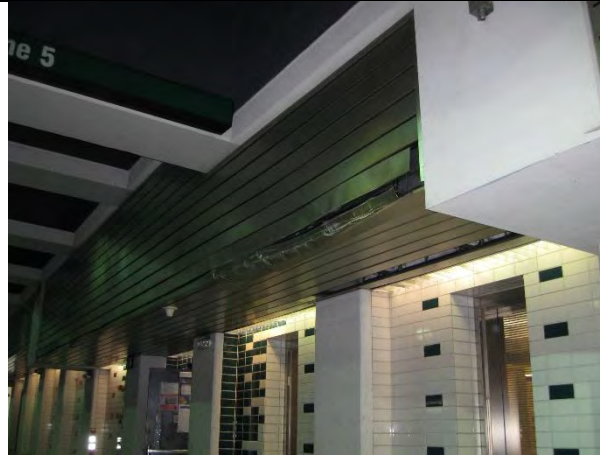
Damaged fascia in bus tunnel

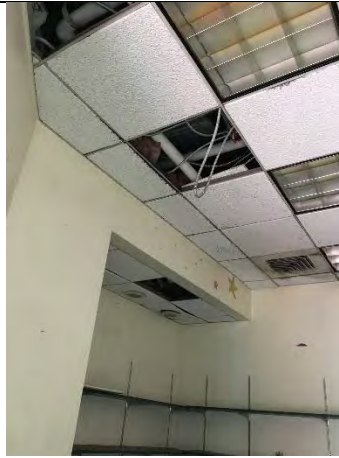
Ceiling tiles missing

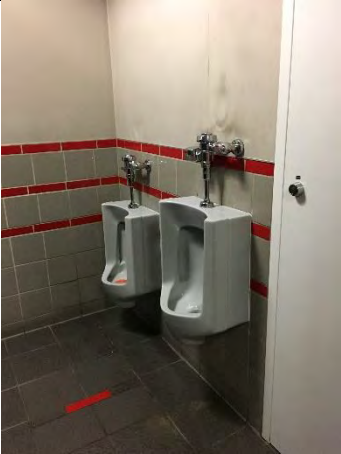
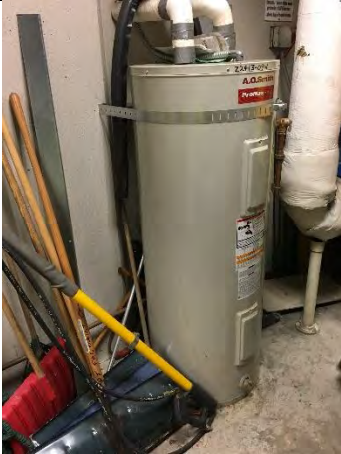
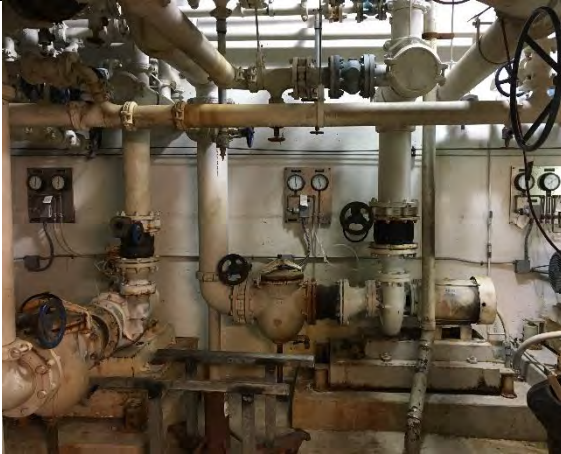
Restrooms in Operator's lobby are in adequate condition	Water heater tank in the work room	Pump room - corrosion throughout

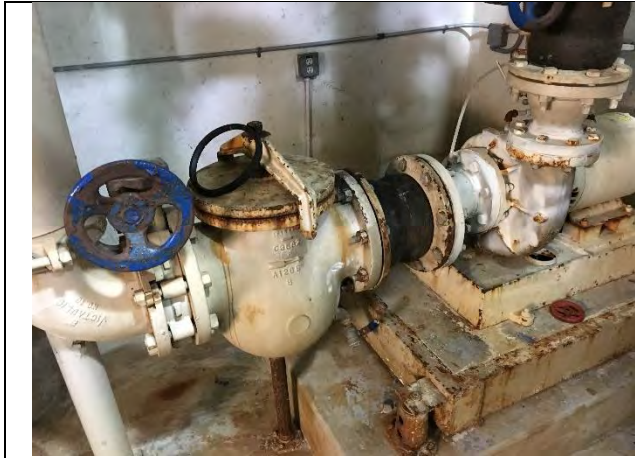
Pump room – corrosion throughout

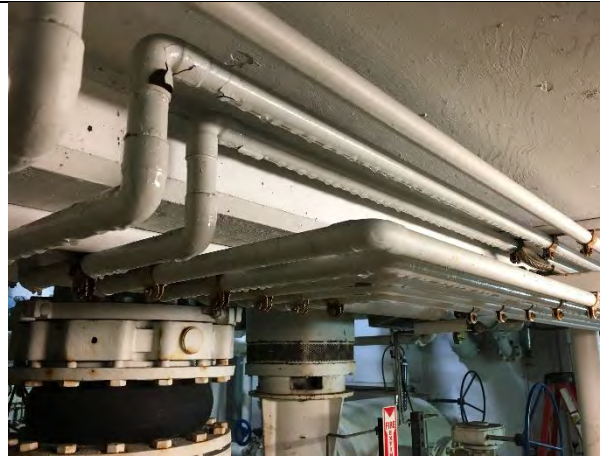
Condensation collecting on the small piping near the chlorine injection system

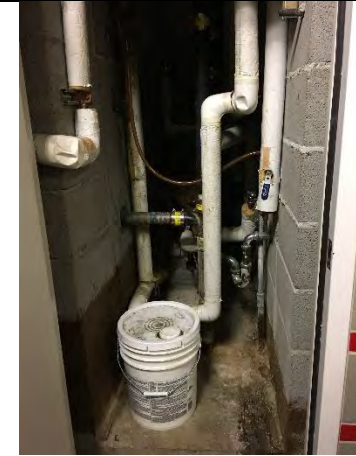
Difficult access for maintenance and repair for the water distribution and sanitary waste for driver break room/rest area

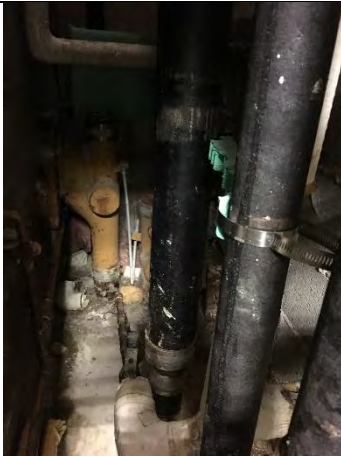
Difficult access for maintenance and repair for the water distribution and sanitary waste for driver break room/rest area

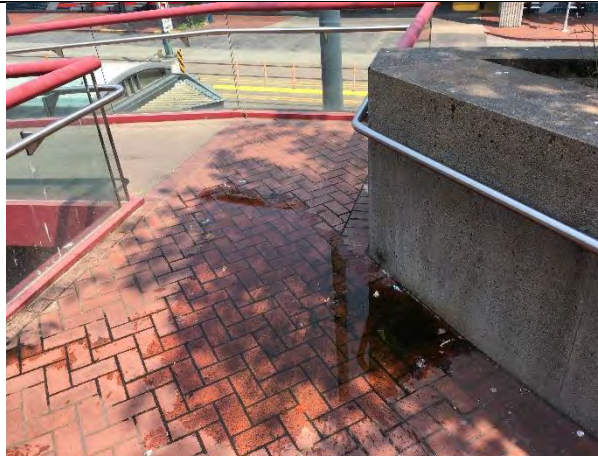
The drain in the walkway at the top of the first wheelchair ramp going up from Commerce Street was clogged at the time of the site visit

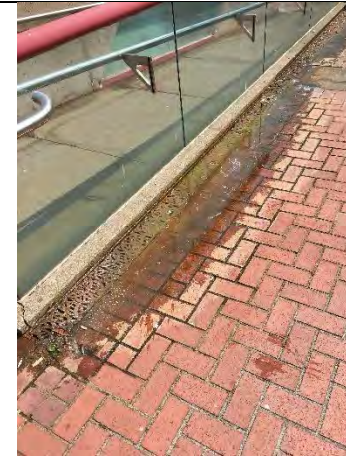
Water was collecting at the top of the wheelchair ramp near Broadway

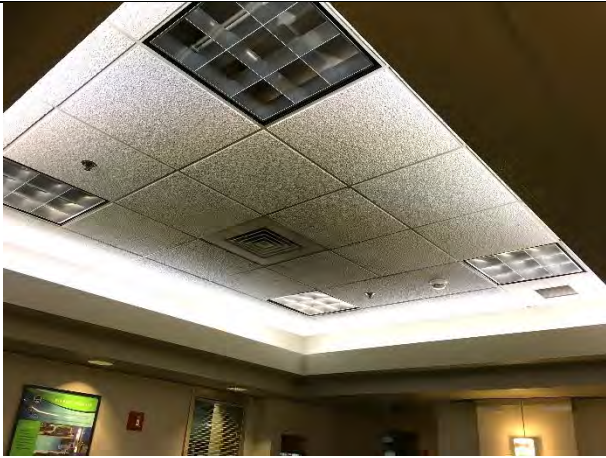
The driver break-room/rest area cooling system

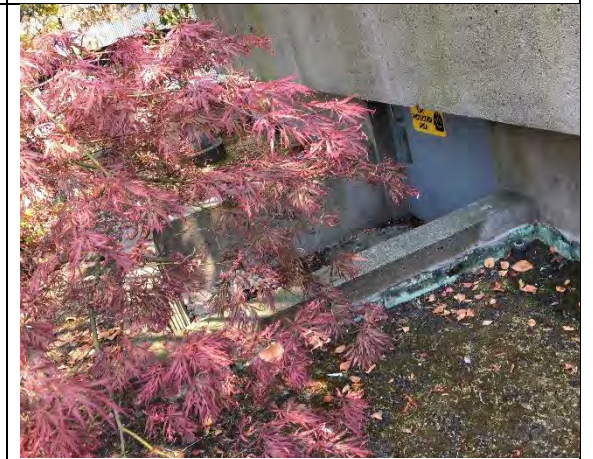
The personnel access to the fan room is limited to a door approximately 3'x3' that is located in a vault on the north side of the room

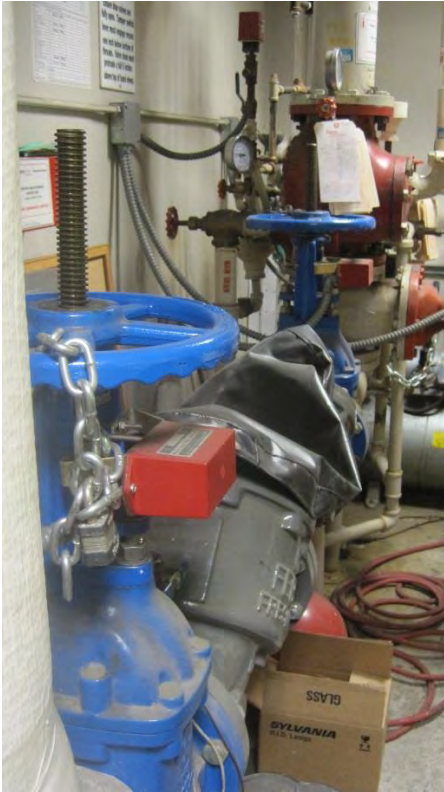
Fire Riser (Dry System Valving)

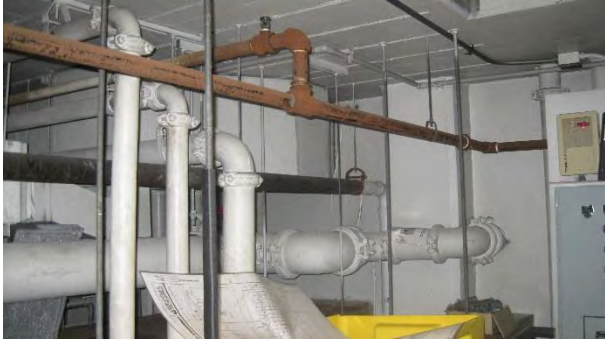
Rusted Mechanical Room Sprinkler Piping

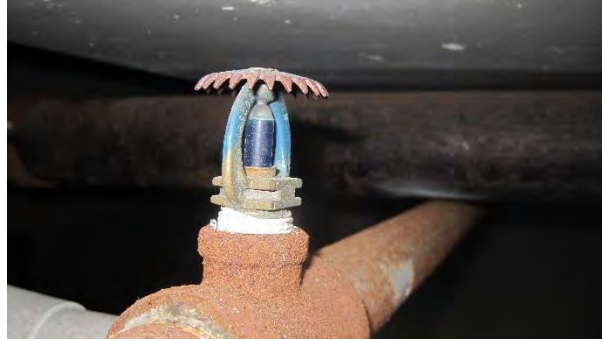
Rusted Mechanical Room Sprinkler Piping

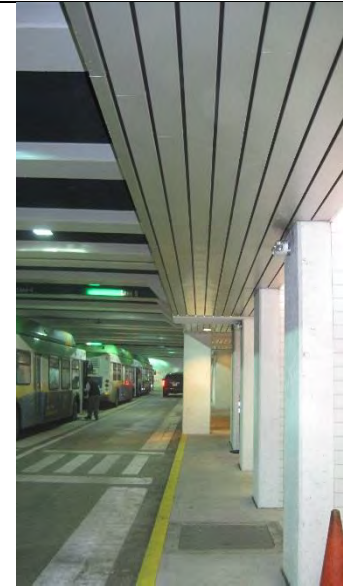
Slatted Ceiling in Tunnel

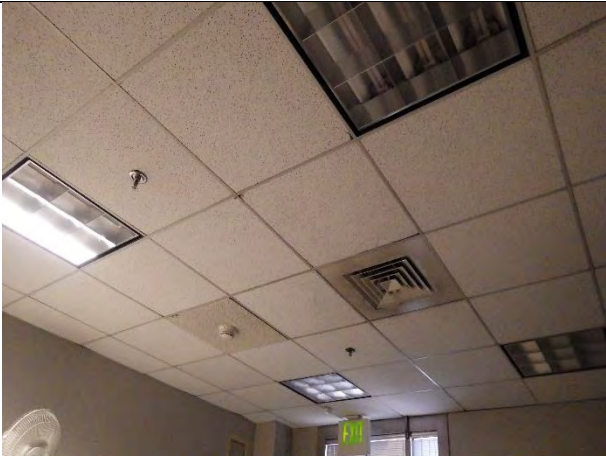
Police storage area lighting

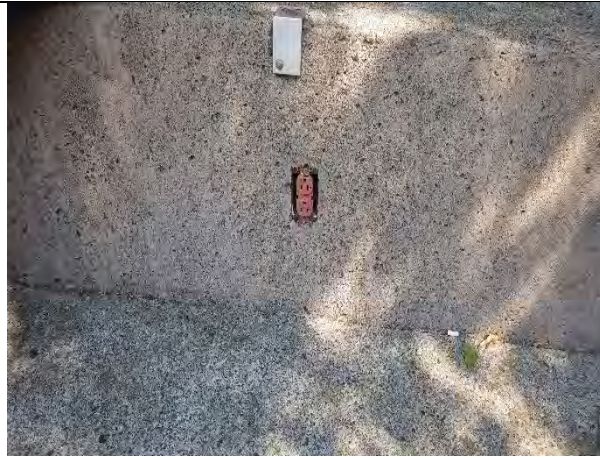
Receptacle in south end of upper plaza missing weatherproof cover

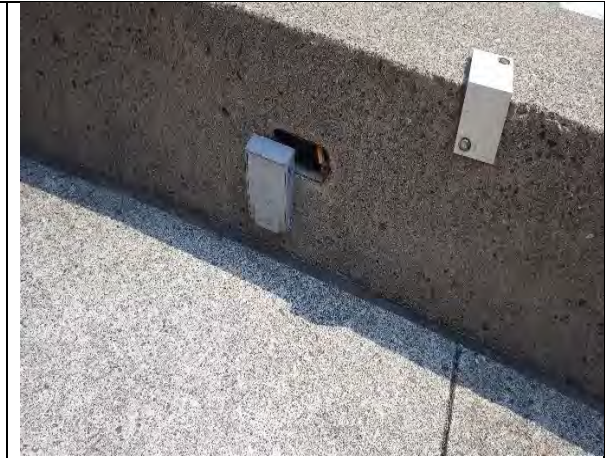
Junction box at north end of plaza have receptacle missing leaving access to exposed conductors

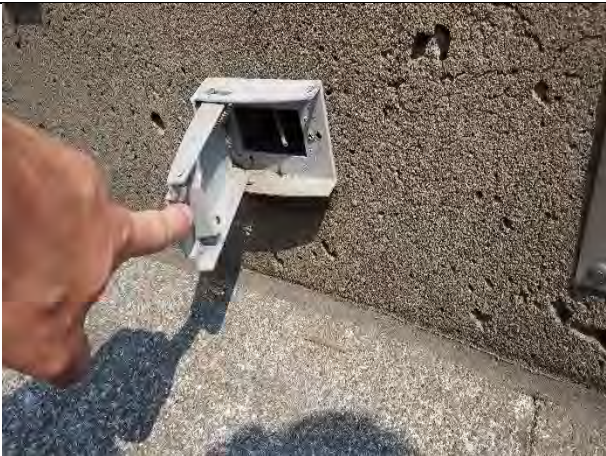
Junction box at north end of plaza have receptacle missing leaving access to exposed conductors

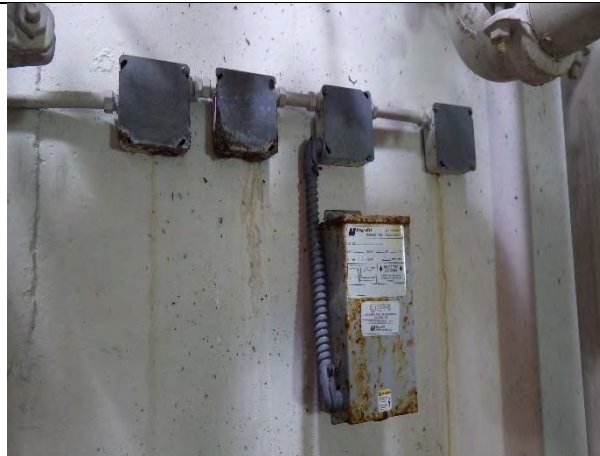
Junction boxes and control transformer in pump room have severe corrosion and should be replaced

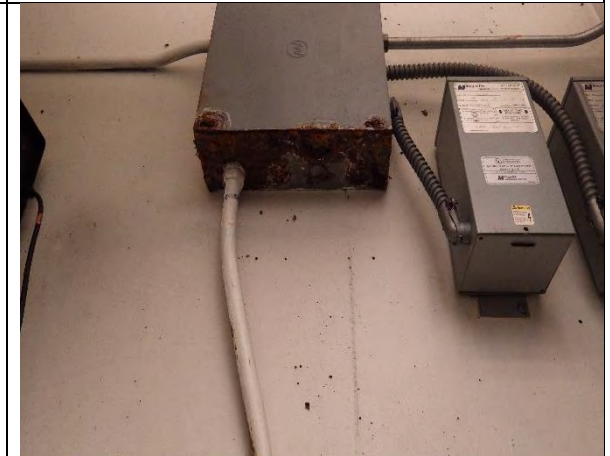
Junction box in main electrical room has severe corrosion and should be replaced

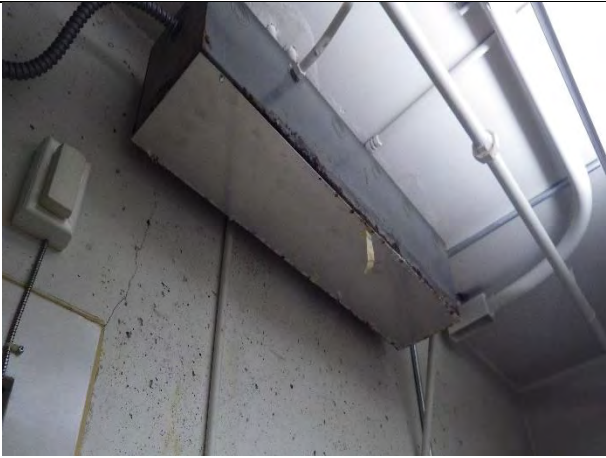
Electrical gutter in storage room has severe corrosion and should be replaced

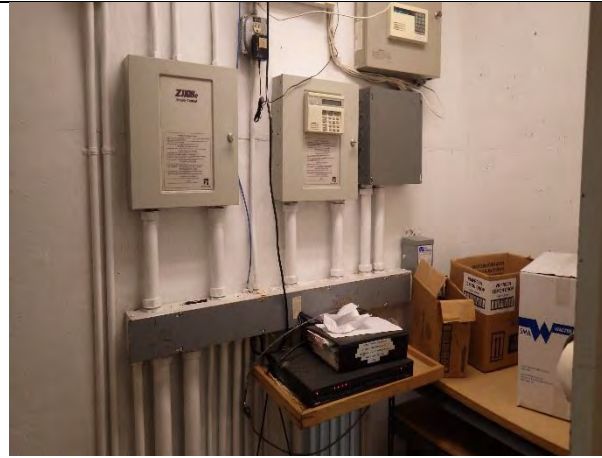
Signs of water dripping on security equipment

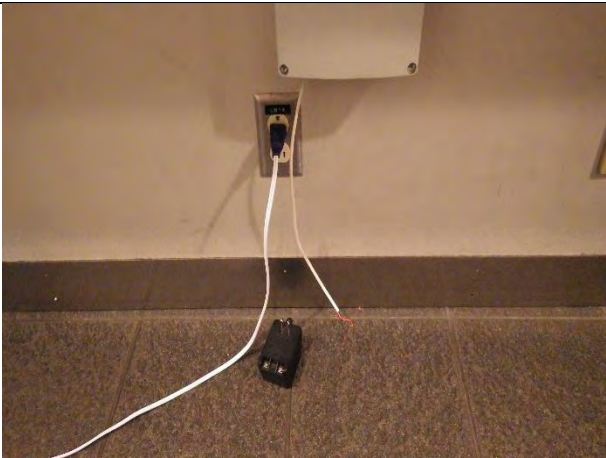
Unknown piece of low-voltage equipment located on wall under counter in the Operator's lobby has disconnected plug in transformer

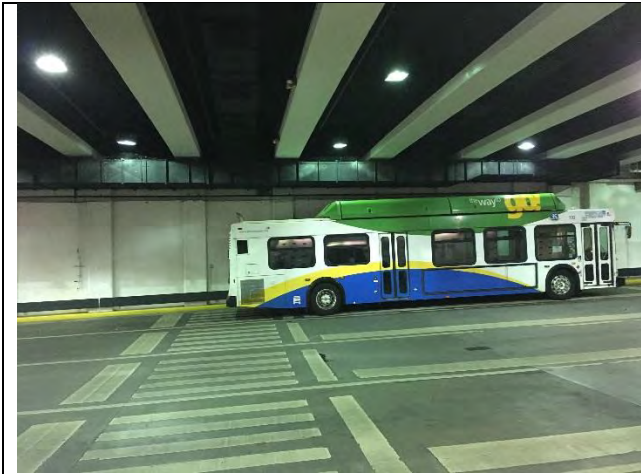
Bus tunnel paint markings on concrete

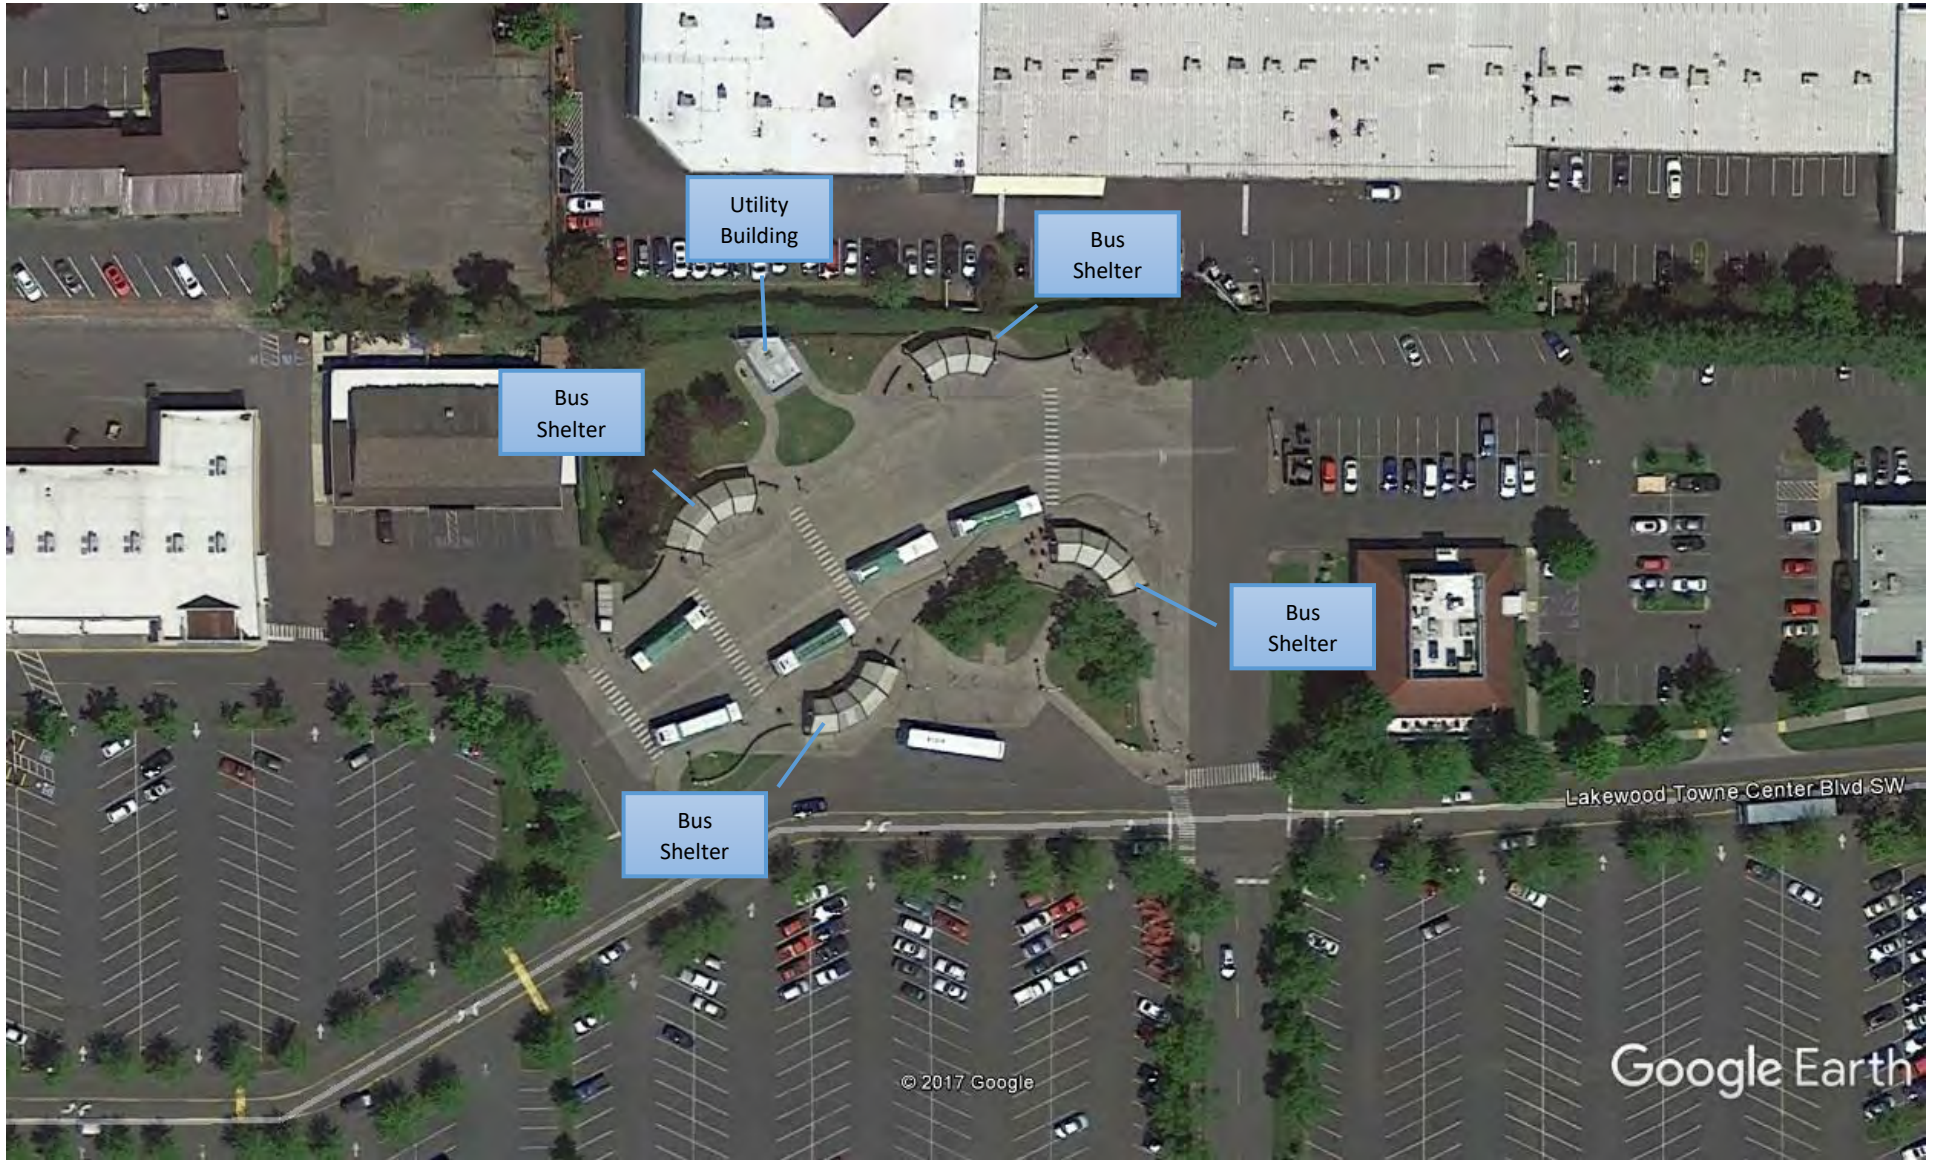
Facility Condition Assessment

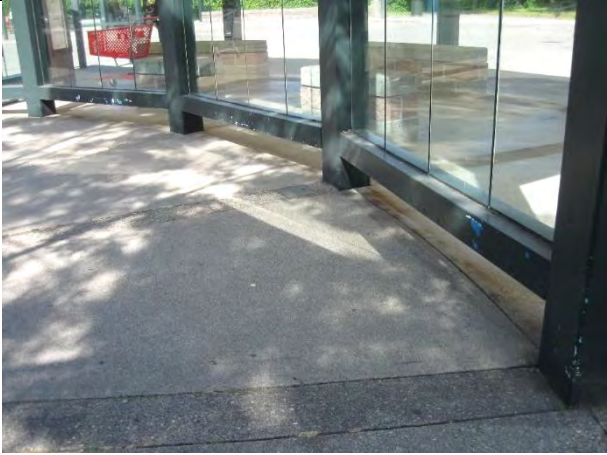
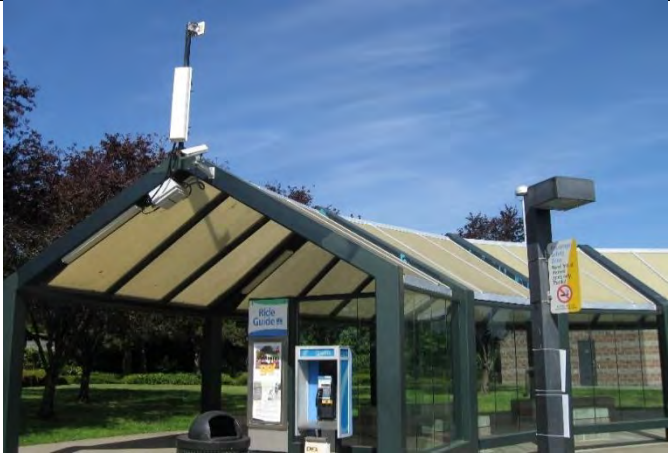
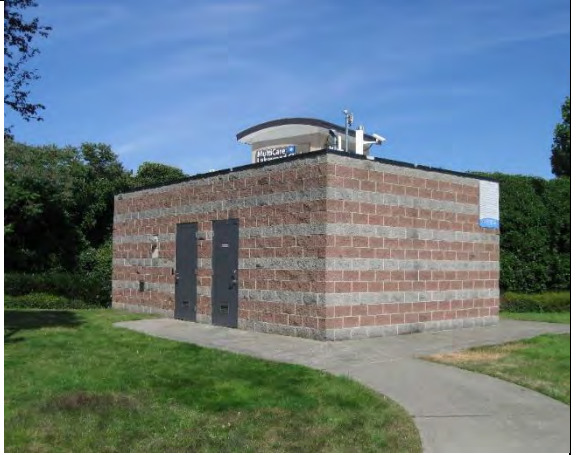
Peeling paint on steel framing on bus shelter		Bus shelter steel framing and plastic roofs		Utility building

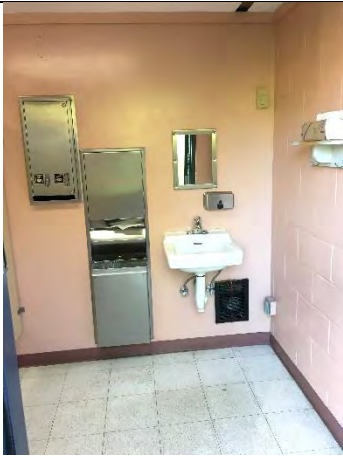
Women's restroom walls

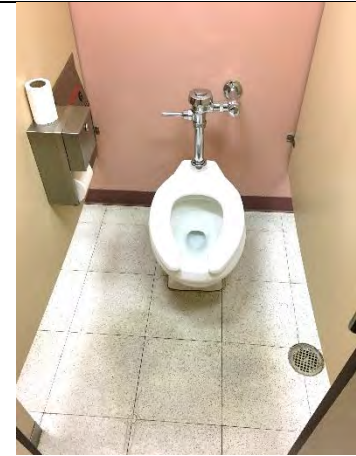
Women's restroom toilet

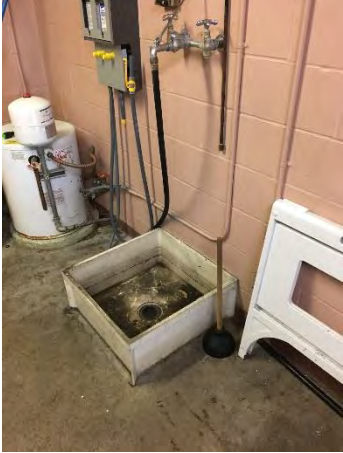
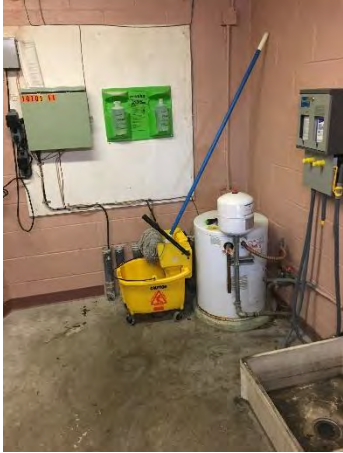
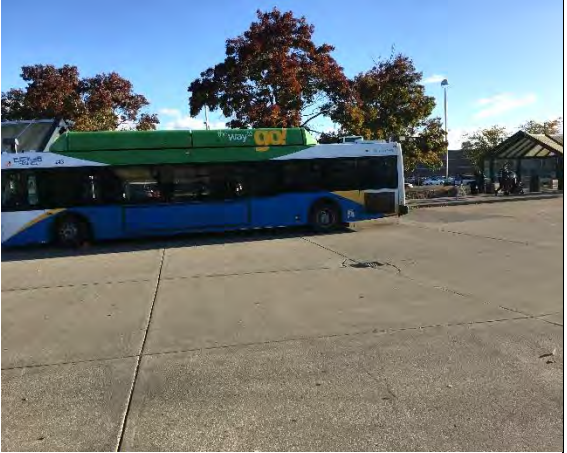
Utility room mop sink drain plugged		Water heater needs straps and appears to be leaking		Storm drains appear to be functioning properly

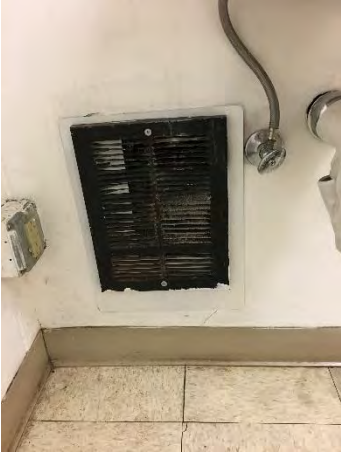
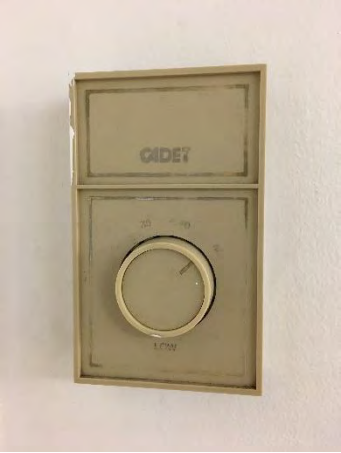
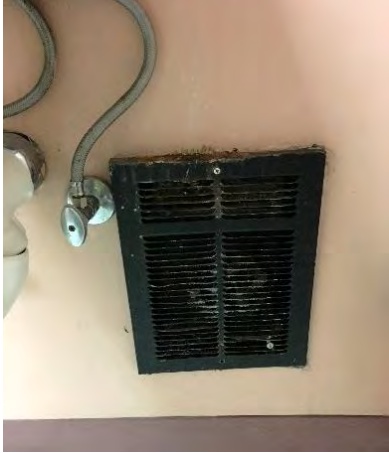
Men's Restroom heater	Restroom thermostat		Women's restroom heater

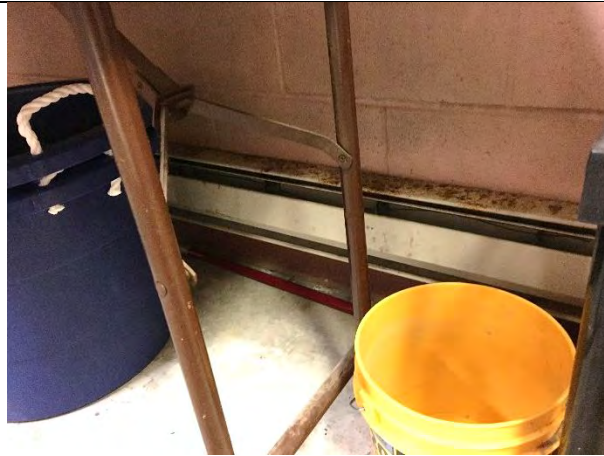
Baseboard heater along north wall has items stored too close

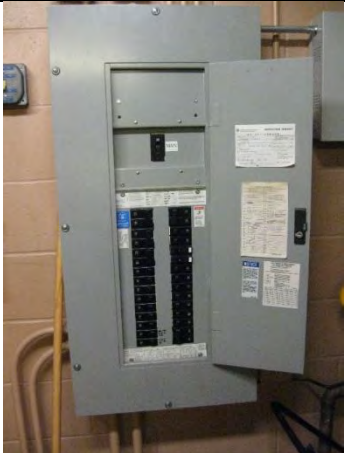
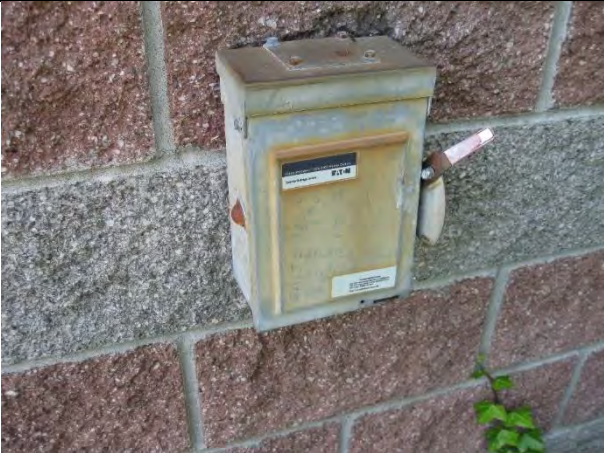
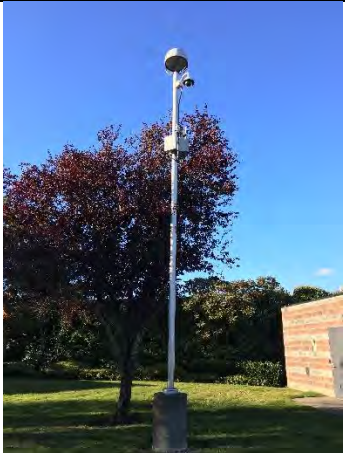
Single phase panel in electrical room		Rusty electrical box located on east side of utility building		Cameras on site

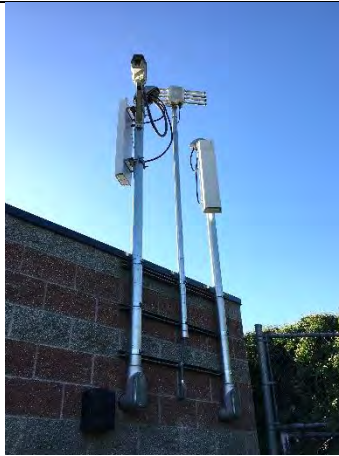
Cameras and radio communication located on utility building

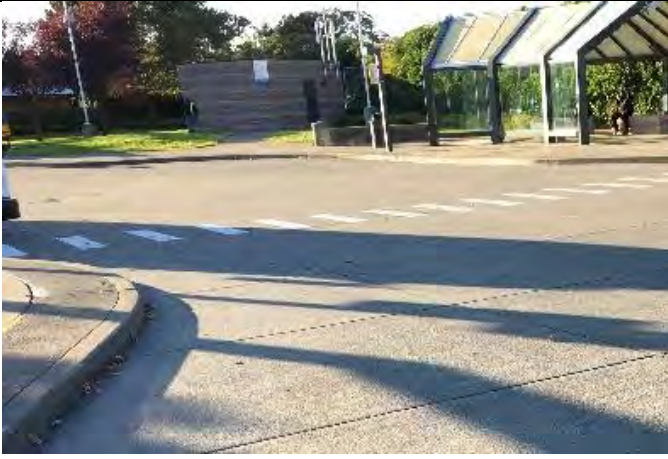
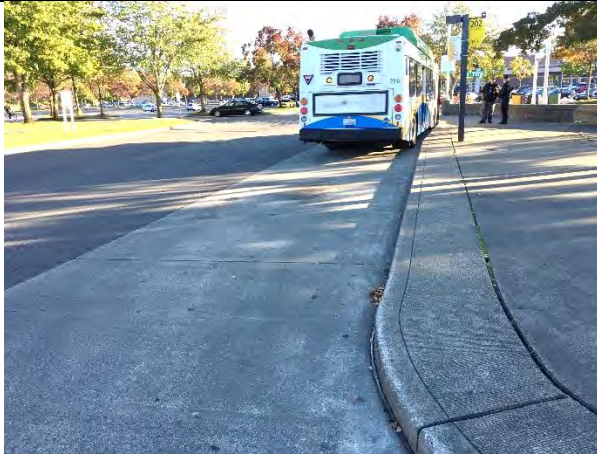
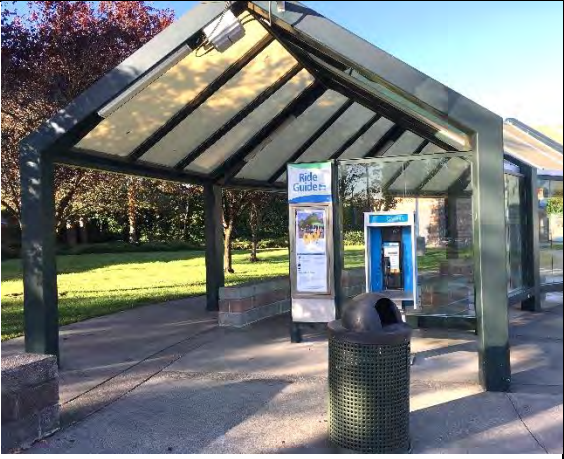
Crosswalks		Internal bus travel lane		Metal trash bins and signage

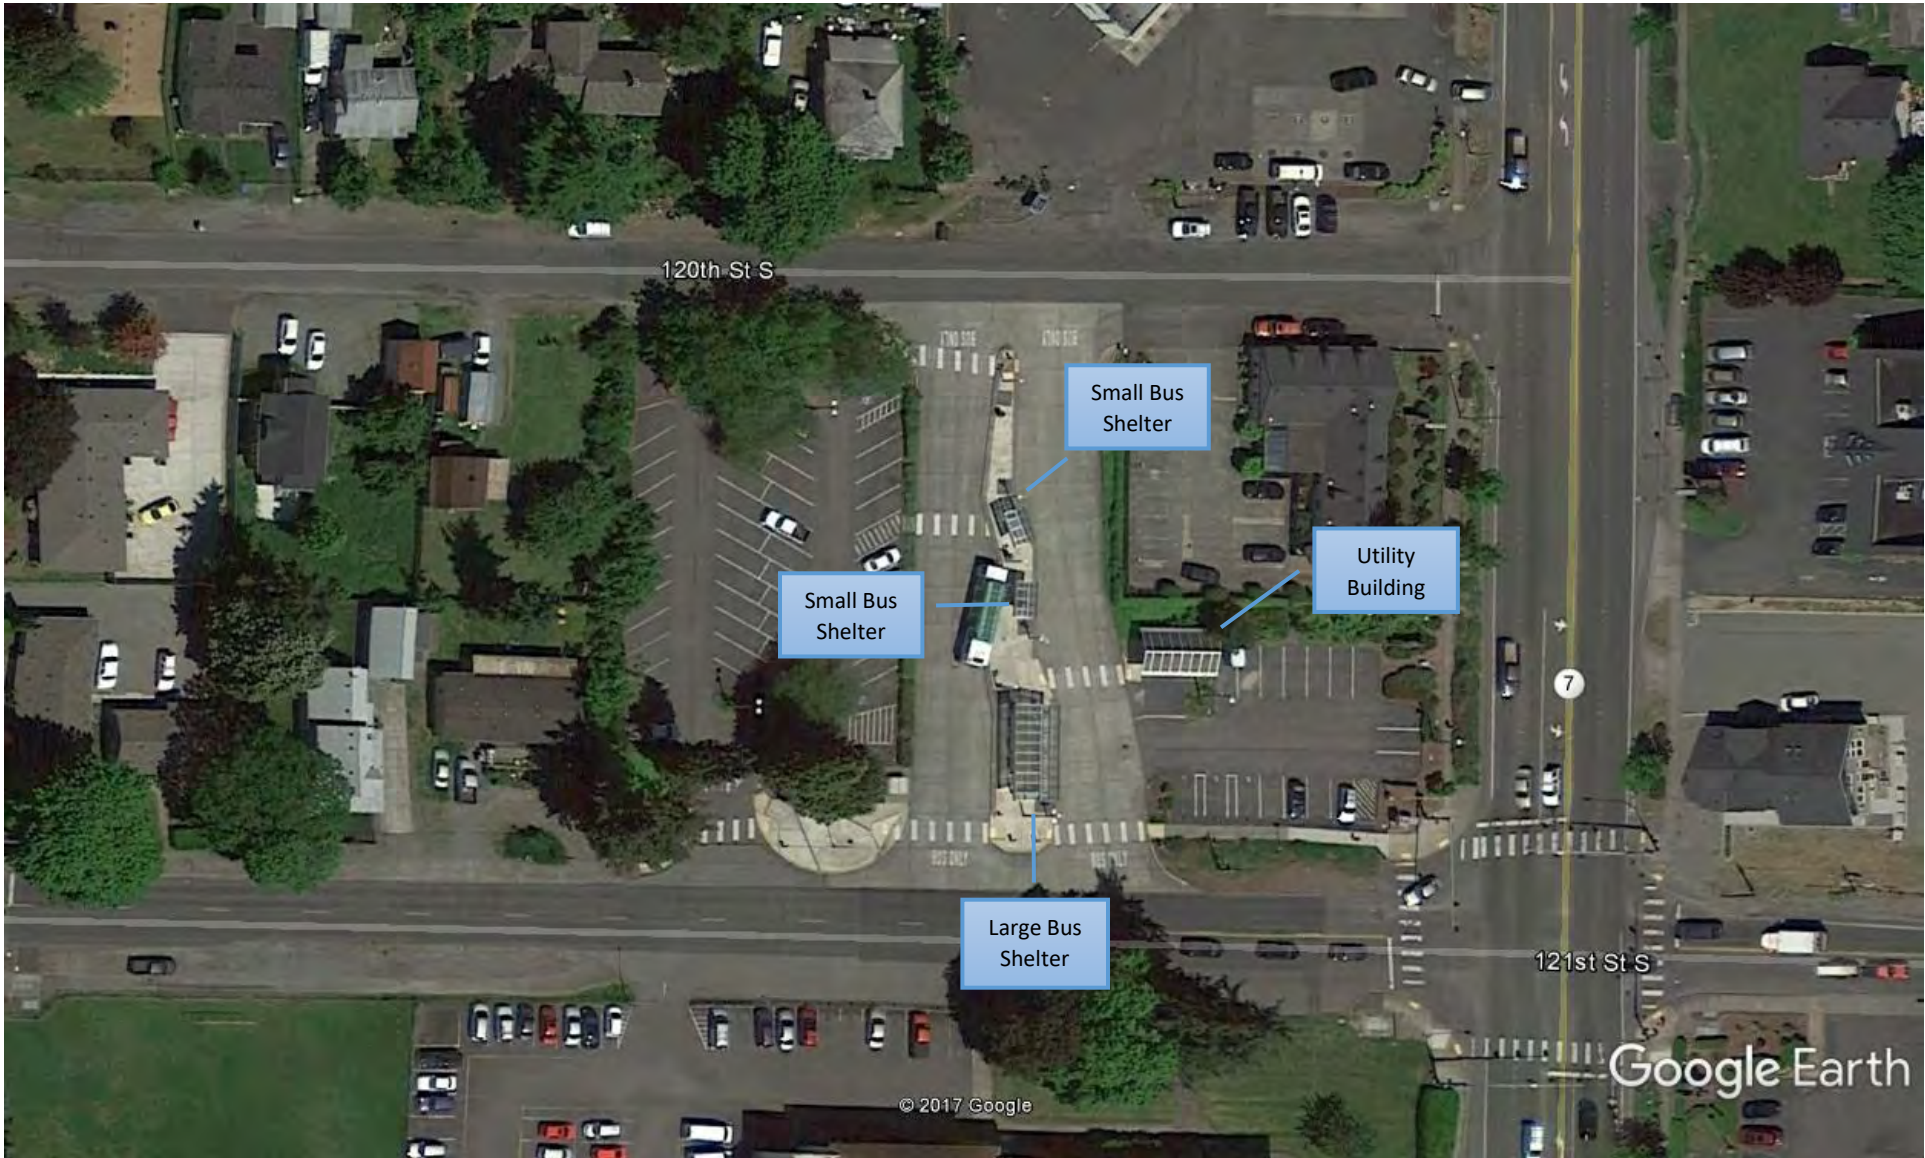
Facility Condition Assessment

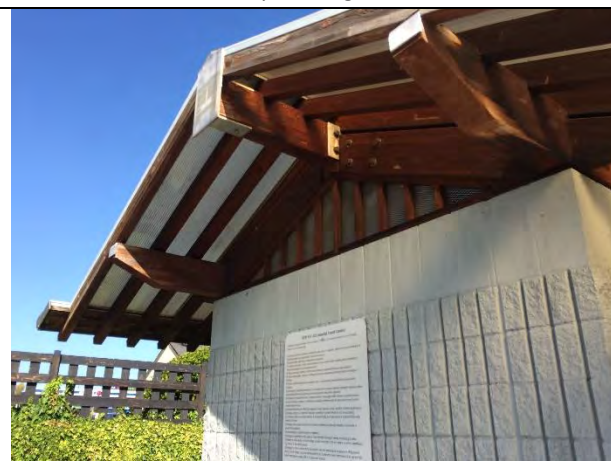
Utility building eave

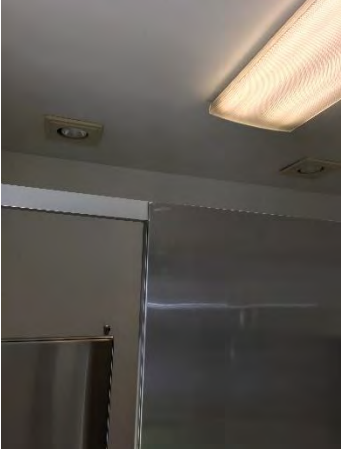
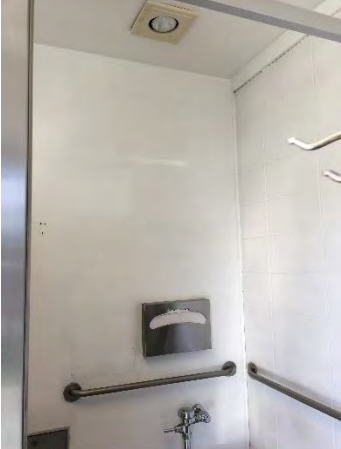
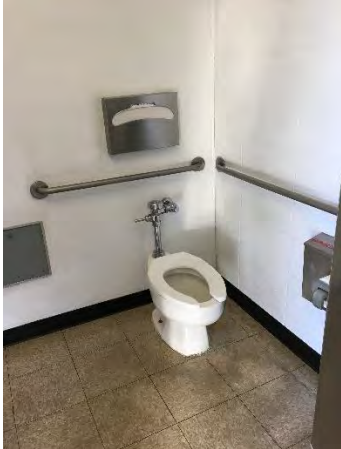
Restroom partitions		Restroom walls and ceiling		Vinyl tile in restrooms

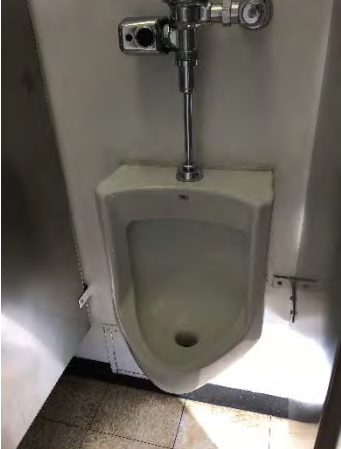
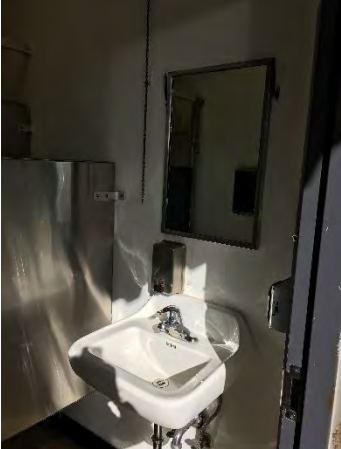
Men's restroom		Men's restroom

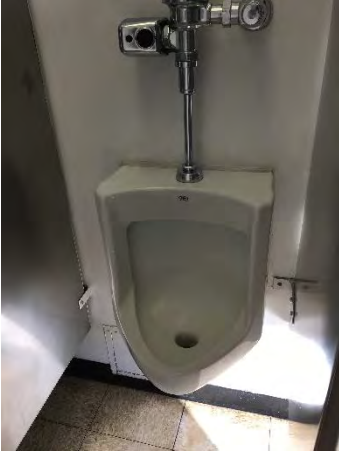
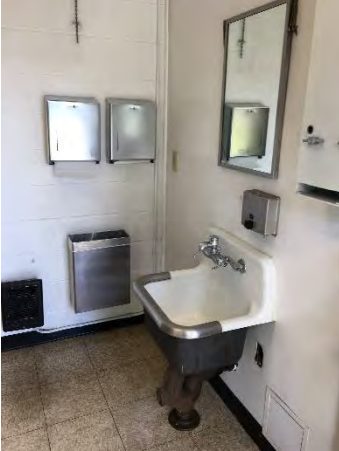
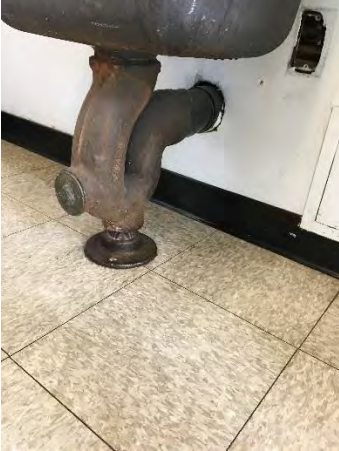
Urinal in men's restroom		Mop sink in women's restroom		Surface rust on mop sink p-trap piping

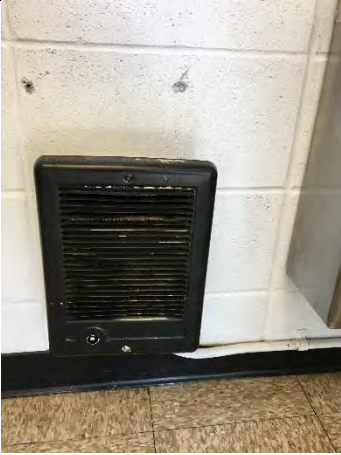
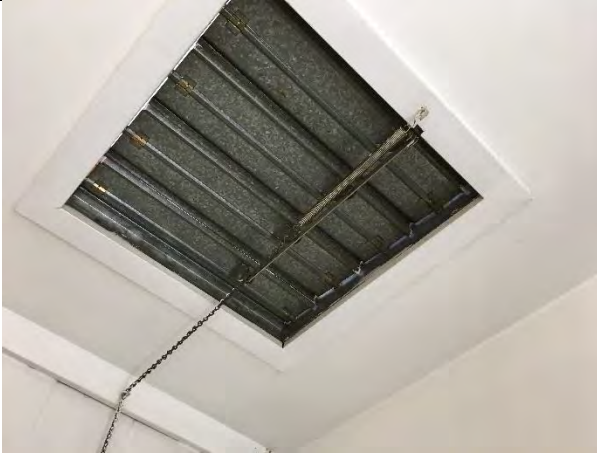
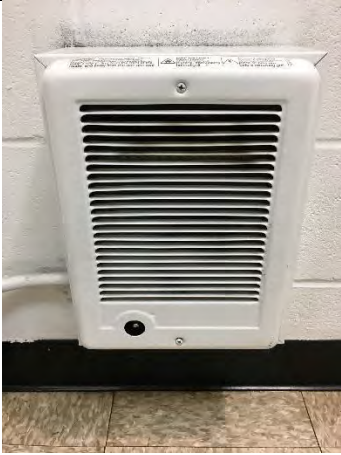
Restroom heater with missing thermostat knob		Ceiling louver/vent in restroom		Restroom heater with missing thermostat knob

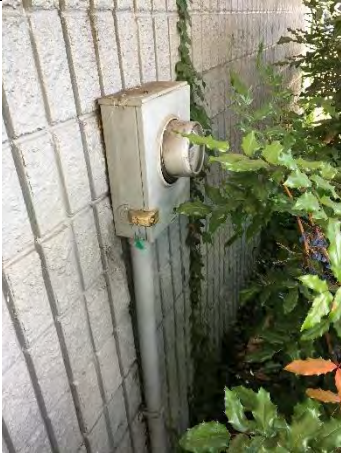
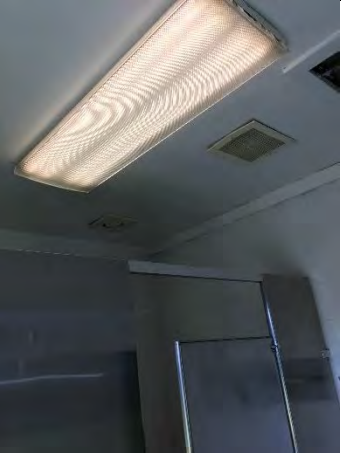
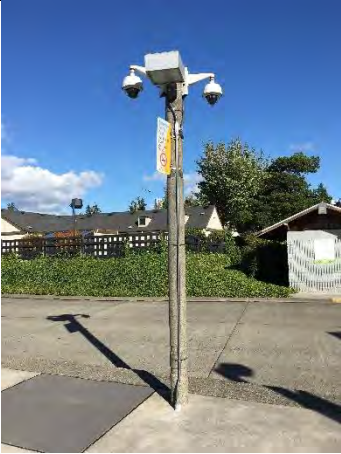
Power meter obstructed by brush		Restroom lighting		Site cameras

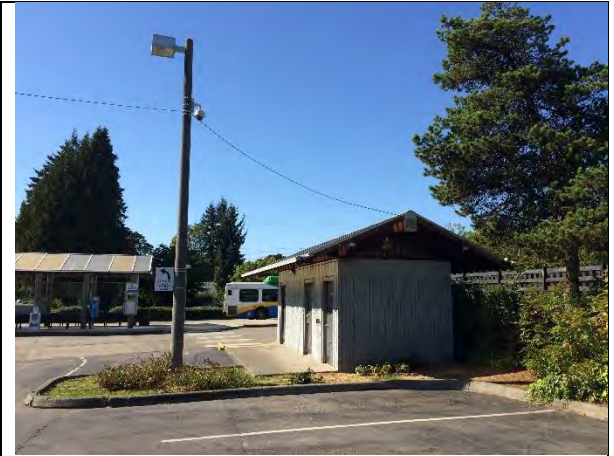
Phone line to the Utility Building

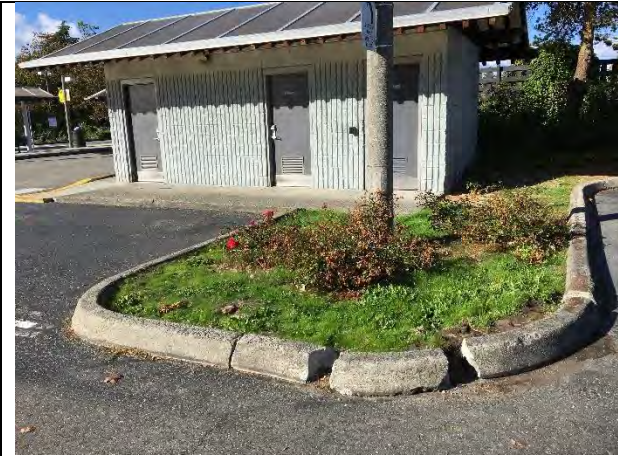
Broken curbing in front of Utility Building

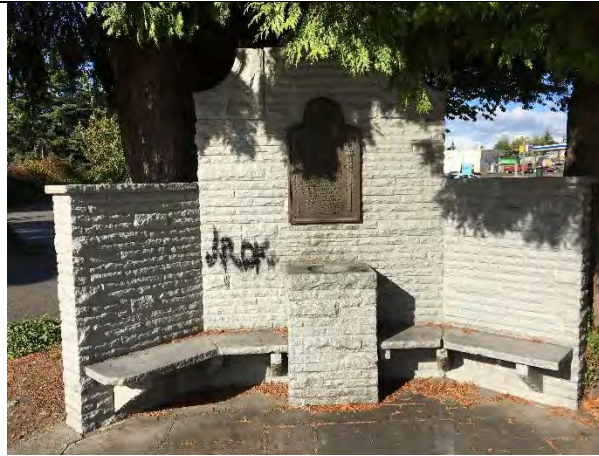
Memorial showing graffiti

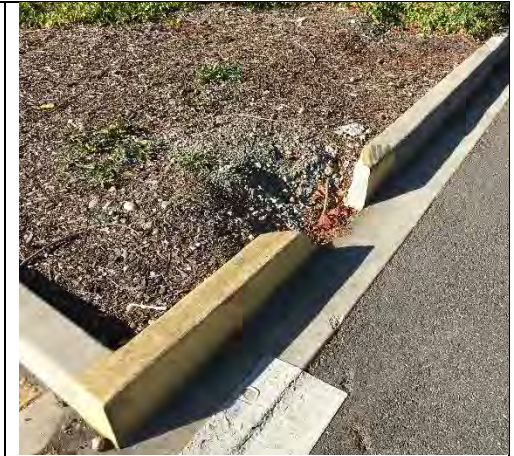
Broken curbing by the southwest parking lot entrance

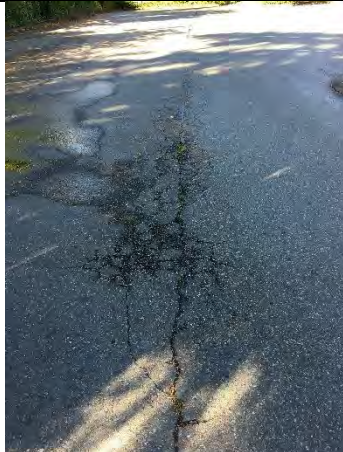
Alligatored asphalt in parking lot

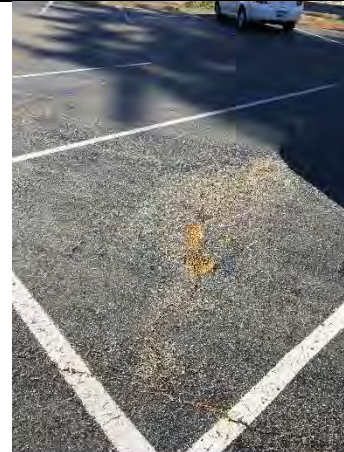
Alligatored asphalt in parking lot with plant growth in cracks

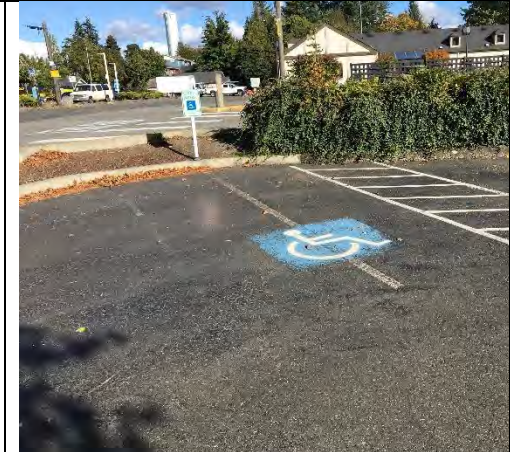
Disabled parking stall needs repainted

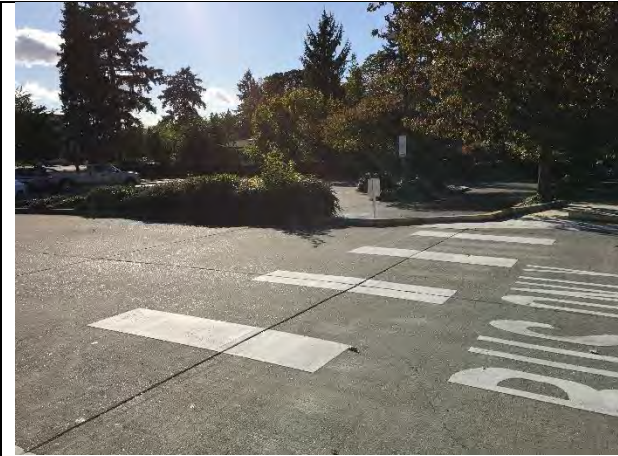
Crosswalk bars are in good condition

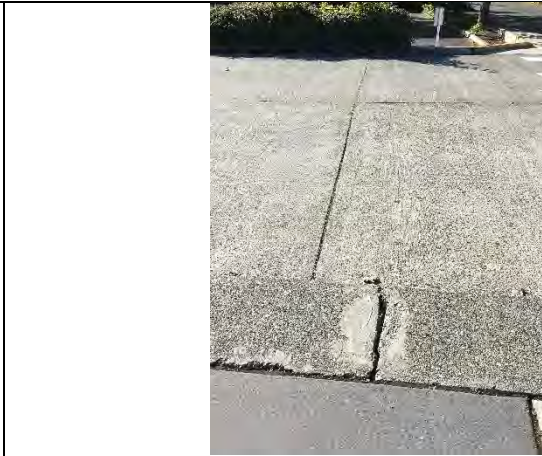
Cracks in sidewalk need repair

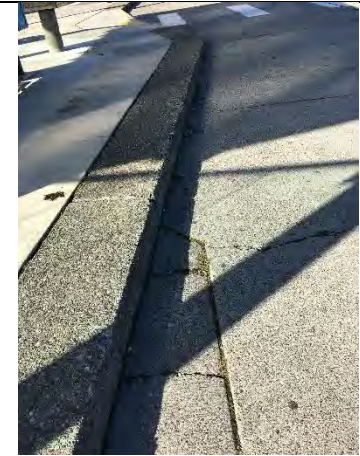
Cracks in bus lane that need sealing

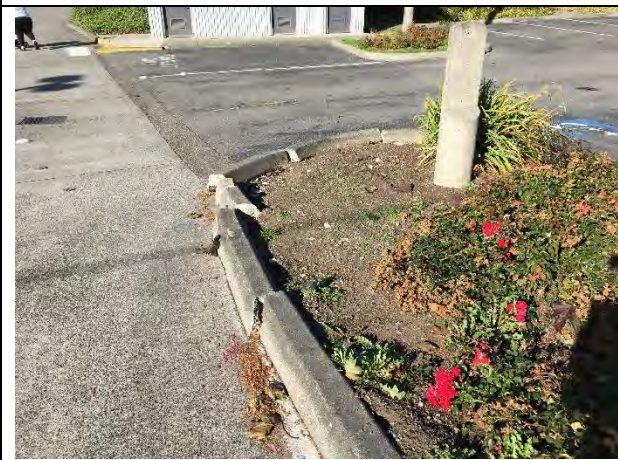
Broken curb just south of utility building

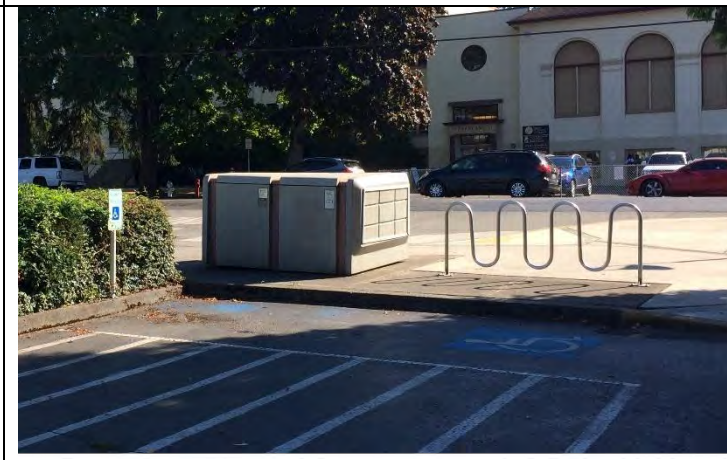
Bike Locker and Bike Rack are in good condition

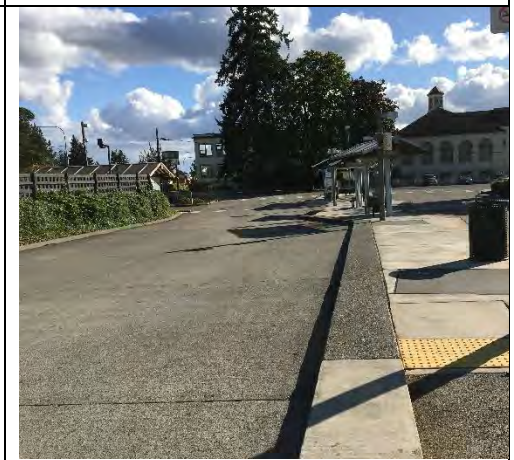
Passenger walkways and waiting areas
