Pierce Transit Facilities Condition Assessment Report

Prepared for

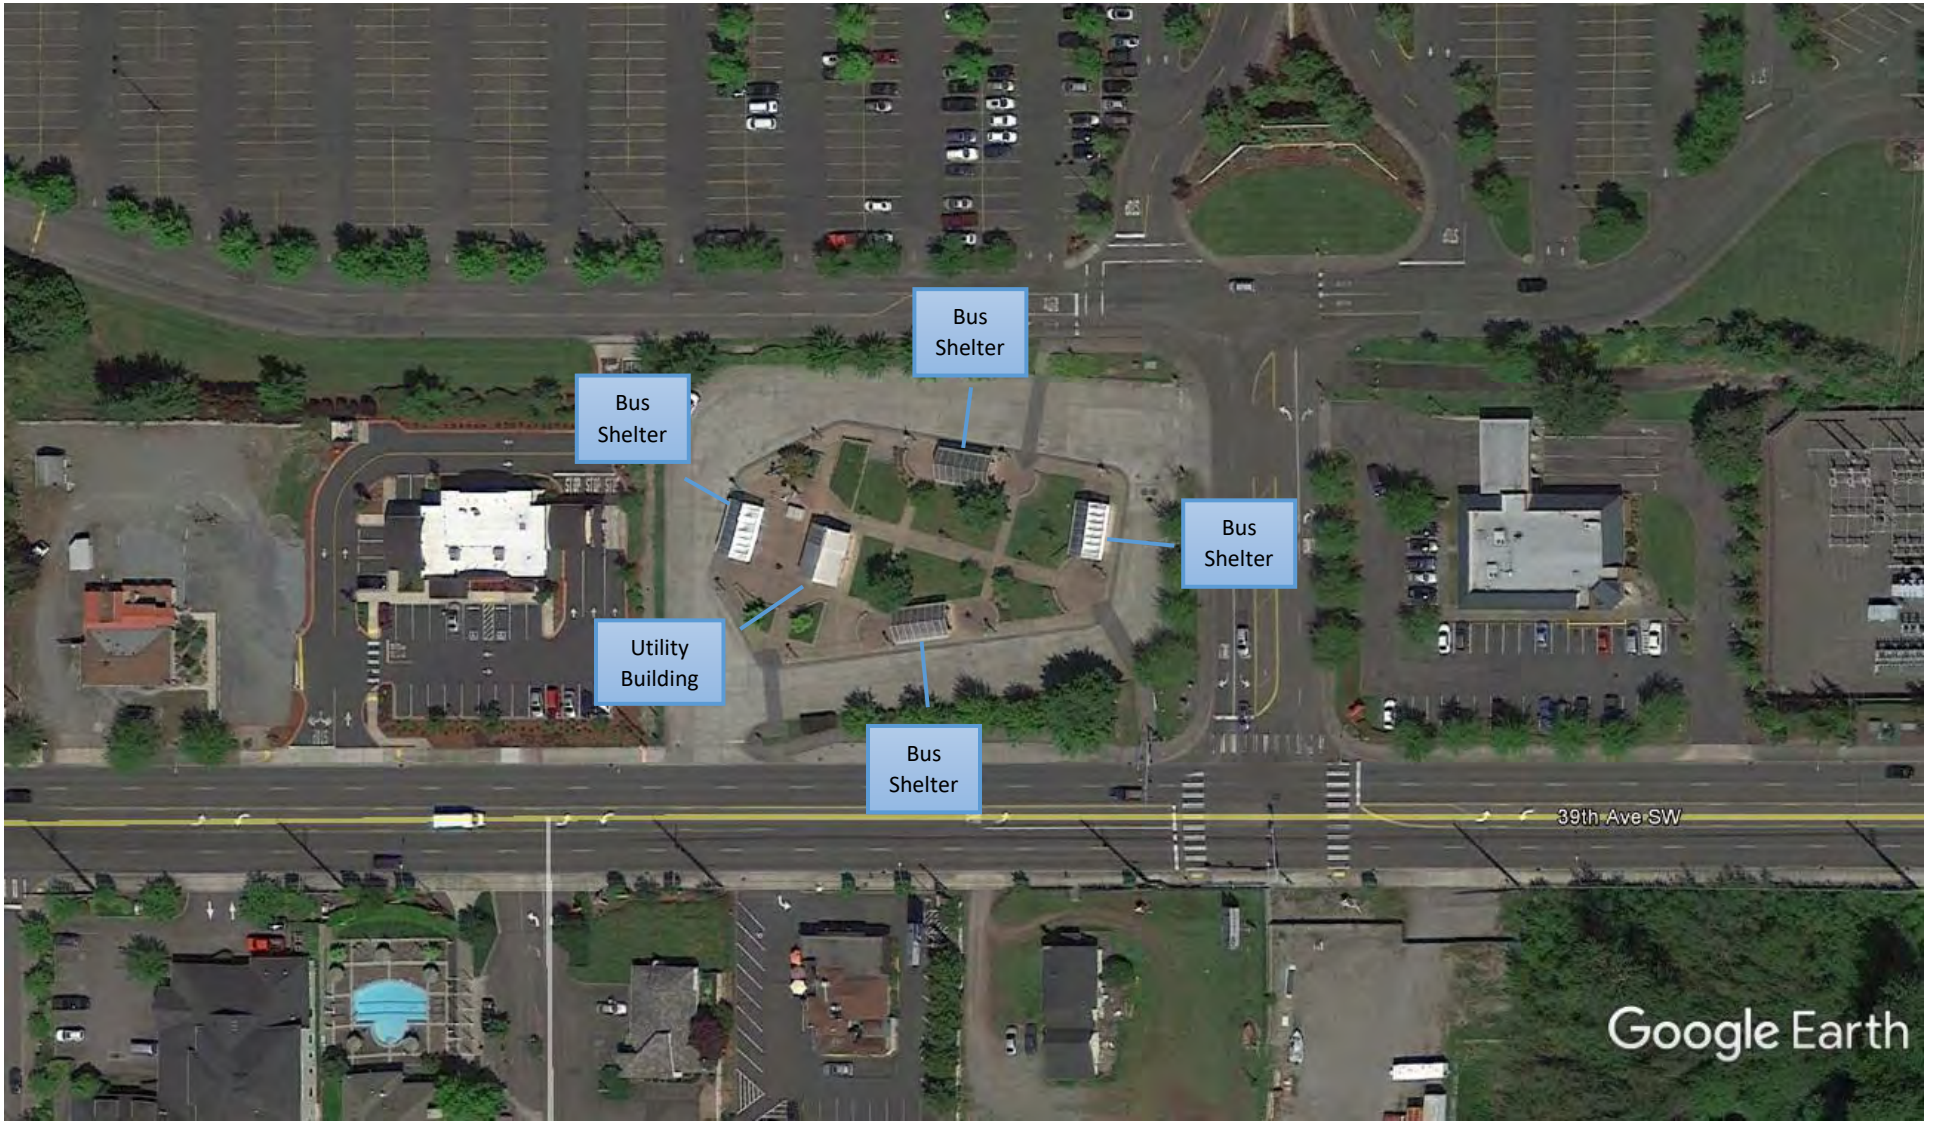
Facility Condition Assessment

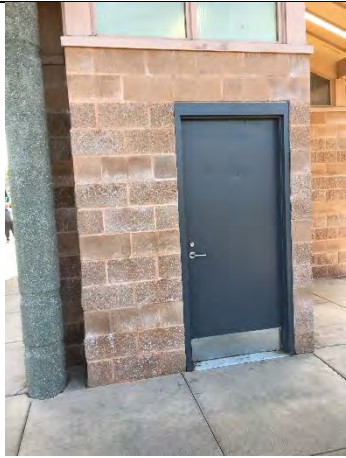
Exterior	Utility building exterior walls and doors.	Exteriors of Utility building are adequate but have some cosmetic damage. Unmarked door at utility building is dented and deadbolt lock is loose. It appears to have been damaged from being tampered with. Door to utility room needs paint. CMU walls on utility building are dirty.	3.3	Paint utility room door. Repair deadbolt lock on utility room door. Clean CMU walls.	\$5,000
Shell appurtenances	Utility building and bus shelters, gutters and downspouts.	Stainless downspouts and gutters on utility building and bus shelters are in good condition and appear to be functioning.	4.0	None	N/A

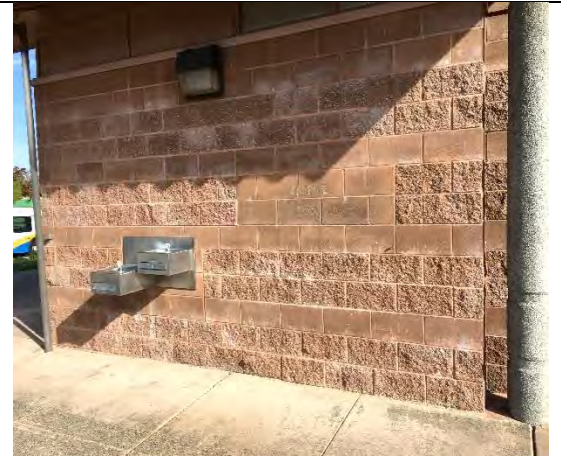
CMU walls need cleaning

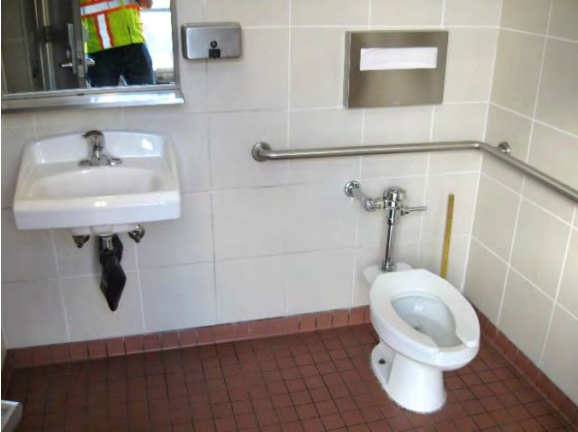
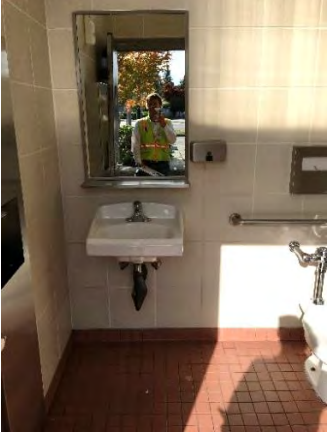
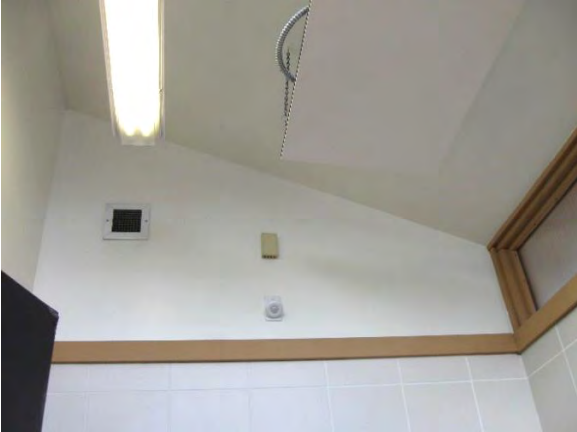
Bathroom facilities		Bathroom facilities		Gypsum wallboard walls

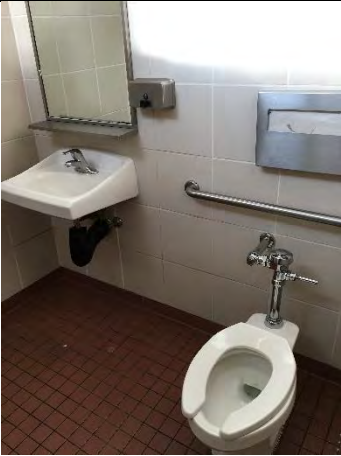
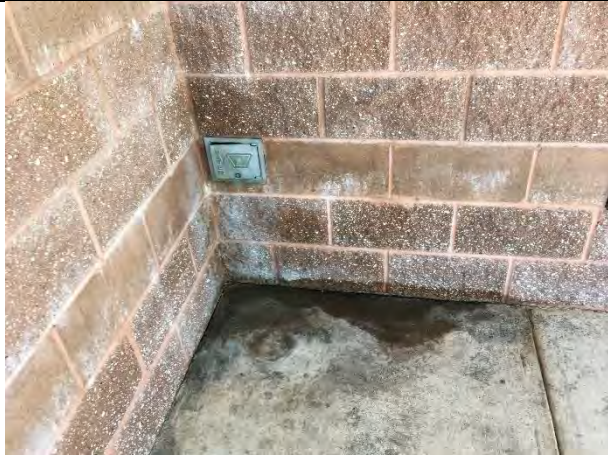
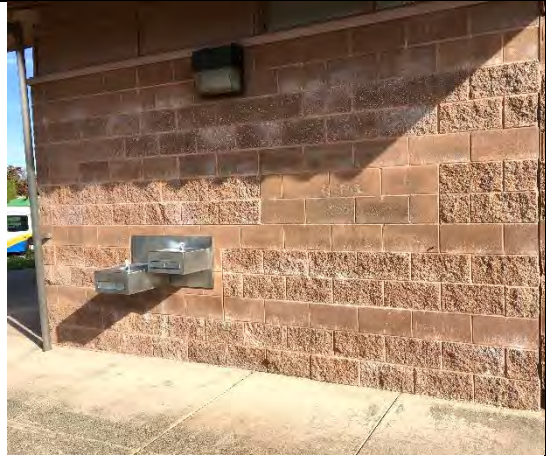
Restroom plumbing		Cover open on lockable water hose bib		Drinking fountains on side of Utility building

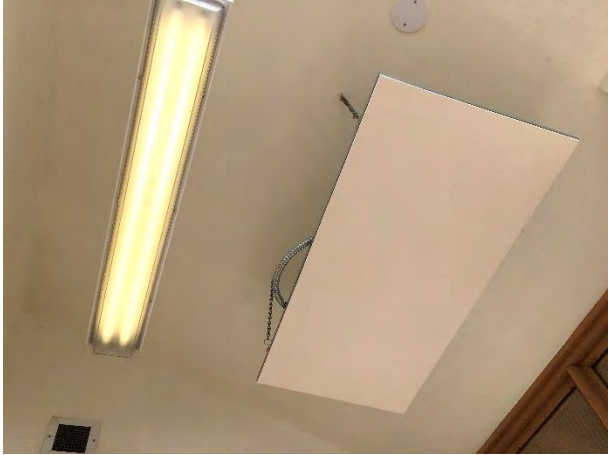
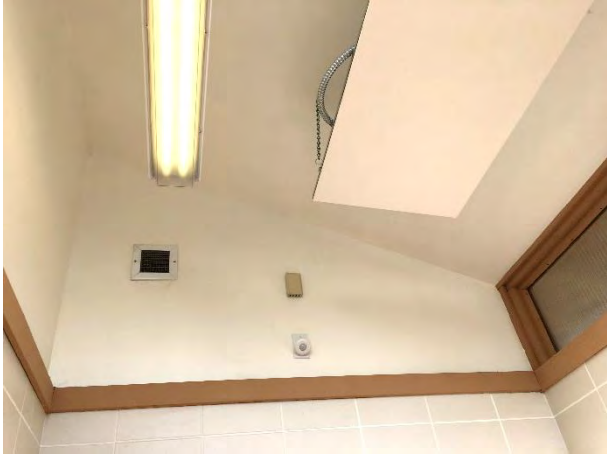
Radiant heater in restroom		Ventilation in restrooms

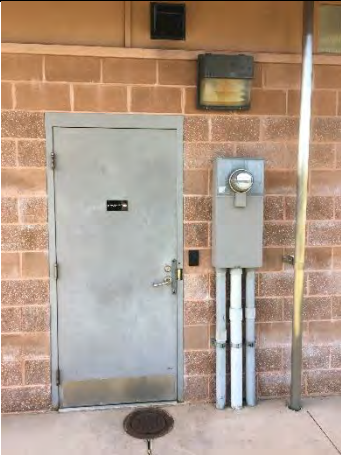
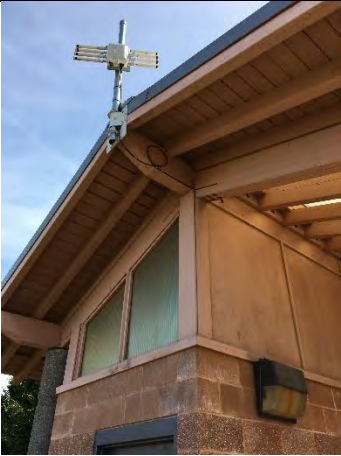
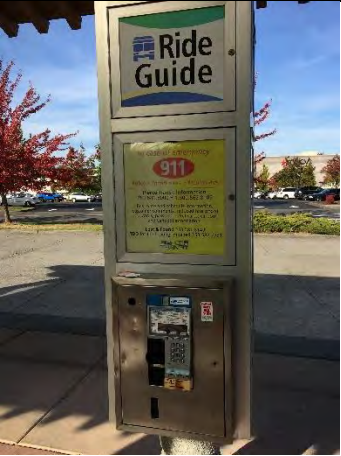
Meter	Radio antenna on utility building		Pay phone with receiver removed

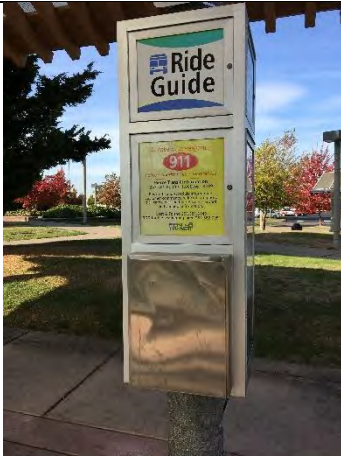
Previous payphone unit covered

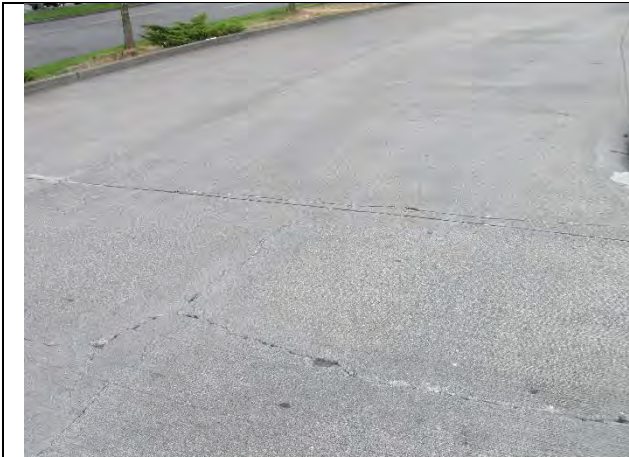
Cracks along interior roadway

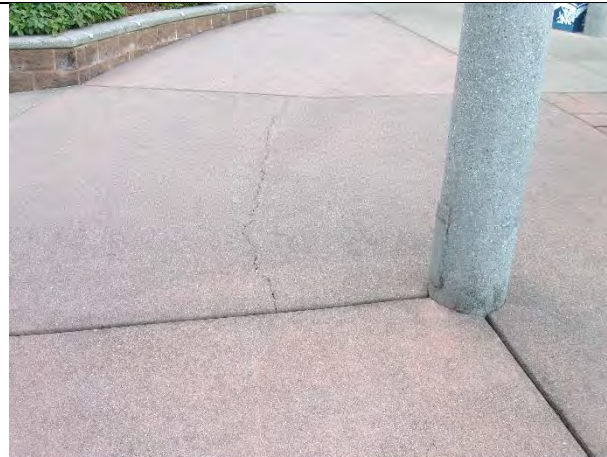
Cracks in concrete walkways

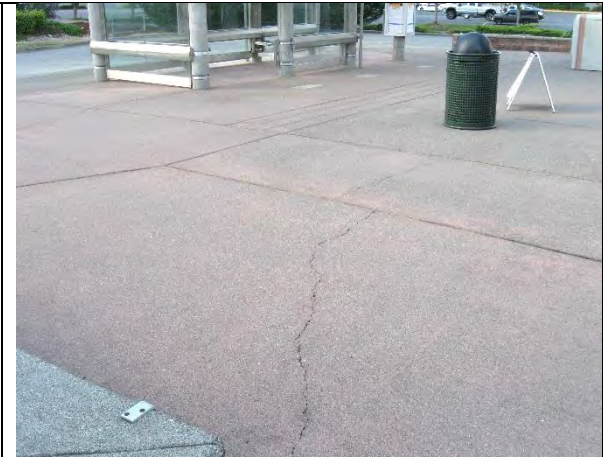
Cracks in concrete walkways

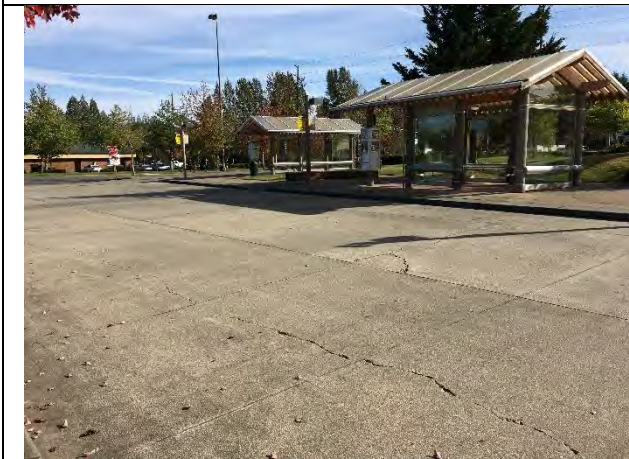
Cracks in interior concrete pavement

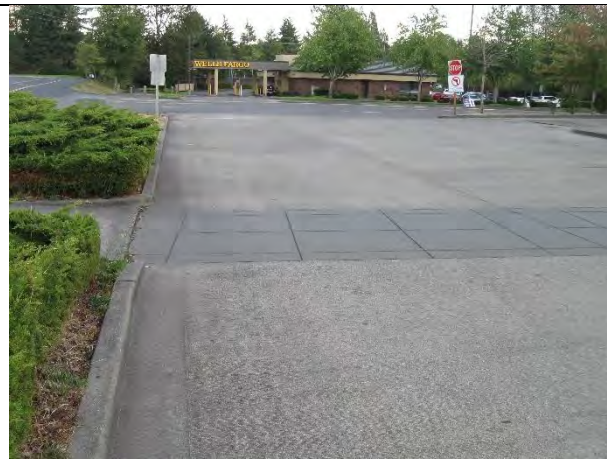
Pedestrian crossings not painted

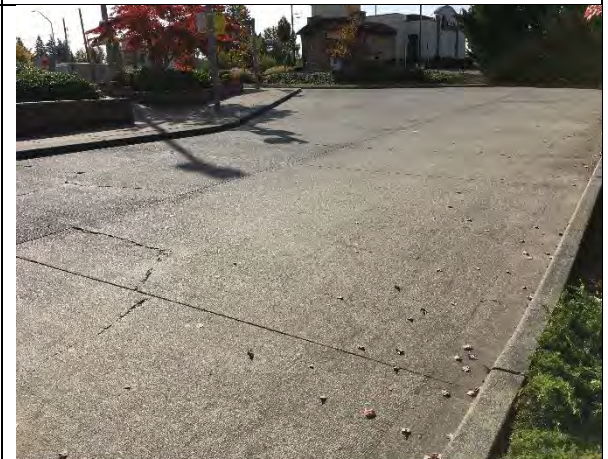
Cracks in interior roadway concrete

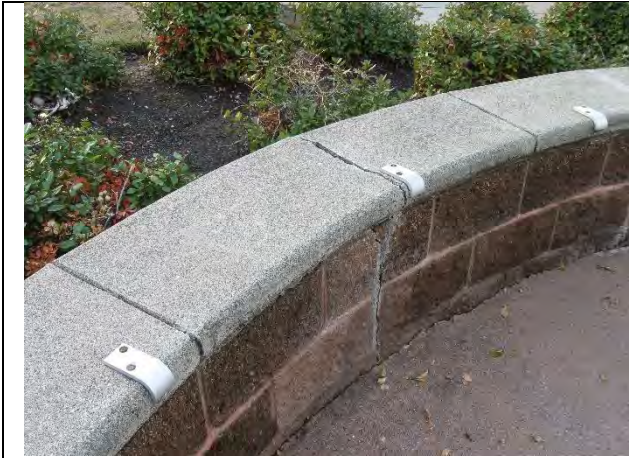
Anti-skateboard lugs showing rust

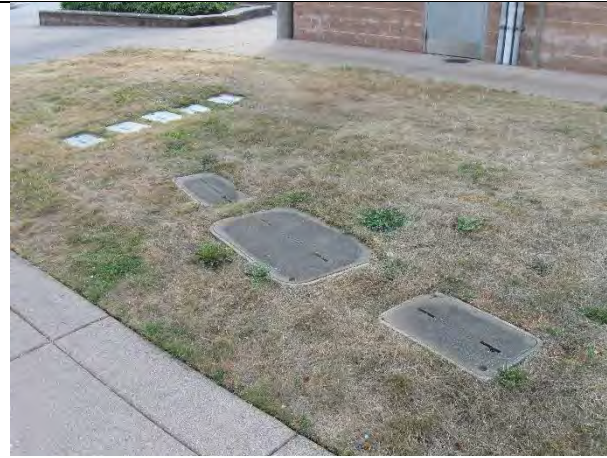
Telephone, electric, communication, and irrigation vaults

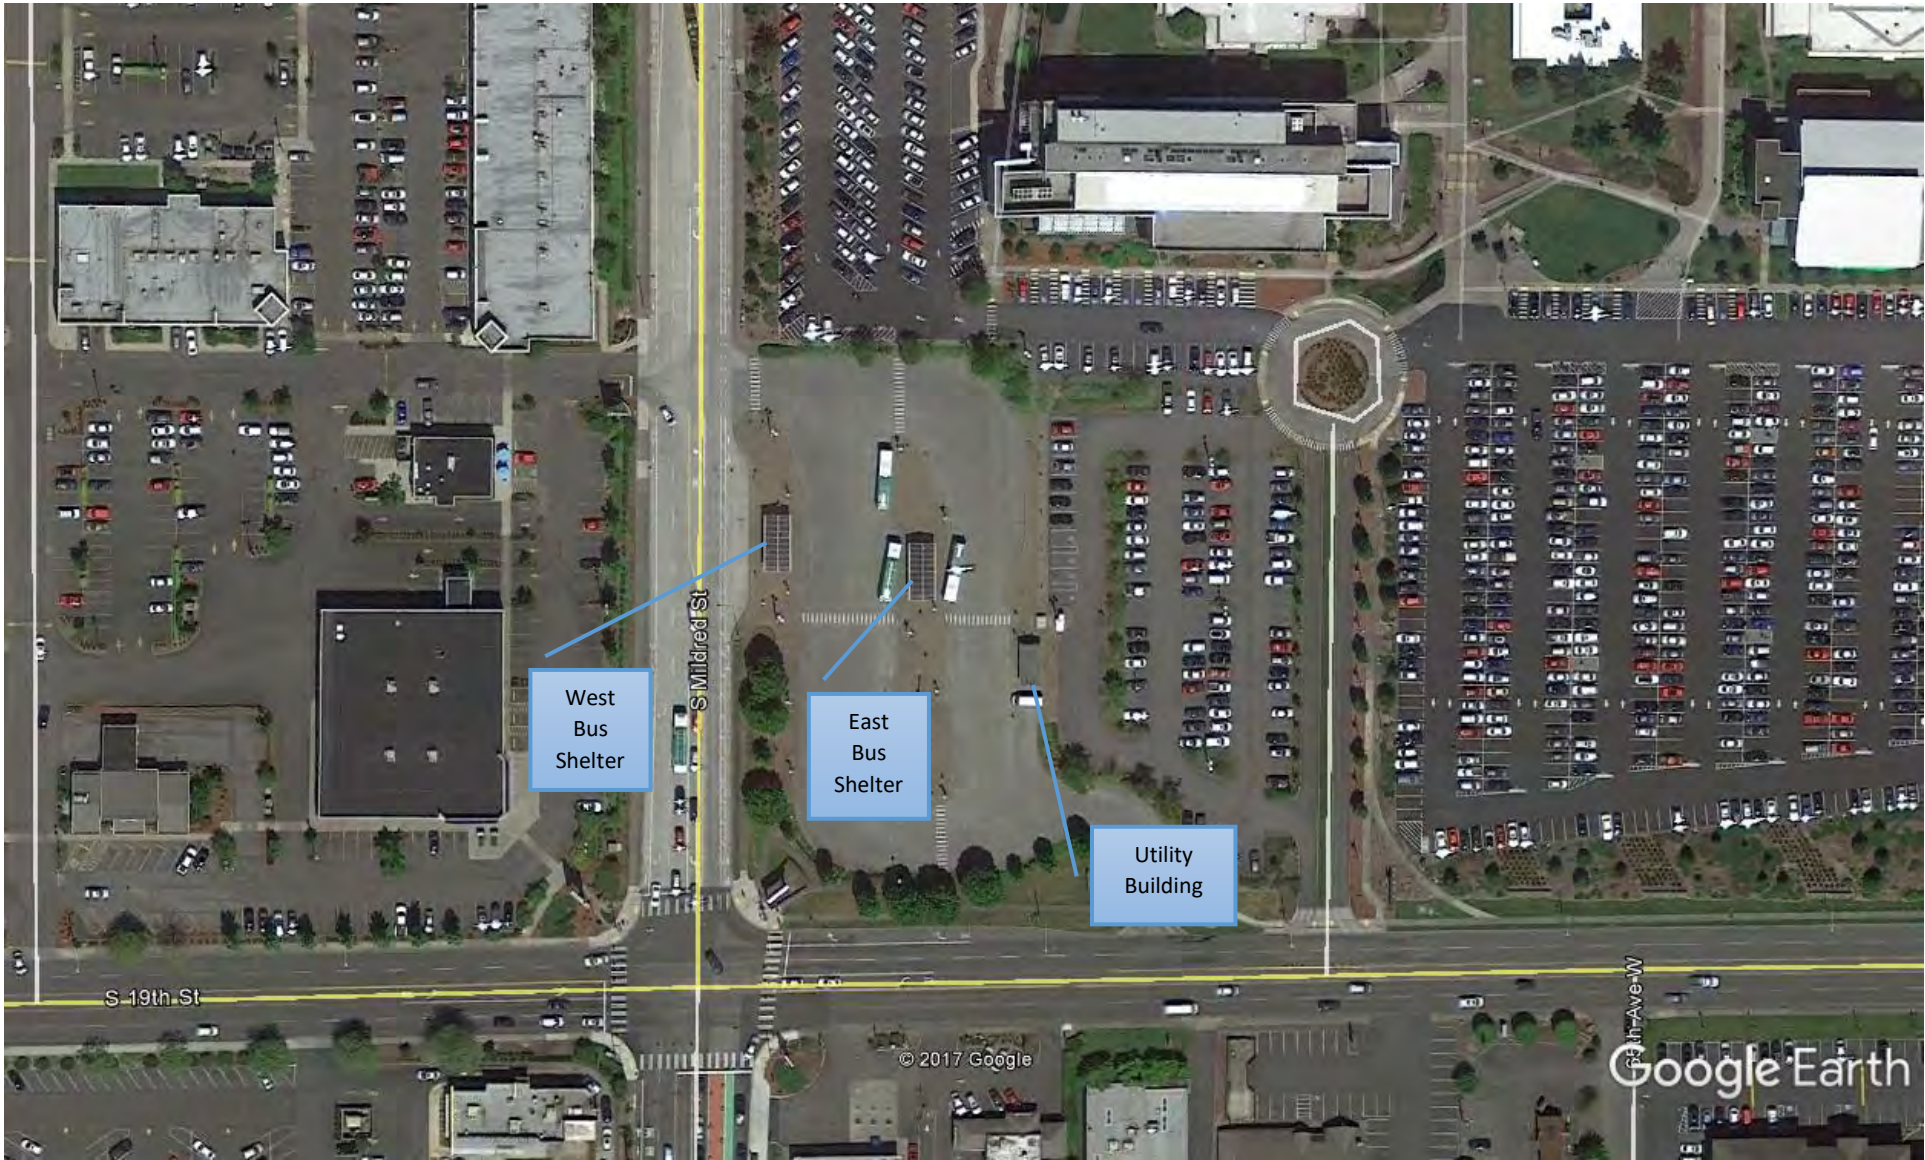
Facility Condition Assessment

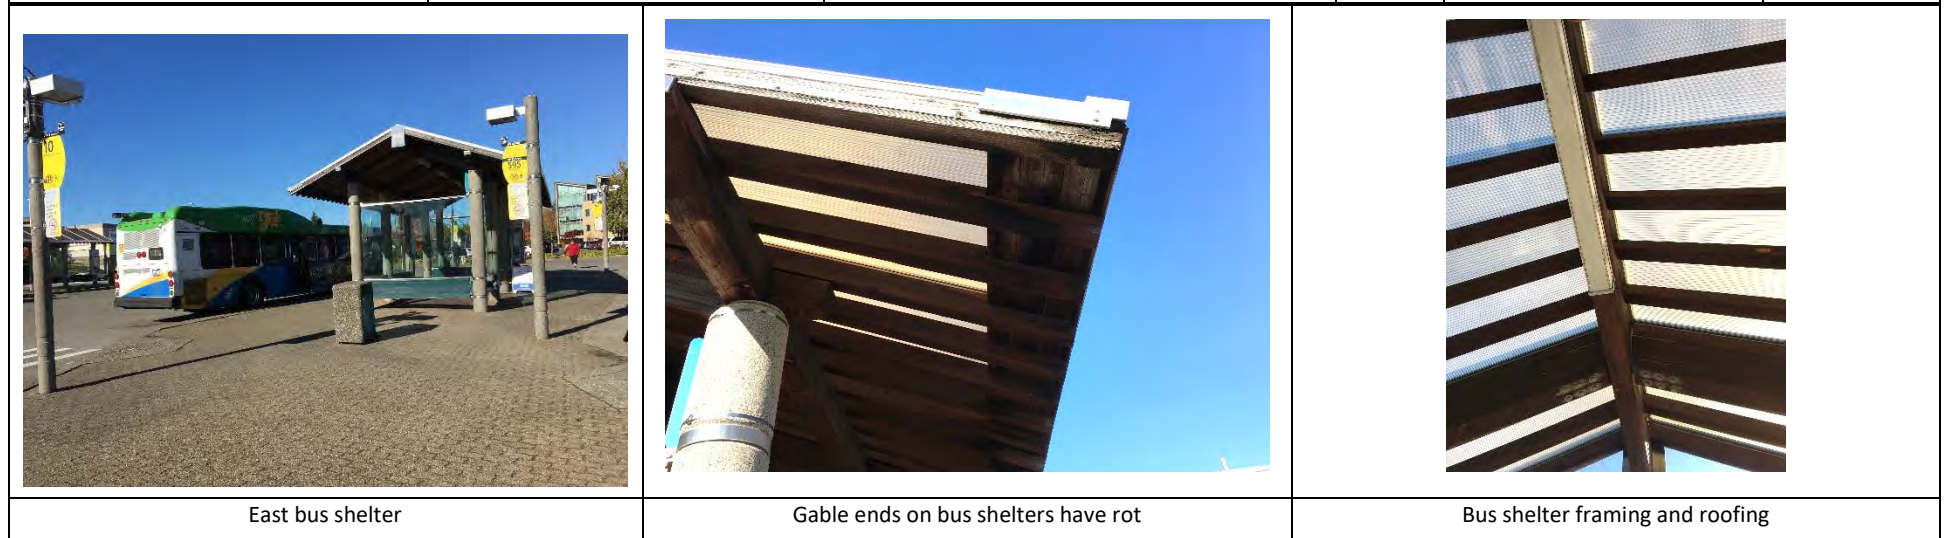
Shell appurtenances	Bus shelter stainless steel gutters. Utility building is painted metal K type.	All gutters and downspouts appear clear and in good condition.	4.0	None	N/A

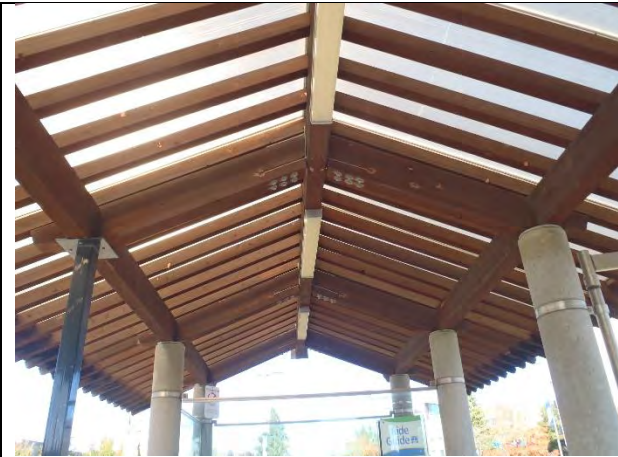
Bus shelter framing and roofing

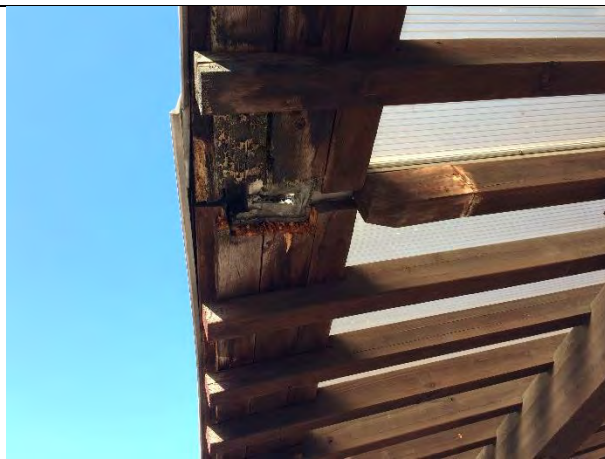
West bus shelter rafters showing rot

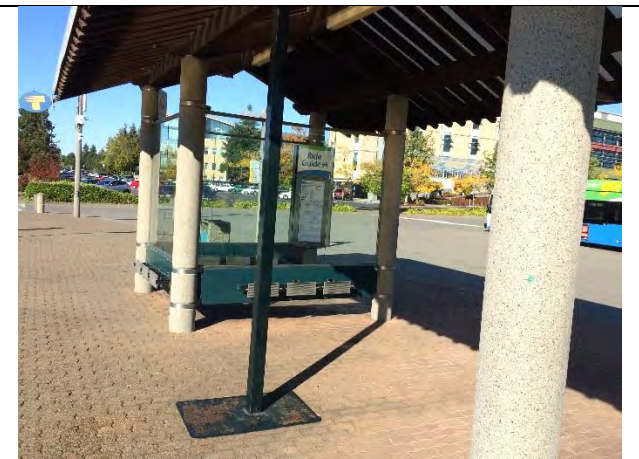
West bus shelter with middle column replaced with steel post

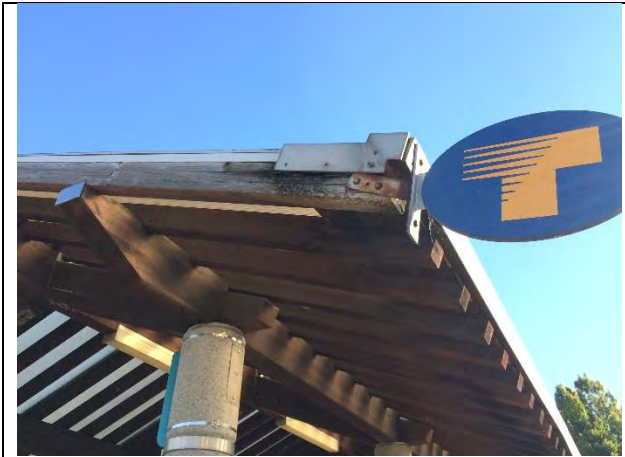
West bus shelter gable rot

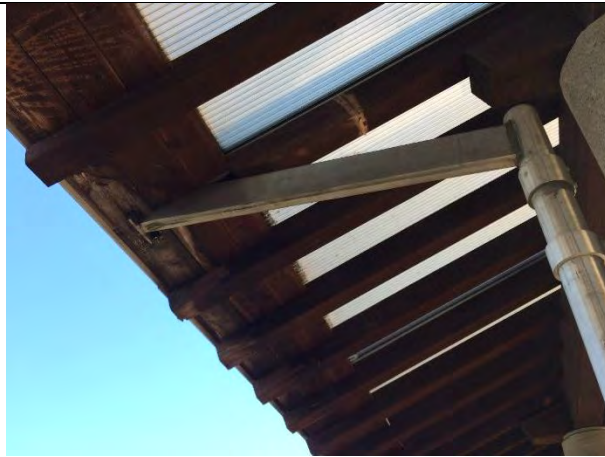
West bus shelter showing rot at downspouts

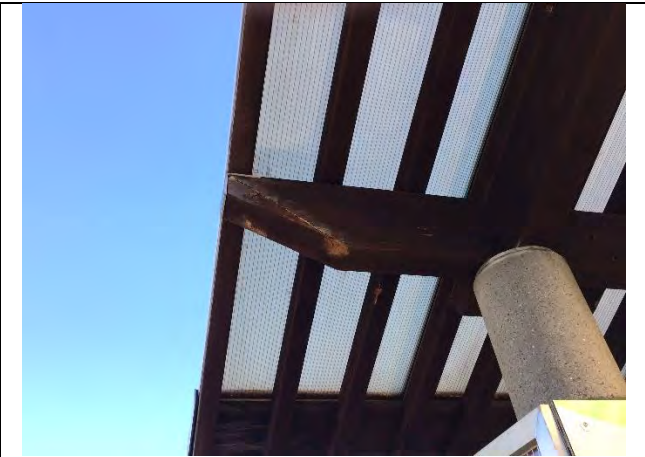
West bus shelter rot damage

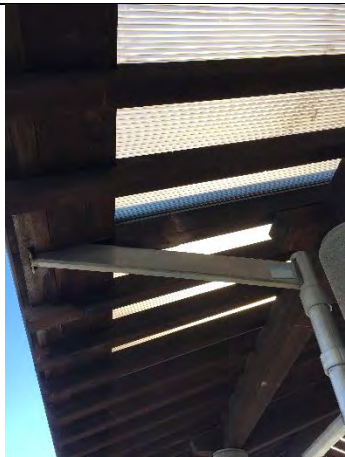
Bus shelter gutter downspout

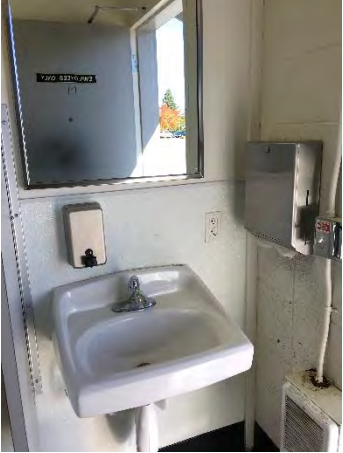
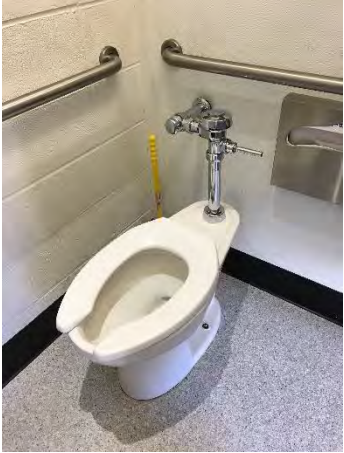
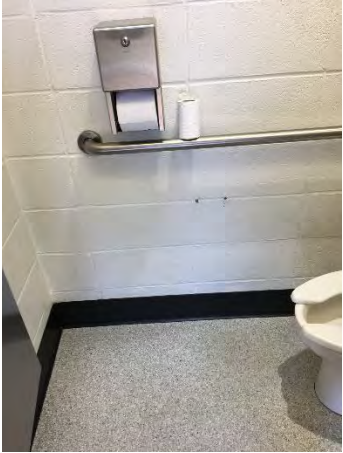
Vinyl wainscot behind sink		Men's restroom toilet		Vinyl flooring in front of toilet

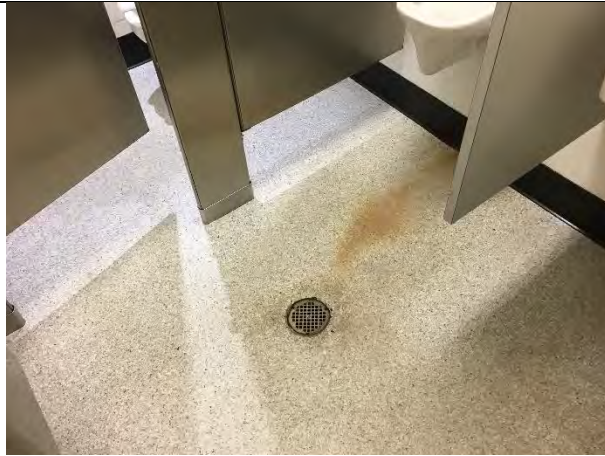
Staining on floor in front of urinal

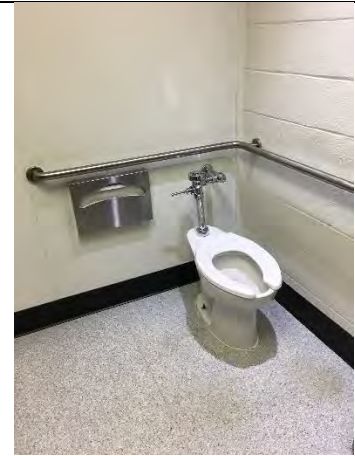
Women's restroom toilet

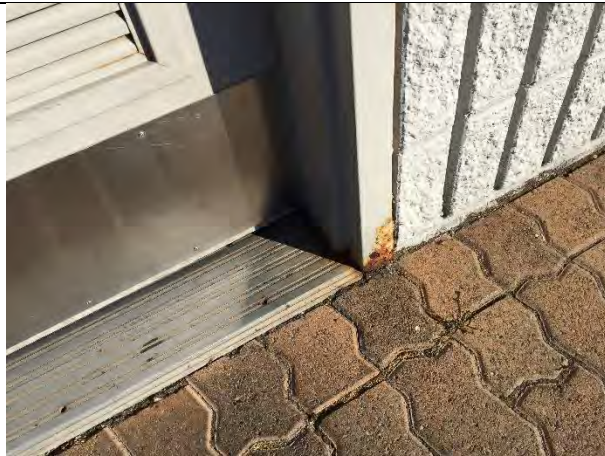
Rust on doors of bathroom at the utility building

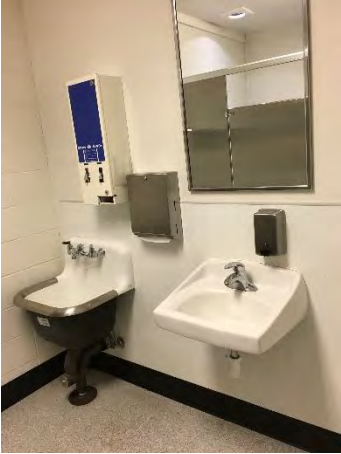
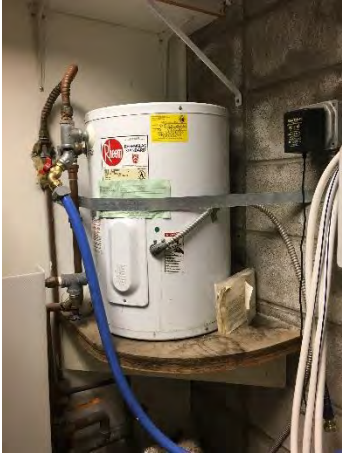
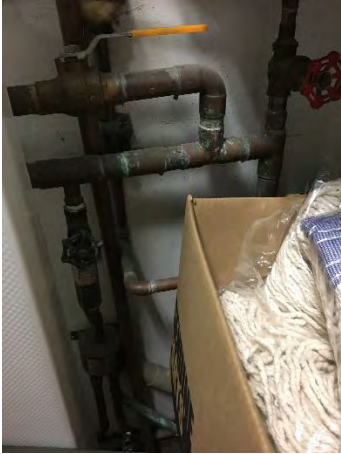
Slop sink in women's restroom		Hot water tank in utility room		Small piping in utility room

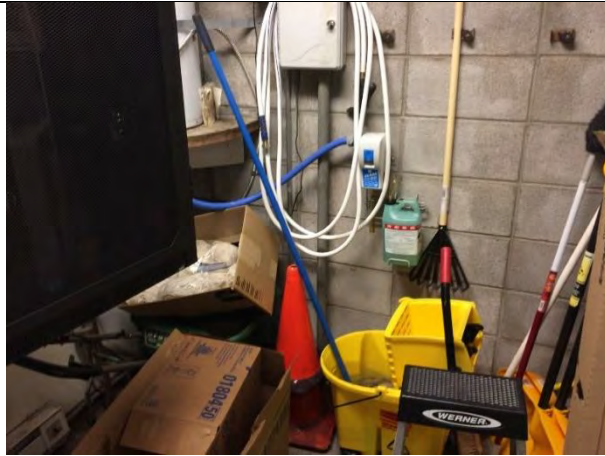
Miscellaneous storage in utility room

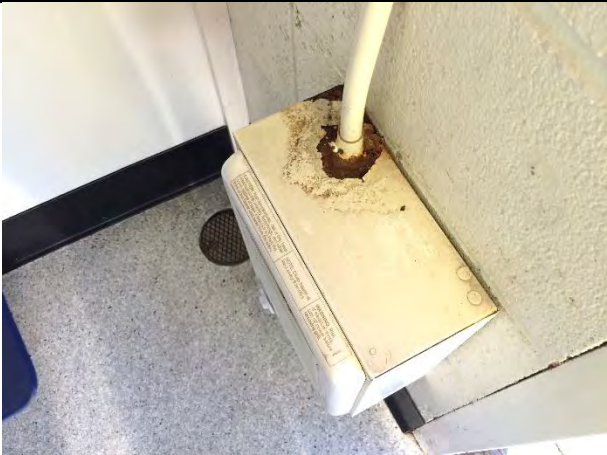
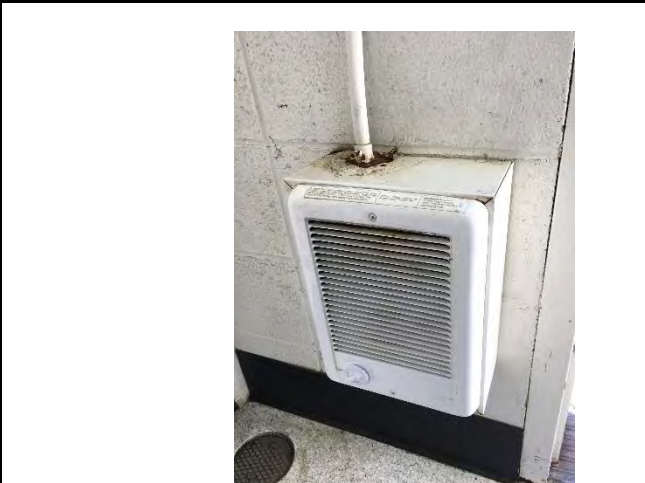
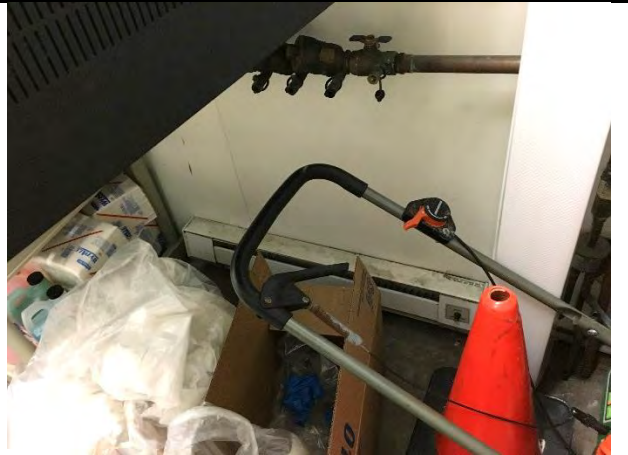
Rusty heater in men's restroom		Rusty heater in men's restroom		Items located too close to baseboard heater in utility room

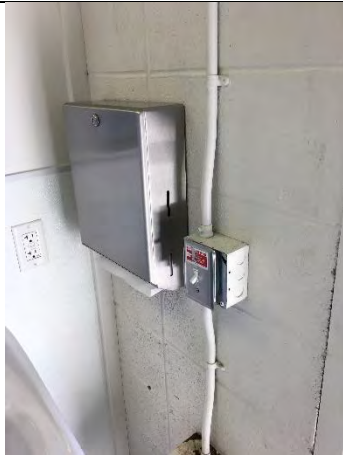
Paper towel dispenser

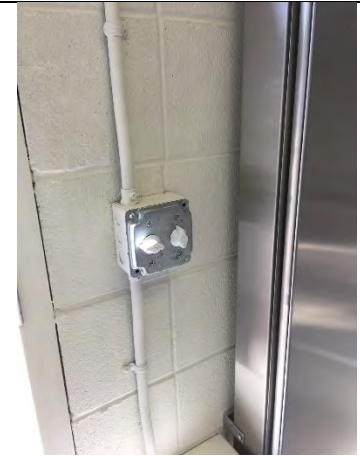
Restroom exhaust fan and light timers

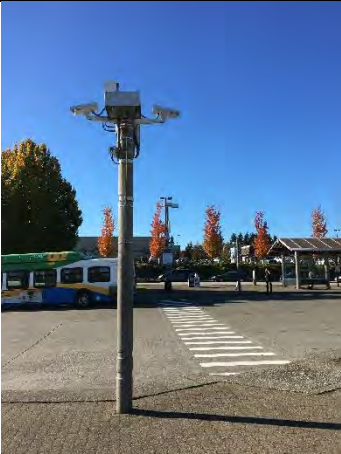
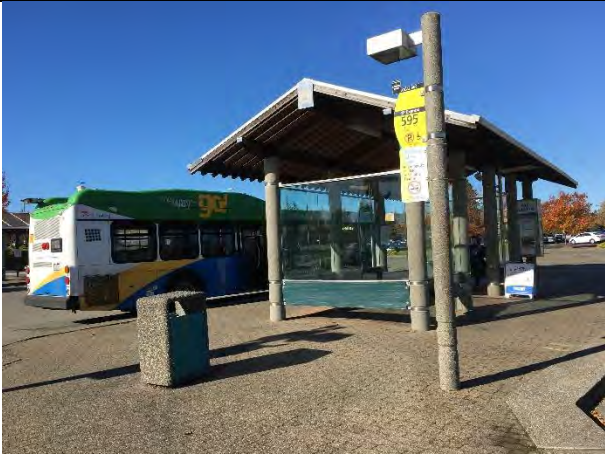
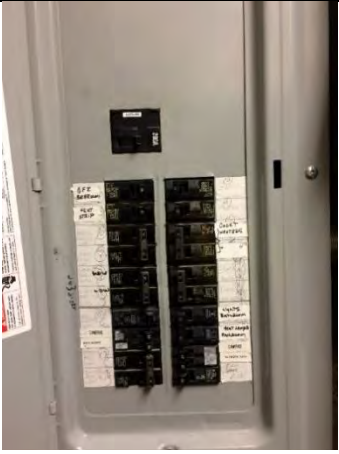
Site lighting and security cameras	Site lighting		Electrical panel in utility building

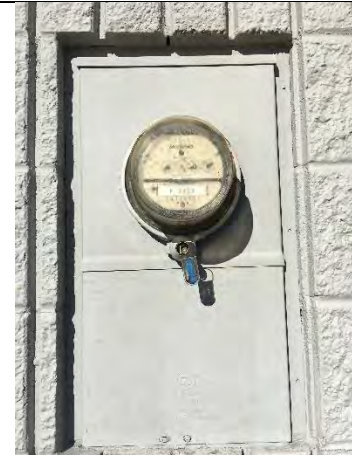
Electrical equipment in utility room

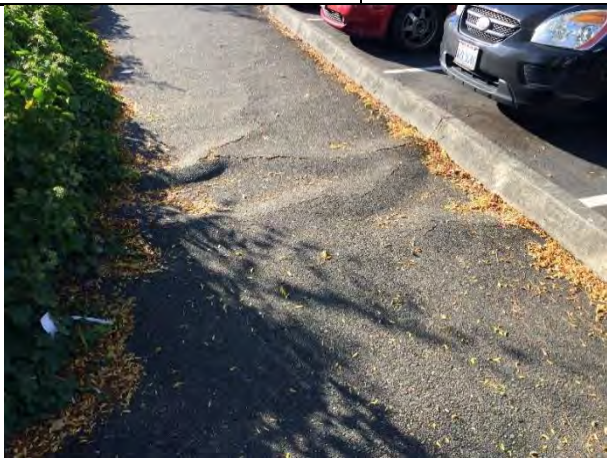
Pedestrian walkway with root growth

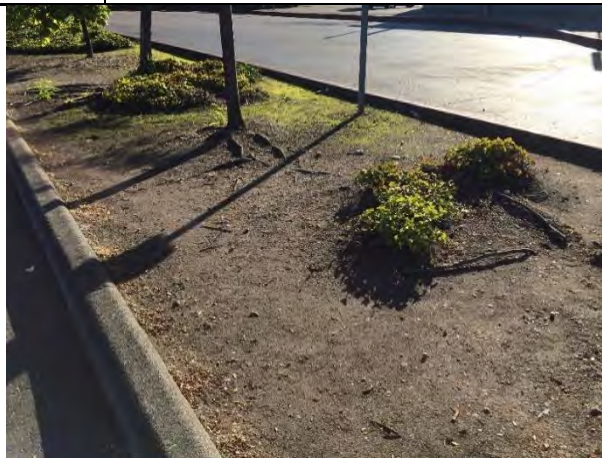
Landscaping missing ground cover

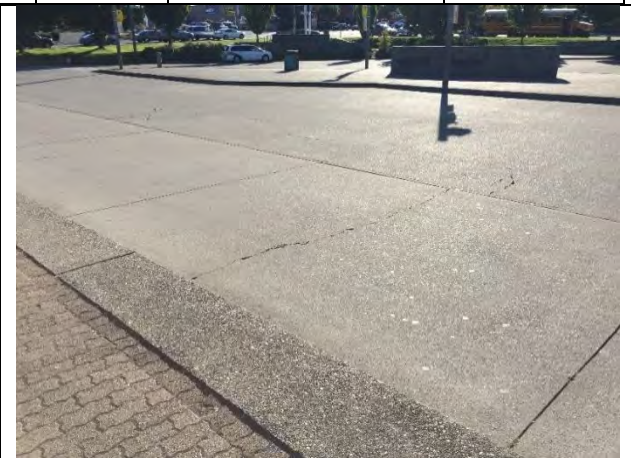
Cracks in concrete panels

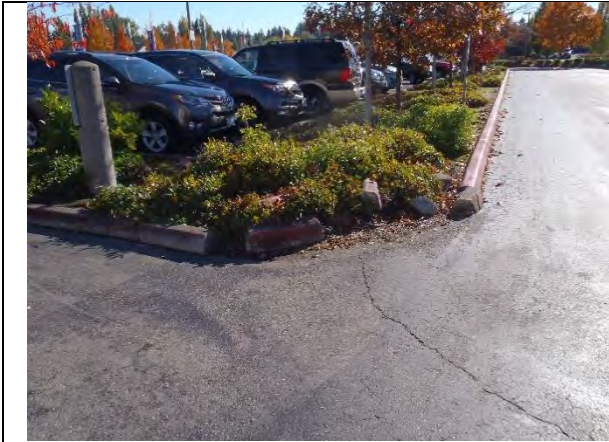
Broken section of curbing

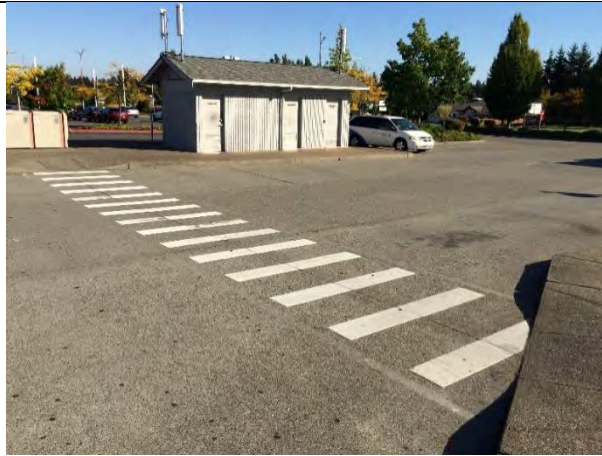
Pedestrian crosswalk paint in adequate condition

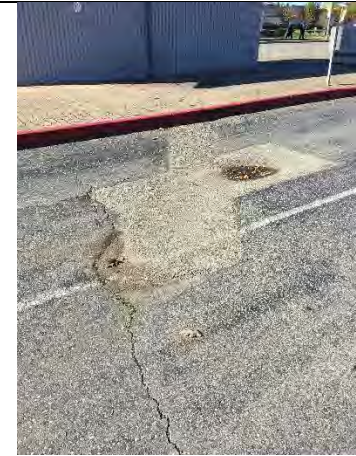
Previously repaired roadway that needs another repair

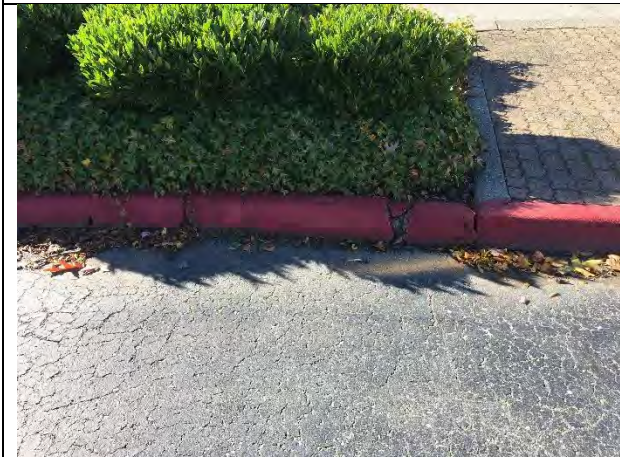
Broken section of curbing

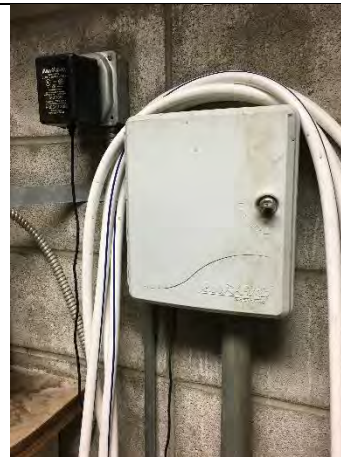
Irrigation system in utility room

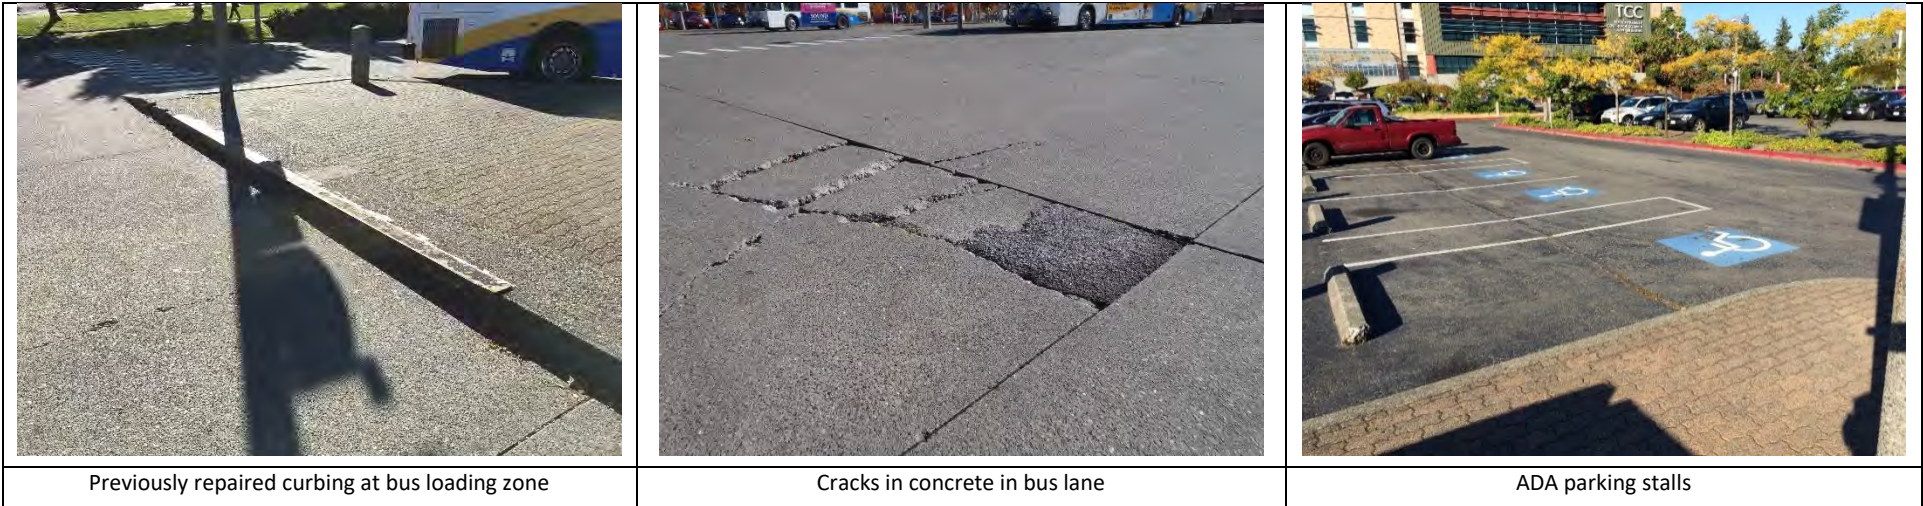
Communication box on outside of utility building

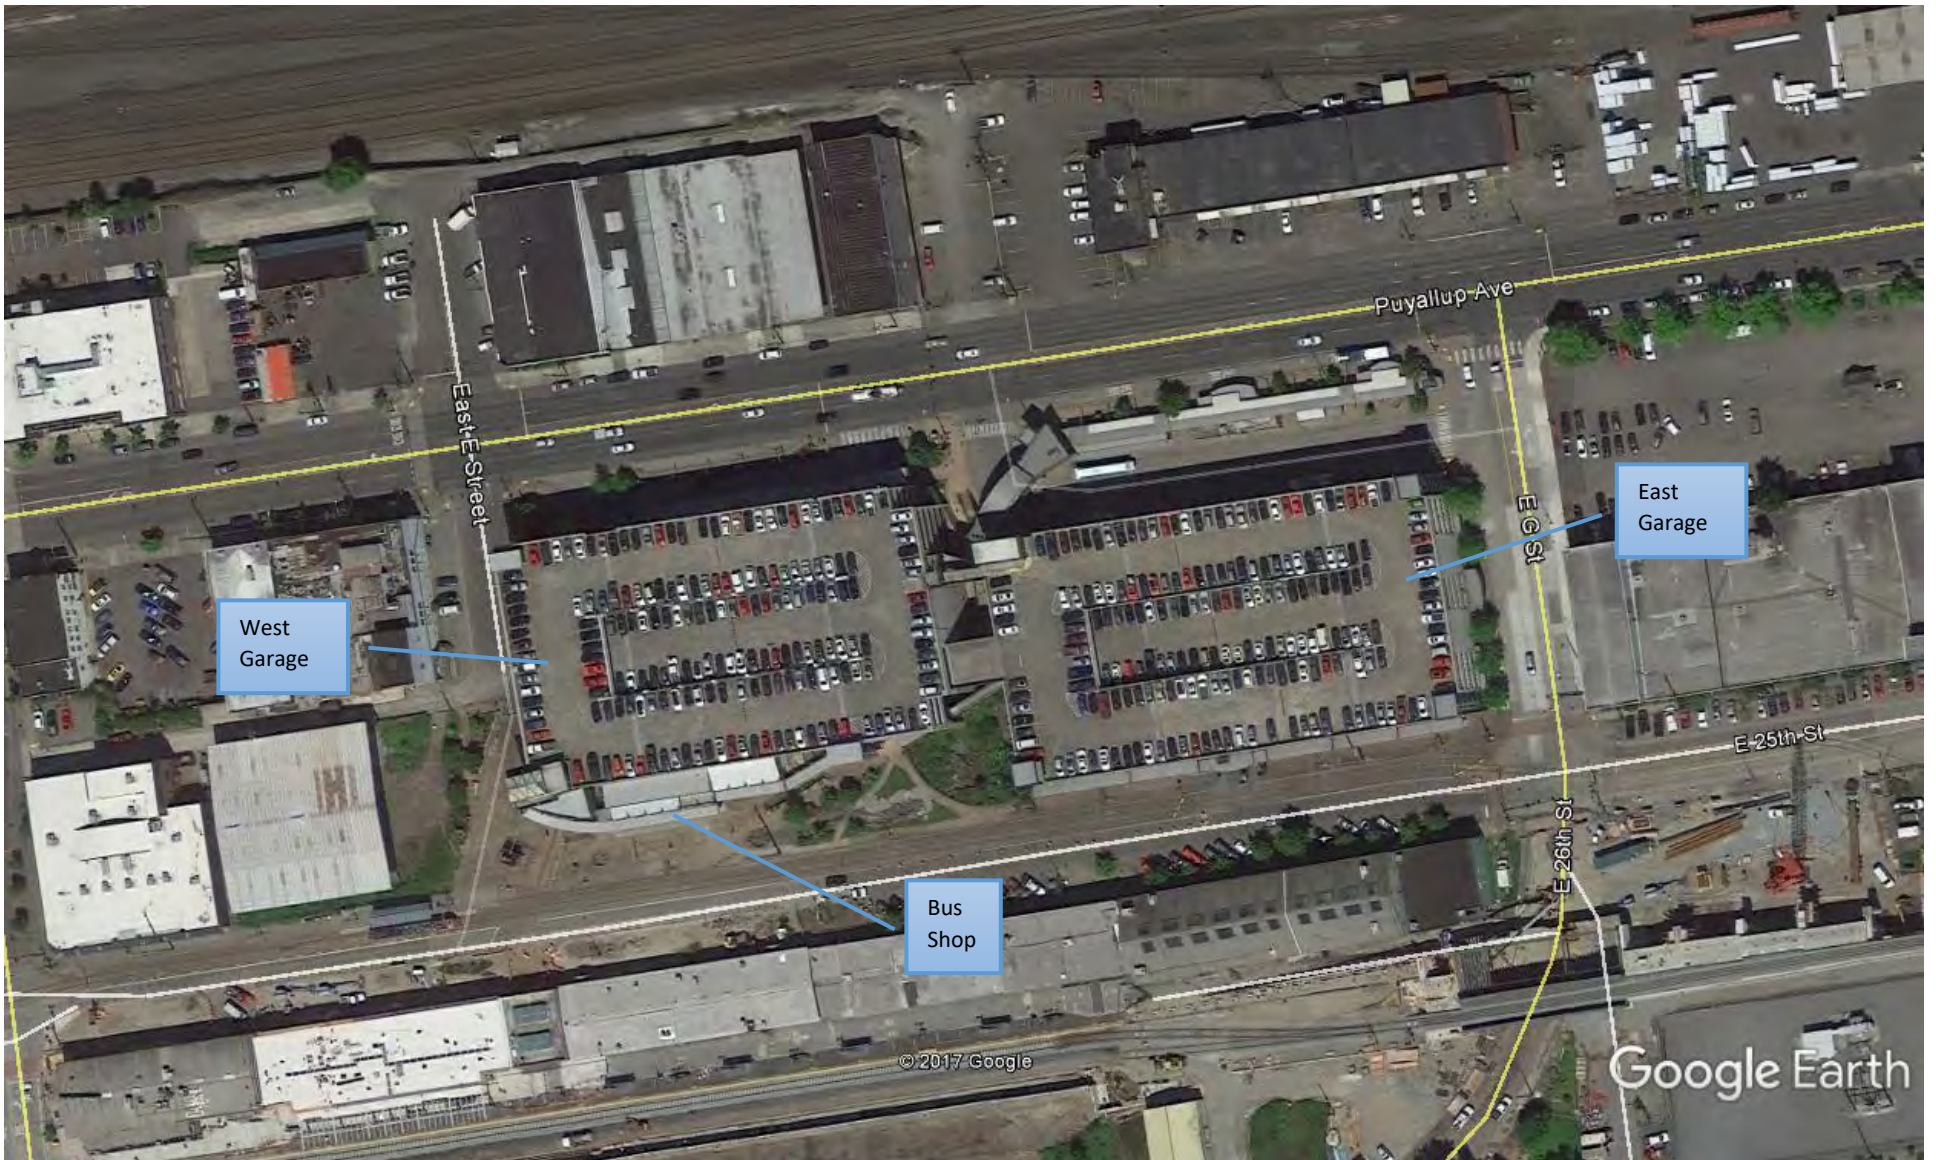
Facility Condition Assessment

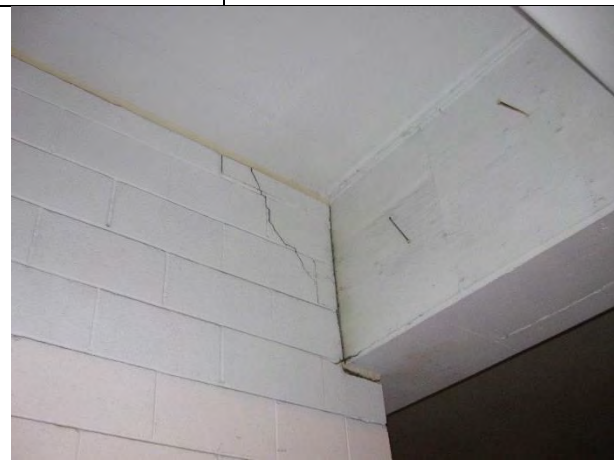
East garage- broken CMU in northwest corner

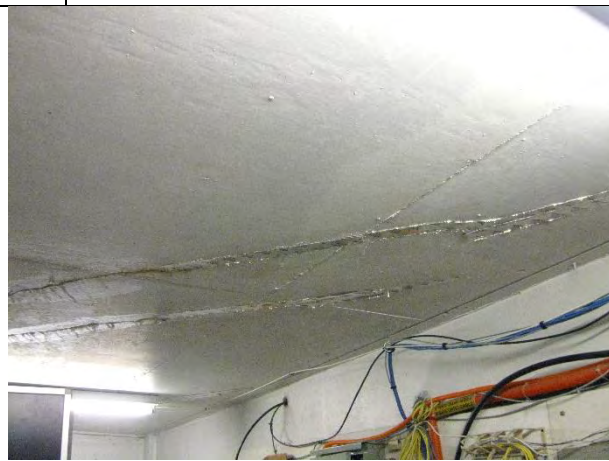
Patched cracks at west garage server room

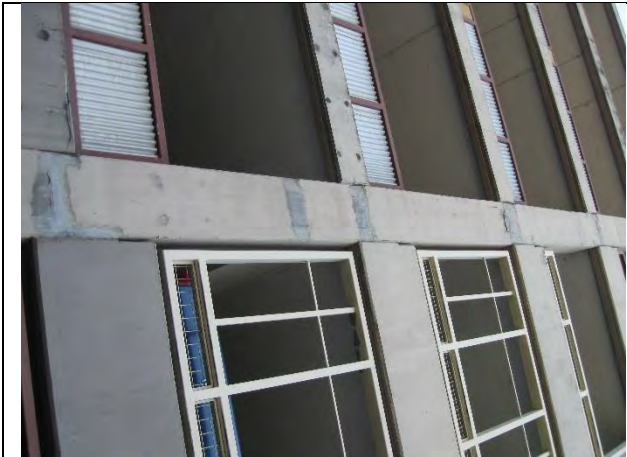
Column to beam joints on east garage showing patched cracking
