Pierce Transit Facilities Condition Assessment Report

Prepared for

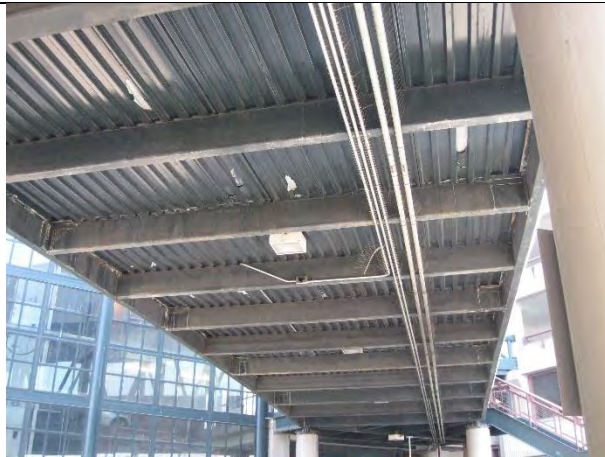
Peeling paint on underside of pedestrian bridge

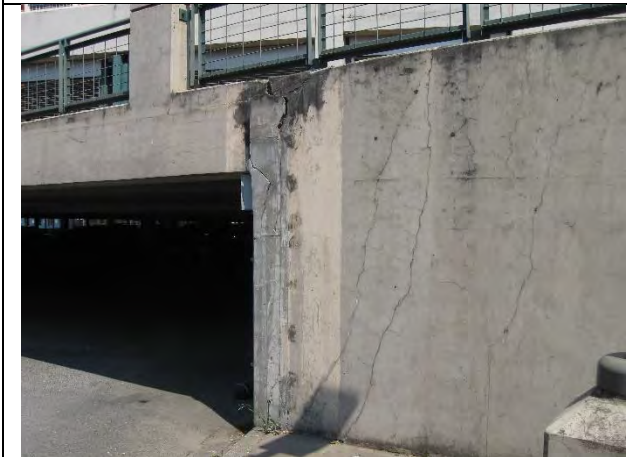
Damaged concrete at ramp on west side of west Garage

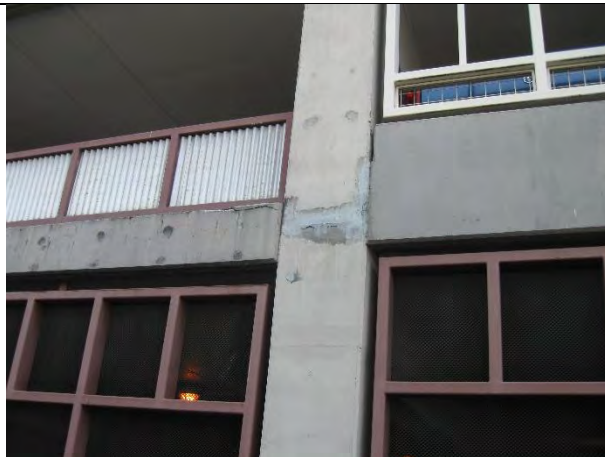
Column to beam joints on north wall of west garage showing patched cracking

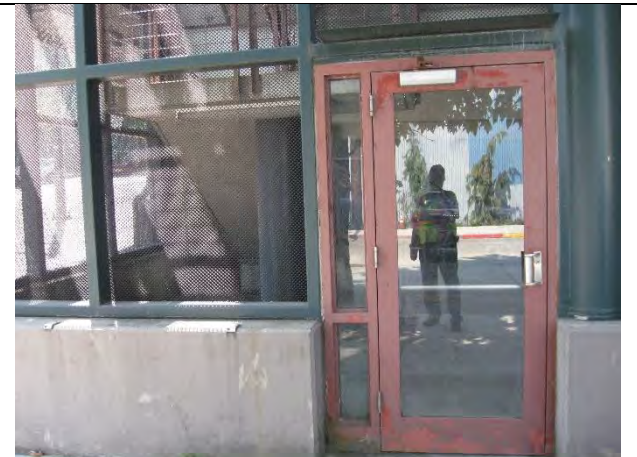
Corroded doorway at southeast corner of east garage

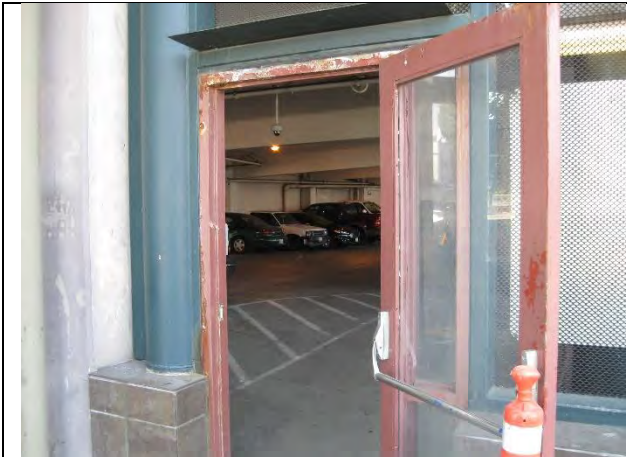
Rusty door frame at northeast corner of east garage

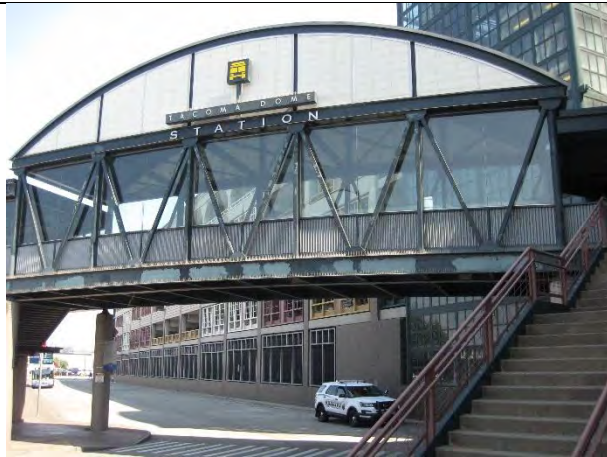
Steel structures at north side shows paint peeling and rust at joints

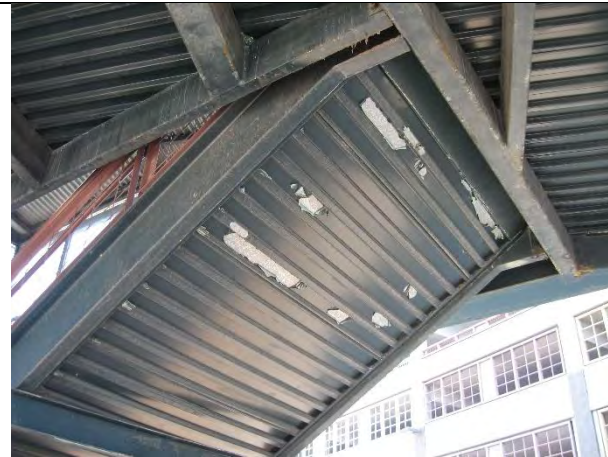
Peeling paint on underside of stairway

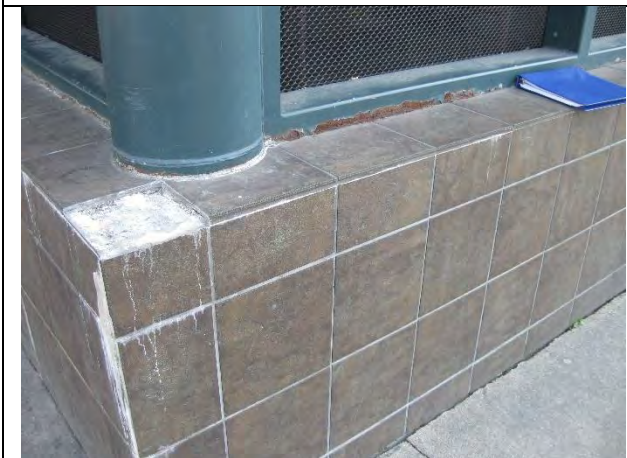
Missing tile and corroded steel frame at northeast corner of east garage

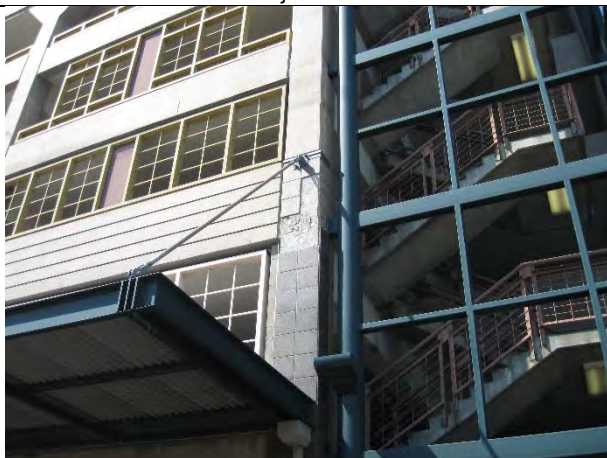
Southeast corner of east garage – missing tile under canopy support rod

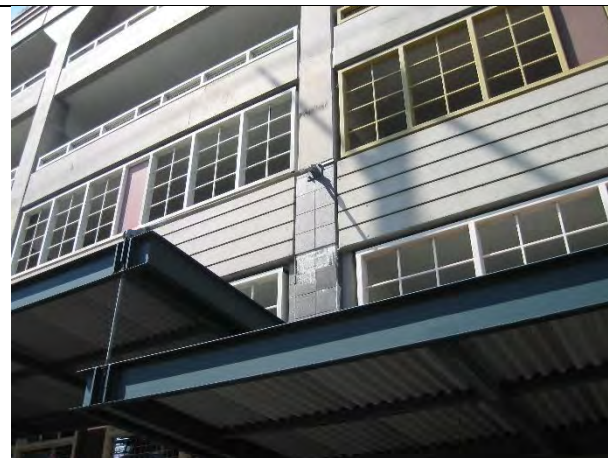
Missing tile approximately 20 feet west on south wall of east garage

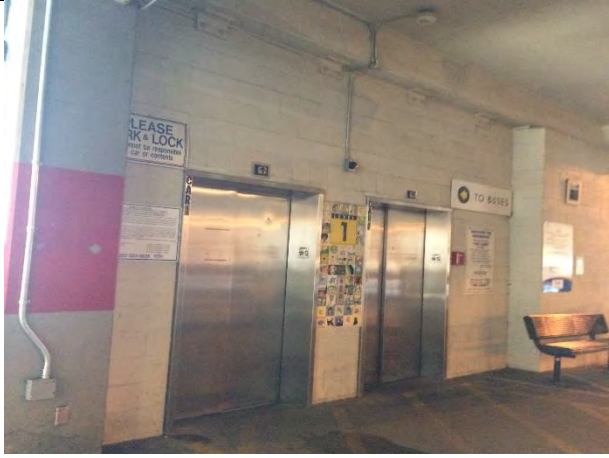
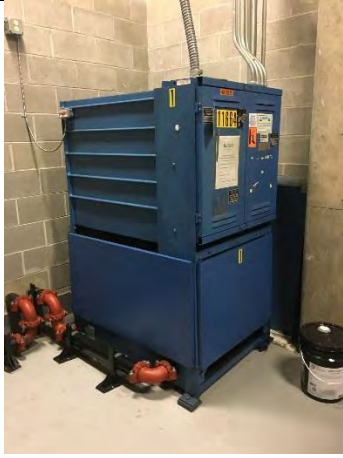
Elevators located in garage structure		Elevator equipment in equipment room

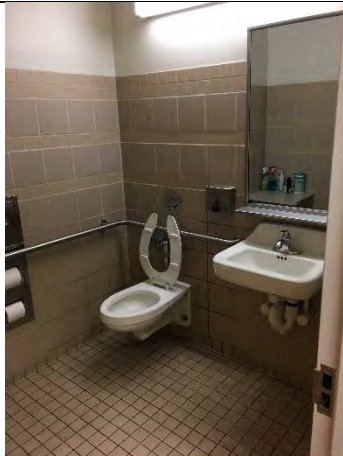
Security room restroom

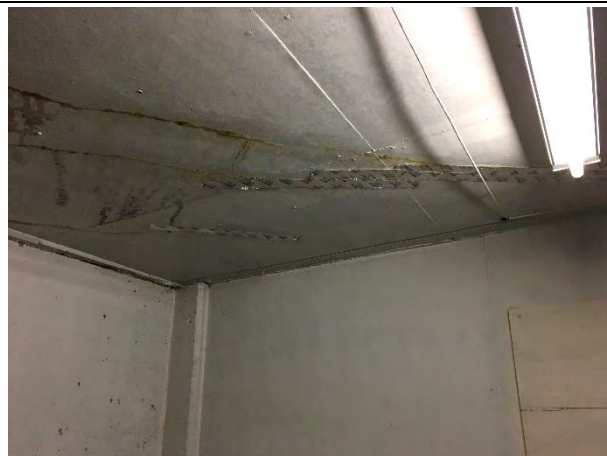
Electrical/controls room in the west parking garage, cracks/leaks in ceiling repaired with sealant tape

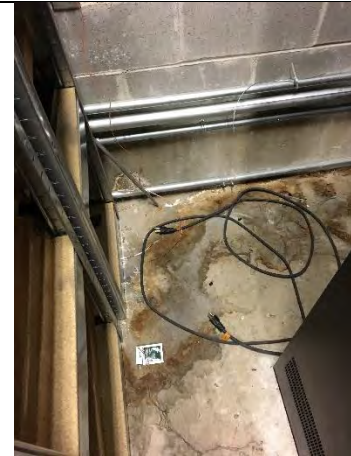
Storage room adjacent to the facilities maintenance work room

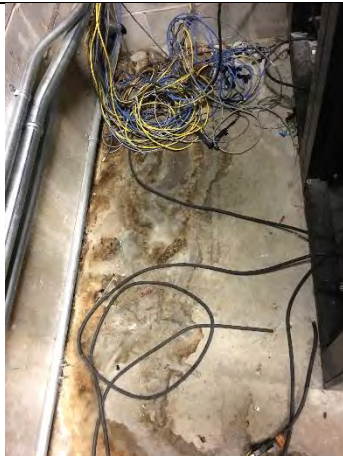
Storage room adjacent to the facilities maintenance work room

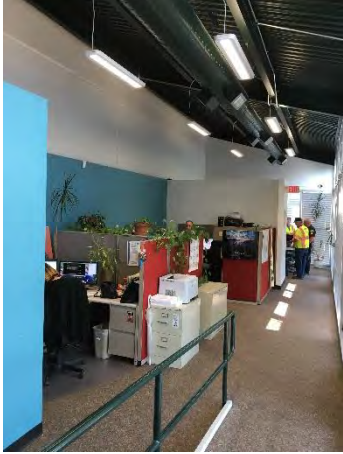
Bus Shop (east end) HVAC distribution system

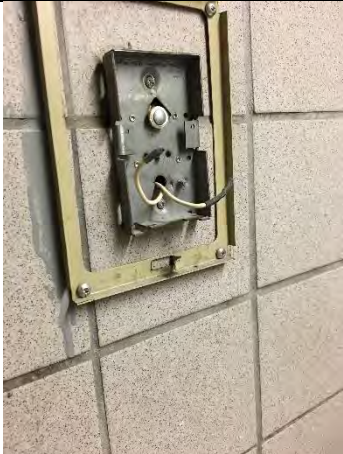
Radiant heater thermostat in public restrooms on the pick-up/drop-off area island

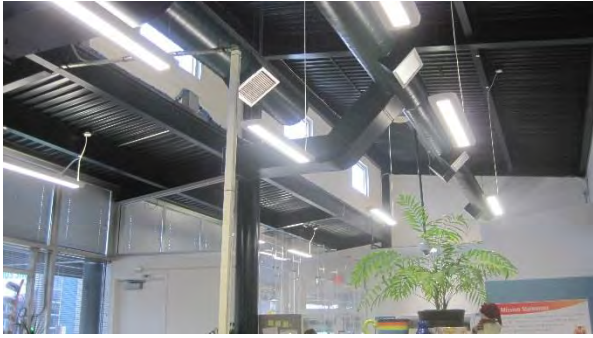
Customer Service (Un-sprinklered)

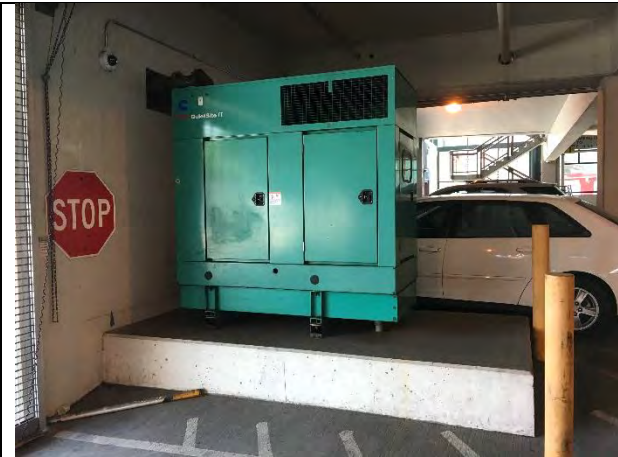
Generator in East Garage

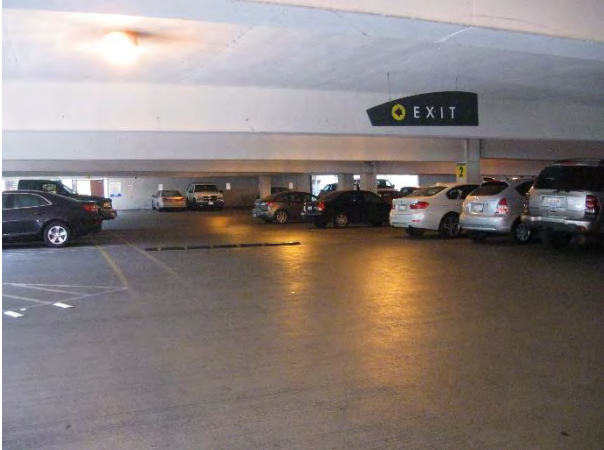
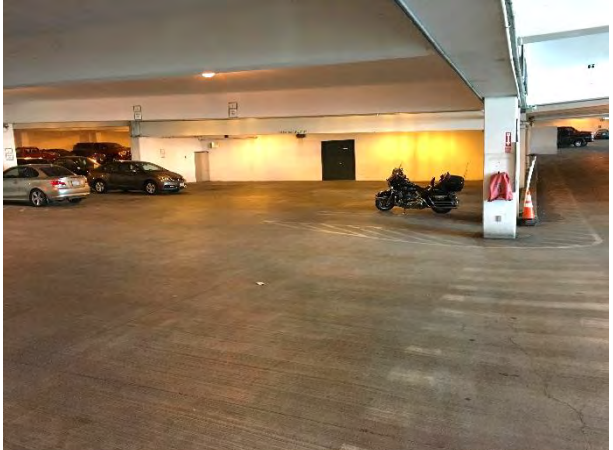
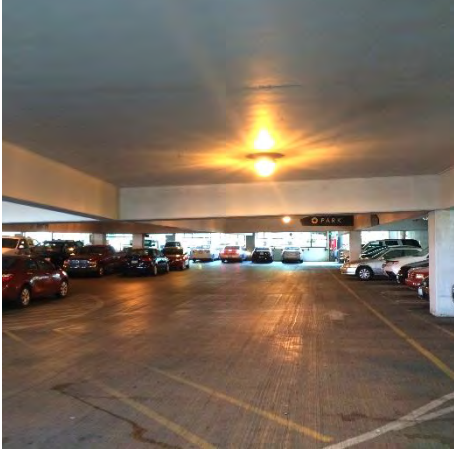
Parking lot striping has faded and needs repainting	Pedestrian crosswalks need to be repainted	Parking lot striping has faded and needs repainting

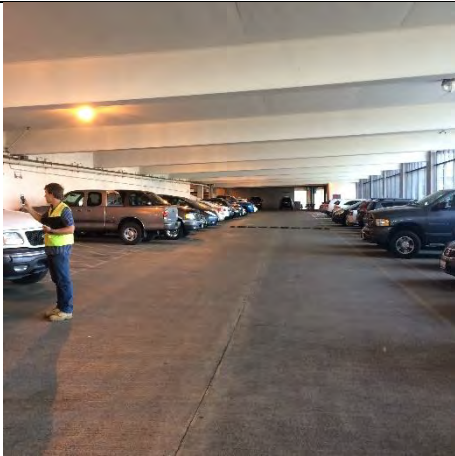
Concrete panels in good condition

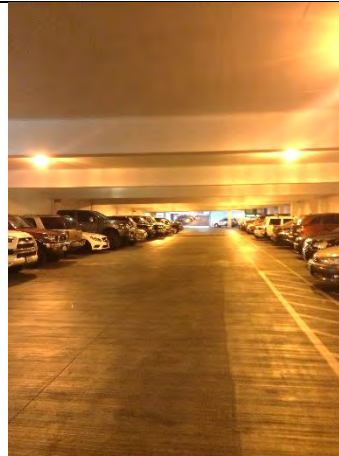
Concrete panels in good condition

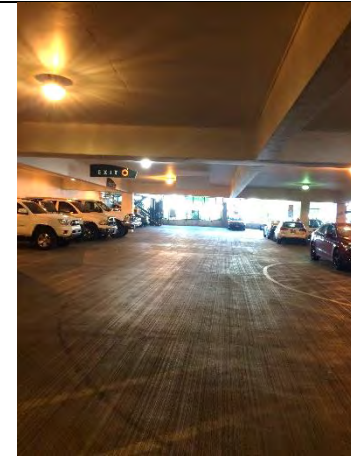
Parking lot striping has faded and needs repainting

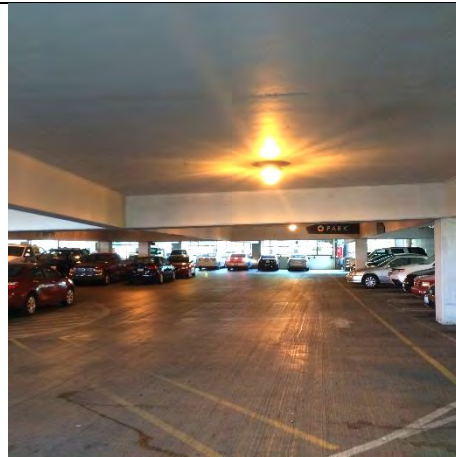
Concrete panels in good condition

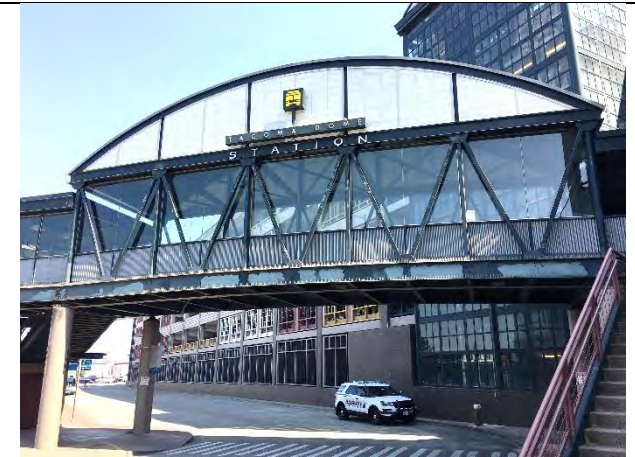
Sky bridge for pedestrians to avoid crosswalk

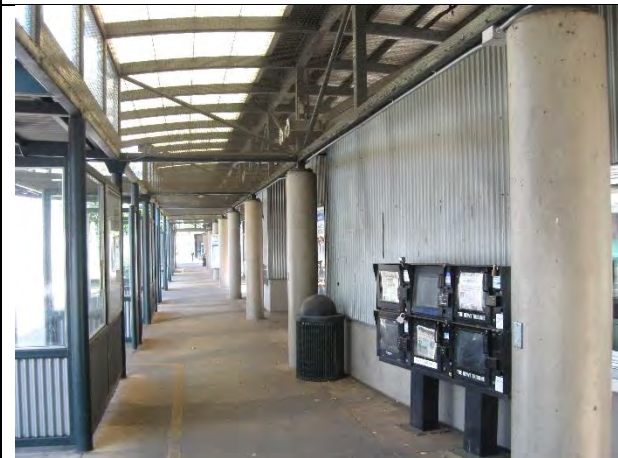
Pedestrian walkway concrete in good condition

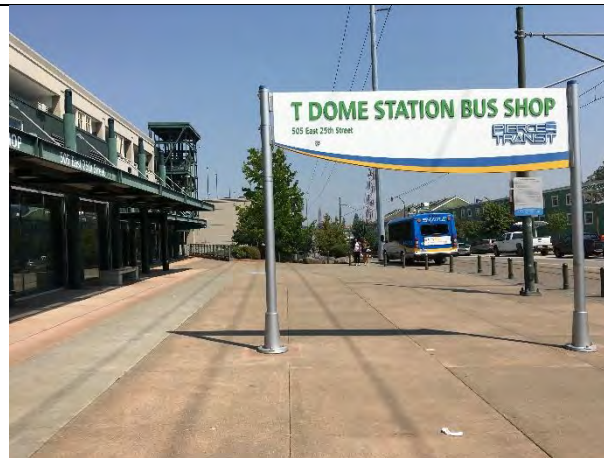
Pedestrian walkway concrete in good condition

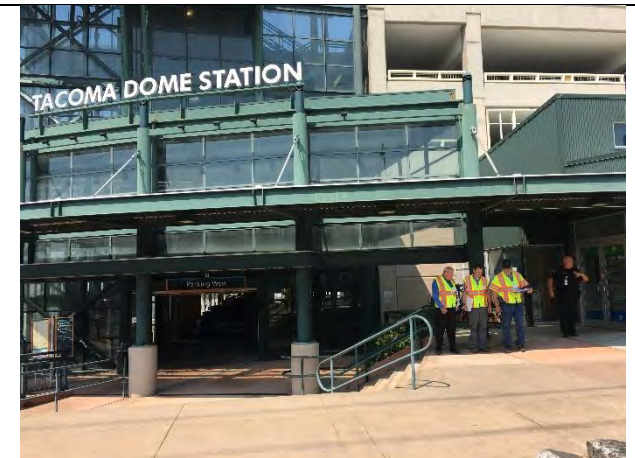
Bus shop and garage entrances

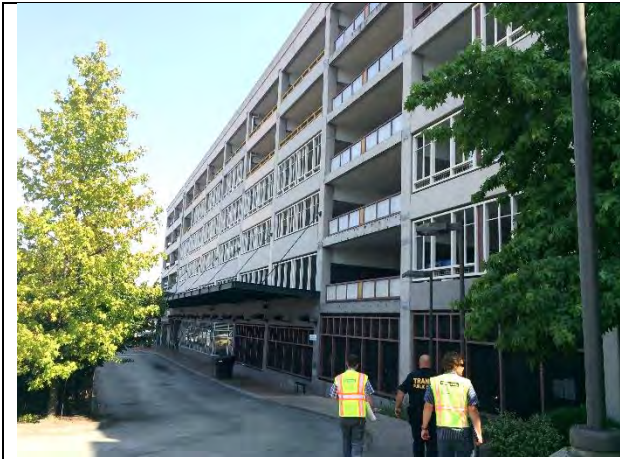
Landscaping on north side is in good condition

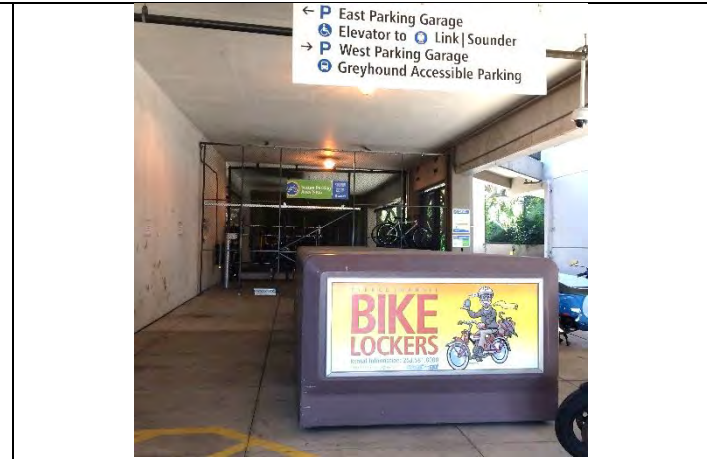
Bike lockers in good condition

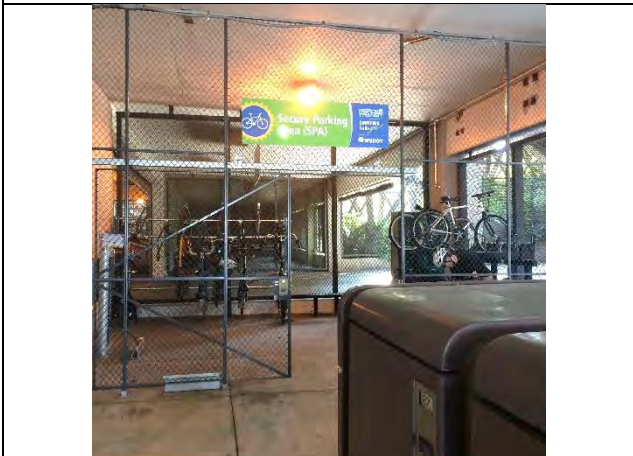
Locking storage area for bikes

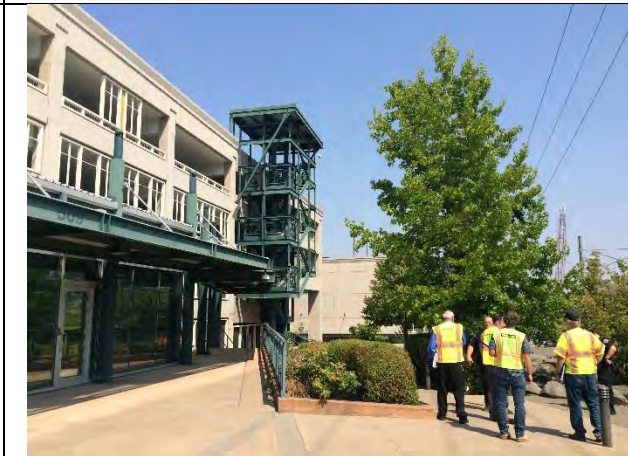
Landscaping on south side is in good condition

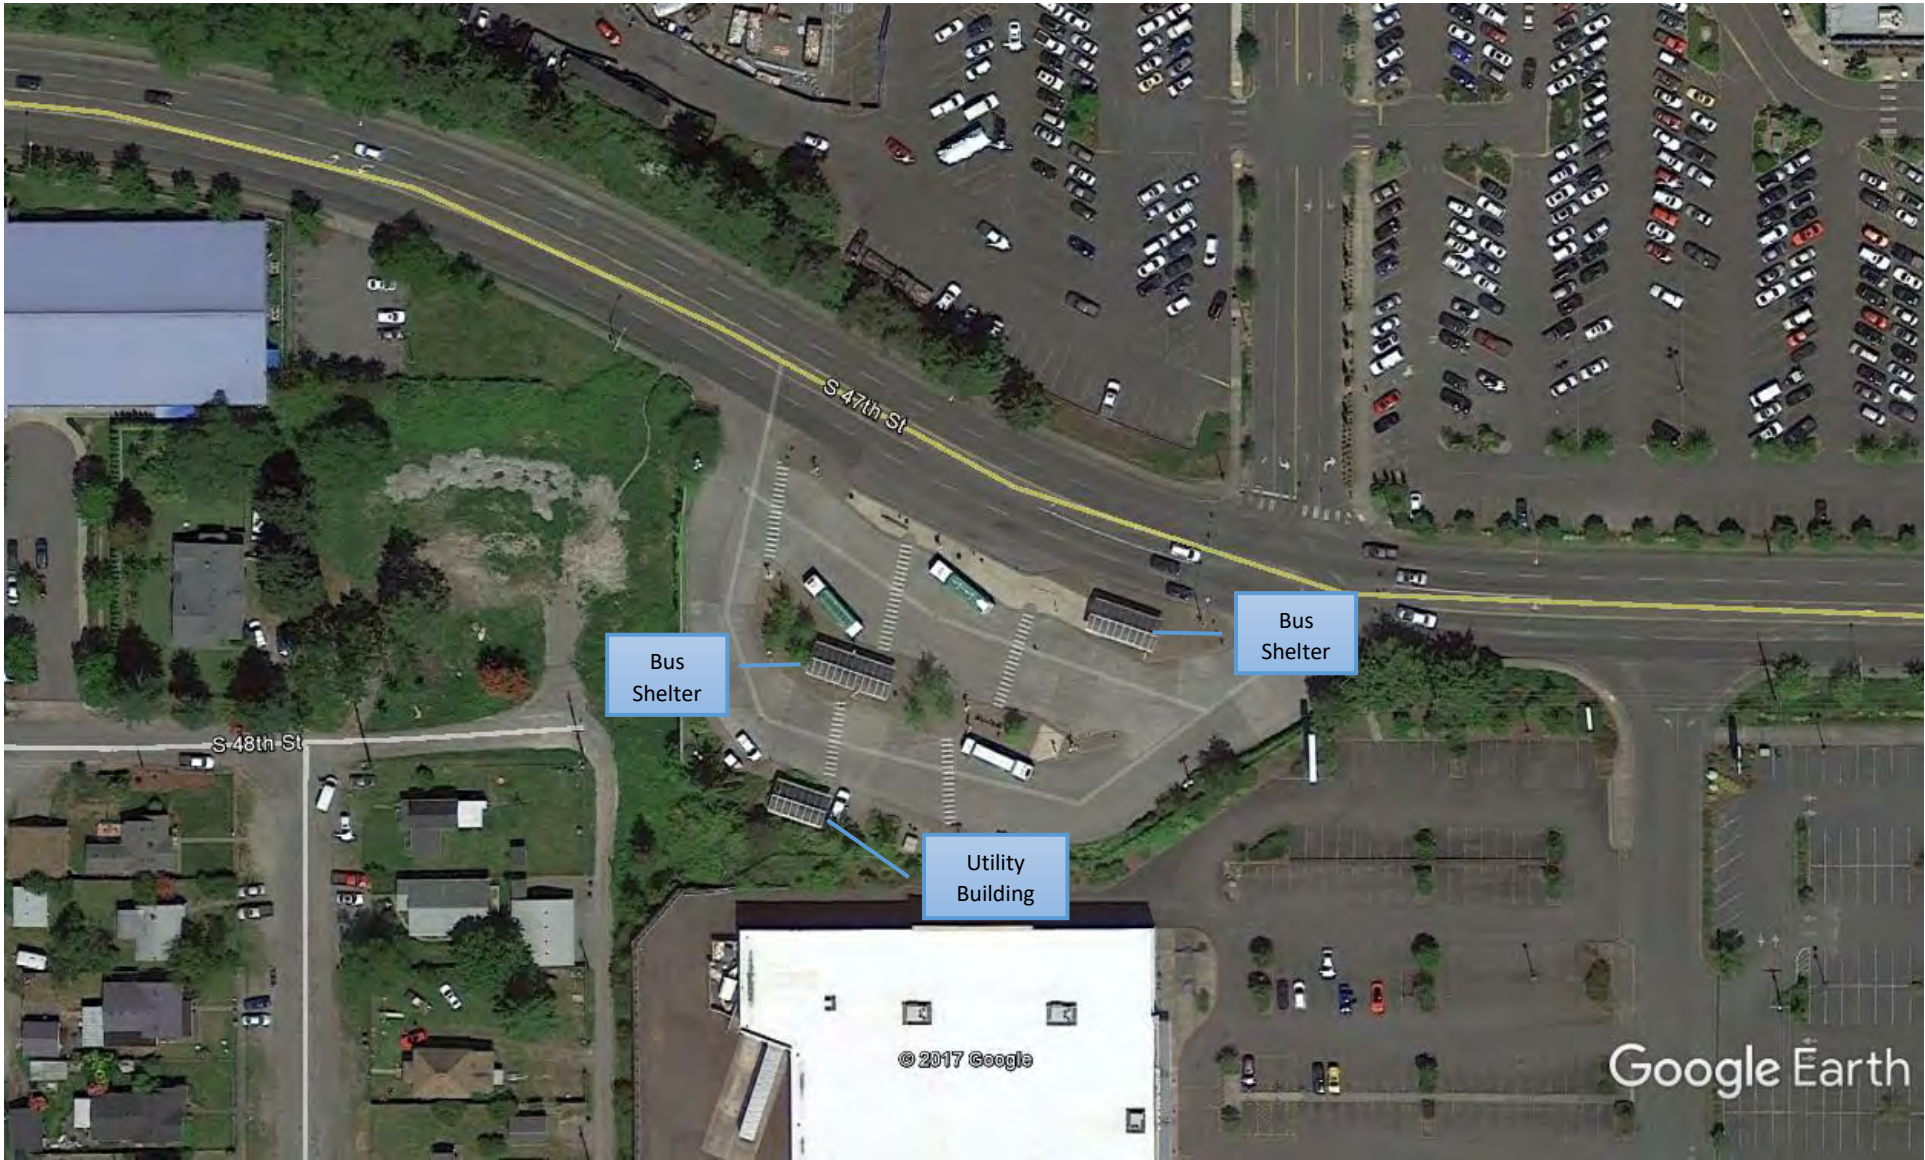
Facility Condition Assessment

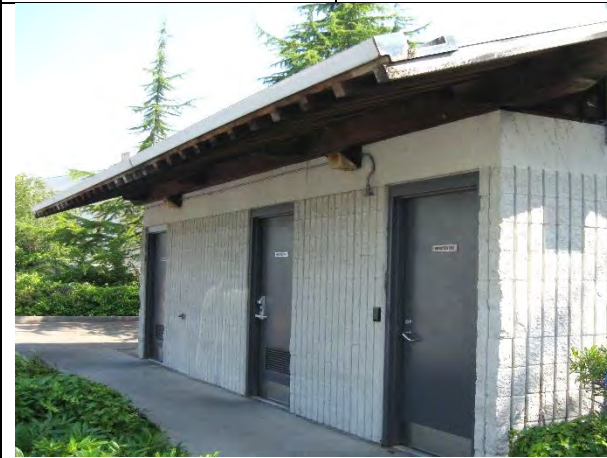
Exterior	Bus shelter glass panels and fold down seats.	Glass panels vandalized with scratches. Seats are fold down type and are in good condition. There is one set of seats missing in the south shelter.	2.5	Replace glass and missing seats.	\$5,000
Shell appurtenances	Stainless steel structure gutters and downspouts.	Gutters and down spouts are stainless steel and are in good condition.	4.0	None	N/A

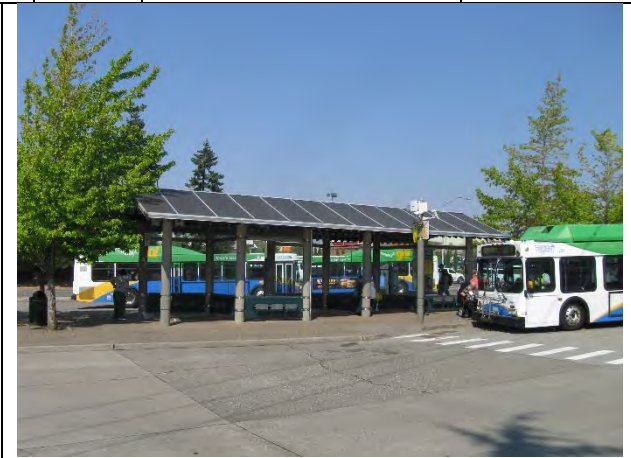
South bus shelter structure is in good condition

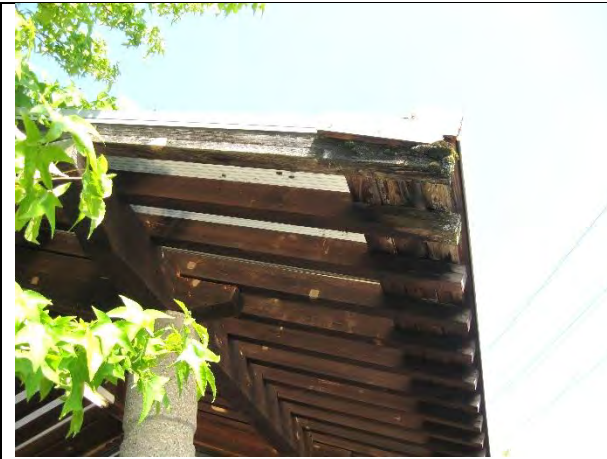
Shelter gable ends are rotting

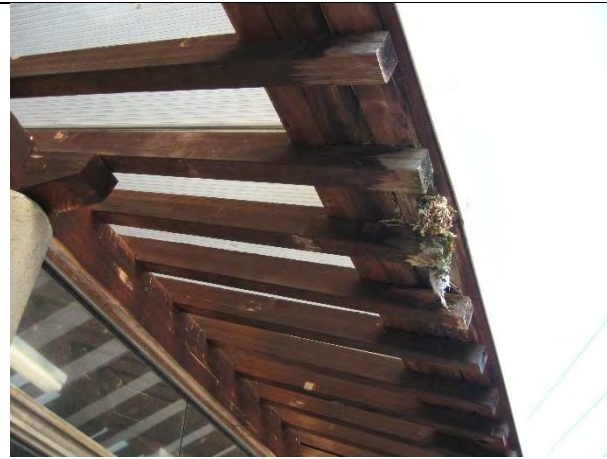
Debris on gable ends causing additional rot

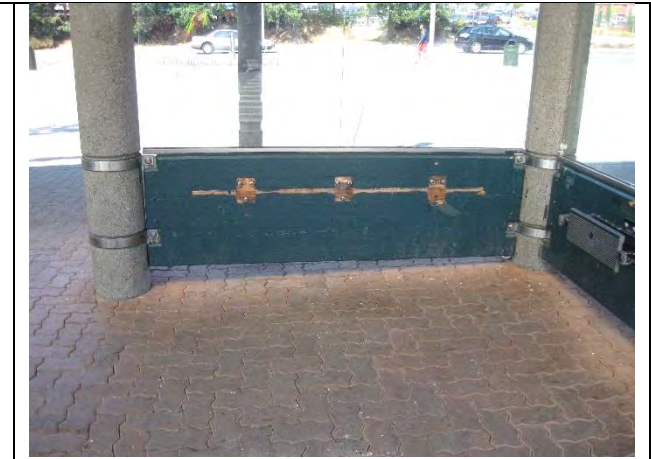
Missing seat in south bus shelter

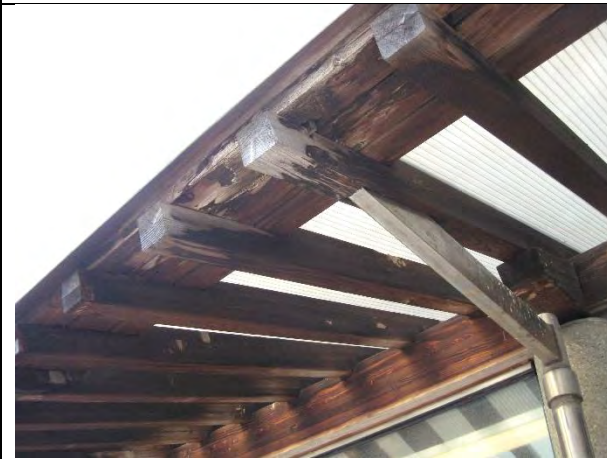
Weathered gable ends on bus shelter

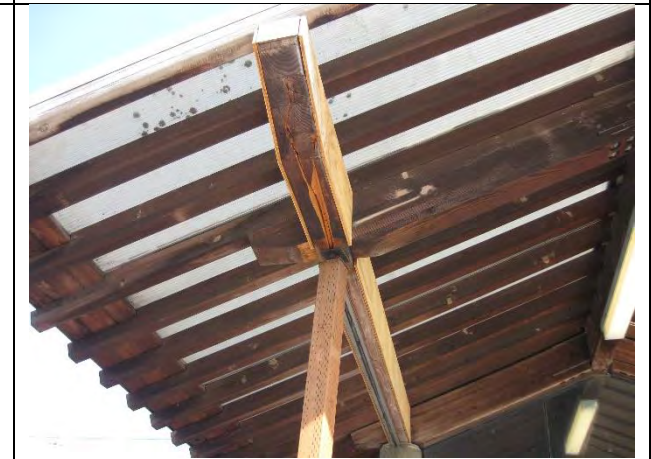
North bus shelter with wood post shoring roof beam

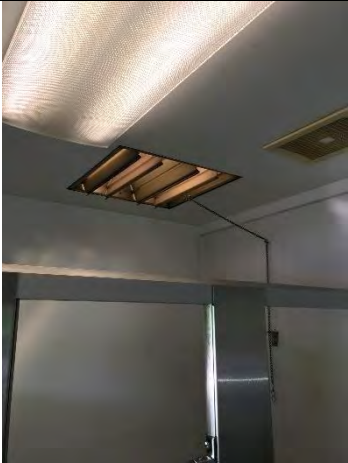
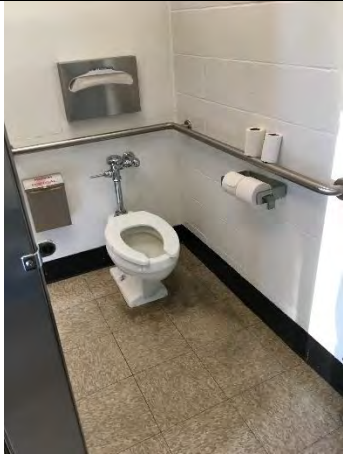
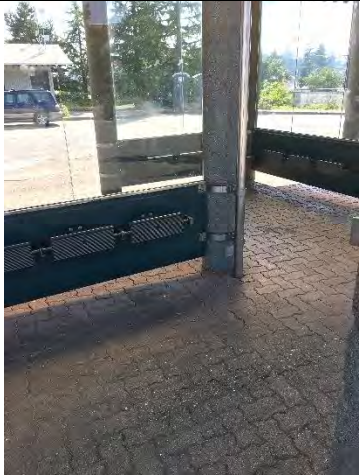
Restroom walls, ceiling, and partitions are in good condition		Restroom flooring and walls		Bus shelter pavers in good condition

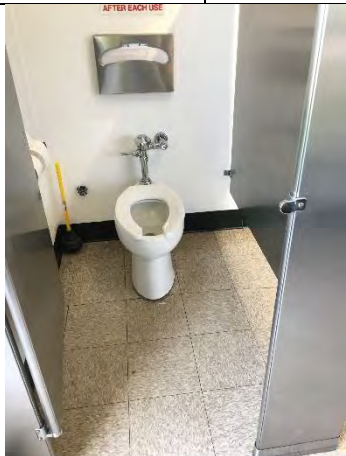
Toilet in driver restroom facility

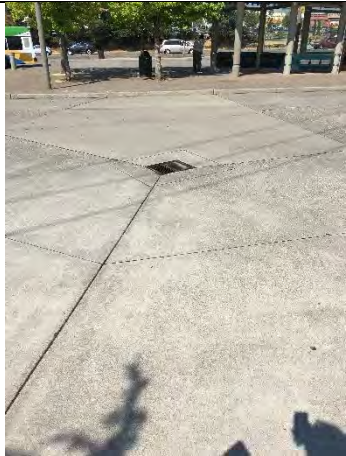
Storm water grate in bus driveway

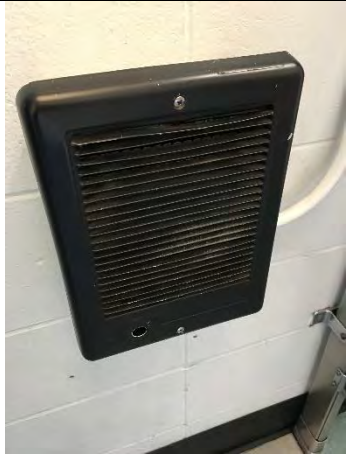
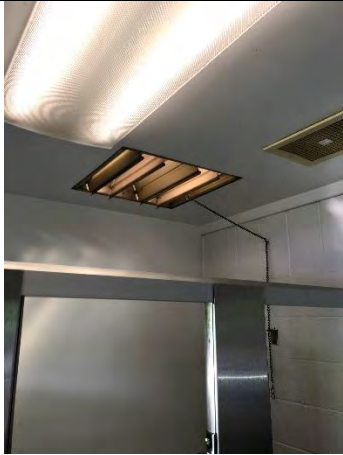
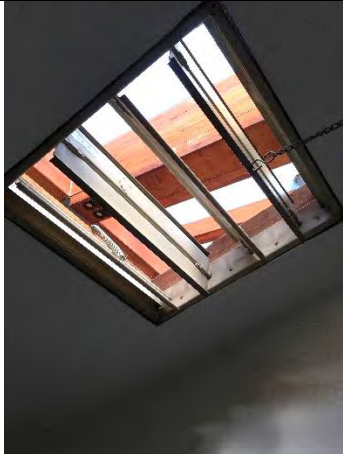
West restroom heater		Restroom facility exhaust fan and louvered vent		Restroom facility louvered ceiling vents

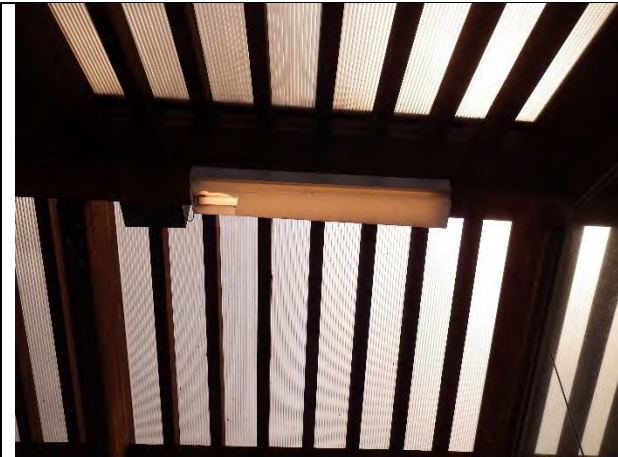
Utility building exterior lights	Utility building exterior lights	Utility building exterior lights

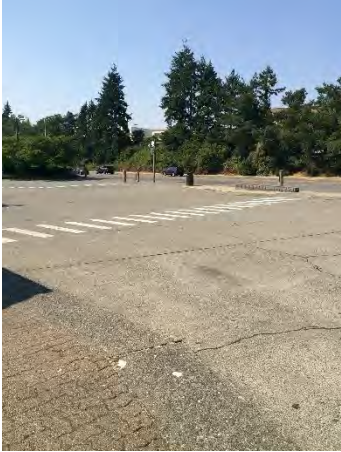
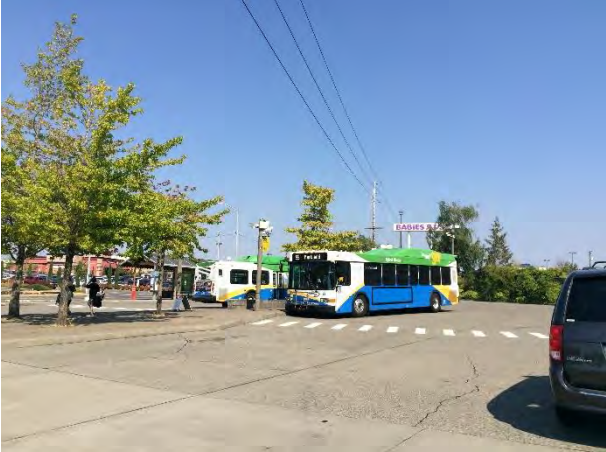
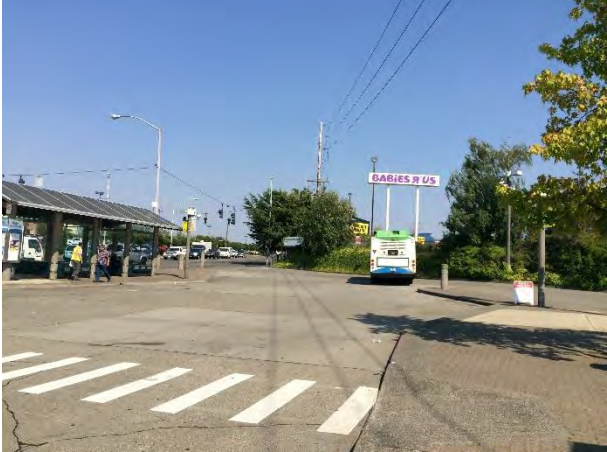
Pedestrian crosswalks from street sidewalk to bus island		Buses on both sides of bus island		Pedestrian crosswalk to utility building

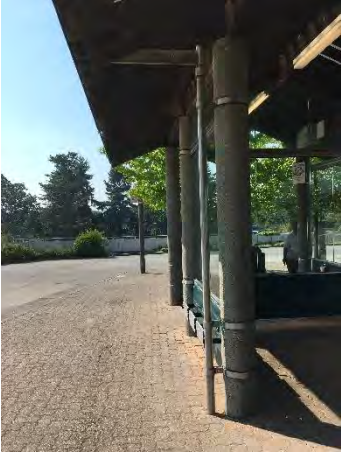
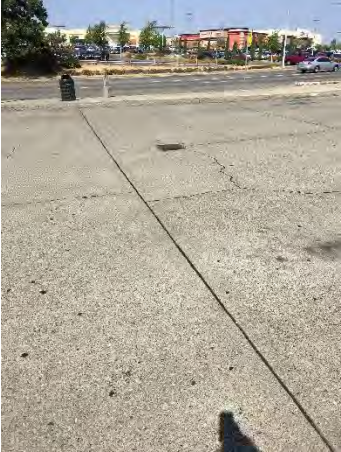
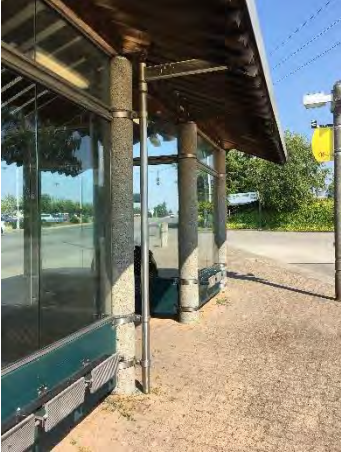
<p>Pedestrian waiting area pavers are in good condition</p>	<p>Concrete panels with some cracking</p>	<p>Pedestrian waiting area pavers are in good condition</p>

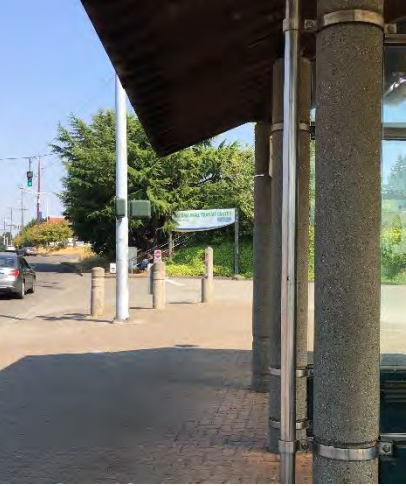
<p>Bollards near bus entrance/exit</p>

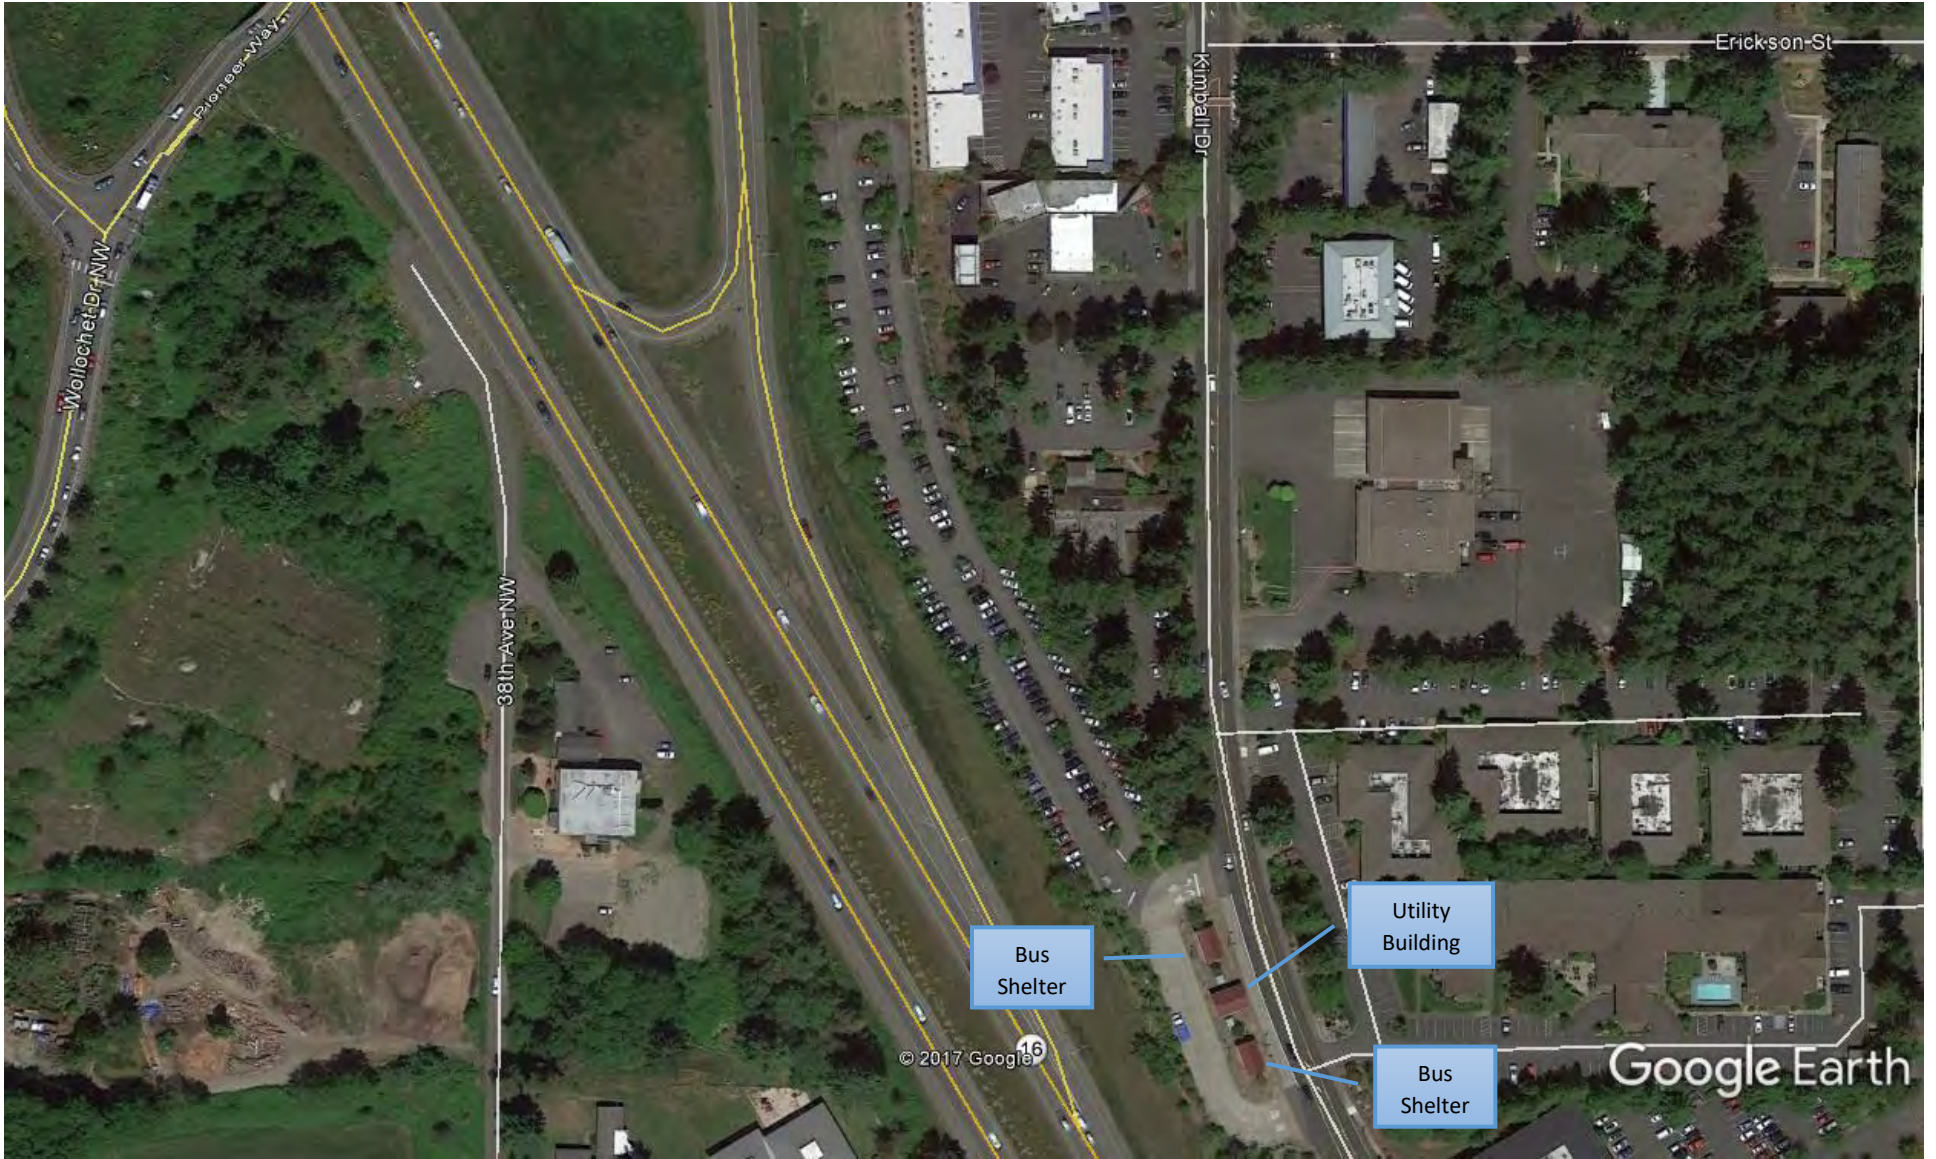
Facility Condition Assessment

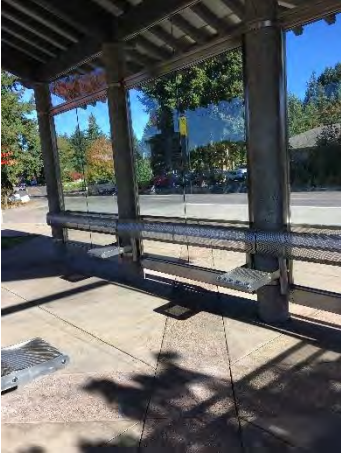
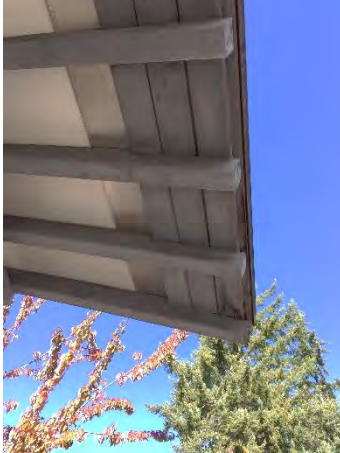
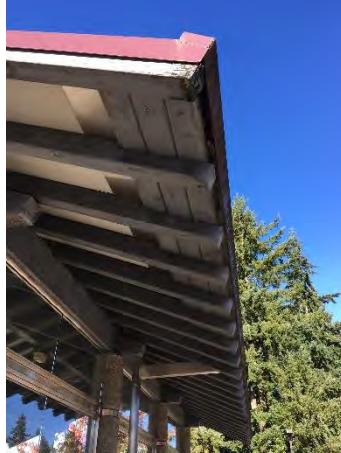
Interior of bus shelter	Gable ends of bus shelter	Edge of bus shelter roof, showing metal flashing and downspout

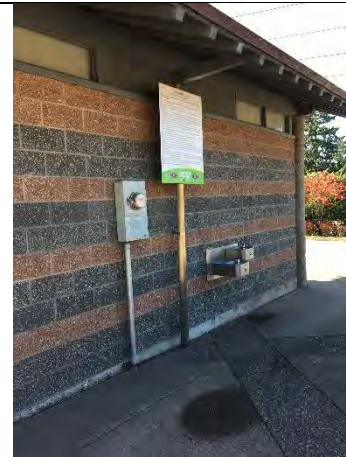
Utility meter and water fountain on utility building

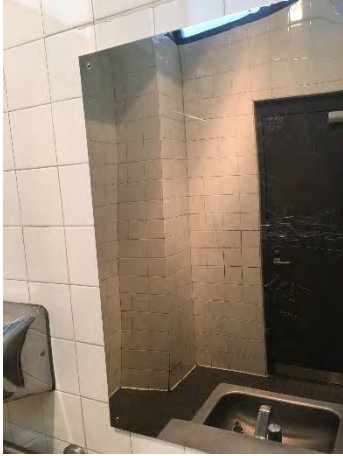
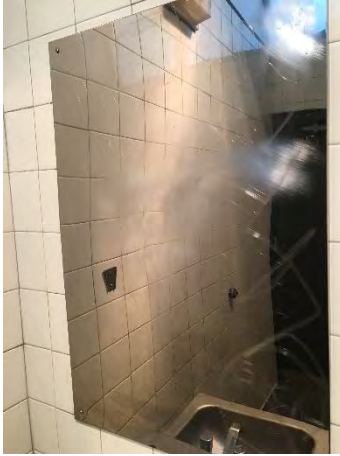
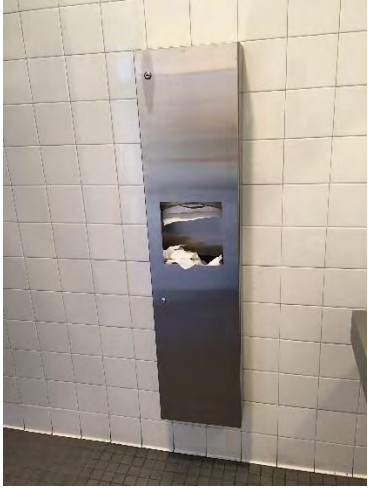
Public restroom mirror is scratched		Public restroom mirror is scratched		Driver restroom paper towel dispenser and trash

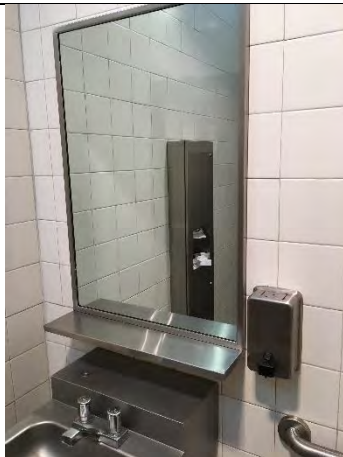
Driver restroom mirror and shelf

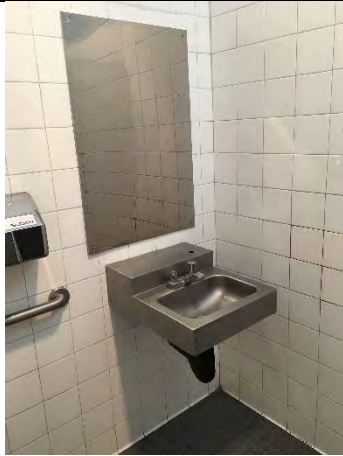
Sink and mirror in public restroom

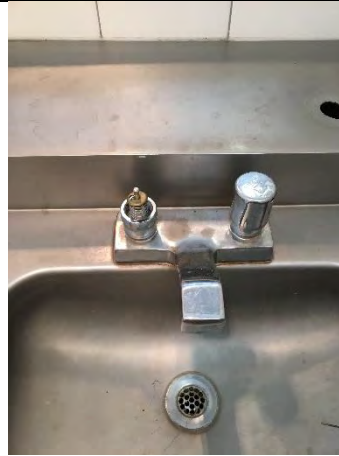
South restroom with missing faucet knob

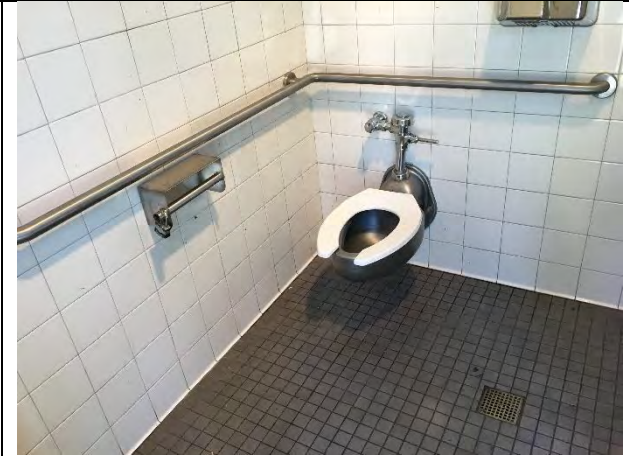
Toilet in public restroom

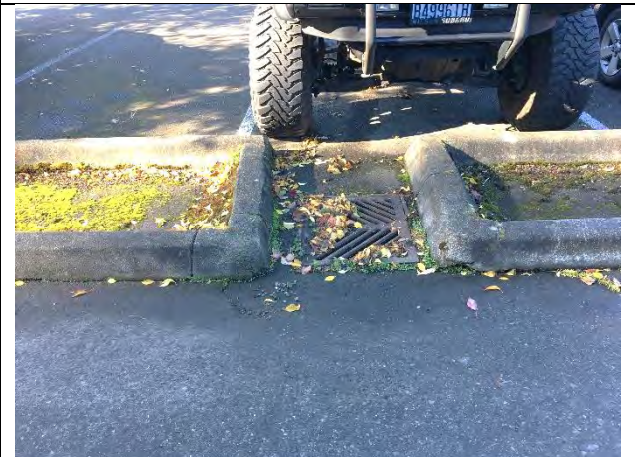
Storm grating in parking area

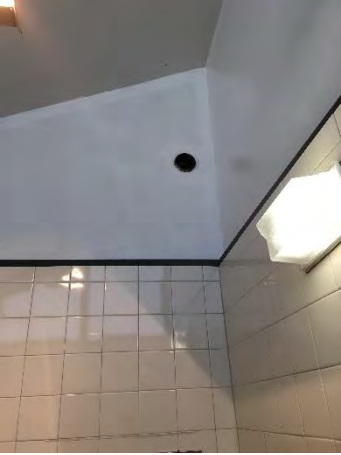
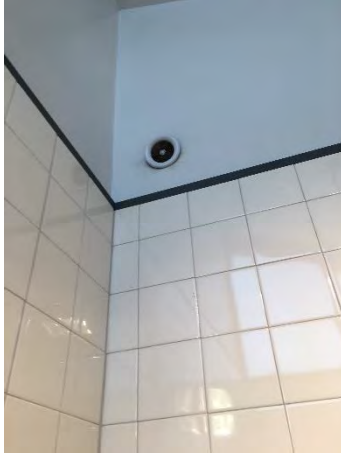
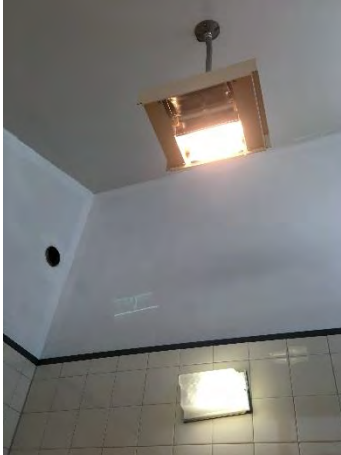
Ventilation fan vent with missing cover in public restroom		Ventilation fan vent in driver restroom		Radiant heater with one bulb out

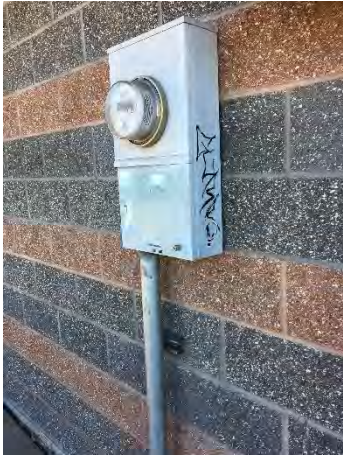
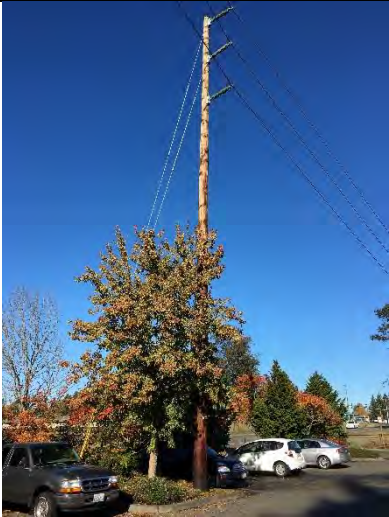
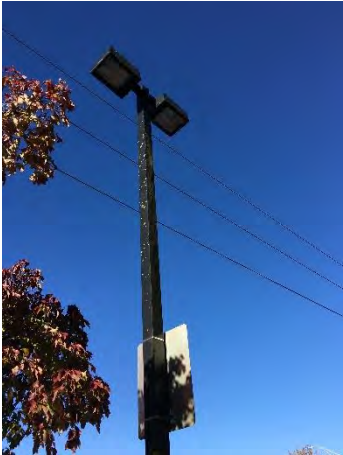
Utility meter with graffiti		High voltage transmission lines over site		Site lighting

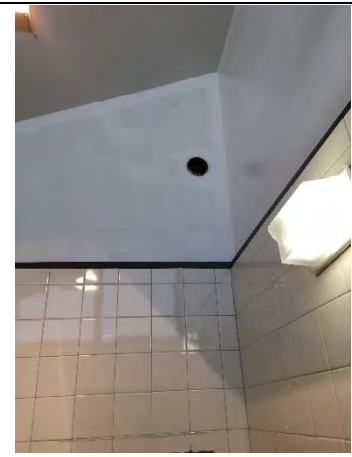
Public restroom light with broken diffuser

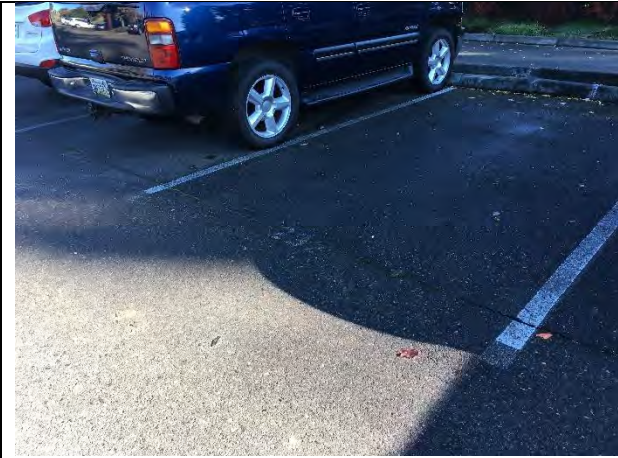
Parking striping and numbers in need of repainting

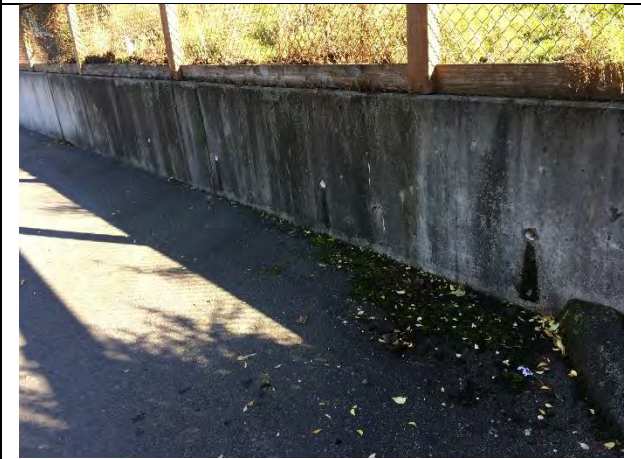
Retaining wall with relief drains
