Pierce Transit Facilities Condition Assessment Report

Prepared for

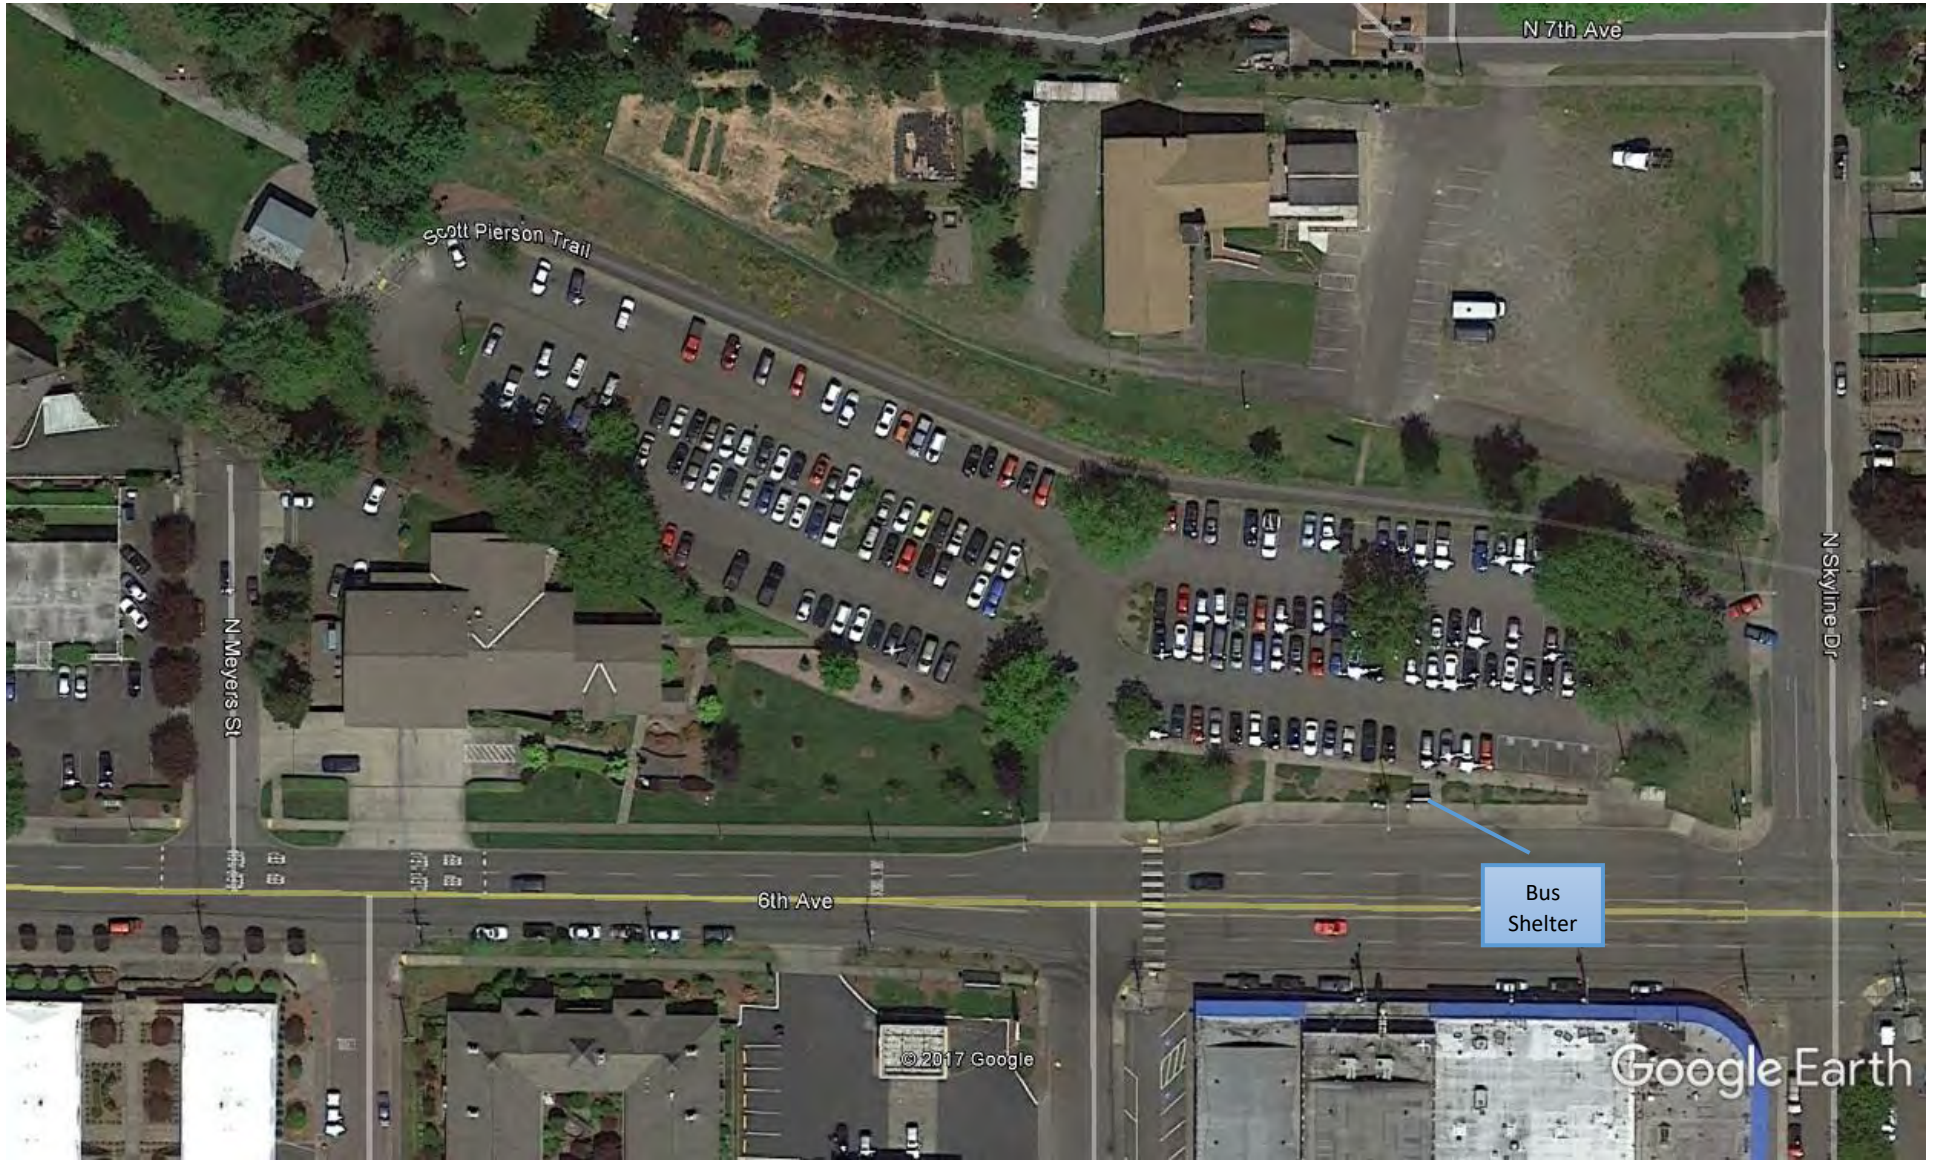
Facility Condition Assessment

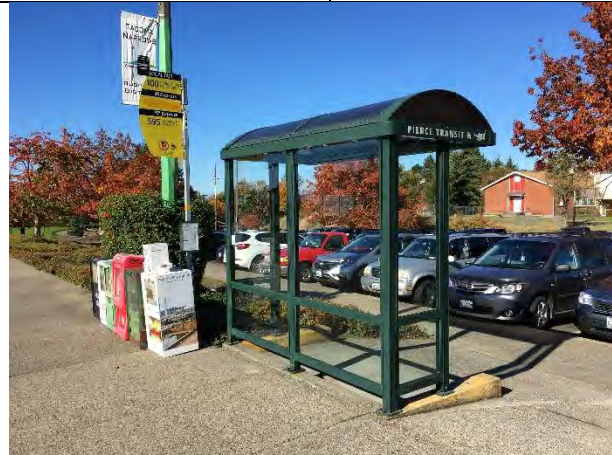
Bus Shelter on 6th Avenue

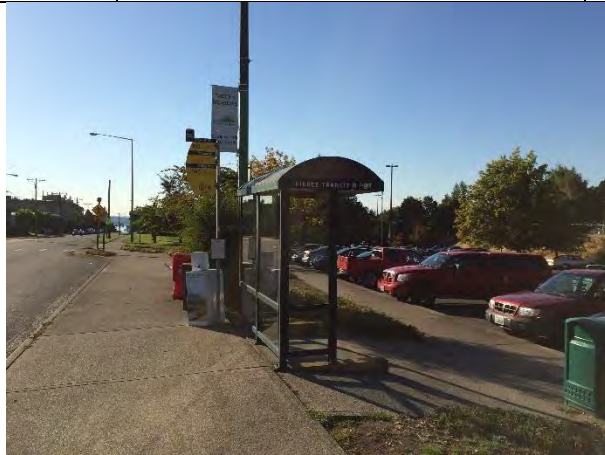
Bus shelter and waiting area

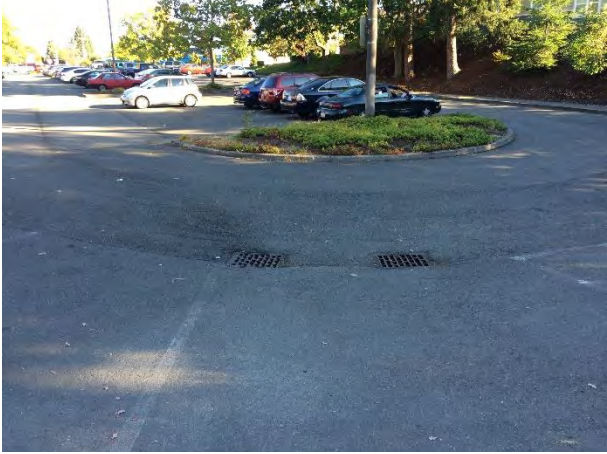
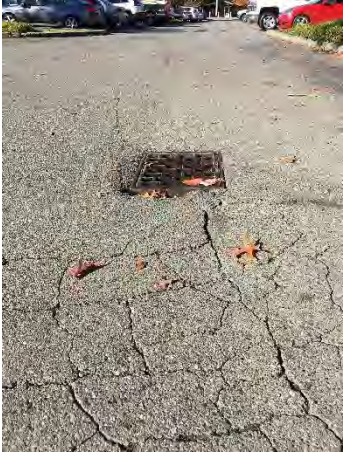
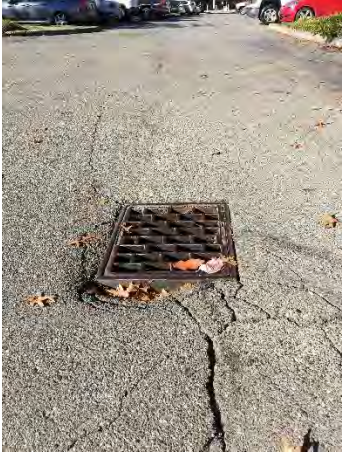
Storm Drain grates at bottom of parking lot in turn-around in front of Memorial Park entrance		Storm drains at upper part of parking lot.		Storm drains at upper part of parking lot.

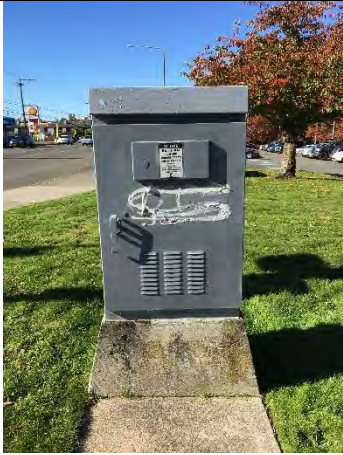
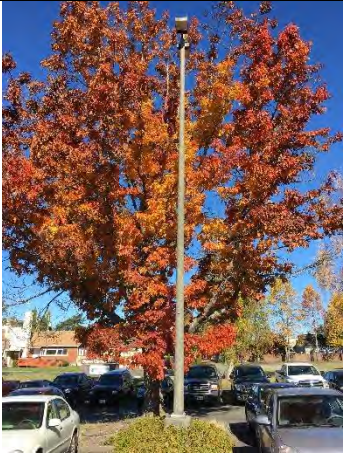
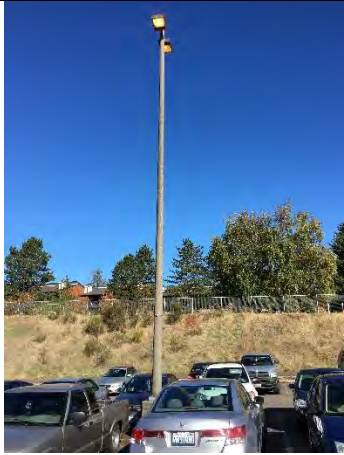
Electrical cabinet has graffiti		Site light pole		Site light is on during daytime hours

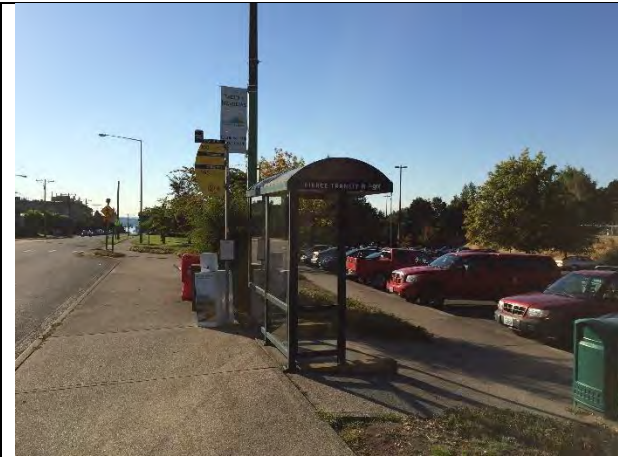
Bus pull-out asphalt paving and concrete sidewalk

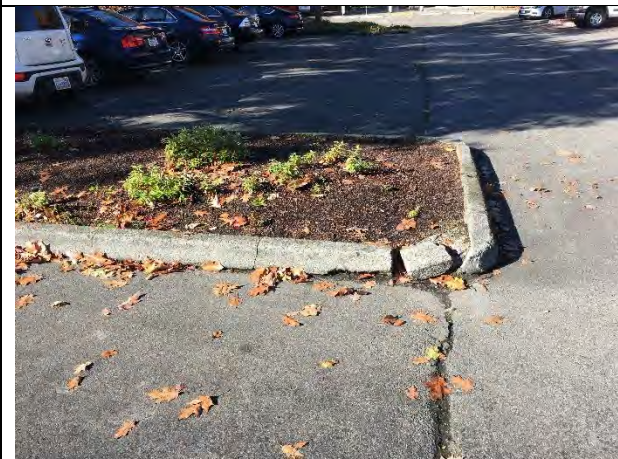
Broken curb and cracked asphalt

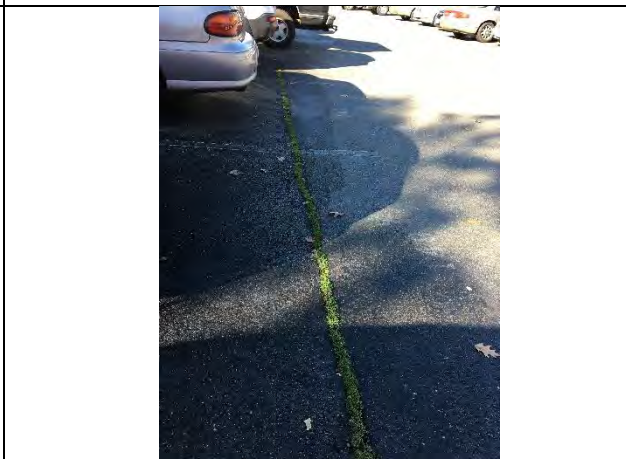
Cracked asphalt with plant growth

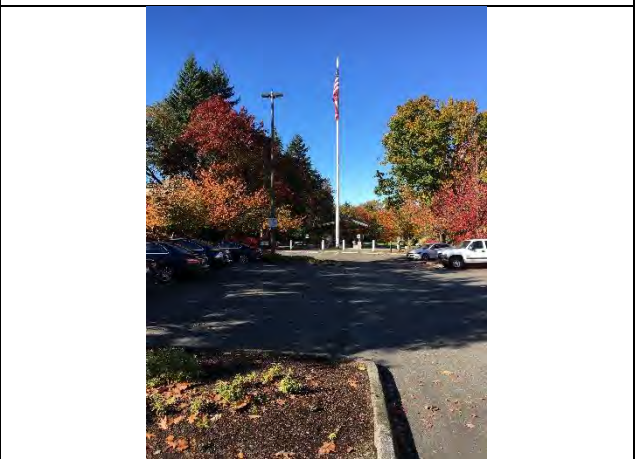
Landscaping and parking area on west end

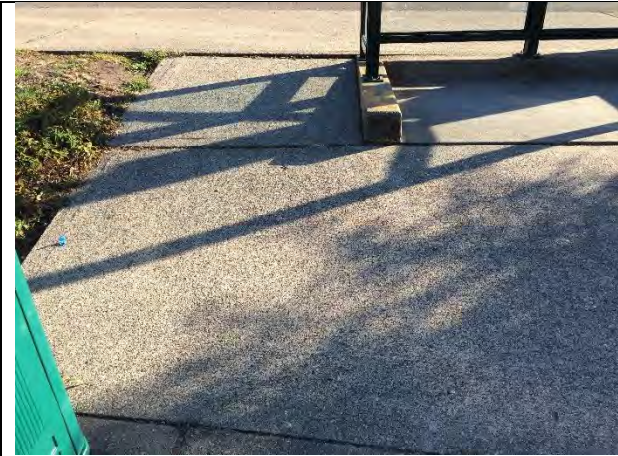
Bus shelter concrete in good condition

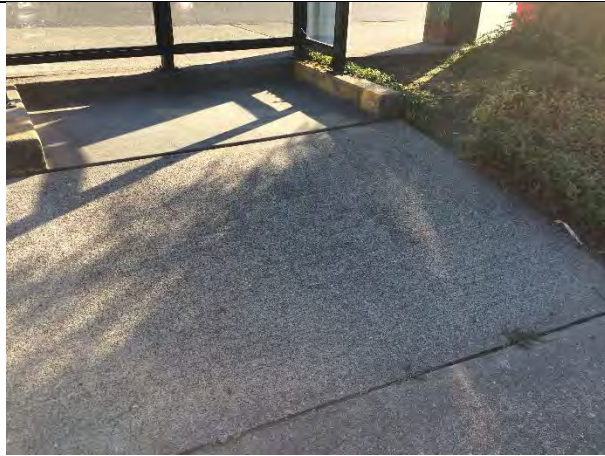
Bus shelter concrete in good condition

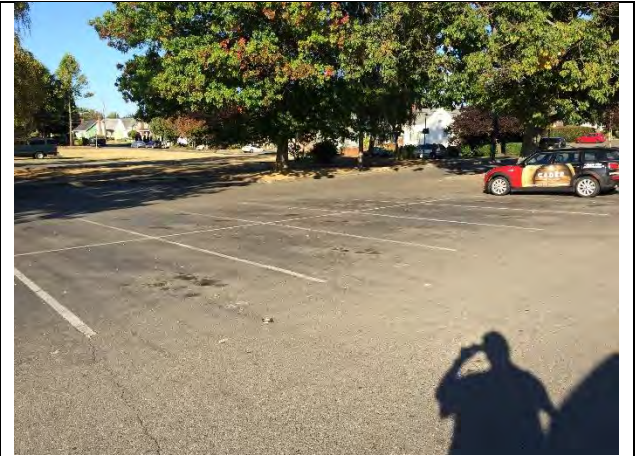
Parking lot striping and numbers are fading

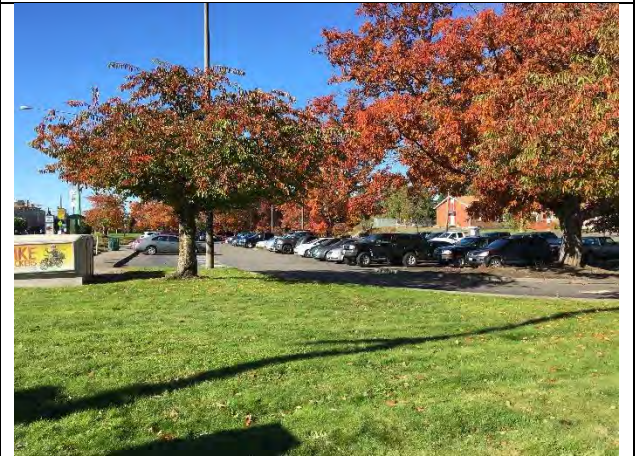
Grass area on east side of parking lot

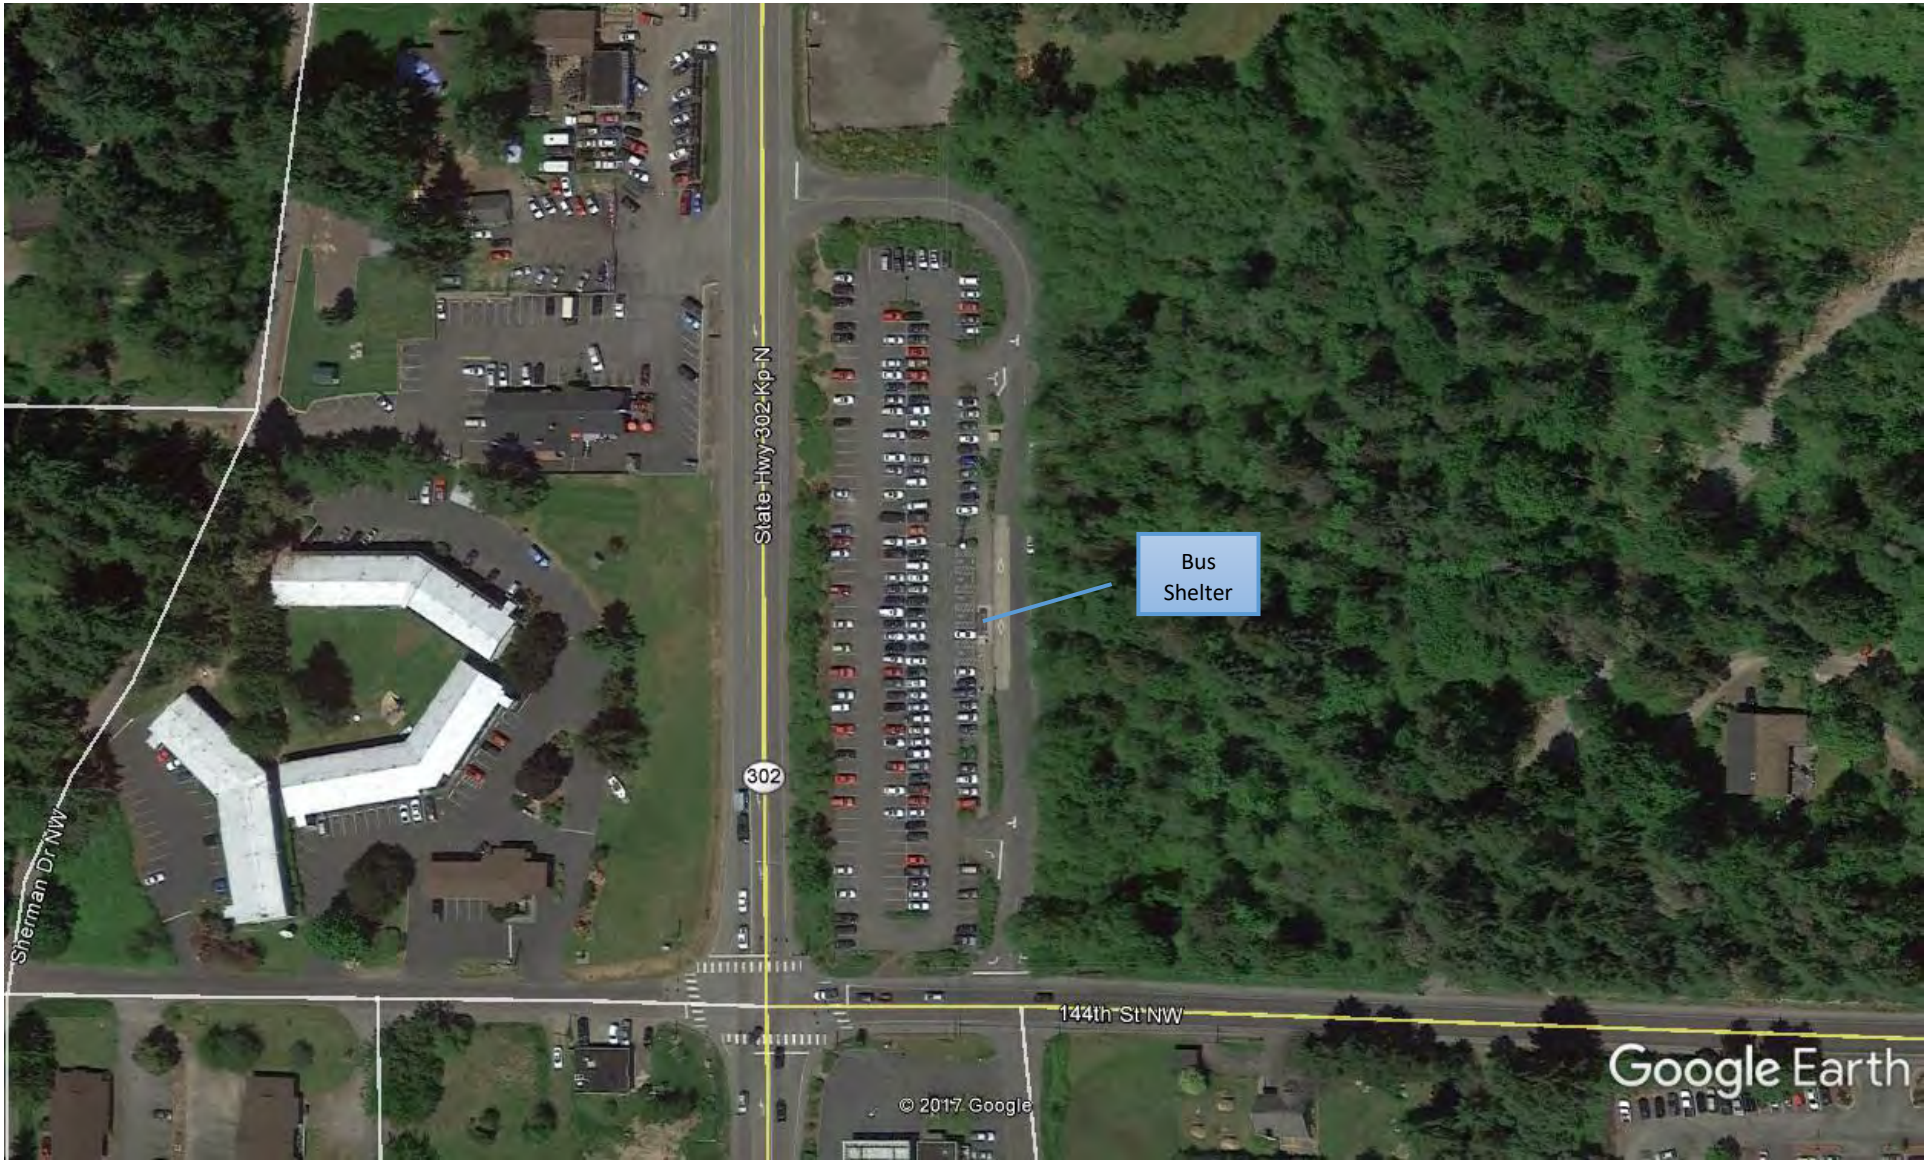
Facility Condition Assessment

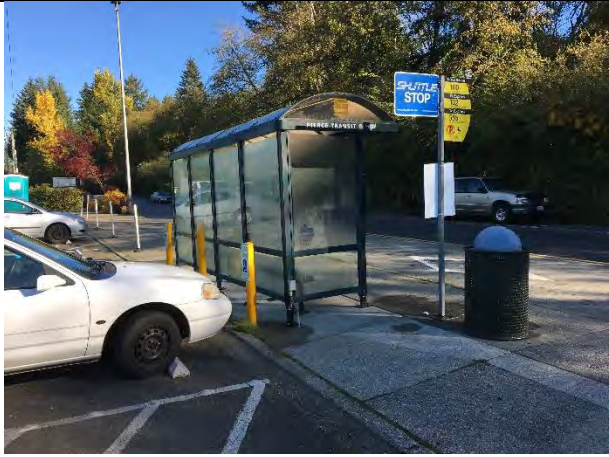
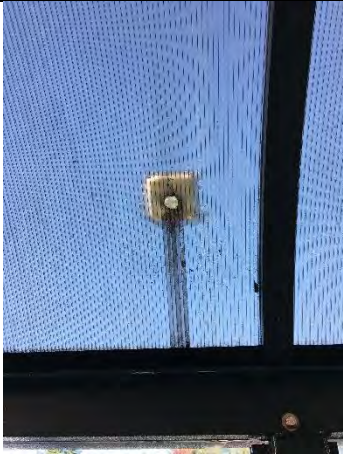
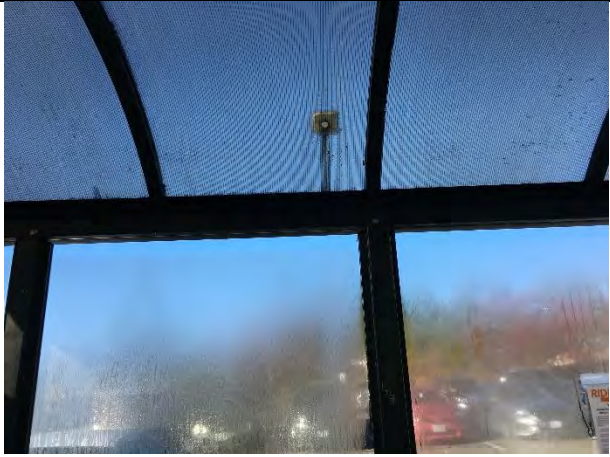
Bus shelter		Hole in bus shelter roof	Bus shelter roof panels

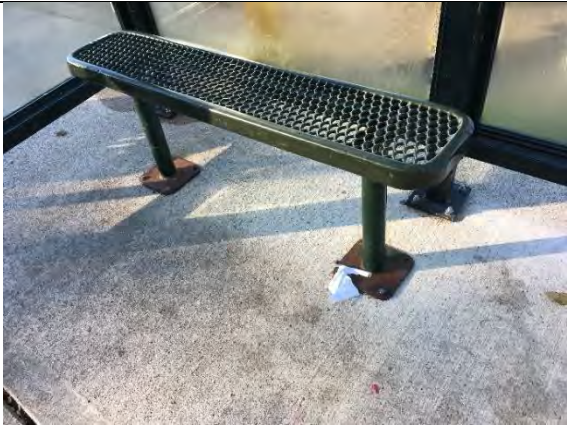
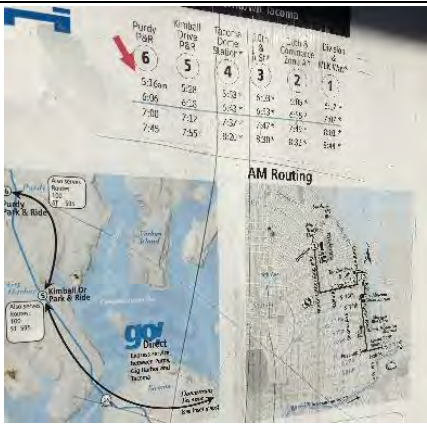
Bus shelter bench		Bus map cabinet with scratched plexiglas

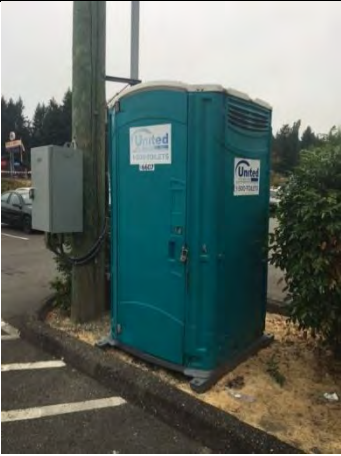
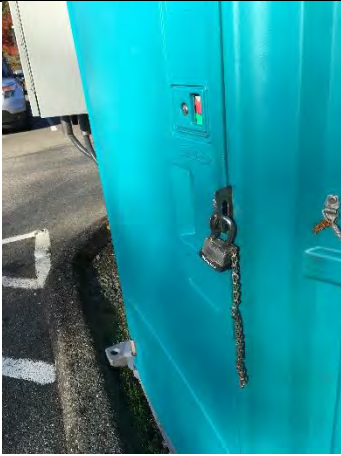
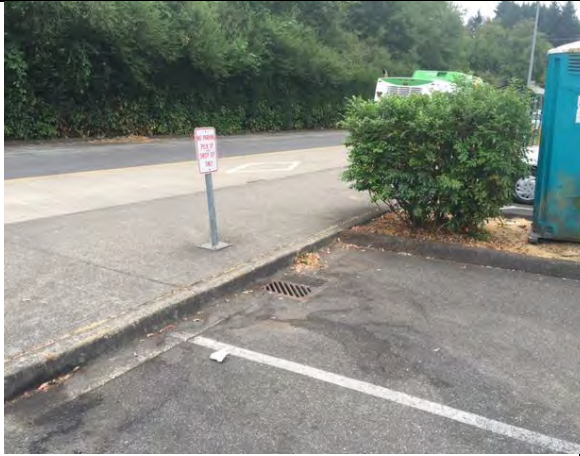
Portable restroom		Portable restroom lock		Stormwater catch basin

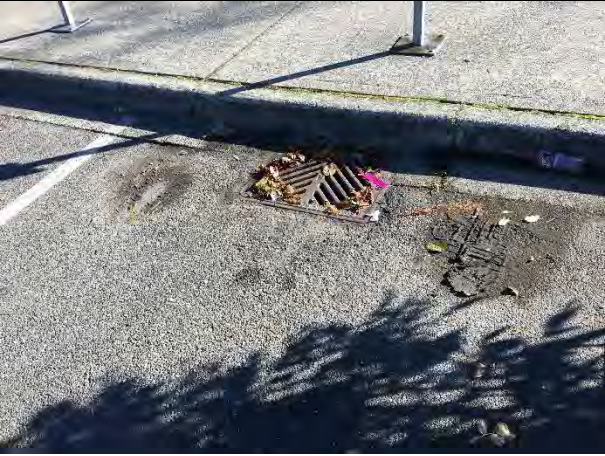
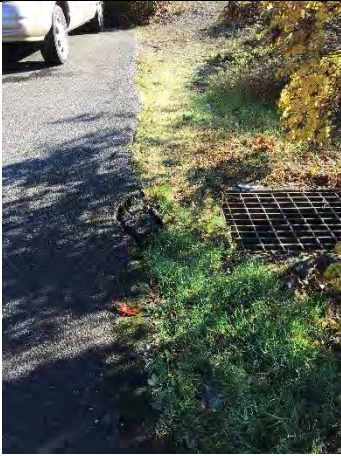
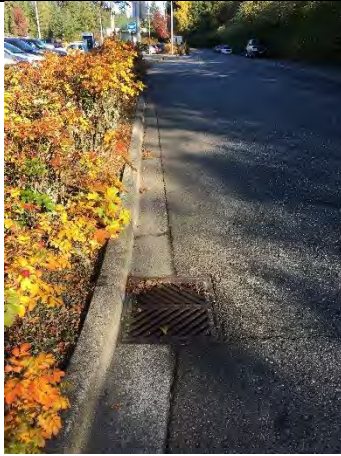
Stormwater catch basin		Stormwater draignage basin		Stormwater catch basin

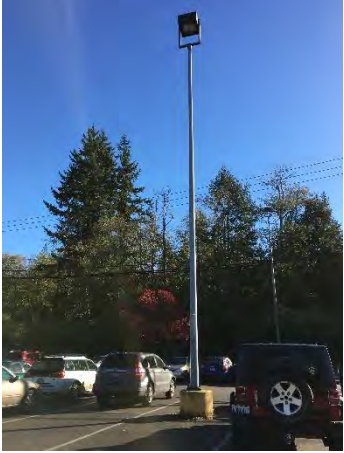
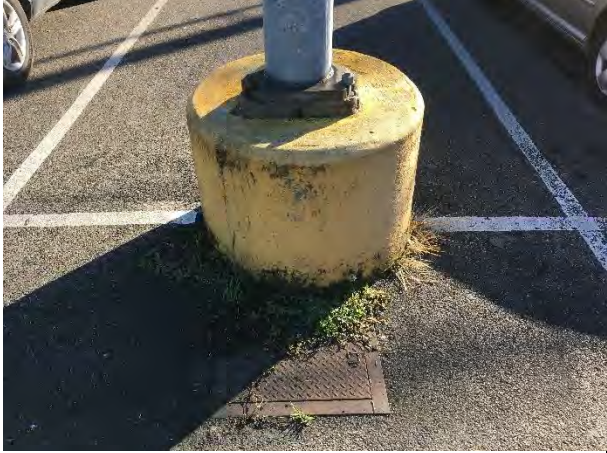
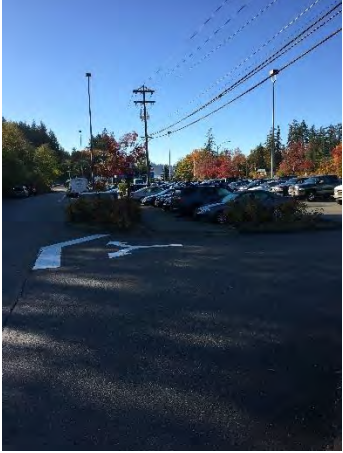
Parking lot lighting		Parking lot lighting		Parking lot lighting

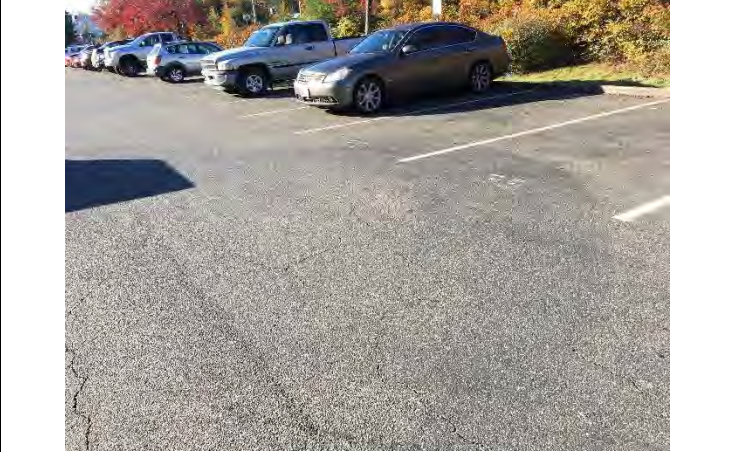
<p>Driveway entrance from the north</p>	<p>Parking stall numbers are fading</p>	<p>Asphalt cracks with previous seal repair</p>

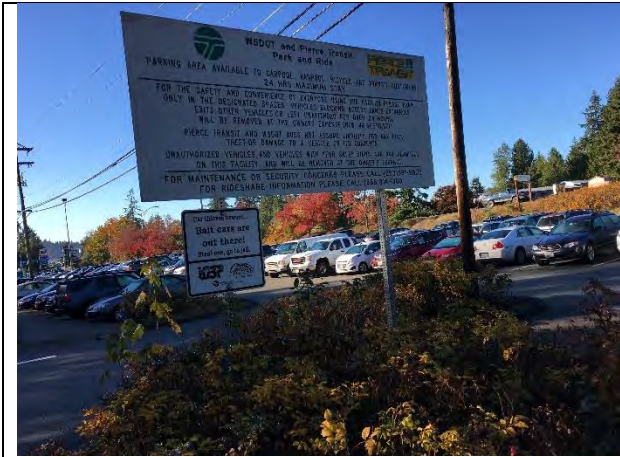
WSDOT signage on-site

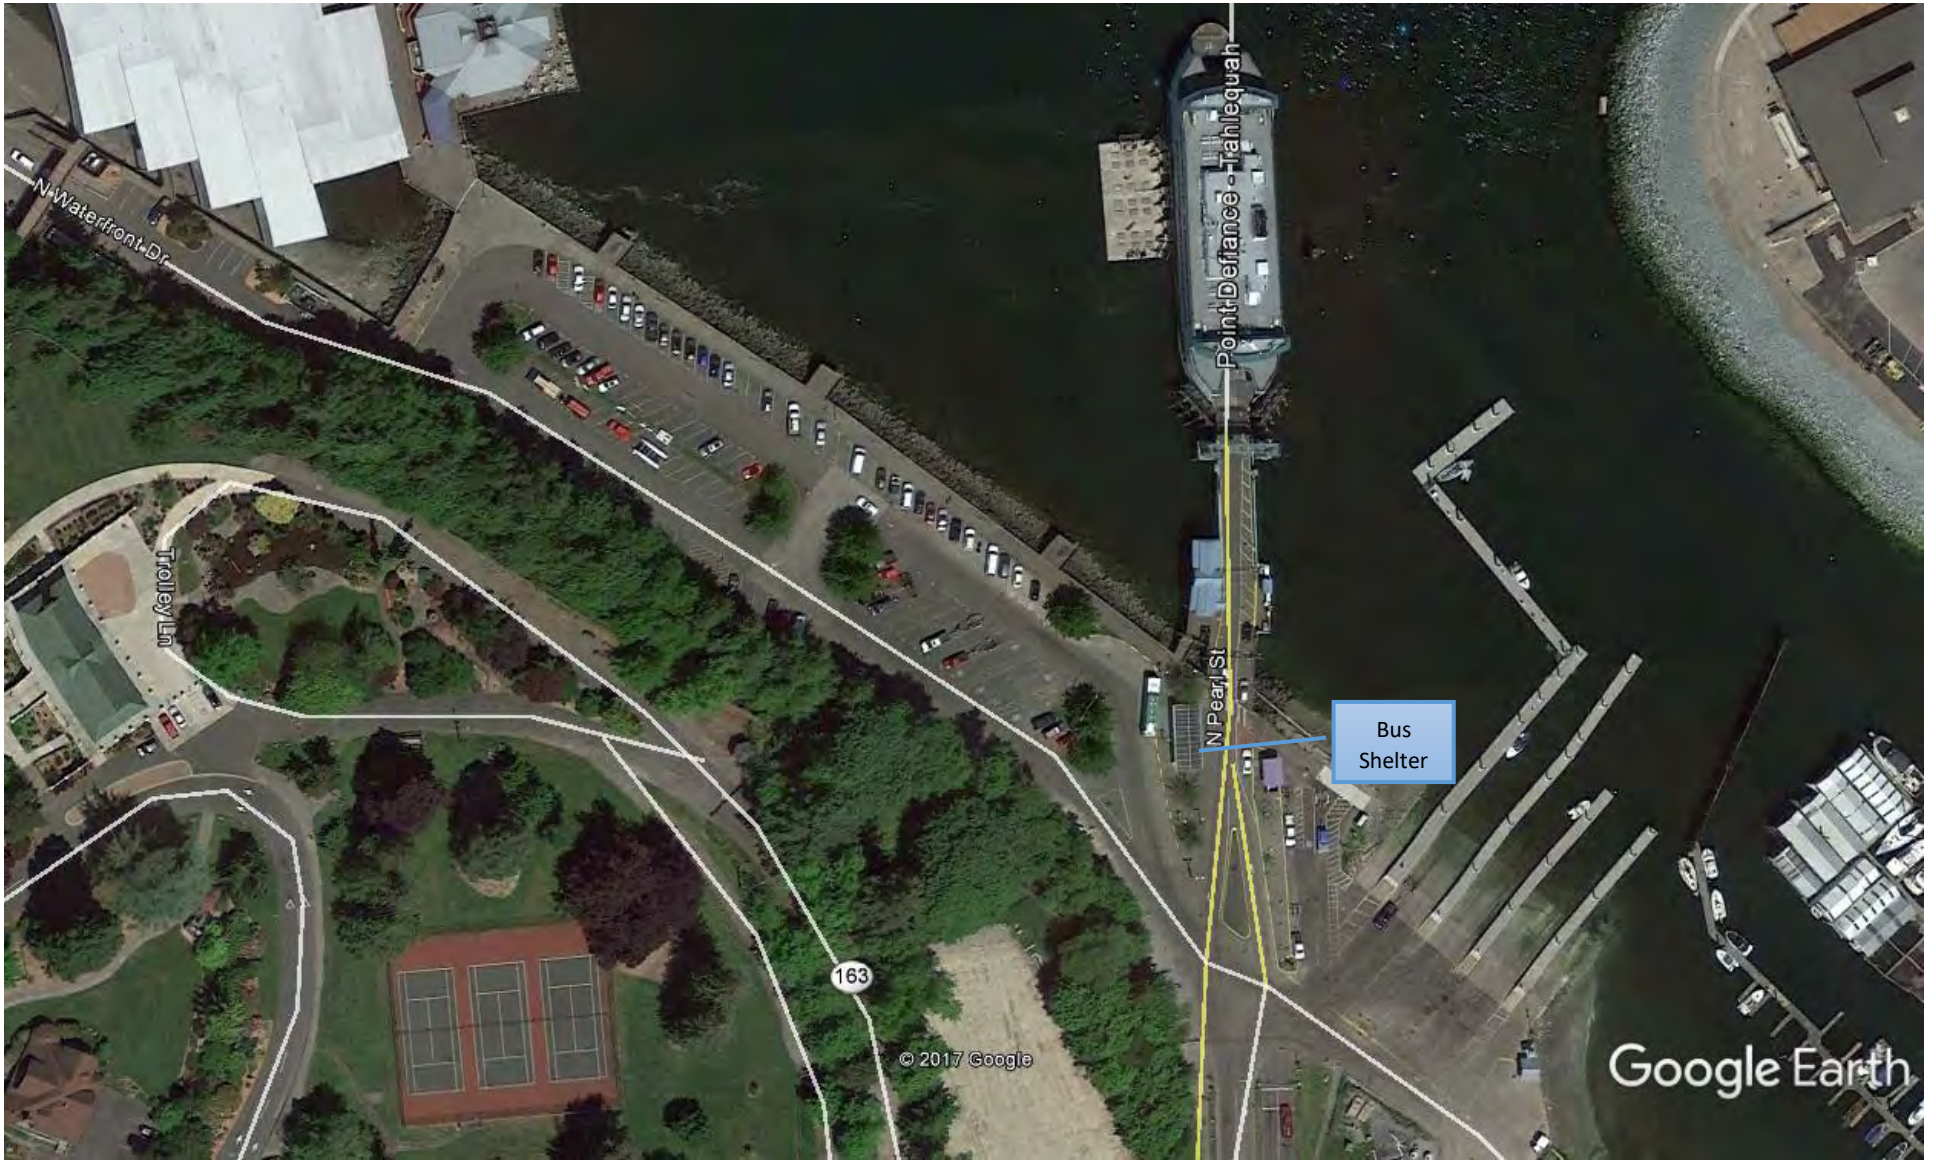
Facility Condition Assessment

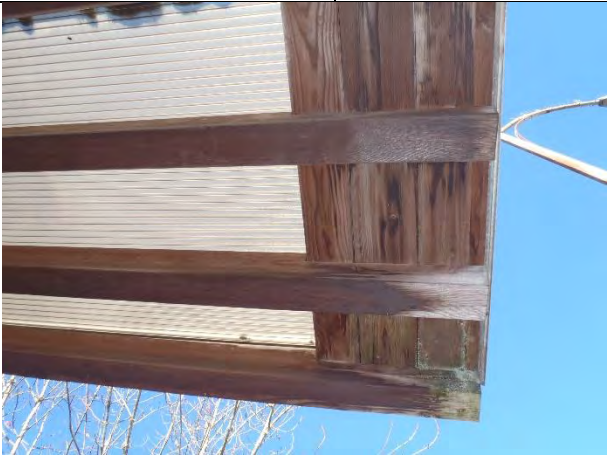
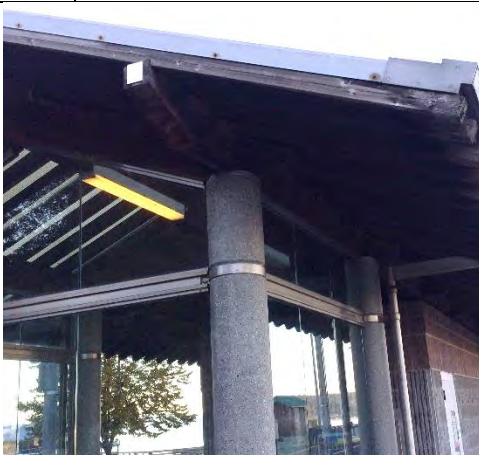
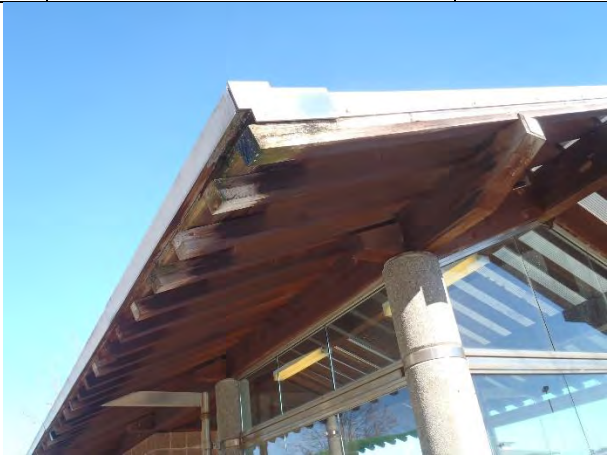
Underside of water damaged rafters		Southeast corner of bus shelter, showing rotted rafter end		Southwest corner of bus shelter

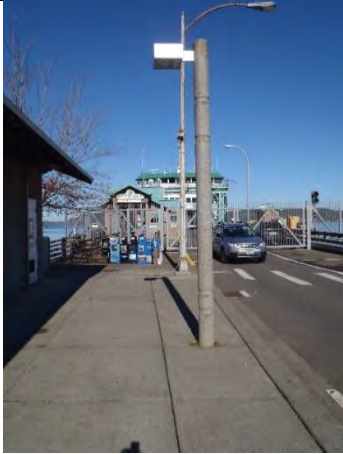
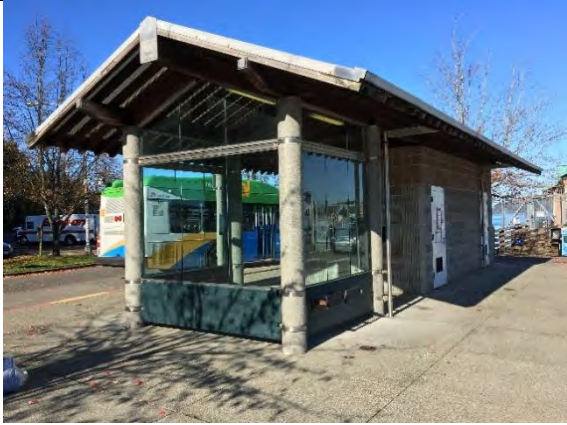
Pole mounted light on east side of building		South side of bus shelter, showing lights

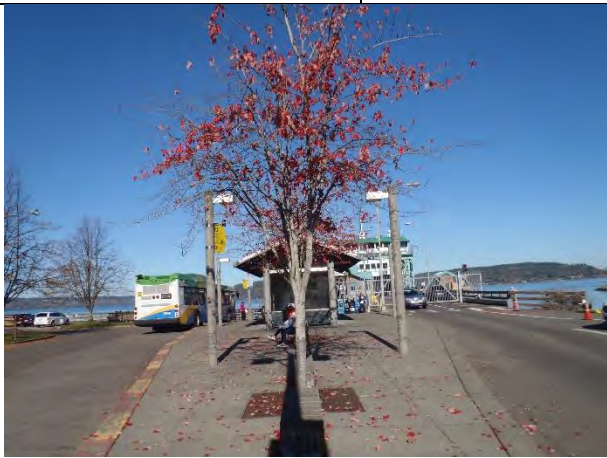
Tree landscaping on south side of facility

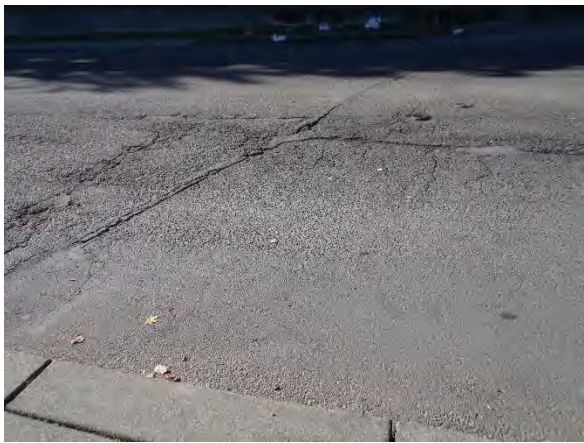
Asphalt near concrete paving needs repair

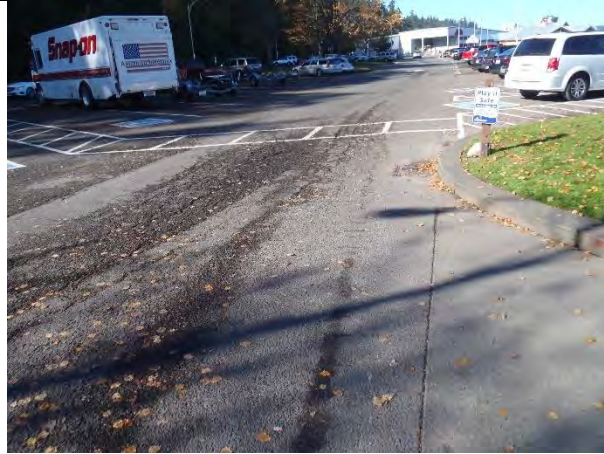
Looking West into Metro Parks parking area

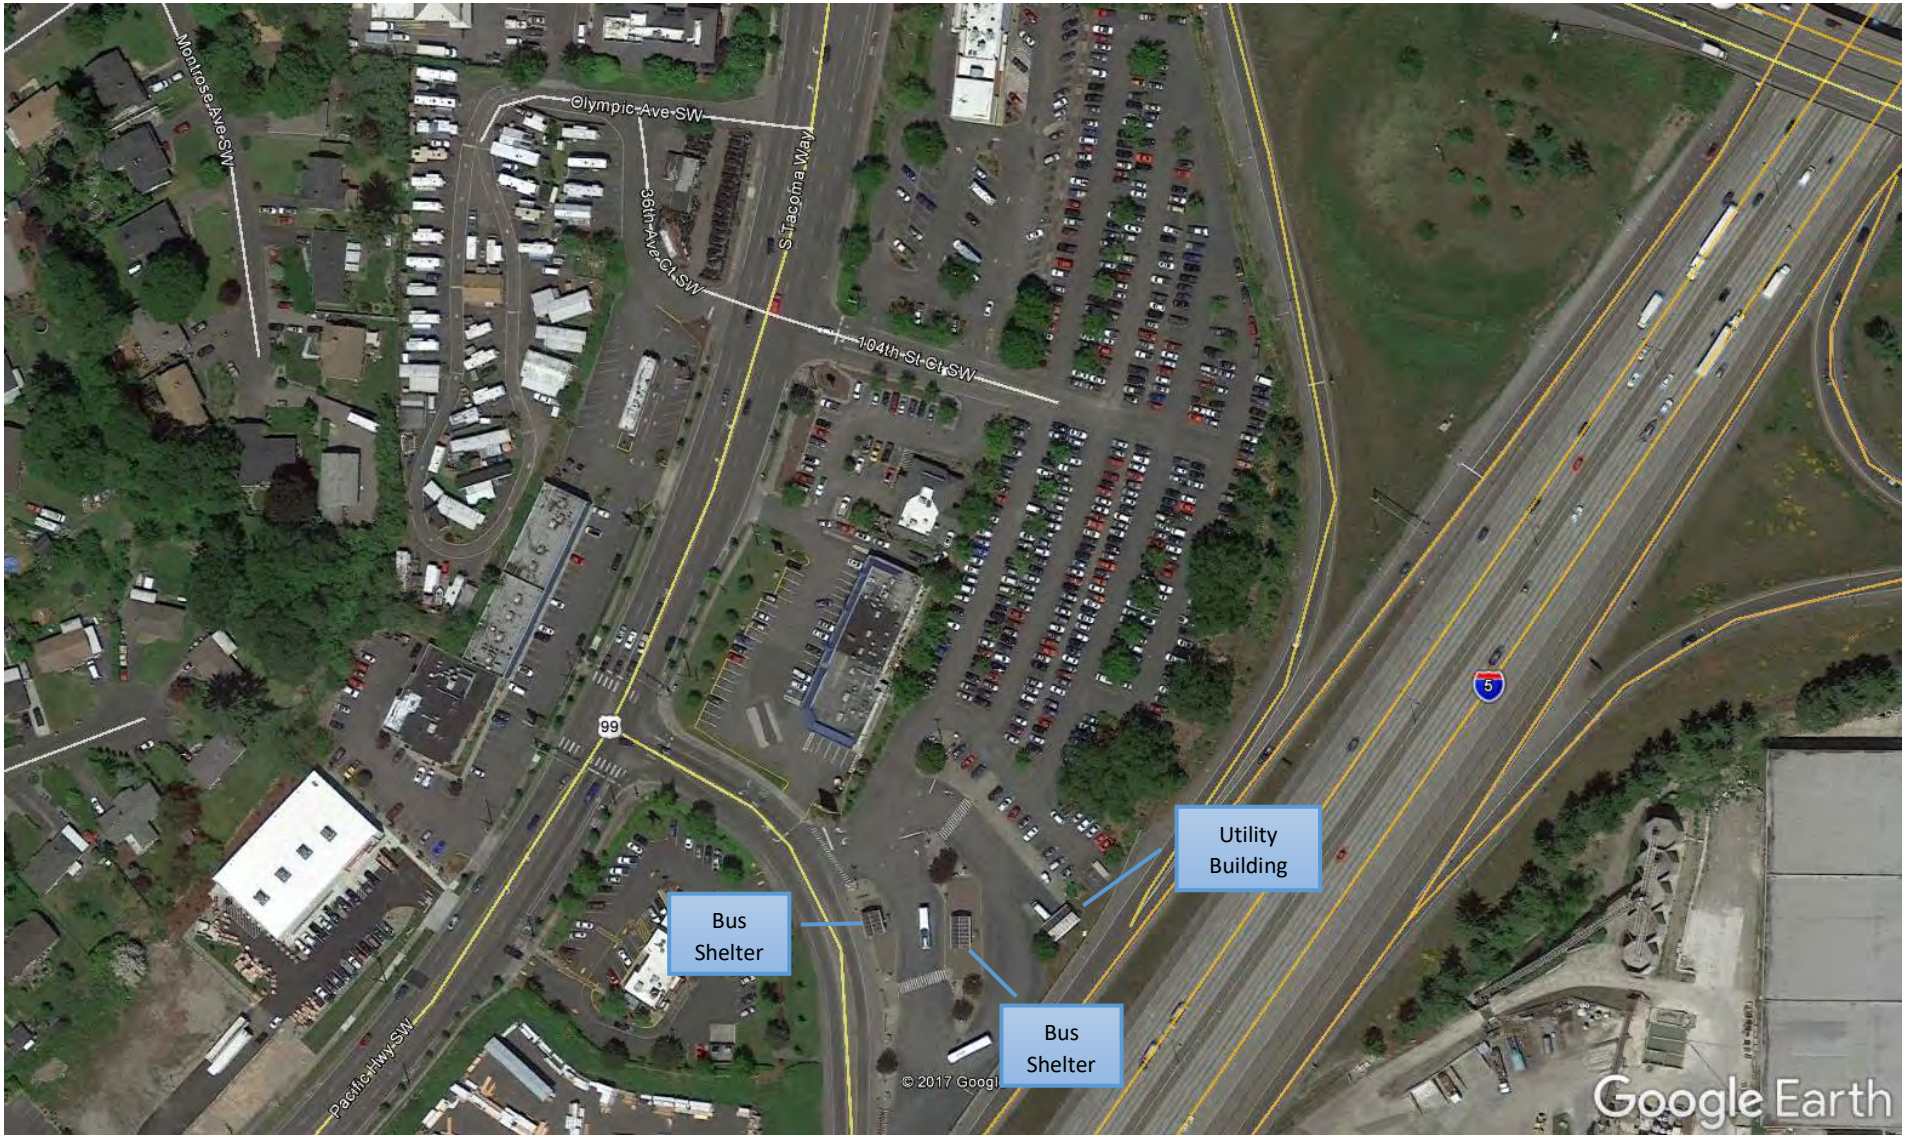
Facility Condition Assessment

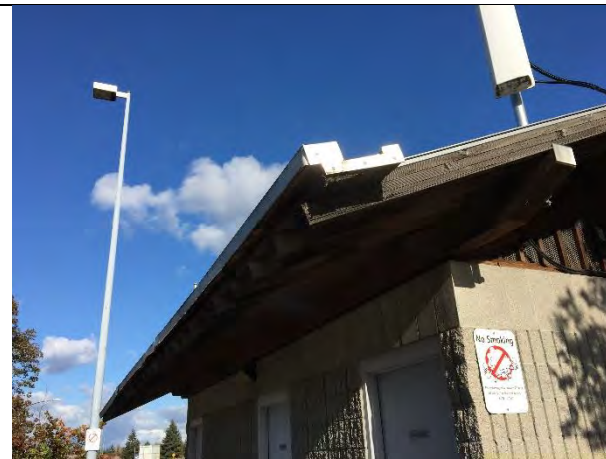
Utility building showing gutters with no downspouts

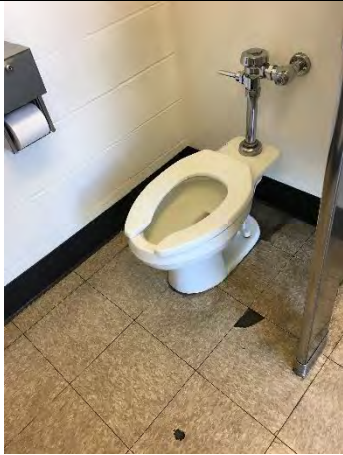
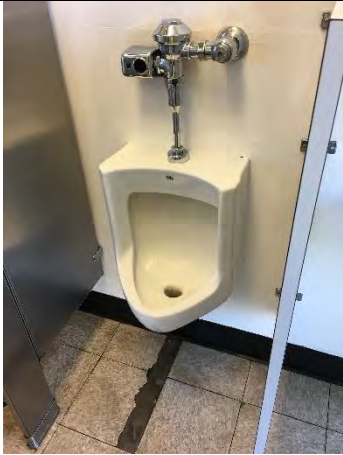
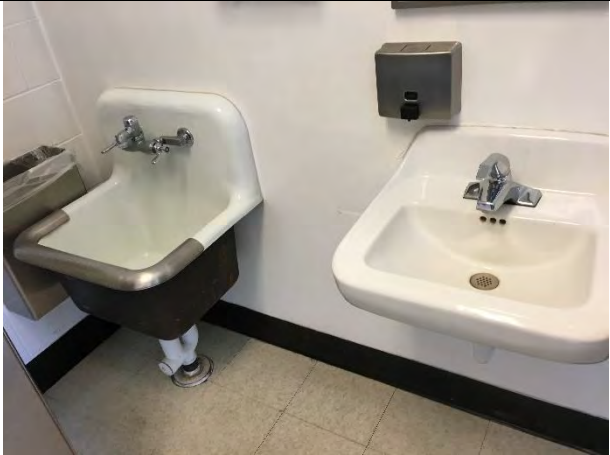
Men's restroom has damaged vinyl flooring		Men's restroom has damaged vinyl flooring		Women's restroom sink and mop sink

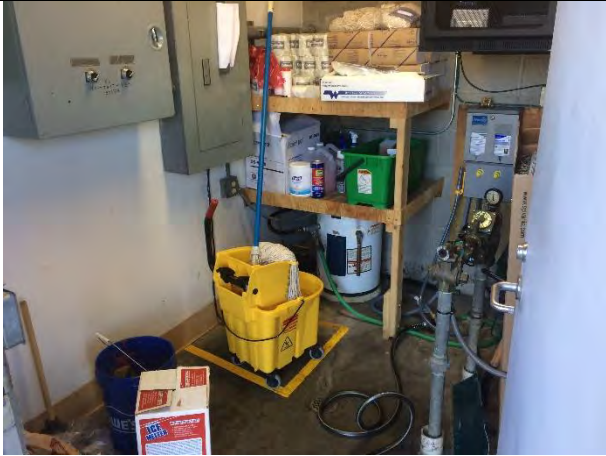
Valves and controls in utility room in utility building

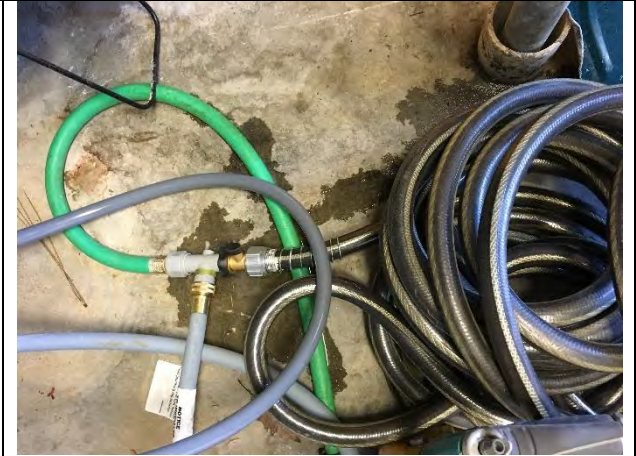
Hose bib connection in utility room

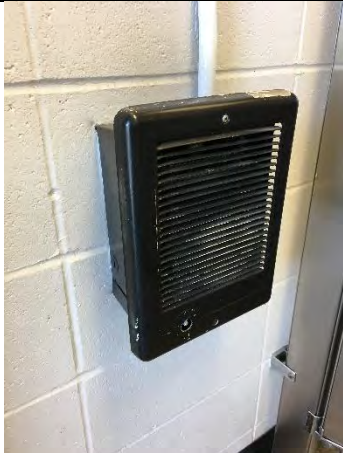
Men's Restroom heater – missing thermostat knobs

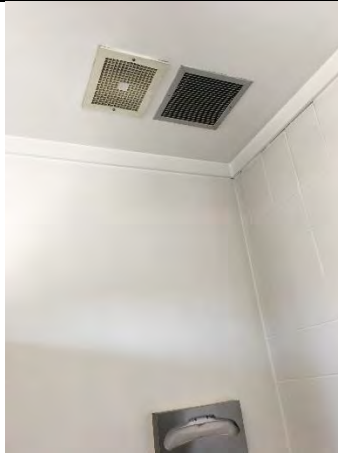
Exhaust fans in restrooms

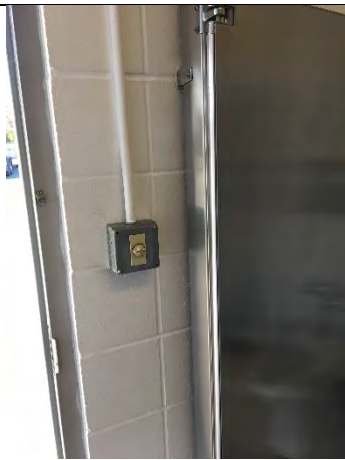
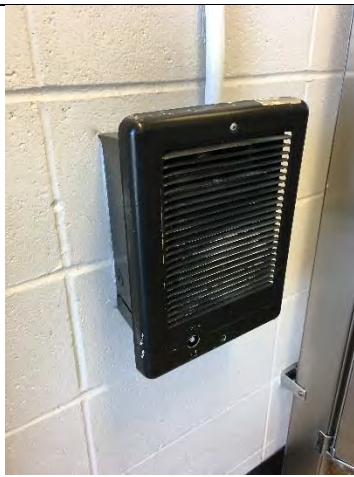
Exhaust fan timer control knob	Women's restroom heater – missing thermostat knob

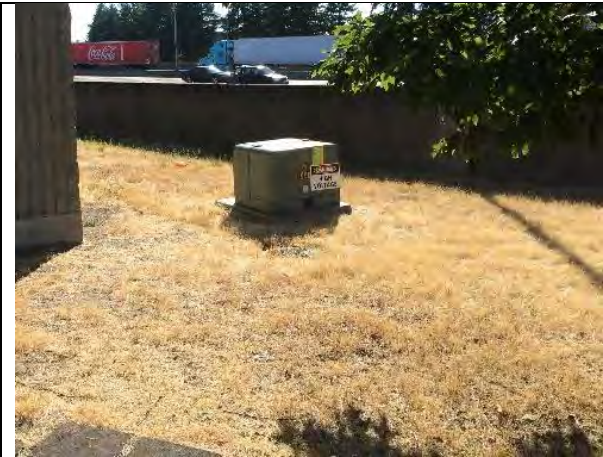
Communications and Security	Security cameras.	Cameras were observed in several locations on site and appear to be in good condition.	4.0	None	N/A

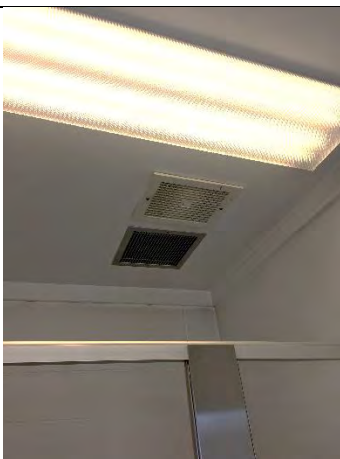
Restroom fluorescent tube lighting

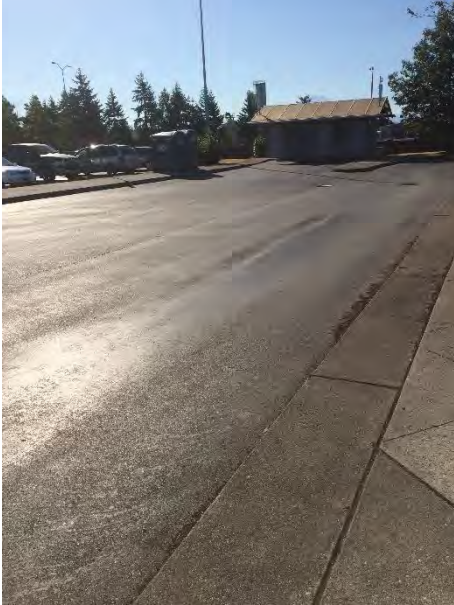
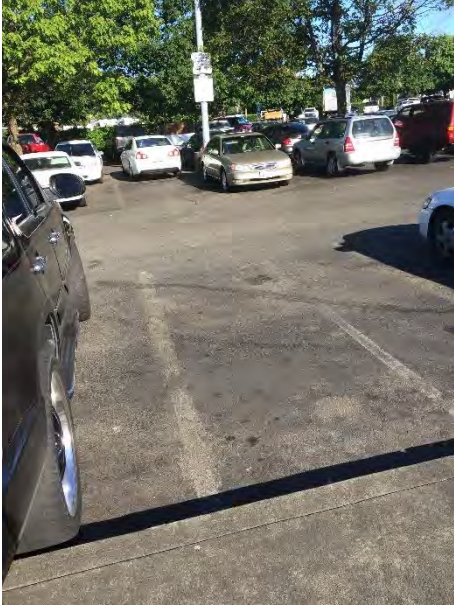
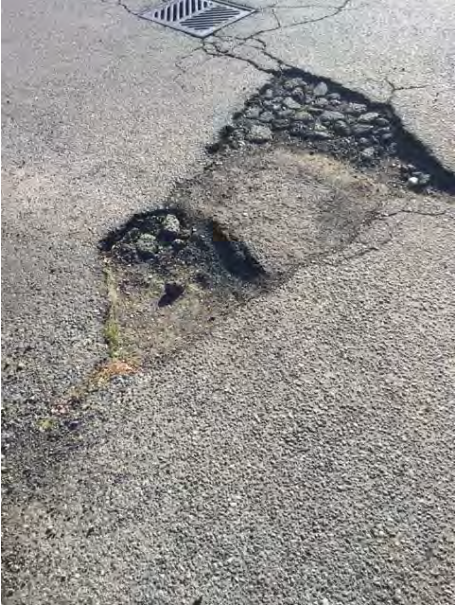
Main roadway		Faded striping in parking area		Parking lot sub base failure
