FACILITY CONDITION SUMMARY

Pierce Transit
3701 96th Street Southwest
Lakewood, Washington 98499
W. Duane Wakan

All Property Summary

May 4, 2022

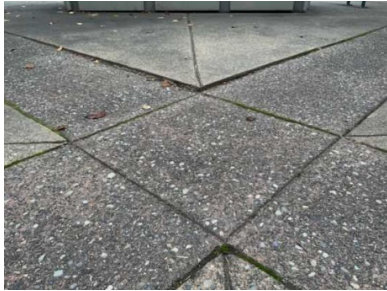
Sidewalk in Poor condition.

Concrete, Large Areas
Kimball Drive Park and Ride Lot Bus Island

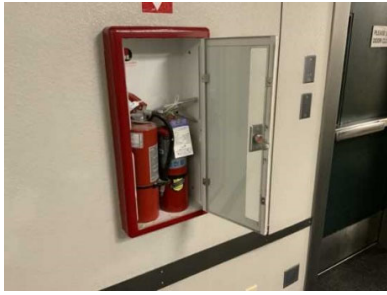
Fire Extinguisher in Poor condition.

Wet Chemical/CO2
Commerce Street Transfer Facility Throughout building

Last inspected in September 2020. Past annual inspection date. - AssetCALC ID: 3420255

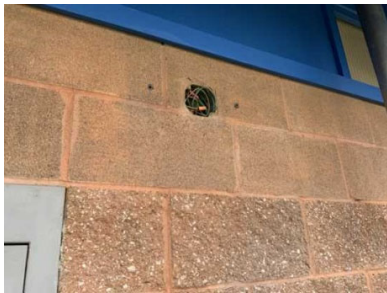
Standard Fixture w/ Lamp in Poor condition.

LED Replacement, 100 W
South Hill Mall Transit Center Comfort Station

Missing light fixtures with exposed wires. - AssetCALC ID: 3437305

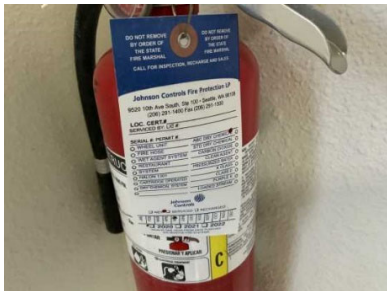
Fire Extinguisher in Poor condition.

Wet Chemical/CO2
Building 6 - Vanpool Throughout building

Last inspected May 2020. Internal maintenance inspection is current. - AssetCALC ID: 3397270

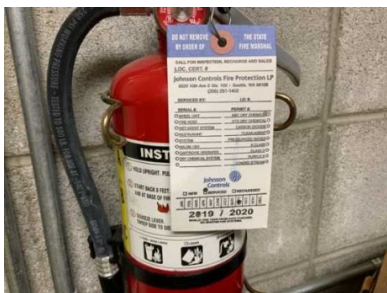
Fire Extinguisher in Poor condition.

Wet Chemical/CO2
Tacoma Community College Transit Center Mechanical room

Inspection out of date - AssetCALC ID: 3373897

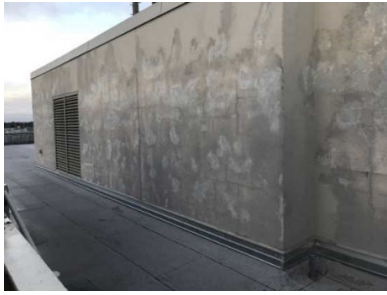
Exterior Walls in Marginal condition.

any painted surface, 1-2 Story Building
Building 4 - Administrative Offices Building
Exterior

Deterioration noted - AssetCALC ID: 3422079

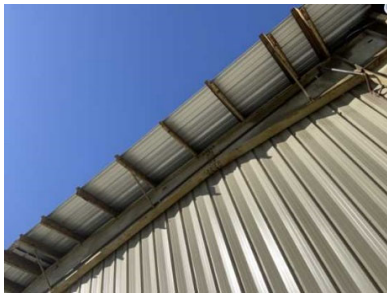
Roofing in Marginal condition.

Metal
Building 7 - West Base/Radio, Service
Supervisors Roof

Material has exceeded its estimated useful life. - AssetCALC ID: 3325806

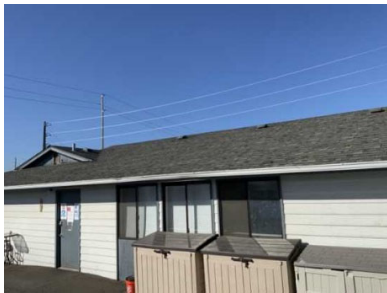
Roofing in Marginal condition.

Asphalt Shingle, 30-Year Premium
Building 7 - West Base/Radio, Service
Supervisors Roof

Shingles have exceeded their expected useful life. Some cupping and wear. - AssetCALC ID: 3325771

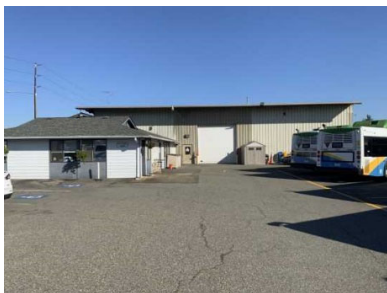
Exterior Walls in Marginal condition.

Painted Surface
Building 7 - West Base/Radio, Service
Supervisors Building Exterior

Paint is worn and finish is not consistent are replacement sections. - AssetCALC ID: 3347411

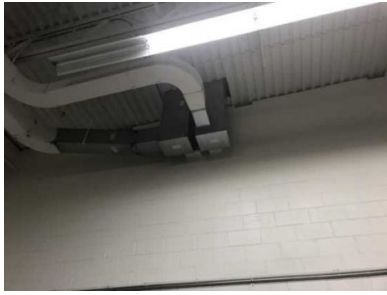
Roofing in Poor condition.

Water Stains
Building 1 - Fleet Maintenance Parts

Roof leak over parts department - AssetCALC ID: 3440869

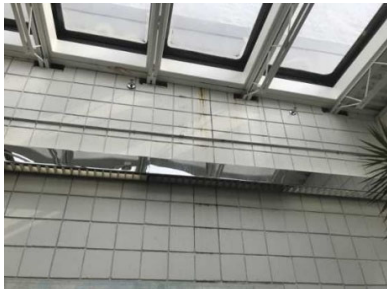
Roofing in Poor condition.

Repairs at skylight
Building 1 - Fleet Maintenance Leak in front Lobby

Water leaks occurring around the lobby skylight. - AssetCALC ID: 3441469

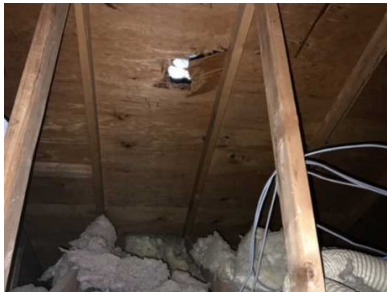
Roofing in Poor condition.

Sheathing Damage
Building 7 - West Base/Radio, Service Supervisors Roof

Hole in roof. - AssetCALC ID: 3345106

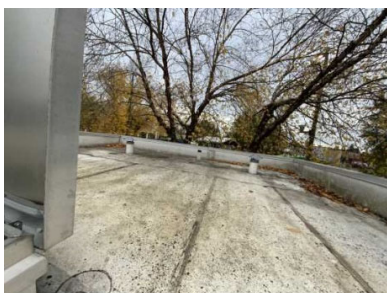
Roofing in Poor condition.

Single-Ply Membrane, TPO/PVC
72nd Street & Portland Avenue Transit Center Comfort Station

Membrane degrading from wear, due to age. - AssetCALC ID: 3432325

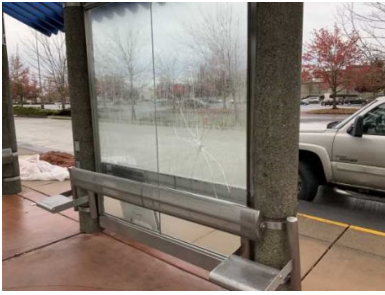
Window in Poor condition.

Glazing
South Hill Mall Transit Center Waiting Station

Two panels have been vandalized. The glass is broken. - AssetCALC ID: 3437324

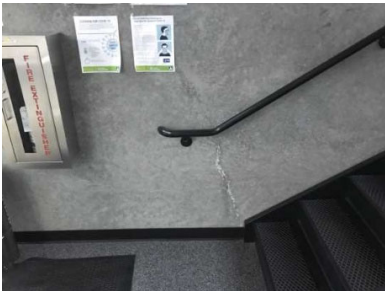
Exterior Wall in Marginal condition.

any type, Waterproofing of Exterior Face
Building 5 - Safety & Training Facility East wall

Leakage of exterior wall both reported and noted - AssetCALC ID: 3432218

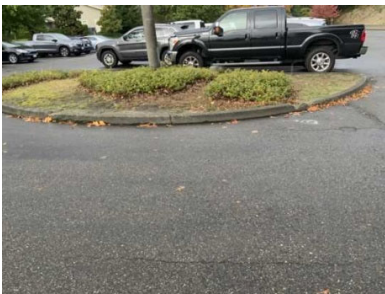
Parking Lots in Marginal condition.

Curb & Gutter, Concrete
Narrows/Skyline Park and Ride Lot Site

Damaged - AssetCALC ID: 3368947

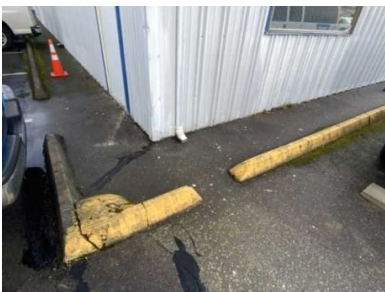
Parking Lots in Marginal condition.

Curb & Gutter, Concrete
Building 6 - Vanpool Site

Damaged - AssetCALC ID: 3397296

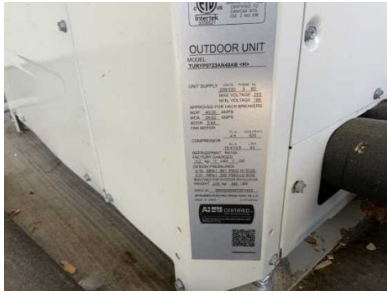
Compressor in Poor condition.

Remote Reciprocating
Commerce Street Transfer Facility North Fan Room

Abandoned in place? - AssetCALC ID: 3420297

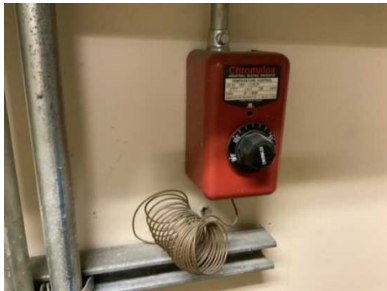
Supplemental Components in Poor condition.

Thermostat, Standard Wall-Mounted
72nd Street & Portland Avenue Transit Center Comfort Station

Parts missing - AssetCALC ID: 3432370

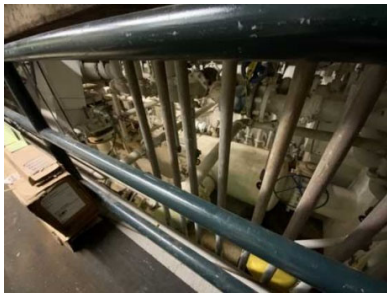
Pump in Poor condition.

Sump
Commerce Street Transfer Facility Water feature pump room

Abandoned in place, should be removed - AssetCALC ID: 3420258

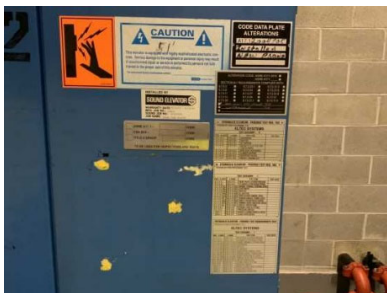
Passenger Elevator in Poor condition.

Hydraulic, 6 Floors
Tacoma Dome Station (East and West Garages) East Parking Garage Elevator Garage

Out of order. Does not function. - AssetCALC ID: 3433548

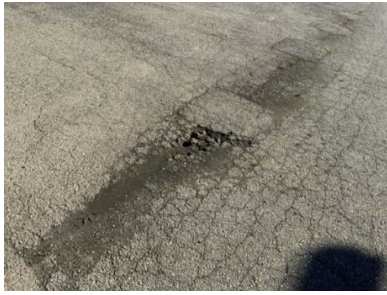
Parking Lots in Poor condition.

Pavement, Asphalt
 Building 7 - West Base/Radio, Service Supervisors Site

Portions of the asphalt parking lot are deteriorating to the point of alligator cracking and raveling leading to potholes. - AssetCALC ID: 3325752

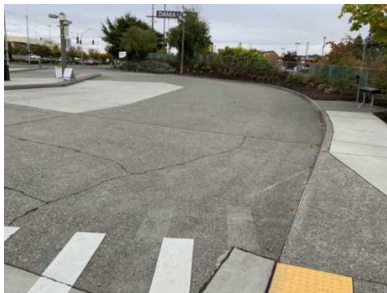
Parking Lots in Poor condition.

Pavement, Asphalt
 Tacoma Mall Transit Center Site

Seal and markings are wearing out. - AssetCALC ID: 3362392

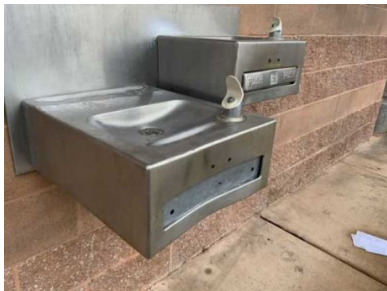
Drinking Fountain in Poor condition.

Wall-Mounted, Bi-Level
 South Hill Mall Transit Center Comfort Station

Dented, broken. - AssetCALC ID: 3437313

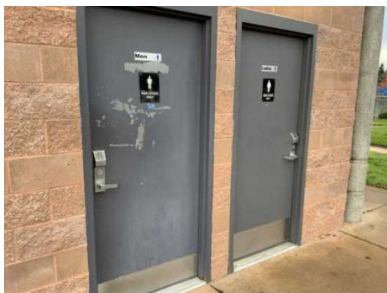
Exterior Door in Poor condition.

Steel, Standard
 South Hill Mall Transit Center Comfort Station

Needs to be repainted. - AssetCALC ID: 3437311

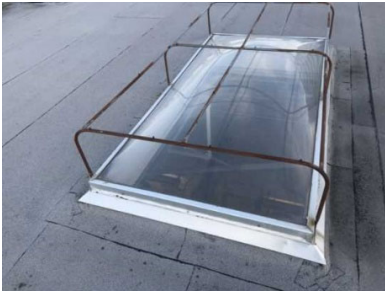
Roof Skylight in Poor condition.

per unit, up to 20 SF
Building 1 - Fleet Maintenance Roof
