# *Transit Asset Management Plan*

# Pierce Transit Facilities Condition Assessment Report: Appendices

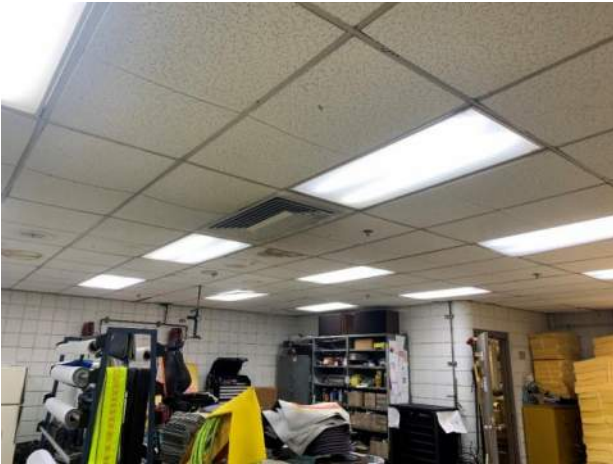
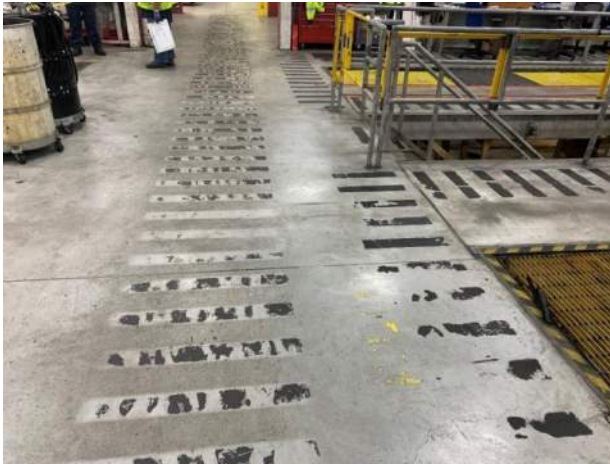
| Ceiling at upholstery shop. | Worn non-skid at SE corner service bays. | Typical "roll-up" door, with telescoping slats. |

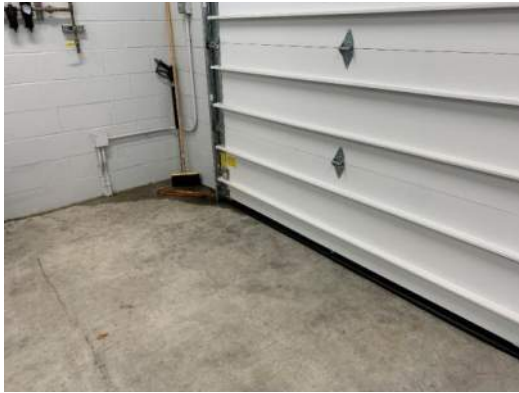
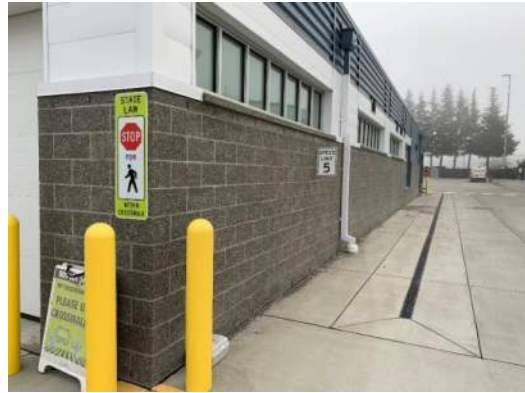
| Shrinkage crack in storeroom floor. | Water in corner of storeroom. | South wall exterior of building. |

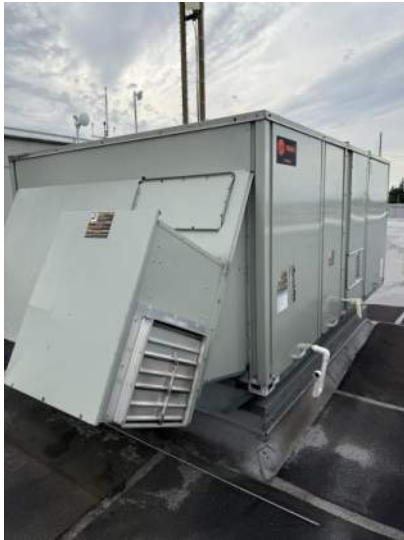
Rooftop HVAC unit with vibration that should be repaired.

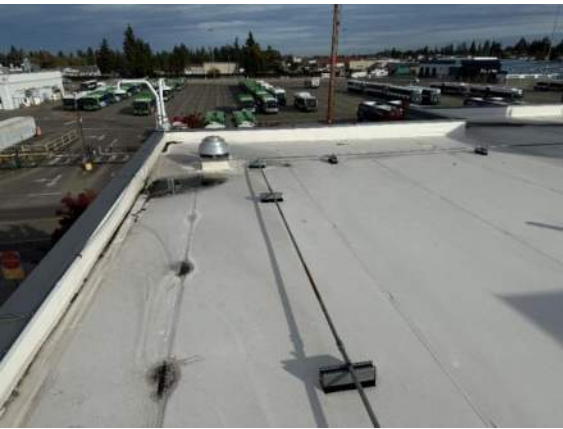
| <p>Low spot collecting water and debris not in front of a drain</p> | <p>Restroom sinks working properly</p> | <p>Restroom toilet working properly</p> |

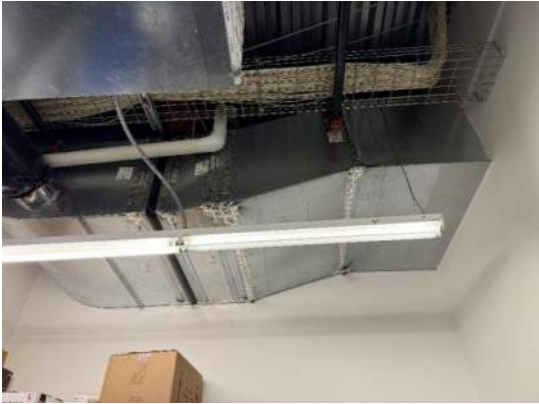
| <p>Rooftop unit with panel that needs to be reinstalled</p> | <p>1<sup>st</sup> Floor Electrical/Phone Room that needs air conditioning unit replaced</p> | <p>Storage Room in Training Room with leaks in HVAC duct</p> |

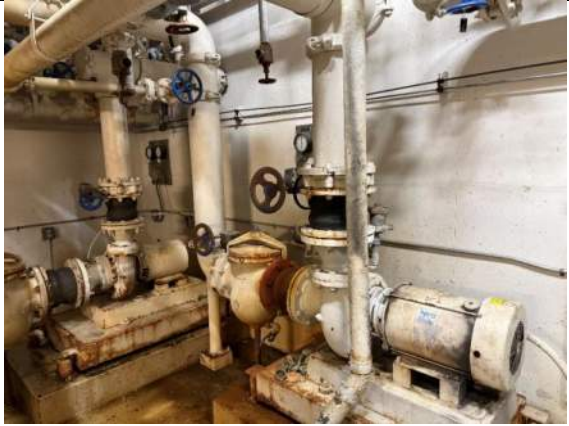
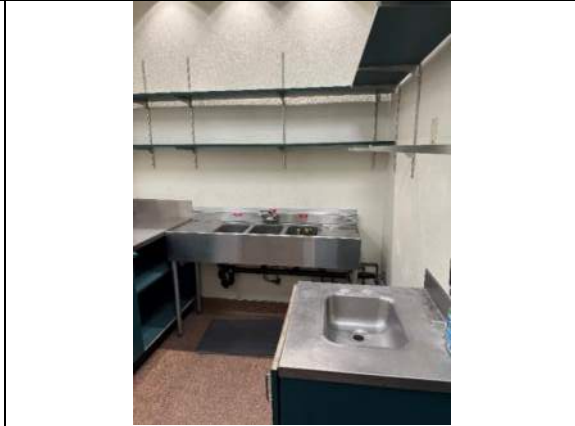
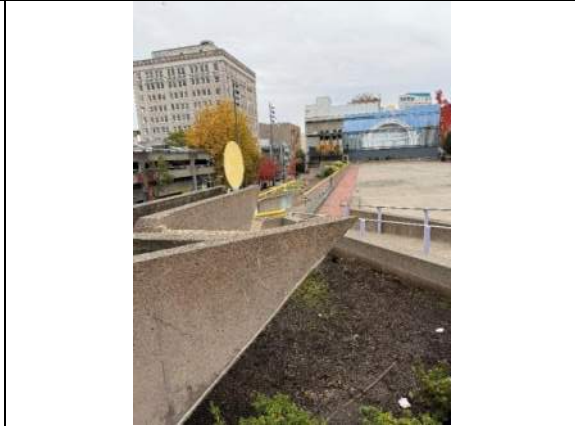
| Pumps, pipe, and valves need to be replaced | Sink faucet in room C8 that needs to be replaced | Fountains were turned off during site visit |

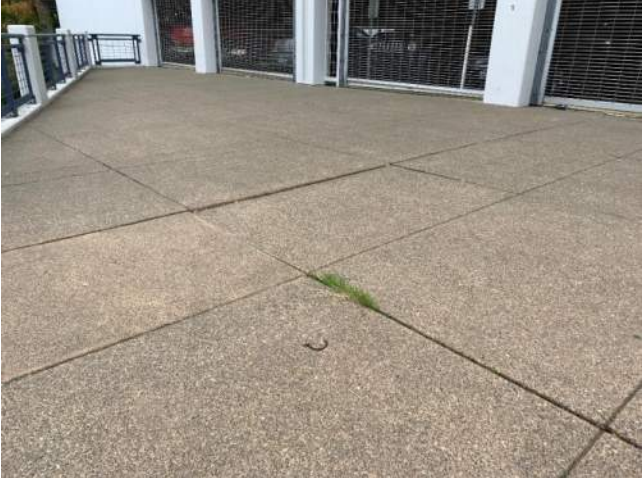
| Sunken paving and vegetation in joints on the patio at west end of the west garage | View of patio from above |

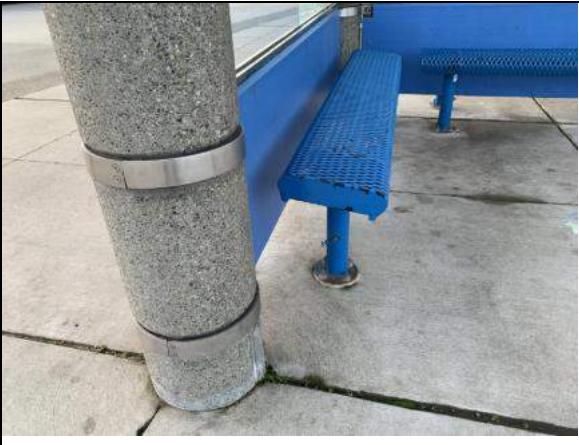
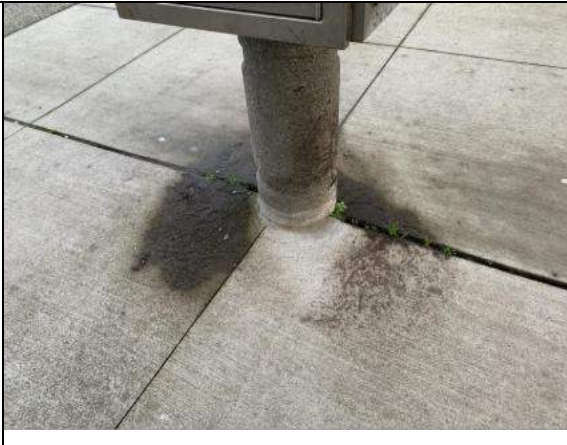
| East Shelter, broken seat | Rusted seat mounting flange | Dirt around column base |

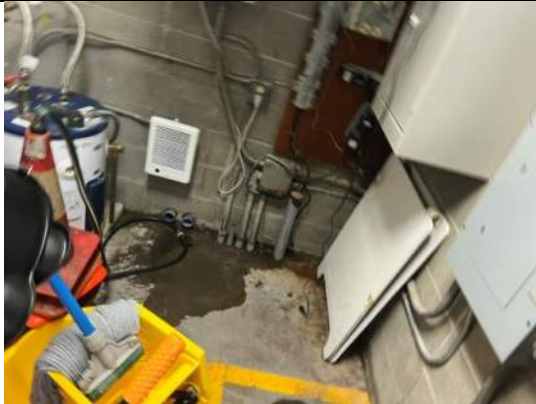
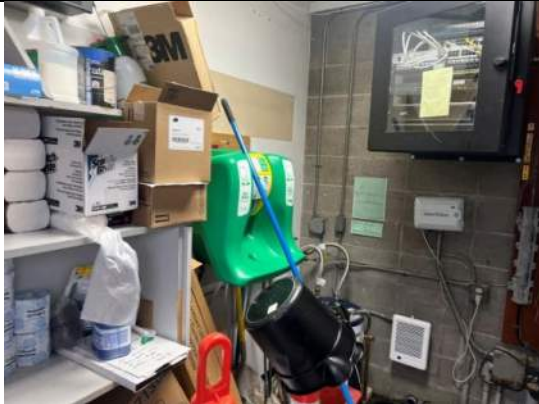
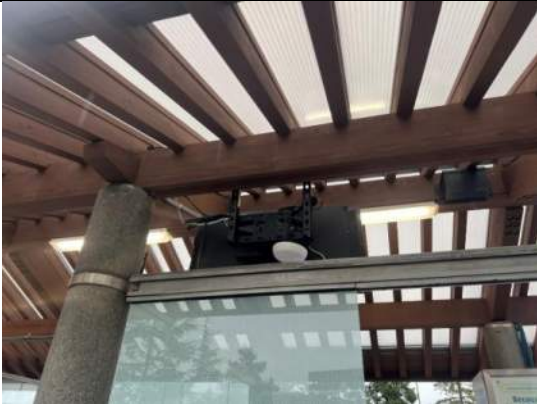
| Evidence of water penetration and corrosion | Obstructed working space around communication equipment | Bus information screen and associated cables open to the public |

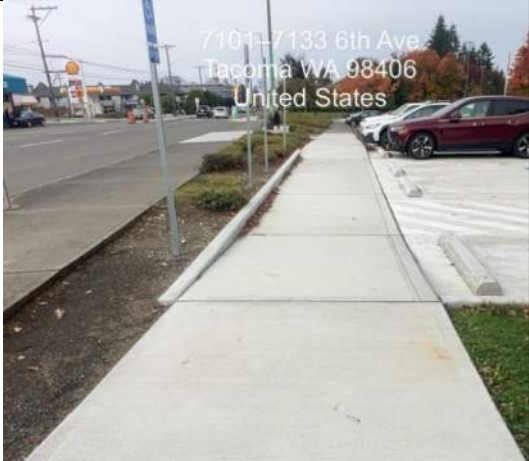
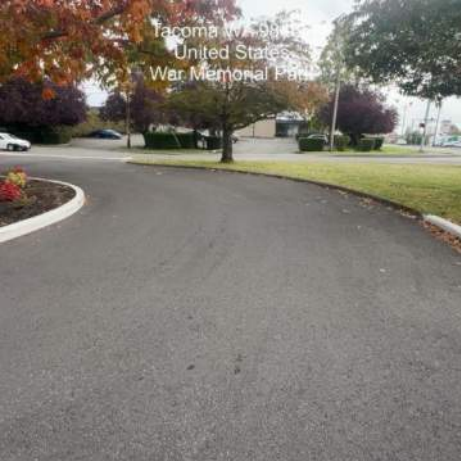
| <p>New concrete sidewalks were observed</p> | <p>Condition of pavement as well as newly installed curb connecting to existing old curb</p> | <p>Condition of pavement adjacent to utility structure lids</p> |
