FACILITY CONDITION SUMMARY

Pierce Transit
3701 96th Street Southwest
Lakewood, Washington 98499
W. Duane Wakan

All Property Summary

May 4, 2022

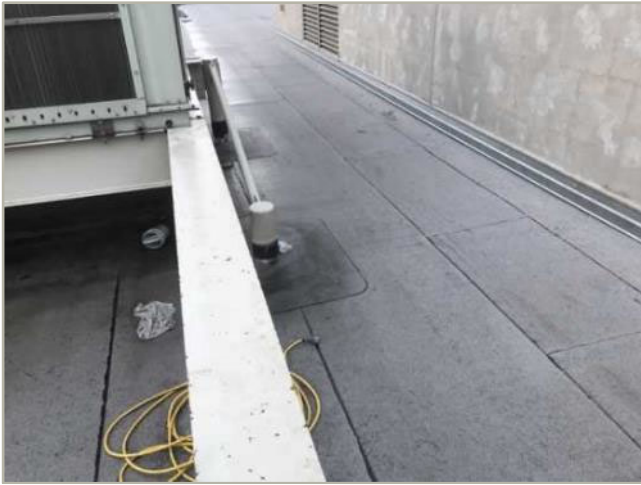
1 - ROOF

B3010 Primary Roof			
Finish	Modified bituminous	Coatings	None
Type / Geometry	Flat	Installation Year	2006
Flashing	Sheet metal	Warranties	Unlikely (based on age)
Parapet Copings	Parapet with sheet metal coping	Roof Drains	Scupper, leaders and downspouts
Fascia	None	Insulation	Indeterminable
Soffits	None	Skylights	Yes
Attics	None	Ventilation Source-1	None
Roof Condition	Adequate	Ventilation Source-2	NA

- The roof finishes were installed in 2006. Information regarding roof warranties or bonds was not available.
- According to the PSQ, there are no active roof leaks. There is no evidence of active roof leaks.
- There is no evidence of roof deck or insulation deterioration. The roof substrate and insulation should be inspected during any future roof repair or replacement work.
- Roof drainage appears to be adequate. Clearing and minor repair of drain system components should be performed regularly as part of the property management’s routine maintenance and operations program.

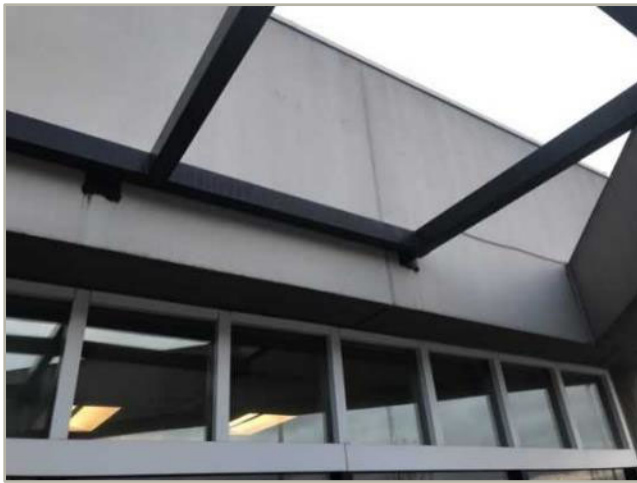
3 - EXTERIOR WALLS

B2010 Exterior Walls		
Type	Location	Condition
Primary Finish	Exposed CMU	Good
Secondary Finish	Tile veneer	Good
Secondary Finish	Painted stucco	Marginal
Building sealants	Between dissimilar materials, at joints, around windows and doors	Adequate

- Ongoing periodic maintenance, including patching repairs, graffiti removal, and recaulking, is highly recommended. Future lifecycle replacements of the components listed above will be required.
- The exterior stucco at the roof has significant areas of deteriorated paint. The damaged finishes must be repaired.

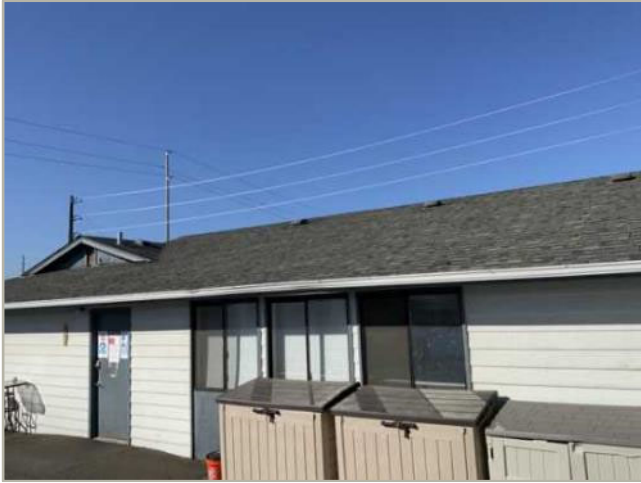
1 - ROOF

- Roof drainage appears to be adequate. Clearing and minor repair of drain system components should be performed regularly as part of the property management’s routine maintenance and operations program.
- A hole was observed in the roof sheathing while looking in the attic access at the water heater. This area is in poor condition. Damaged areas should be repaired or replaced. A cost allowance for this work is included in the Immediate Repairs.

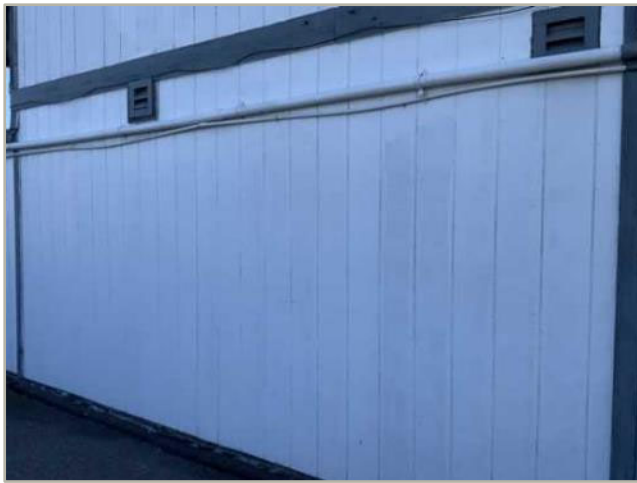
3 - EXTERIOR WALLS

- The exterior finishes have significant areas of painting that is old and degraded. The exterior walls will require painting in the next few years.

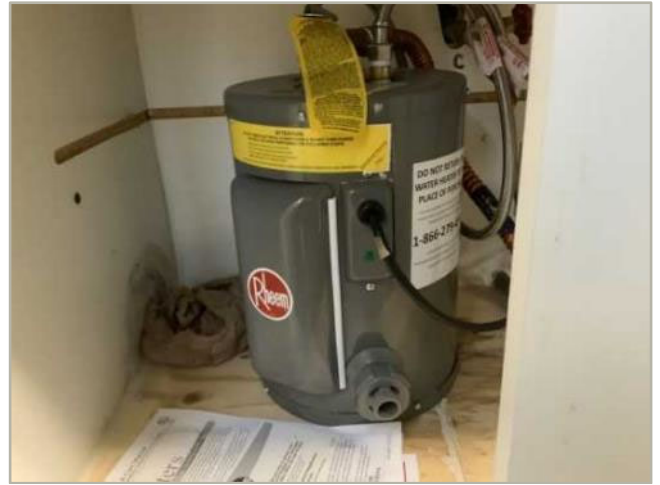
8 – WATER HEATER

Poor Condition Assets			
Location	Description	Condition	Cost
Site	Parking Lots, Pavement, Asphalt, Cut and Patch	Poor	\$14,123
Loft	Packaged Terminal Air Conditioner, PTAC, Replace	Poor	\$3,595
Shop	Water Heater, Electric, Residential, Replace	Poor	\$835
Roof	Roofing, Sheathing Damage, Repair	Poor	\$11,298
Total			\$29,851
