# *Transit Asset Management Plan*

# Pierce Transit Facilities Condition Assessment Report: Appendices

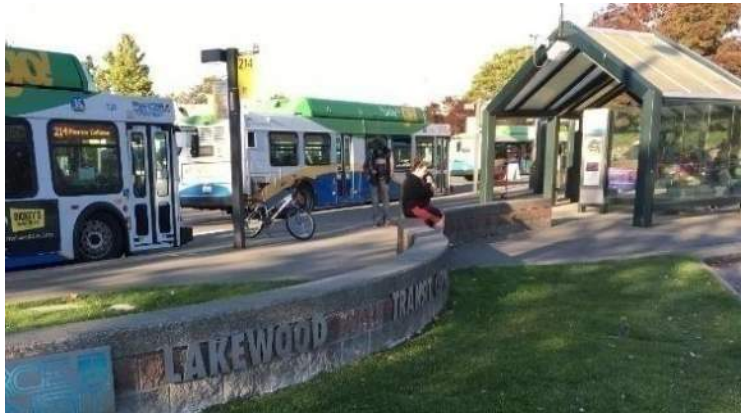
- Overall facility was rated at 3.6
- Deficiencies (items rated 1 or 2) were found in the Plumbing and HVAC primary levels.
- The combined cost estimate of recommended repairs or corrective actions needed to bring the facility up to a State of Good Repair is \$2,500.
- No defects were identified that would constitute a safety concern that would require immediate attention.

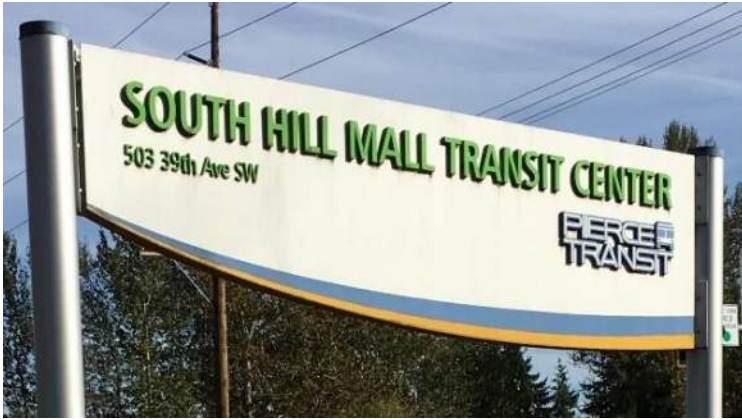
- Overall facility was rated at 4.0
- Deficiencies (items rated 1 or 2) were found in the Interiors, HVAC, Electrical, and Site primary levels.
- The combined cost estimate of recommended repairs or corrective actions needed to bring the facility up to a State of Good Repair is \$17,750.
- No defects were identified that would constitute a safety concern that would require immediate attention.

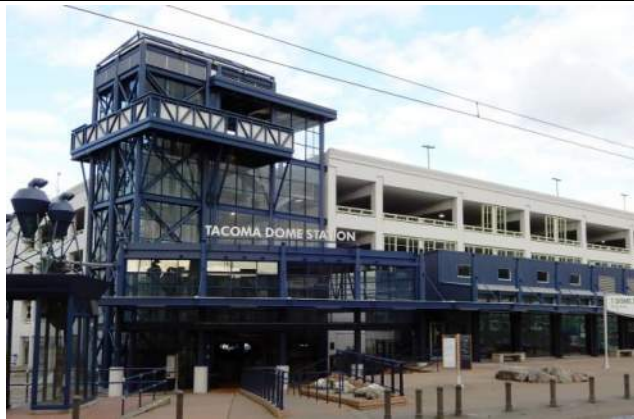
- Overall facility was rated at 3.2
- Deficiencies (items rated 1 or 2) were found in the Plumbing, HVAC, and Site primary levels.
- The combined cost estimate of recommended repairs or corrective actions needed to bring the facility up to a State of Good Repair is \$76,000.
- No defects were identified that would constitute a safety concern that would require immediate attention.

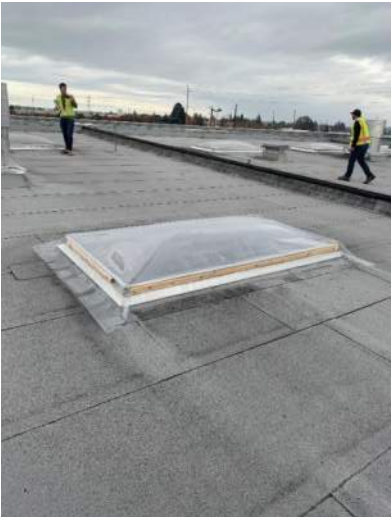
| <p>Skylight covered with plastic sheeting to prevent leaking.</p> | <p>Skylight over entry – covered with plastic sheeting.</p> | <p>Roof near north end of building showing condition and the many roof penetrations in this area.</p> | <p>Lower roof on east siding, shows good drainage slope, but with accumulation of dirt.</p> |

| Secondary Level | Description | Current Condition | TERM Lite Rating | Recommended Corrective Action | Estimated Cost |
|---|---|---|---|---|---|
| | | Most of the roof skylights have developed cracks and are collecting water between the two panes. Some of the skylights have been covered in vinyl/plastic sheets. This issue is common knowledge to PT staff. See structural for recommended corrective actions. | | None | N/A |

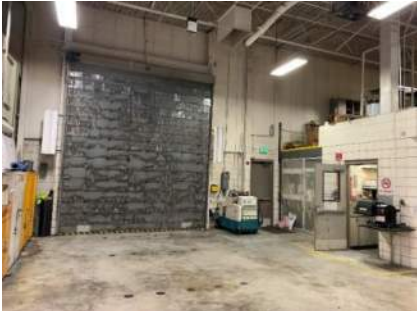
| <p>East door at north end painting area. Worn door panels.</p> | <p>Paint/body shop showing large fans hung from ceiling.</p> | <p>Tire shop, looking west. Mezzanine is to the left. Door with worn slats.</p> | <p>Mechanical area, with wall and floor mounted jib cranes. Hoists are reported to be scheduled for replacement.</p> |

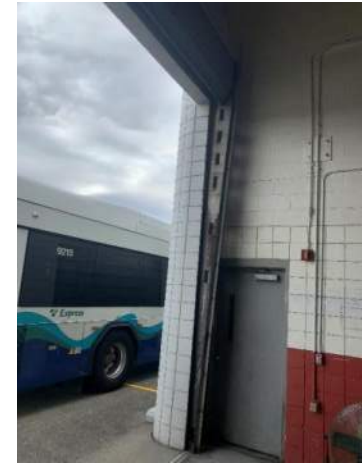
| Ceiling at upholstery shop. | Worn non-skid at SE corner service bays. | Typical "roll-up" door, with telescoping slats. |

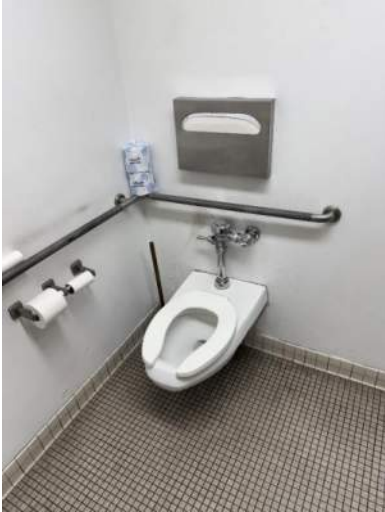
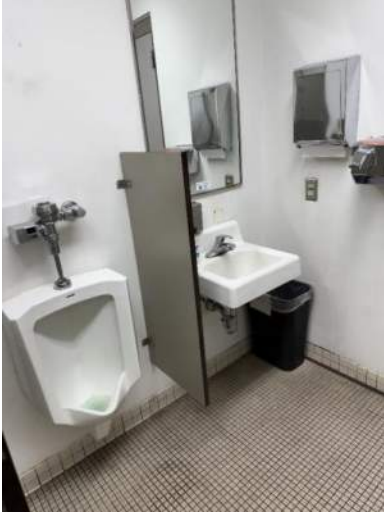
| Restroom fixtures are working and in adequate condition. | Restroom fixtures are working and in adequate condition. | Hot water tank has proper seismic restraint. |

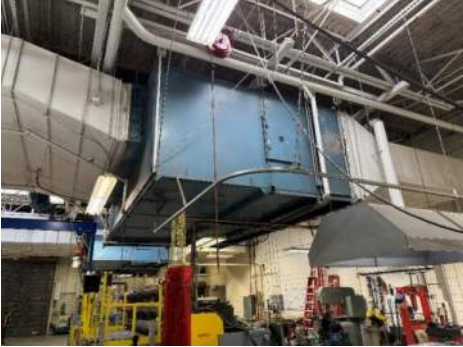
| Large HVAC unit that has reached the end of its typical life. | Caution sign indicating door can slam shut without warning. | Rooftop vent/fan unit that has likely reached the end of its useful life. | Upholstery room that lacks ventilation during adhesive application. |

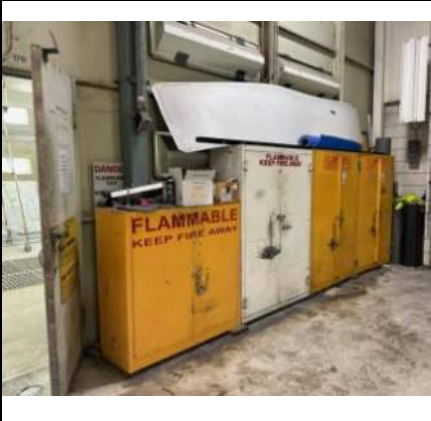
| <p>Flammable storage</p> | <p>Exterior Fire Department Connection</p> | <p>Riser (Inspected 06/25 – no discrepancies noted) (equipment blocking access)</p> | <p>Battery storage room (confirm adequate fire protection and ventilation)</p> |

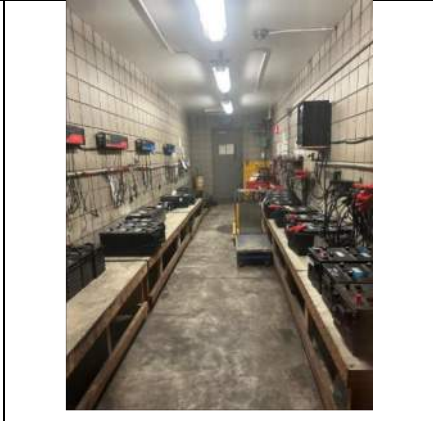
| Secondary Level | Description | Current Condition | TERM Lite Rating | Recommended Corrective Action | Estimated Cost |
|---|---|---|---|---|---|
| Battery Storage Room | Dedicated room for battery charging | Enclosed room for battery storage with emergency shower and fire extinguisher. Wooden shelving for batteries. Appears to be inadequate ventilation and fire protection for quantity of batteries. Need to confirm battery type and quantities. | 2.5 | Upgrade to meet fire code and ventilation requirements. | \$40,000 |

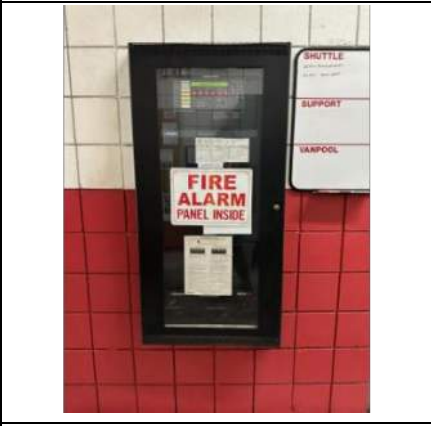
| <p>Fire alarm panel (Inspected 07/25 – no discrepancies noted.)</p> | <p>Emergency shower (Inspected 10/25 – no discrepancies noted.)</p> | <p>Riser (Inspected 06/25 – no discrepancies noted.)</p> | <p>Paint spray booth</p> |

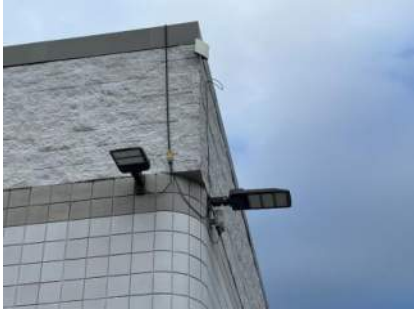
| Exterior Lighting Powered by Extension Cord. | Lights in Quick Check Service Bay Missing Covers | Decoupled Conduit on North End of Roof. |

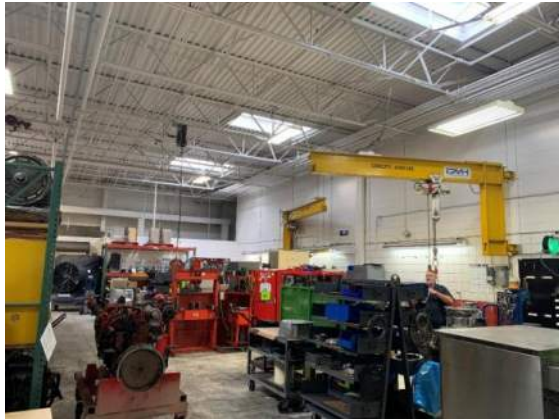
Jib cranes in engine shop

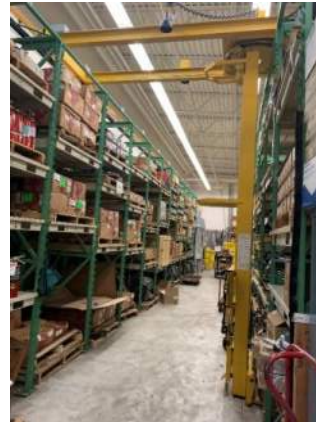
Pallet lift in parts.

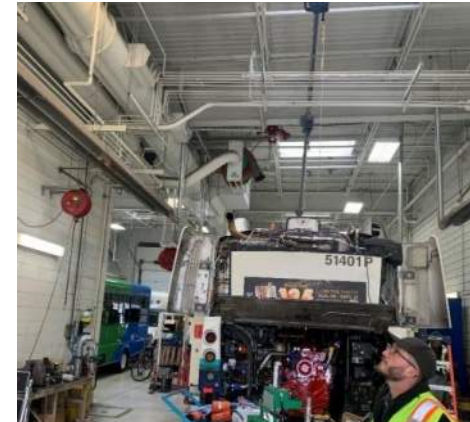
Overhead fall protection equipment for on-top-of-bus work.

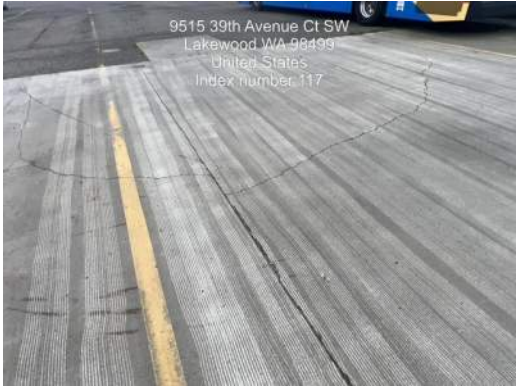
| <p>Cracked concrete pavement</p> | <p>Cracked concrete pavement near bus parking</p> | <p>Cracked concrete pavement requiring sealant</p> |

| Secondary Level | Description | Current Condition | TERM Lite Rating | Recommended Corrective Action | Estimated Cost |
|---|---|---|---|---|---|
| Roadways, parking lots and associated signage, marking, and equipment | Roadways, parking lots, curbs, and site gates. | The large parking and driving areas directly adjacent to Building #1 are concrete pavement in adequate condition with cracks that need to be addressed. There is also an asphalt area to the southwest of the building that is heavily damaged and should be replaced. | 3.0 | Caulk approximately 1000 LF of concrete cracks. | \$50,000 |

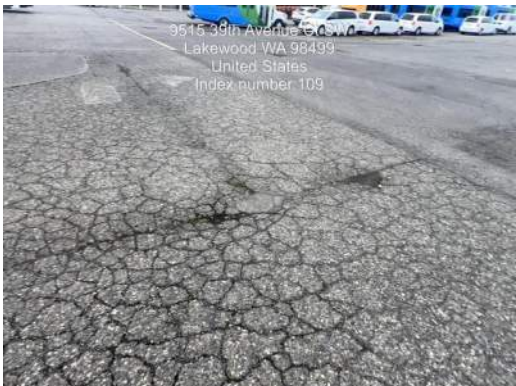
| Secondary Level | Description | Current Condition | TERM Lite Rating | Recommended Corrective Action | Estimated Cost |
|---|---|---|---|---|---|
| | | Asphalt Pavement – The asphalt pavement to the southwest of the building is extremely damaged and should be replaced. | | Long-term – Replace 15,000 SQFT of asphalt parking area and entrance. | \$78,000 |

| <p>Damage asphalt to southwest of building.</p> | <p>Damaged asphalt to the southwest of building.</p> | <p>Cracked concrete pavement near bus parking</p> |

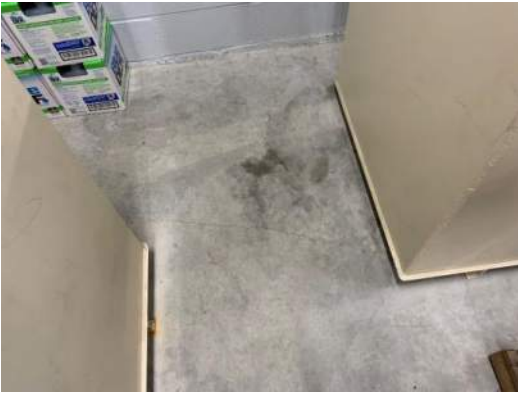
| Secondary Level | Description | Current Condition | TERM Lite Rating | Recommended Corrective Action | Estimated Cost |
|---|---|---|---|---|---|
| Foundation | Assumed to be shallow concrete foundations | There were some shrink cracks in the storeroom floor.<br>Ground face CMU exterior with metal siding upper.<br>Some areas that were wet in the SW corner of the storeroom. There appears to be leakage under door and low area in corner. | 4.0 | Normal concrete condition, not seen as problem requiring attention.<br><br>Adjust door bottom seal and build up corner with grout to remove low spot. | \$1,500 |

| Shrinkage crack in storeroom floor. | Water in corner of storeroom. | South wall exterior of building. |

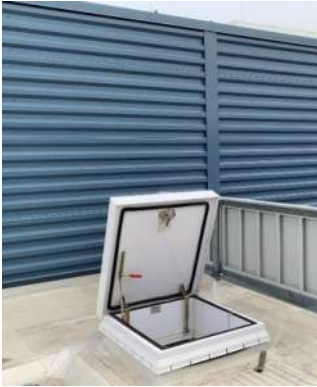
| South wall at storage/office/restroom bay. | Steel framing at fueling bays. | Roof access hatch which was awkward to open and exit. | Ladder access to higher roofs. Showing roof features. | Roof top equipment, screen walls and lightning protection. |

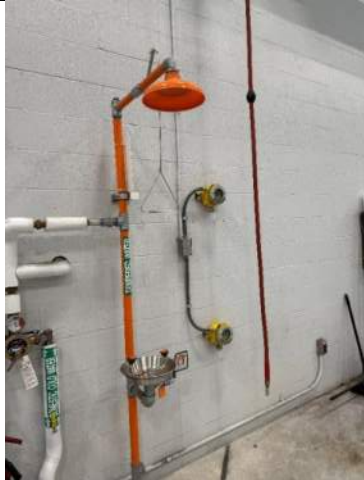
| Emergency eyewash/shower is being regularly inspected. | Water heater with proper seismic restraint. | Washdown hose for washing vehicles. |

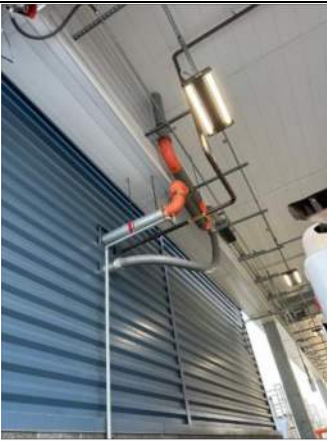
| Fire extinguisher (Inspected 09/25 – no discrepancies noted.) | Interior to exterior expansion loop | Clean agent system (Inspected 07/25 – no discrepancies noted.) |

| Secondary Level | Description | Current Condition | TERM Lite Rating | Recommended Corrective Action | Estimated Cost |
|---|---|---|---|---|---|
| Sprinklers | Wet pipe and dry pipe systems | Inspected 07/25 – no discrepancies noted. | 3.7 | Confirm exterior expansion loops have breakaway couplings for seismic. | \$5,000 |

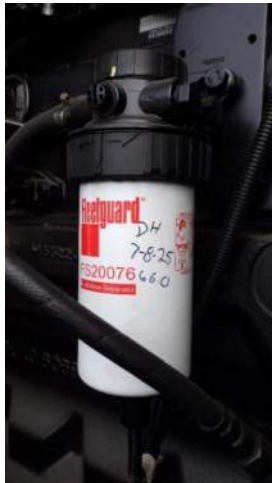
| Generator Service Date On Filter | ATS In Electrical Room | Linear Lighting |

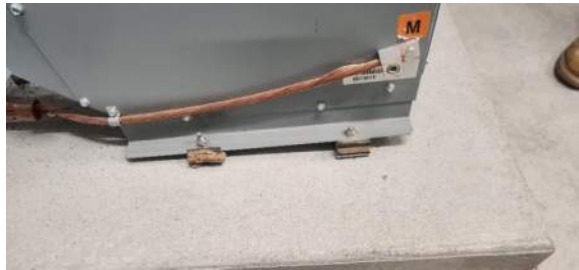
| Secondary Level | Description | Current Condition | TERM Lite Rating | Recommended Corrective Action | Estimated Cost |
|---|---|---|---|---|---|
| Electrical service & distribution | Distribution Panels<br>Distribution Transformers | The electrical distribution equipment is in good working order and appears to be near new.<br>The vibration isolation pads for the transformers in the electrical room were installed upside down. This has led to some being compressed or damaged. | 4.7 | Transformer isolation pads should be replaced and installed properly. Failure to replace it could lead to equipment damage. | \$1,800 |

| Compressed/Damaged Vibration Isolation Pads | Generator | |

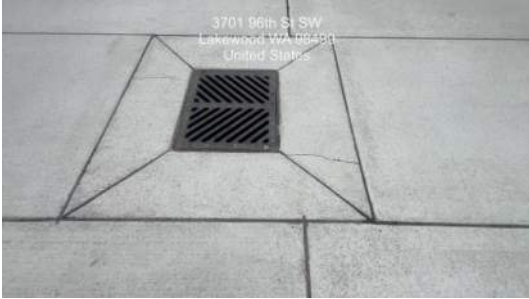
| Secondary Level | Description | Current Condition | TERM Lite Rating | Recommended Corrective Action | Estimated Cost |
|---|---|---|---|---|---|
| Roadways/driveways, parking lots, and associated signage, marking, and equipment | Roadways, parking lots, curbs, and site gates. | The large parking and driving areas directly adjacent to the fuel and wash building are concrete pavement in good condition with minor cracks around utility vaults and drainage structures that need to be addressed.<br><br>The pavement markings were found in good condition. | 3.5 | Caulk approximately 50 LF of concrete cracks | \$2,500 |

| View of the pavement adjacent to buildings 2 and 3 | Minor cracking around drainage catch basins | Minor cracking utility vaults and castings |

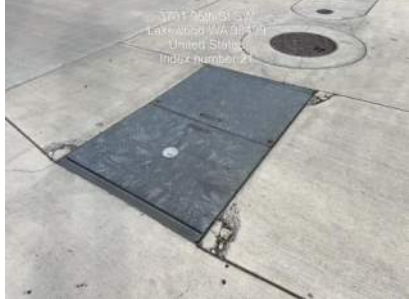
| Secondary Level | Description | Current Condition | TERM Lite Rating | Recommended Corrective Action | Estimated Cost |
|---|---|---|---|---|---|
| Site utilities | Catch basin and utility vaults | The utilities within the concrete paving were observed in adequate condition. Concrete cracks were observed around structures and are described above in the 'Roadways/driveways, parking lots, and associated signage, marking, and equipment' section. | 3.0 | None | N/A |

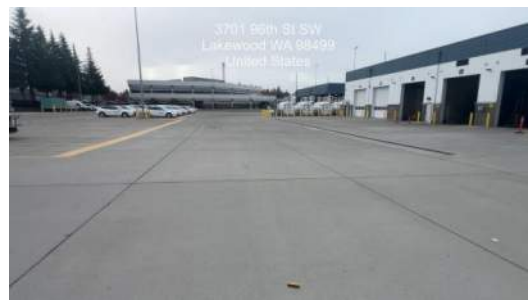
| Concrete pavement in good condition | Concrete pavement markings are in good condition. | Concrete pavement markings are in good condition including stop bars |

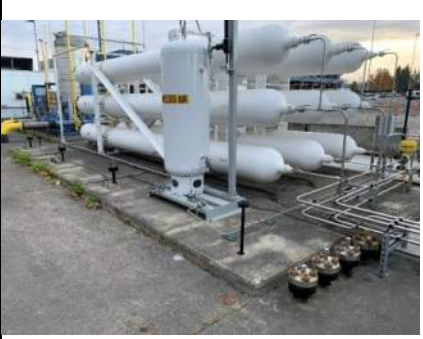
| Secondary Level | Description | Current Condition | TERM Lite Rating | Recommended Corrective Action | Estimated Cost |
|---|---|---|---|---|---|
| Foundation | Independent shallow concrete equipment pads. | Slight weathering of concrete on older pads.<br>All equipment appears to be properly anchored.<br>The concrete cylinder pad was recently installed at the West end of enclosure. | 4.0 | None | N/A |

| Cylinder pad | Filter | Compressors | Generator |

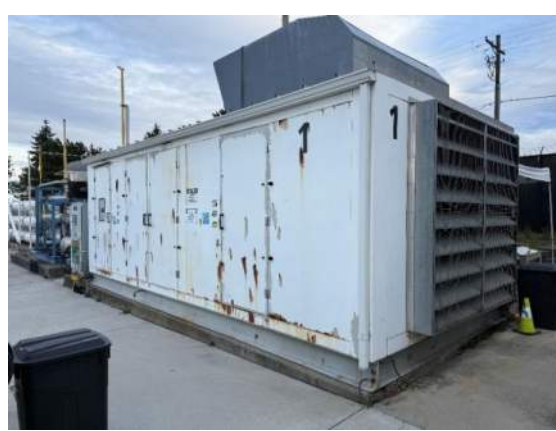
| Secondary Level | Description | Current Condition | TERM Lite Rating | Recommended Corrective Action | Estimated Cost |
|---|---|---|---|---|---|
| Rain water drainage | Site drainage. | Site visit was during a dry day, but area appears to be draining properly without evidence of significant sediment buildup in low spots.<br>Site appears to have slope across large units. | 3.7 | None | N/A |

Site slope is evident at base of large units

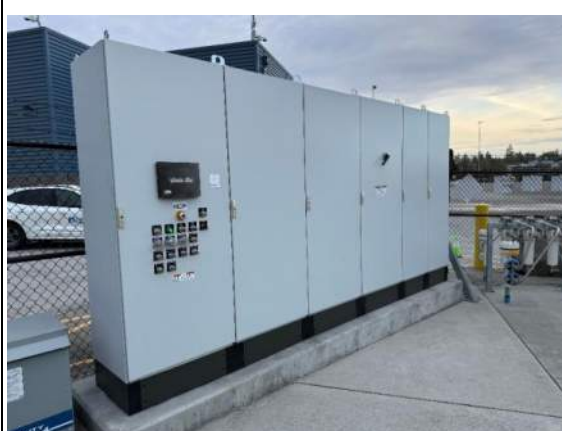
Site slope is evident at base of large panel

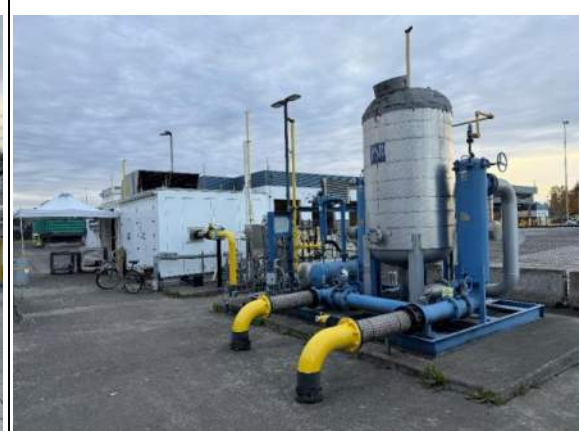
No evidence of sediment build-up in low spots on site

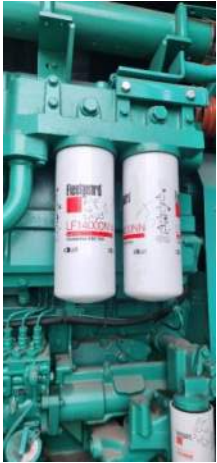
| Secondary Level | Description | Current Condition | TERM Lite Rating | Recommended Corrective Action | Estimated Cost |
|---|---|---|---|---|---|
| Other electrical system-related pieces such as lightning protection, generators, and emergency lighting | Generator<br>Automatic transfer switches | The generator and automatic transfer switches appeared to be in good working order.<br><br>The generator filters have annotations of being serviced on 07-11-2025.<br><br>There was significant standing water in the generator enclosure. | 4.0 | It is recommended that the enclosure be inspected for leaks and repaired as needed. | \$450 |

| Generator Filter Service Date. | Pole Lighting. | Seal-Off Deficiency Near Compressor #1. | ATS | Distribution Switchgear | Standing Water in Generator Enclosure |

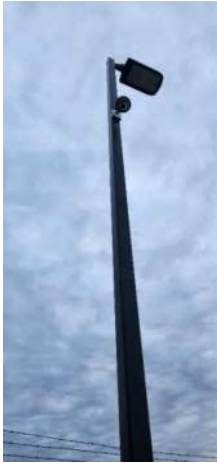
| Secondary Level | Description | Current Condition | TERM Lite Rating | Recommended Corrective Action | Estimated Cost |
|---|---|---|---|---|---|
| Lighting & branch wiring (interior and exterior) | Pole lighting | Assessment was conducted during daylight hours and area lighting could not be properly observed. | 4.0 | It is recommended that the lighting be assessed during non-daylight hours and deficiencies addressed as required. | \$100 |

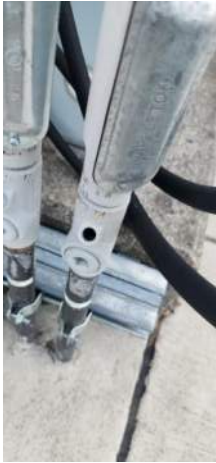
- Overall facility was rated at 3.7
- Deficiencies (items rated 1 or 2) were found in the Electrical primary level.
- The combined cost estimate of recommended repairs or corrective actions needed to bring the facility up to a State of Good Repair is \$1,500.
- A seal-off next to compressor #1 is missing its plug and appears unfilled, creating an explosion hazard.

| Secondary Level | Description | Current Condition | TERM Lite Rating | Recommended Corrective Action | Estimated Cost |
|---|---|---|---|---|---|
| Electrical service & distribution | Electrical distribution switchgear. | The switchgear and compressor starter panels appeared to be in good working order.<br><br>There is a seal-off missing the plug next to compressor #1. The seal-off does not appear to be filled. This is an explosion hazard. | 1.5 | The seal must be checked for fill and the plug replaced. Fill seal-off if not already sealed.<br><br>With the discrepancy in one location, it is recommended that all seal-offs in the area be checked to ensure they are sealed. | \$1,500 |

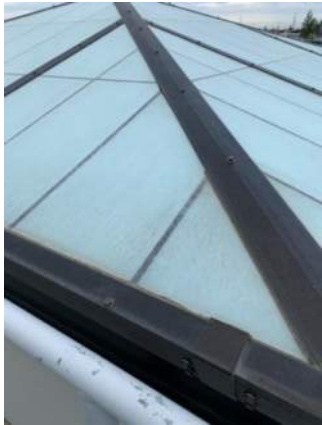
| Secondary Level | Description | Current Condition | TERM Lite Rating | Recommended Corrective Action | Estimated Cost |
|---|---|---|---|---|---|
| Roof | Roofing – 2 levels | Large Skylight was noted to be aged but OK.<br>Flex cracks were seen in the roofing. West of skylight. | 3.0 | Clean skylight.<br>Possible flexing in deck or insulation- monitor. | \$1,000 |

| Low roof skylight, clean and re-caulk as required. | Low roof, splits in roofing at north side. | Low roof, perimeter handrail needs painting. |

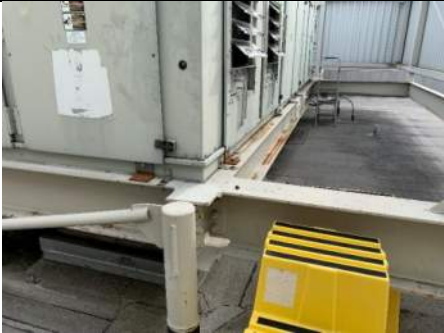
| Upper roof, rust on Air Handle support beams and clips. | Upper roof, showing general condition, walkways, and drain sloping | Penthouse interior, efflorescence on interior concrete block walls. Source of possible water leakage on exterior not identified. |

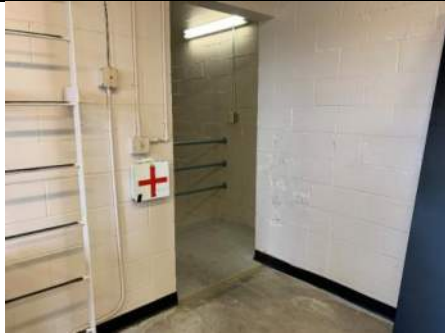
| Secondary Level | Description | Current Condition | TERM Lite Rating | Recommended Corrective Action | Estimated Cost |
|---|---|---|---|---|---|
| Superstructure/<br>structural frame | At roof penthouse<br>Main structure | Penthouse-Efflorescence on interior of CMU walls. No cracking of exterior stucco finish noted.<br>No problems identified with main building structure. | 3.8 | Clean surfaces with mild acid solution and stiff bristle brush. Monitor whether it reappears, which would be a sign of moisture intrusion. | \$1,500 |

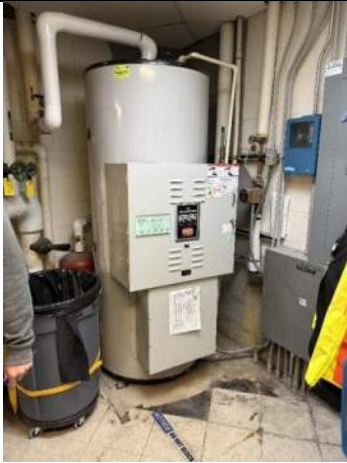
| Water heater that needs seismic restraint strapping to be installed. | Toilet fixture in downstairs restroom is working and in good condition. | Sinks in downstairs restroom are working and in good condition. |

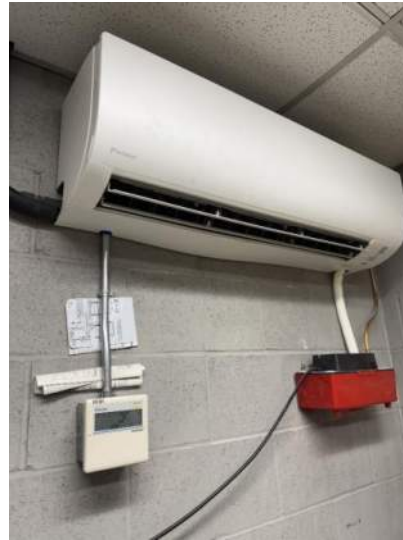
Interior air handler unit for cooling elevator mechanical room.

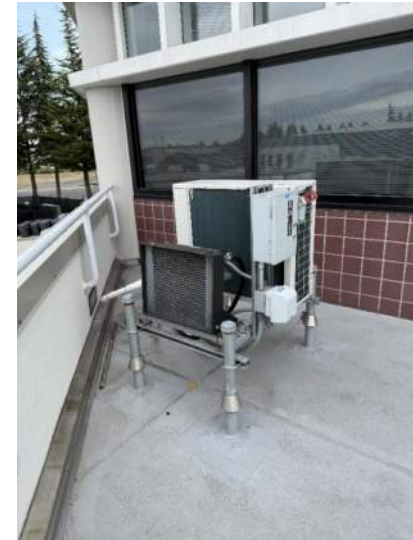
Exterior cooling units for elevator mechanical room.

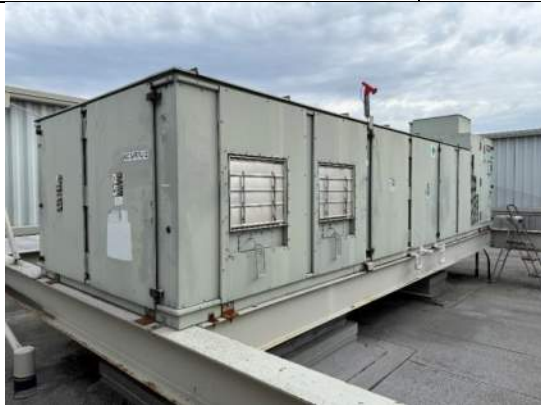
Large rooftop mounted HVAC unit.

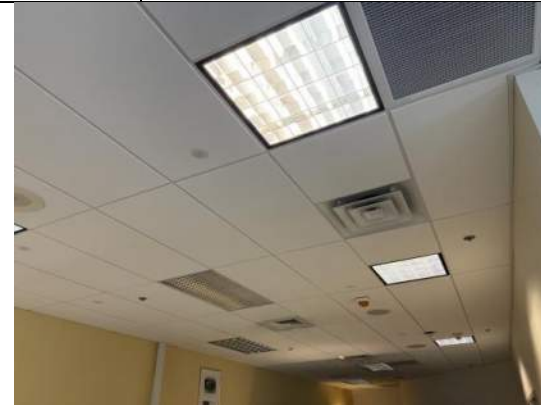
HVAC supply and return vents in ceiling.

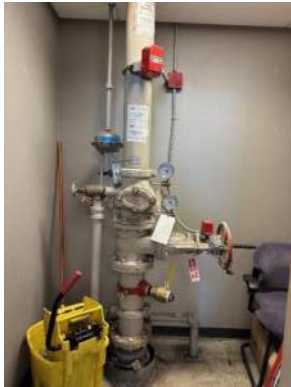
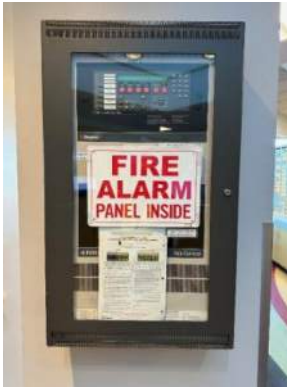
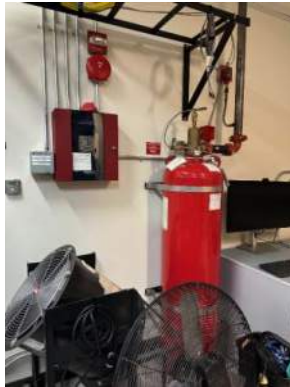
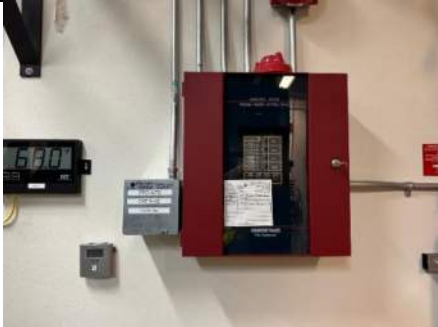
| Secondary Level | Description | Current Condition | TERM Lite Rating | Recommended Corrective Action | Estimated Cost |
|---|---|---|---|---|---|
| Sprinklers | Wet Pipe System | Inspected 09/25 – no discrepancies noted. | 3.8 | Keep riser clear of stored items (mop bucket, chair, etc) | N/A |

| Fire riser (Inspected 09/25 – no discrepancies noted.) | Fire alarm panel | Clean agent system (IT room) (Inspected 07/25 – no discrepancies noted.) |
| Clean agent fire alarm panel (Inspected 07/25 – no discrepancies noted.) | Sprinkler head | Riser inspection tag (Inspected 09/25 – no discrepancies noted.) |

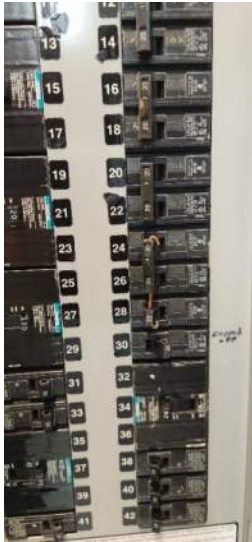
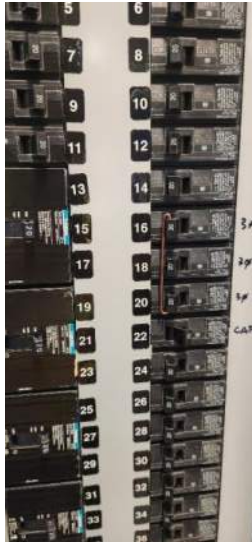
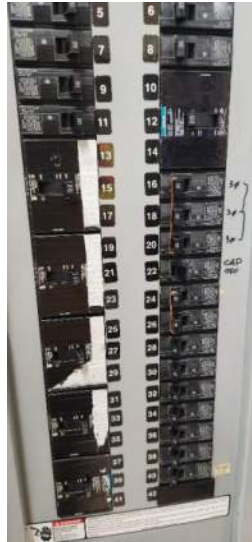
| Secondary Level | Description | Current Condition | TERM Lite Rating | Recommended Corrective Action | Estimated Cost |
|---|---|---|---|---|---|
| | | Panels UPS-A, UPS-B, and UPS-D located in the server room have copper wire acting as handle ties inside the panel. These field fabricated handle ties do not meet the function requirements of the National Electric Code. | | To correct deficiencies in electrical panels UPS-A, UPS-B, and UPS-D the circuits should be evaluated for suitability in a multi-pole application. If suitable for the application, a manufacturer's listed handle tie should be installed, or the circuit breakers should be replaced with single-unit multipole breakers. If not suitable for a multipole application, the field fabricated handle ties should be removed. | \$10,000<br><br>It is unclear if this work could be completed during a planned network shutdown or if a cost for temporary power will be associated |

| Panel UPS-D Field Fabricated Breaker Tie | Panel UPS-A Field Fabricated Breaker Tie | Panel UPS-B Field Fabricated Breaker Tie | Generator Filter Replacement Date | UPS Located in Panel X5A's Working Space |

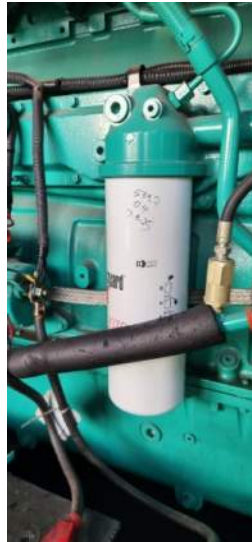
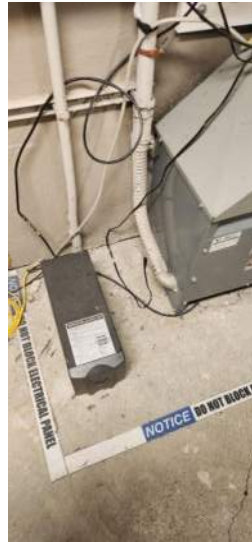
| Secondary Level | Description | Current Condition | TERM Lite Rating | Recommended Corrective Action | Estimated Cost |
|---|---|---|---|---|---|
| Other electrical system-related pieces such as lightning protection, generators, and emergency lighting | Standby Generator. | Generator appeared to be in good working order with filters annotated as being replaced in July of 2025 | 4.5 | None | N/A |

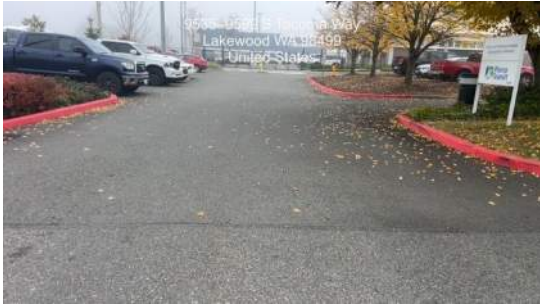
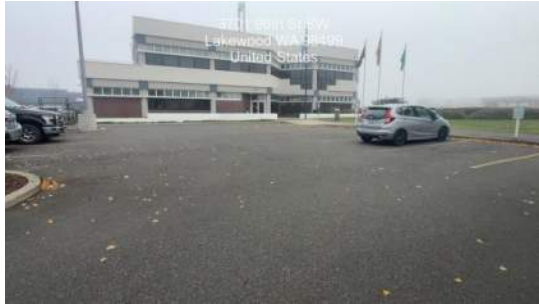
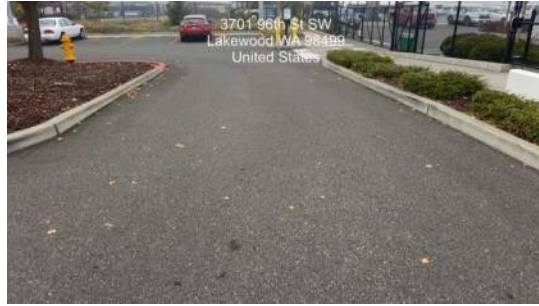
| Secondary Level | Description | Current Condition | TERM Lite Rating | Recommended Corrective Action | Estimated Cost |
|---|---|---|---|---|---|
| Roadways/driveways and associated signage, marking, and equipment | Roadways, driveways | Asphalt in parking area has some imperfections and small cracks but overall, the asphalt parking lot is in adequate working condition. | 3.2 | None | N/A |
| Parking lots and associated signage, markings, and equipment | Curb | New curb was noticed throughout the parking lot. This appears to have been installed recently. The existing curb was moderately deteriorated but not past useful life. | 3.8 | None | N/A |

| Condition of asphalt at entrance to Building #4 | Condition of asphalt throughout parking lot | Newer curb is light gray color |

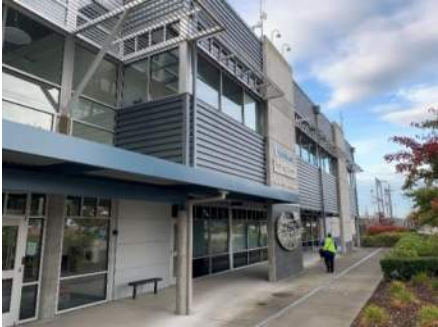
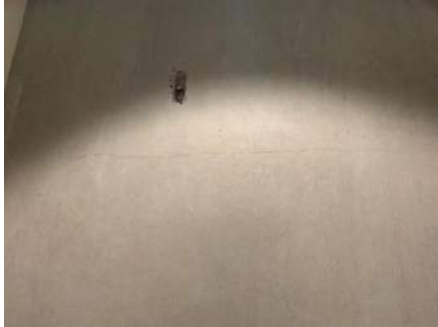
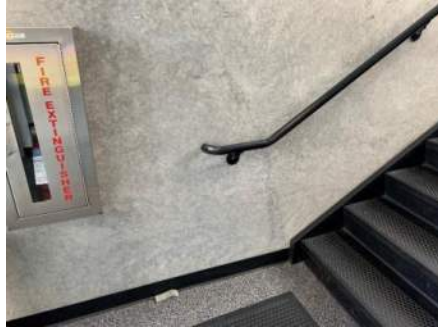
| Secondary Level | Description | Current Condition | TERM Lite Rating | Recommended Corrective Action | Estimated Cost |
|---|---|---|---|---|---|
| Superstructure/structural frame | Tilt up concrete walls-steel frame/bar hoists, concrete filled pan deck | Shipping: horizontal crack in exterior wall.<br>West stairwell: horizontal cracks in exterior wall<br>Staff Lunchroom: Cracks on the west wall near the windows.<br>East stairwell: horizontal and diagonal cracks in exterior wall. | 4.0 | These walls are shear walls that provide East-West bracing for the building. Cracks are narrow and may have occurred in construction or during Nisqually earthquake. They do not appear to be of structural concern. | N/A |

| Secondary Level | Description | Current Condition | TERM Lite Rating | Recommended Corrective Action | Estimated Cost |
|---|---|---|---|---|---|
| Exterior | Tilt-up concrete panels, metal siding, architectural windows. | Hairline cracks in many tilt-up panels. Suspect they may be from original construction or Nisqually Quake. Do not appear to be of structural significance. | 4.0 | Efflorescence stains should be checked for wetness and cracks sealed if wetness detected. If not wet, cracks are probably self-healed with the mineral deposits. | N/A |

| North (public entry) side of building. | Horizontal crack in concrete wall, typical of many. This one is in receiving. | Crack in wall at east stair, this one has efflorescence from moisture leaking from outside. | West exit door, which needs repair. |

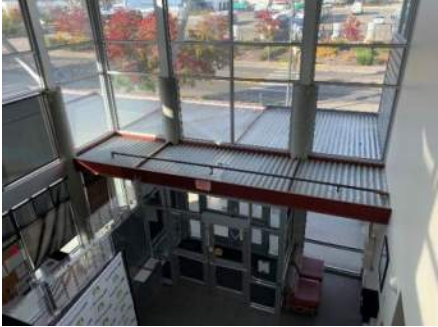
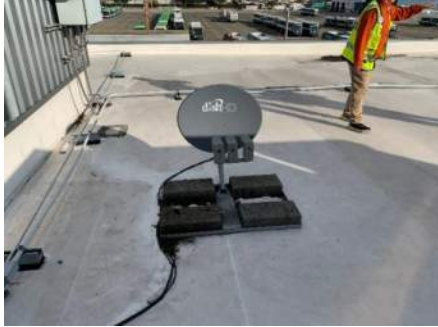
| Secondary Level | Description | Current Condition | TERM Lite Rating | Recommended Corrective Action | Estimated Cost |
|---|---|---|---|---|---|
| Roof | Metal roof deck, with rigid insulation, single ply roofing over.<br>Roof drains-thru parapet scuppers with overflows.<br>Penthouse-Steel stud framed with metal siding.<br>Main Entryway | Single Ply membrane roofing: Noted to be in good condition, but with some notable patches. Some puddles noted a low spots near drains.<br>Penthouse-Steel stud framed with metal sidings.<br>The interior metal roof over the entryway is dirty. | 4.0 | None<br>Clean interior roof | N/A |

| Interior "roof" over entry needing cleaning. | On the roof. Showing conduit supports, dish, wall of penthouse and some debris ponded next to roof drain. | Efflorescence due to water intrusion behind tile facing. | Landing at top of penthouse stairs. Could be improved with concrete or other non-skid material. |

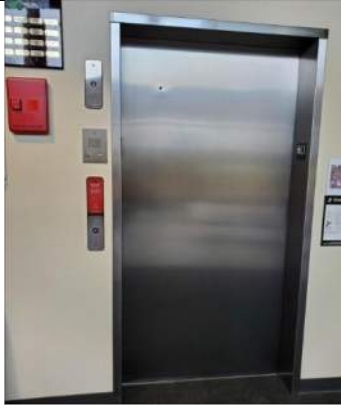
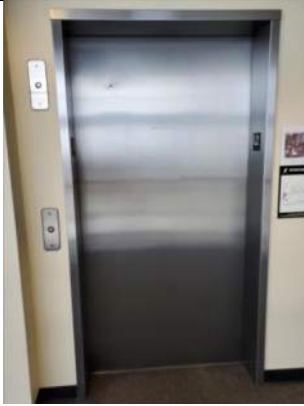
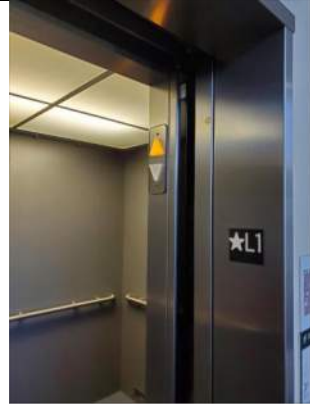
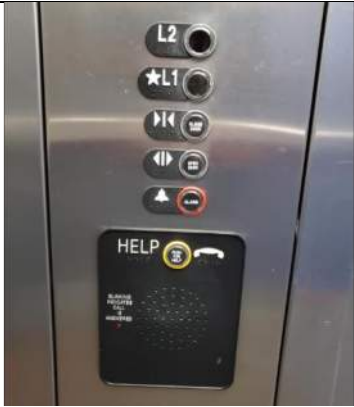
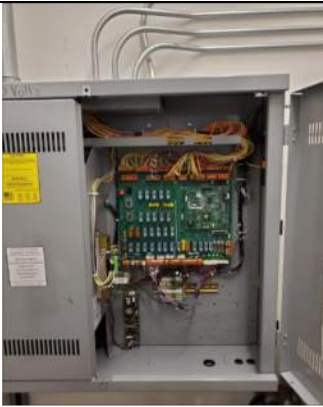
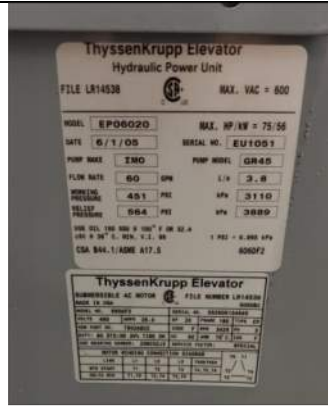
| Secondary Level | Description | Current Condition | TERM Lite Rating | Recommended Corrective Action | Estimated Cost |
|---|---|---|---|---|---|
| Elevators | 3,000 lbs. capacity, 2-stop hydraulic passenger elevator, manufactured around 2005. | The operation of the elevator is somewhat jerky with some rattling during travel. Otherwise, the car and equipment appear in good condition. | 3.8 | Have elevator maintenance provider review whether adjustments can be made to improve starting/stopping and ride quality. | Varies, may be included under current elevator maintenance contract. |

| Level 1 Elevator Landing | Level 2 Elevator Landing | Cab Interior |
| Elevator Car Operating Panel | Elevator Control Cabinet | Hydraulic Power Unit Data |

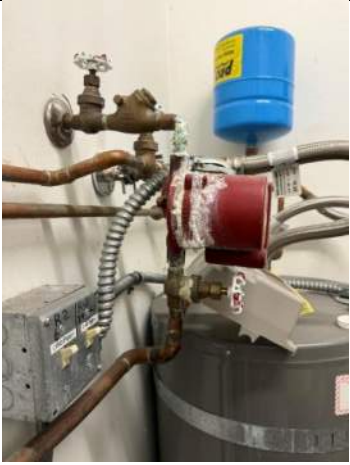
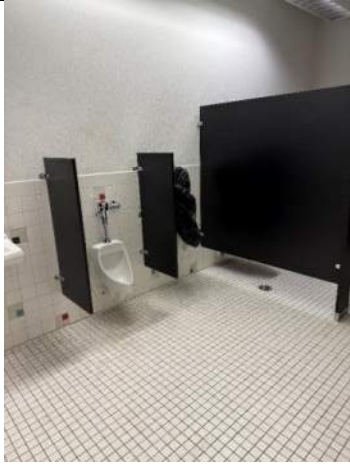
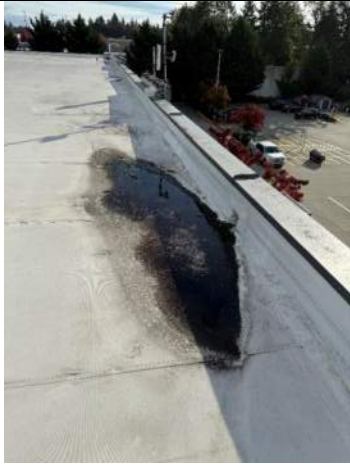
| Secondary Level | Description | Current Condition | TERM Lite Rating | Recommended Corrective Action | Estimated Cost |
|---|---|---|---|---|---|
| Rain water drainage | Roof drainage | There were several low spots that collect water and debris along the edge of the roof in front of drains and also where no drain was present. This is not an immediate concern but could cause issues over time after numerous freezing and thawing cycles of the puddles. | 3.7 | None | N/A |

| <p>Water leak with mineral deposits above water heater.</p> | <p>Men's Restroom with non-operational urinal</p> | <p>Low spot collecting water and debris in front of drain</p> |

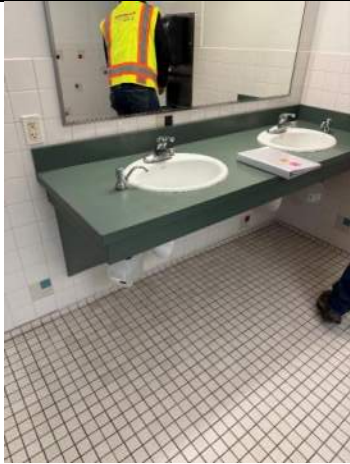
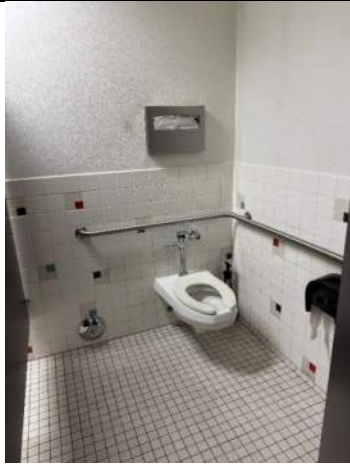
| <p>Low spot collecting water and debris not in front of a drain</p> | <p>Restroom sinks working properly</p> | <p>Restroom toilet working properly</p> |

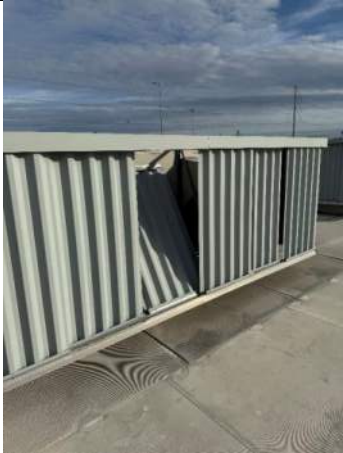
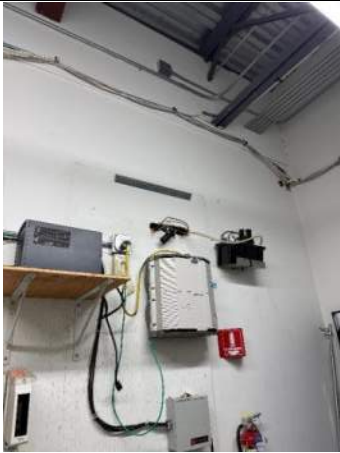
| <p>Rooftop unit with panel that needs to be reinstalled</p> | <p>1<sup>st</sup> Floor Electrical/Phone Room that needs air conditioning unit replaced</p> | <p>Storage Room in Training Room with leaks in HVAC duct</p> |

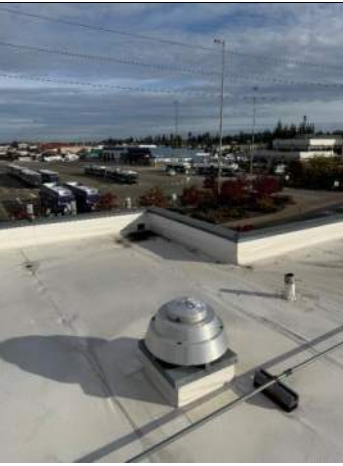
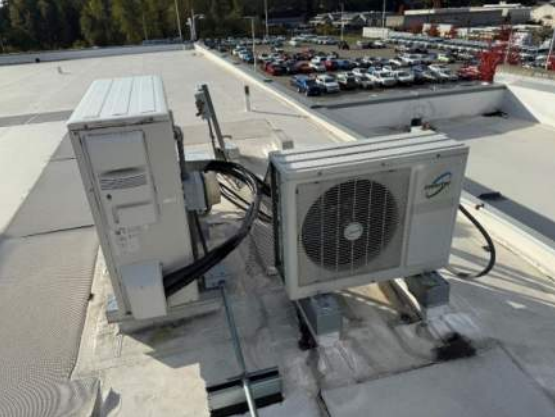
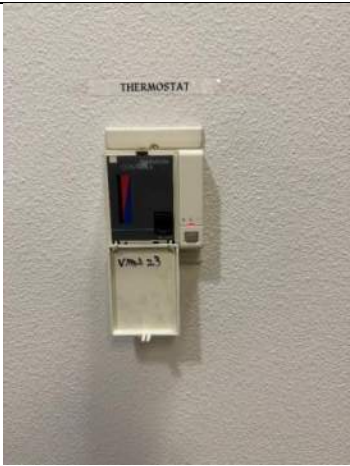
| <p>Roof mounted fan is working properly</p> | <p>Roof mounted heat pump is working properly</p> | <p>Training Room thermostat is working properly</p> |

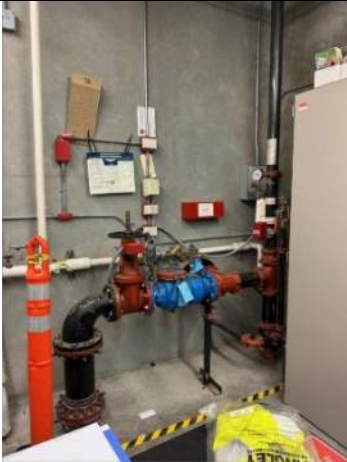
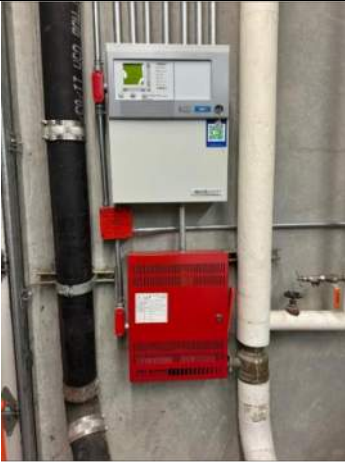
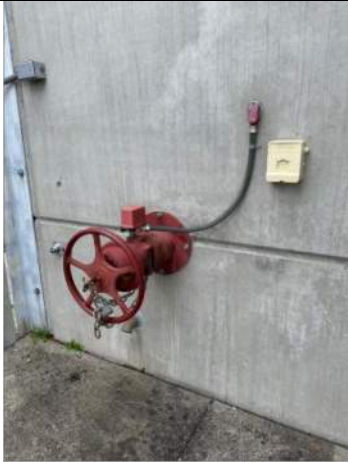
| Wet Pipe System riser (inspected 7.25) | Wet Pipe Fire Alarm Panel<br>(Inspected 07/25 – no discrepancies noted) | Exterior Fire Protection Valve |

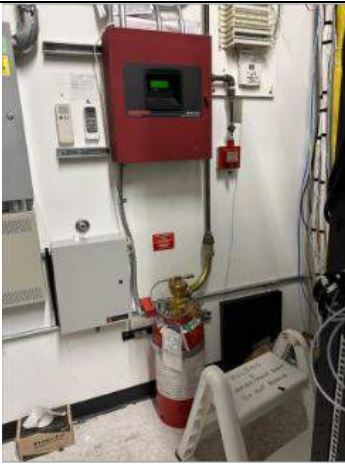
| IT room clean agent system (Inspected 07/24 – overdue – no discrepancies noted.) | IT room (exterior) | Flammable storage |

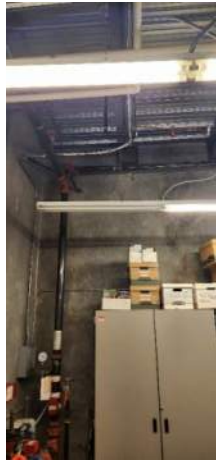
| Secondary Level | Description | Current Condition | TERM Lite Rating | Recommended Corrective Action | Estimated Cost |
|---|---|---|---|---|---|
| Lighting & branch wiring (interior and exterior) | Building Interior: fluorescent and LED.<br>Building exterior: LED | In General, the lighting is in good working order and had minimal deficiencies. Some fluorescent lamps are out or show signs of dimming.<br>Branch wiring is in good working order and no deficiencies were found. | 3.9 | Replace deficient lamps. | \$1,500 |

| UPS Alarm Light | PVC Conduit on Roof | Example of Deficient Lighting | Generator Filter Annotation | Panel L, Missing Blank Cover |

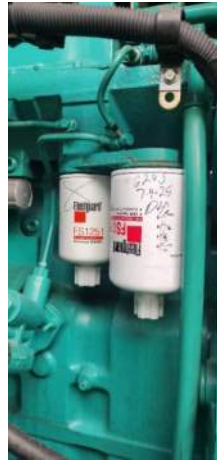
| Secondary Level | Description | Current Condition | TERM Lite Rating | Recommended Corrective Action | Estimated Cost |
|---|---|---|---|---|---|
| Other electrical system-related pieces such as lightning protection, generators, and emergency lighting | Standby generator and distribution equipment | Standby generator and automatic transfer switch appear to be in good working order. Filter annotation indicate service in July of 2025. | 4.5 | None | N/A |

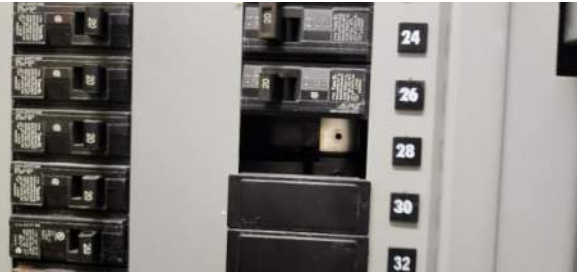
| Secondary Level | Description | Current Condition | TERM Lite Rating | Recommended Corrective Action | Estimated Cost |
|---|---|---|---|---|---|
| | | Panel L in the first-floor electrical room has a blank cover that is missing, exposing live bus to facility personnel. This is a safety concern that should be addressed immediately. | | The missing blank cover in Panel L must be replaced to protect facility personnel. | \$250 |

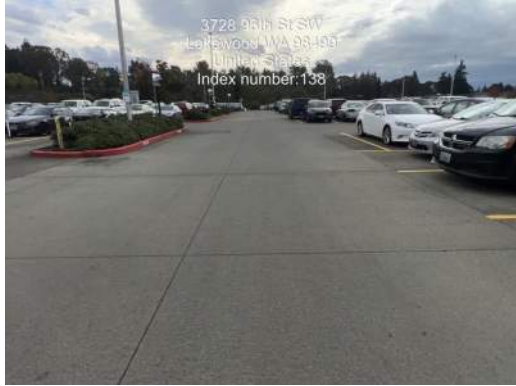
| Secondary Level | Description | Current Condition | TERM Lite Rating | Recommended Corrective Action | Estimated Cost |
|---|---|---|---|---|---|
| Roadways/driveways, parking lots, and associated signage, marking, and equipment | Driveways, parking lots and associated signage, marking, and equipment. | The parking lot contains concrete paving that was observed in good condition. There was minor cracking observed throughout the parking lot that should be sealed with caulking.<br><br>Pavement markings and lines were observed in adequate condition and appeared to have been recently painted. | 3.3 | Caulk approximately 200 LF of concrete cracks | \$10,000 |

| Condition of concrete parking lot | Newly painted curb and striping<br>Cracks in concrete | Cracking in concrete pavement |

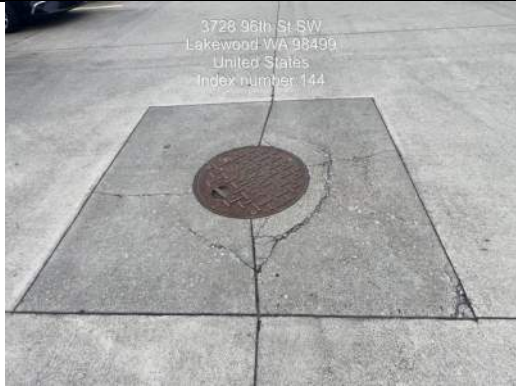
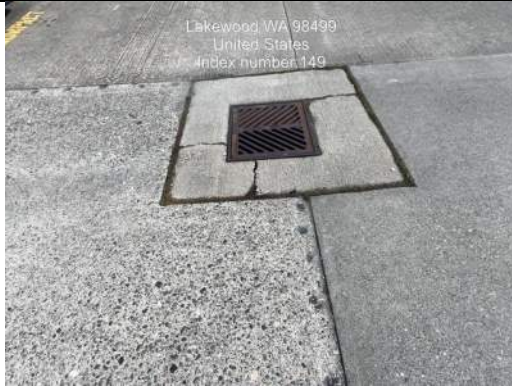
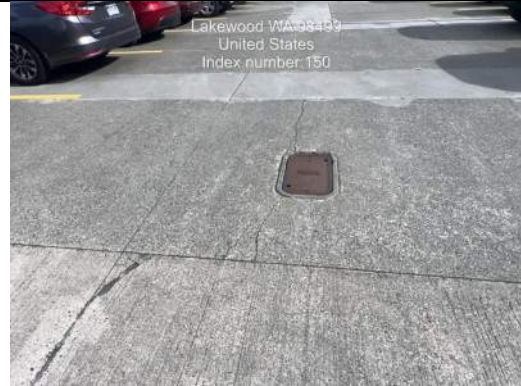
| Secondary Level | Description | Current Condition | TERM Lite Rating | Recommended Corrective Action | Estimated Cost |
|---|---|---|---|---|---|
| Site utilities | Storm drainage system | The storm drainage appeared to be unclogged and functioning.<br>The concrete collars/pavement around the structures have cracks that should be sealed with caulking. | 3.9 | Caulk approximately 50 LF of concrete cracks | \$2,500 |

| Cracks in concrete pavement/collar around sewer lid | Cracks in concrete pavement/collar around storm drain catch basin | Cracks in concrete pavement/collar around meter box |

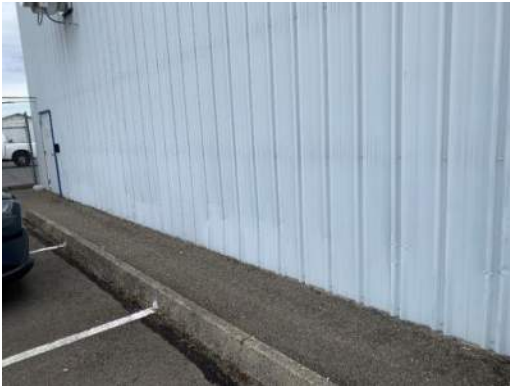
| Secondary Level | Description | Current Condition | TERM Lite Rating | Recommended Corrective Action | Estimated Cost |
|---|---|---|---|---|---|
| Exterior | Corrugated metal siding. | Metal siding damage at the west wall. This is along the whole length.<br>There were two big dents and other small damage on the south wall. There were siding patches on the low roof located at the south wall.<br>Siding bottoms covered by paving. Corrosion noted at the bottom edges of panels.<br>There was also damage to the east wall, at the garage door jamb. | 3.0 | Siding is functional but may need replacement in future. | N/A |

| Damaged panels at west wall. | Wall panel corrosion continues along east (front) wall.<br>Down spout at corner. | Corroded siding bottoms at NE corner. |

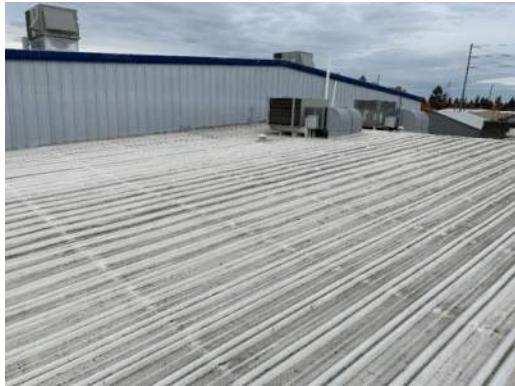
| Secondary Level | Description | Current Condition | TERM Lite Rating | Recommended Corrective Action | Estimated Cost |
|---|---|---|---|---|---|
| Roof | Corrugated metal roofing, with spray on coating. | 2 large hung units on the high roof.<br>Coating over metal roofing chipping off in places. | 2.0 | Roof will need maintenance. Replacement is needed within the next 10 years. | \$300,000 |

| View at low roof over office area. Coating has been applied over roofing to seal leaks at roof fasteners. Roof must be crossed to service large HVAC units on both roofs. | Corrosion at bottom of siding at south wall, roof access ladder at left. | |

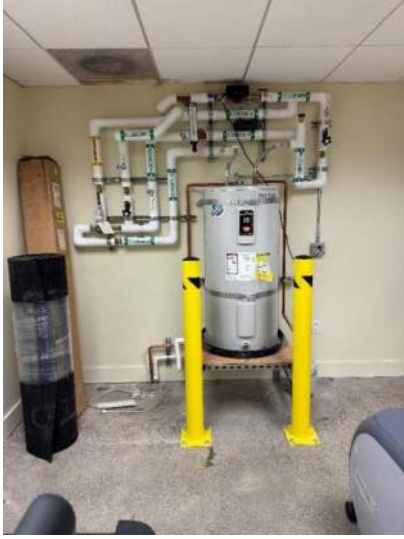
| Secondary Level | Description | Current Condition | TERM Lite Rating | Recommended Corrective Action | Estimated Cost |
|---|---|---|---|---|---|
| Fixtures | Bathroom fixtures, water heater, and eyewash/shower. | Fixtures in bathrooms are working and in adequate condition.<br><br>Water heater in workout area is in adequate condition and is braced properly.<br><br>Eyewash/shower is being checked regularly, every 1-2 months. | 3.5 | None | N/A |

| Water heater working and braced properly | Eyewash/shower is being checked regularly | Restroom fixtures are all working properly |
