# *Transit Asset Management Plan*

# Pierce Transit Facilities Condition Assessment Report: Appendices

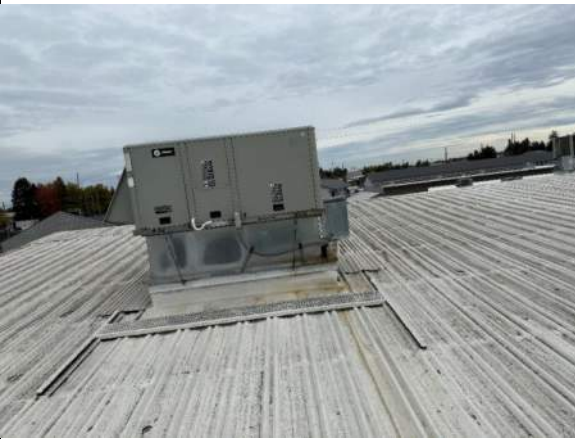
| Return air vent in utility room | Exhaust hood in working area | Roof mounted HVAC unit working properly |

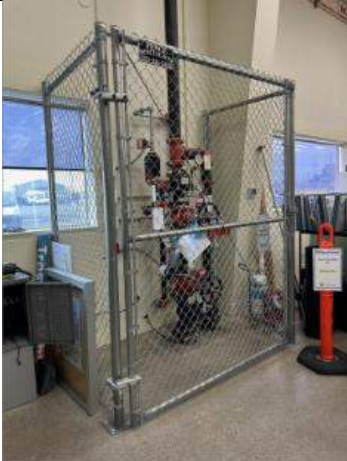
| Secondary Level | Description | Current Condition | TERM Lite Rating | Recommended Corrective Action | Estimated Cost |
|---|---|---|---|---|---|
| Sprinklers | Wet pipe system | Inspected 07/25 – no discrepancies noted. | 3.8 | None | N/A |

| <p>Fire riser (Inspected 07/25 – no discrepancies noted.)</p> | <p>Records room</p> | <p>Flammable storage</p> |

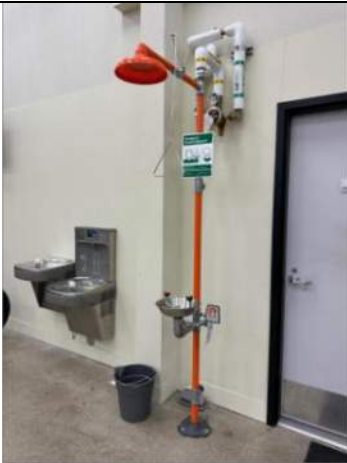
| Secondary Level | Description | Current Condition | TERM Lite Rating | Recommended Corrective Action | Estimated Cost |
|---|---|---|---|---|---|
| Hydrants and other fire protection specialties | Emergency shower | Inspected 10/25 – no discrepancies noted. | 3.8 | None | N/A |

| <p>Emergency shower<br/>(Inspected 10/25 – no discrepancies noted)</p> | <p>Fire alarm panel<br/>(Inspected 07/25 – no discrepancies noted)</p> | <p>Shop area</p> |

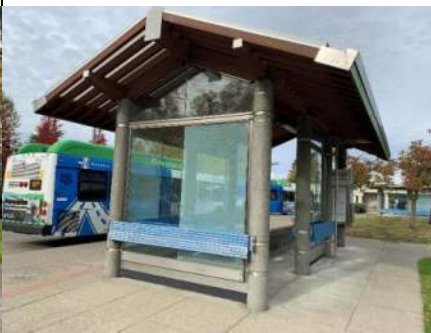
| Utility building | The wood lean rail on the shelter is worn and needs to be painted. | Protective stainless steel beam covers are missing on ends of two beams on the south end of the east shelter. | Concrete has eroded around the downspout on the west side of the west shelter. |

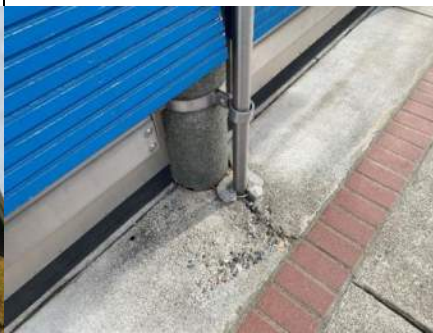
| Secondary Level | Description | Current Condition | TERM Lite Rating | Recommended Corrective Action | Estimated Cost |
|---|---|---|---|---|---|
| Shell appurtenances | Shelter | South shelter concrete noted to have corrosion at downspout | 3.0 | Check if drain blocked, repair concrete | \$1,500 |

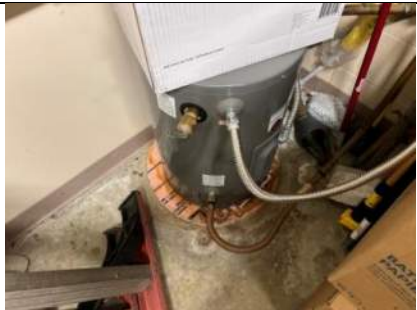
| Secondary Level | Description | Current Condition | TERM Lite Rating | Recommended Corrective Action | Estimated Cost |
|---|---|---|---|---|---|
| Fixtures, water distribution, sanitary waste, rainwater/drainage | Utility building water, sewer, valves, toilets and utility controls<br>Hot water tank, eye wash and mop sink in utility room | Restroom and utility room fixtures in good working condition<br>No issues seen with water distribution or sanitary waste<br>Site stormwater drains are in good condition and appear to function properly<br>Water Heater seems to be replaced recently. The area of the water heater had evidence of a past leak<br>All toilets flush as intended | 3.8 | Inspect the water heater area to confirm that there is no leak | NA |

| Water heater | Eye wash station | Water distribution piping in the Utility Room | Mop sink in the utility room |

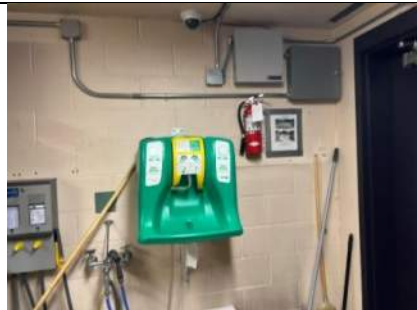
| Secondary Level | Description | Current Condition | TERM Lite Rating | Recommended Corrective Action | Estimated Cost |
|---|---|---|---|---|---|
| | | On-site staff noted that this eye wash in the utility room is outdated and needs to be updated. It was unclear what it needs to be updated to | | Replace eye wash system | \$500 |

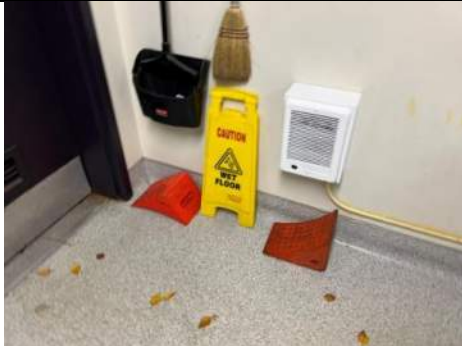
| Secondary Level | Description | Current Condition | TERM Lite Rating | Recommended Corrective Action | Estimated Cost |
|---|---|---|---|---|---|
| Heat generation and distribution systems | Electrical heaters and exhaust fans in utility building Baseboard heaters in utility room | <p>All wall heaters work. The knob is missing on both the men's and women's restrooms, but it is assumed that is intentional to prevent unauthorized personnel from adjusting the heaters</p> <p>Exhaust fans in restrooms were operating and functional during site visit. The actual equipment is located in the attic space and could not be visually observed</p> <p>Unable to test the exhaust fan in the utility room</p> <p>A thermostat was found without a knob. This missing knob might be for the exhaust fan control</p> | 3.5 | Replace thermostat knob or thermostat if needed to be able to adjust equipment operation | \$200 |

| Wall Heater in the Men's Restroom with missing knob | Thermostat with missing knob | Women's Restroom Wall Heater |

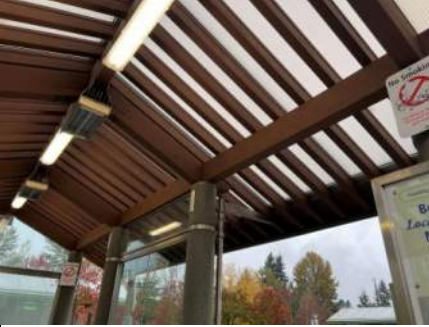
| Secondary Level | Description | Current Condition | TERM Lite Rating | Recommended Corrective Action | Estimated Cost |
|---|---|---|---|---|---|
| Communications & security | Key Card Access<br>Security Cameras<br>Bus Information Screen | Key card access was in good working order<br>Security cameras appeared to be in good working order<br>Passenger bus information screen was working properly and showed no signs of damage. The screen and associated cables are accessible to the public and risk vandalism | 3.5 | It is recommended that the bus information screen be enclosed to protect equipment and cables from vandalism | \$1,000 |

| Utility Meter Termination Panel Unsecured | Bus Information Screen and Associated Cables Open to the Public | Exterior Lighting | Interior Lighting |

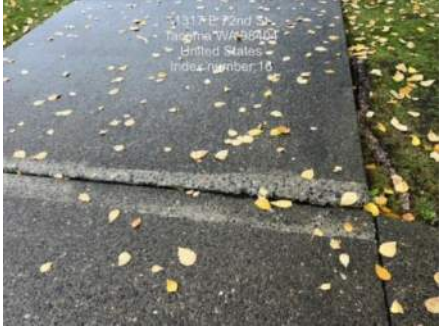
| Secondary Level | Description | Current Condition | TERM Lite Rating | Recommended Corrective Action | Estimated Cost |
|---|---|---|---|---|---|
| | | Sidewalk flatwork and walkways were in good condition with new concrete evident throughout the site. One concrete panel in the sidewalk is sticking up and should be replaced | | Replace sidewalk panels. 32 SQFT | \$2,500 |

| <p>Concrete joint is sticking up. Replace this portion of the sidewalk</p> | <p>Ponded water in the corner of the parking lot</p> | <p>Curb and gutter missing in the parking lot</p> |

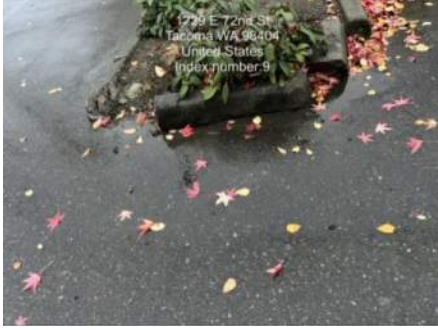
| Secondary Level | Description | Current Condition | TERM Lite Rating | Recommended Corrective Action | Estimated Cost |
|---|---|---|---|---|---|
| | | Curb and gutter replacement needed in parking lot | | Replace curb and gutter Approximately 50 LF | \$4,000 |

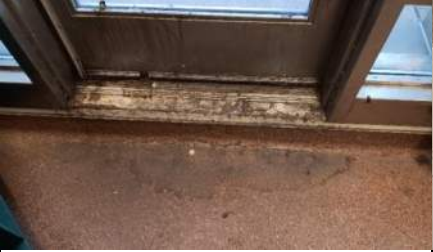
| Secondary Level | Description | Current Condition | TERM Lite Rating | Recommended Corrective Action | Estimated Cost |
|---|---|---|---|---|---|
| Shell appurtenances | No doors open to public | Exterior door closed, but leaking<br>Windows exposed to public | 2.0 | Recommend installing wall over unused exterior windows and doors for security to reduce vandalism risks and maintenance | \$25,000 |

| Inside view | Inside view | Unused exterior door leaking. | Floor slab cracking |

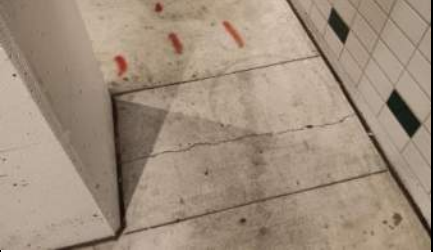
| Secondary Level | Description | Current Condition | TERM Lite Rating | Recommended Corrective Action | Estimated Cost |
|---|---|---|---|---|---|
| Superstructure/structural frame | Frame is concrete pre-stress beams | Concrete is in good condition with no observed cracks or deflections<br>Minor cracking in floor slabs<br>Minor damage at ceiling level near bus lanes | 4.0 | None<br>Cracks minor- no action recommended<br>Cosmetic and not visible to public | N/A |

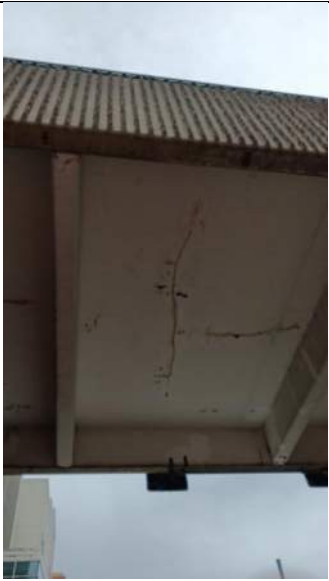
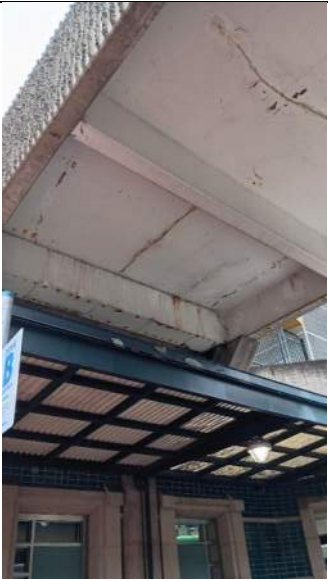
| Cracks on underside of pedestrian bridge | Cracks on underside of pedestrian bridge | Top surface of bridge w/ standing water | Park on top of bus tunnel |

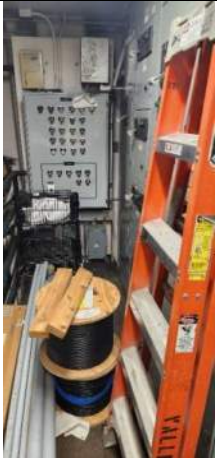
| Secondary Level | Description | Current Condition | TERM Lite Rating | Recommended Corrective Action | Estimated Cost |
|---|---|---|---|---|---|
| | Pump Room Distribution Equipment | Pump Room distribution equipment shows signs of corrosion on exterior of motor control center<br>Working space in front of motor control center is being used as storage space<br>Fountain electrical equipment was turned off at time of inspection and was reported to have been shut down for more than a year | 3.0 | Refinish corroded areas to prevent further damage<br>Remove equipment and materials from motor control center working space<br>Use lock-out-tag-out procedures on the motor control center to prevent unintended use of pump room equipment | \$500 |

| Pump Room motor control center corrosion and obstructed working space | Communication junction boxes in lighting panel dedicated space and obstructed lighting panel working space | Obstructed control equipment working space | Pump room junction box and branch circuit corrosion | Bus Shop lighting | Park area nonfunctional GFCI receptacle |

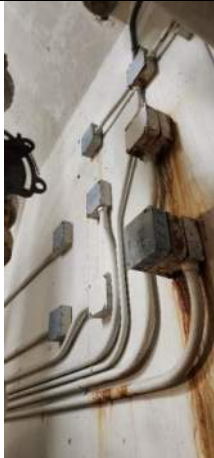
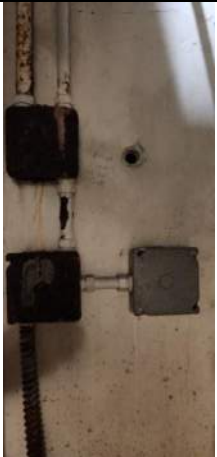
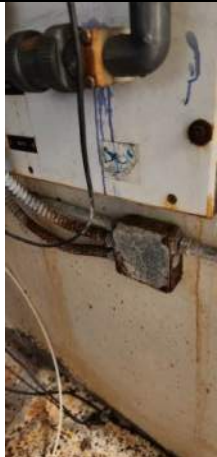
| Secondary Level | Description | Current Condition | TERM Lite Rating | Recommended Corrective Action | Estimated Cost |
|---|---|---|---|---|---|
| | Pump Room | Lighting in the lower pump room is dim and inadequate for maintenance and repairs<br>Junction boxes and branch wiring showed signs of severe corrosion and water penetration. This is a safety hazard due to the potential for short circuits and sparking<br>Open j-boxes with loose wires | 1.5 | Increase lighting capacity in lower pump room<br><br>The corroded j-boxes with water penetration present a safety hazard. Prevent water penetration and replace corroded equipment and junction boxes. This should be a high priority. Powering the system with these deficiencies could lead to short circuit and arc-flash events<br><br>Close j-boxes to prevent access by untrained personnel | \$103,200 |

| Pump Room junction box and branch circuit corrosion | Pump Room junction box and branch circuit corrosion | Pump Room open junction boxes | Pump Room open junction boxes | Nonfunctional security panels with wire trough | Inactive communication equipment in north end Electrical Room |

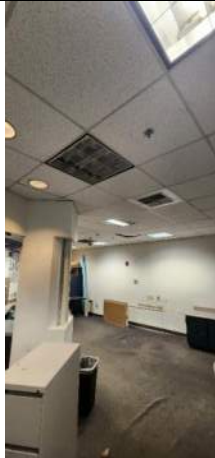
| Secondary Level | Description | Current Condition | TERM Lite Rating | Recommended Corrective Action | Estimated Cost |
|---|---|---|---|---|---|
| | Bus Shop | Some fluorescent lamps are out and lighting is dim | 3.0 | Replace nonfunctional lamps or replace with LED lighting | \$400 |

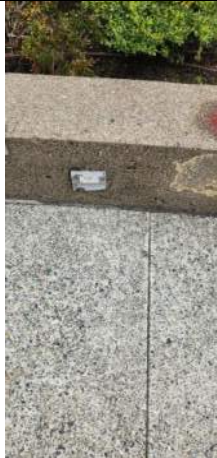
| Secondary Level | Description | Current Condition | TERM Lite Rating | Recommended Corrective Action | Estimated Cost |
|---|---|---|---|---|---|
| | Park Area | Lighting appeared to be in good working order<br>One nonfunctional GFCI receptacle located at north end of park with broken cover | 4.5 | Replace the nonfunctional outlet with a blank cover as was done throughout the rest of the park | \$225 |

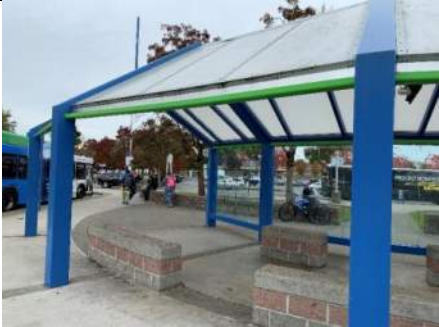
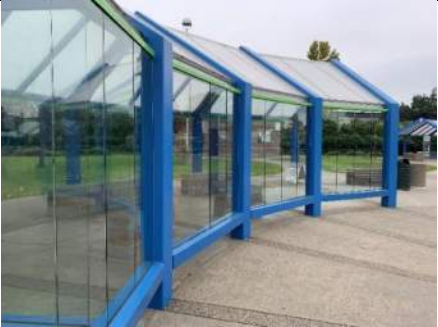
| Overall view from North | Shelter, showing flaking paint on gutters | Shelter, showing flaking paint on gutters |

| Secondary Level | Description | Current Condition | TERM Lite Rating | Recommended Corrective Action | Estimated Cost |
|---|---|---|---|---|---|
| Finishes | Shelters | Shelters: The paint needs touch up. There were minor spots on the blue frame. The green paint is peeling on the gutters<br>Restrooms: Interior epoxy floor. Painted CMU walls are in good condition | 4.0 | Prep and repaint gutters, touch up paint steel tube frames | \$5,000 |

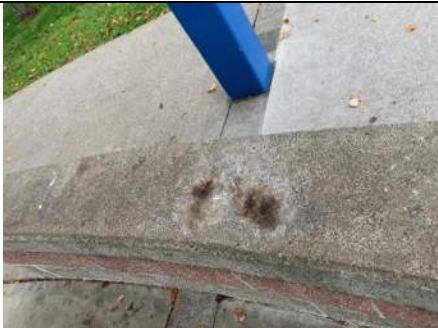
| Dirty seating wall inside shelter | Utility Building | Shelter interior view, dirty seating and floor |

| Secondary Level | Description | Current Condition | TERM Lite Rating | Recommended Corrective Action | Estimated Cost |
|---|---|---|---|---|---|
| Partitions | Partitions | Seating walls need cleaning<br>Exterior wall tops are weathered<br>It was noted the utility room was okay | 4.0 | None | N/A |

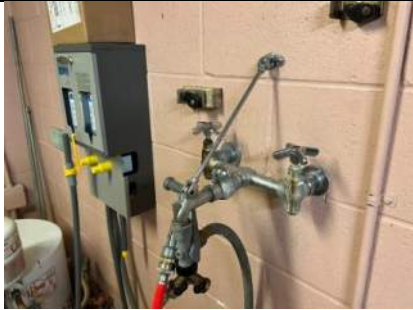
| Secondary Level | Description | Current Condition | TERM Lite Rating | Recommended Corrective Action | Estimated Cost |
|---|---|---|---|---|---|
| | | Floor sink faucet was noted to have a slight leak | | Replace the floor sink faucet | |

| Floor sink faucet in the utility room | Water heater in the utility room | Floor sink in the utility room | |

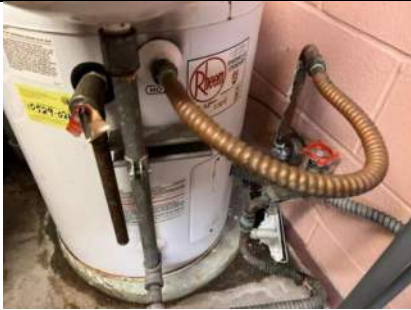
| Secondary Level | Description | Current Condition | TERM Lite Rating | Recommended Corrective Action | Estimated Cost |
|---|---|---|---|---|---|
| | | Water heater was operating as expected. It was noted that there may have been a past water leak on the water heater. Water heater has rust on the base and is not properly braced | | Inspect the water heater for water leaks. | |

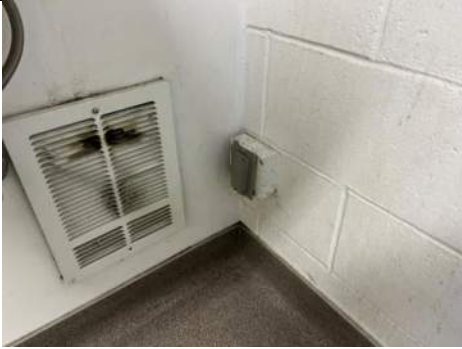
| Wall heater grille damage in the women's restroom | Exhaust fan in the women's restroom | Exhaust fan in the utility room |

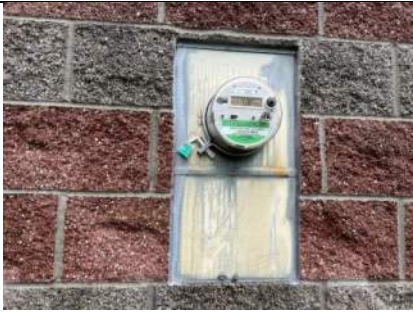
| Utility meter termination panel is mechanically secured but missing utility security seal | Bus information screen and associated cables accessible to the public | Distribution Equipment | Interior Lighting |

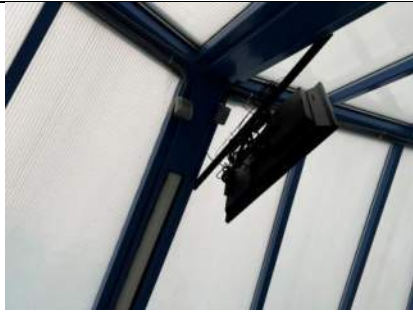
| Secondary Level | Description | Current Condition | TERM Lite Rating | Recommended Corrective Action | Estimated Cost |
|---|---|---|---|---|---|
| Communications & security | Key Card Access<br>Security Cameras<br>Bus Information Screen | Key card access was in good working order<br>Security cameras appeared to be in good working order<br><br>Passenger bus information screen was working properly and showed no signs of damage. The screen and associated cables are accessible to the public and risk vandalism | 3.5 | Enclose the bus information screen to protect equipment and cables from vandalism | \$1,000 |

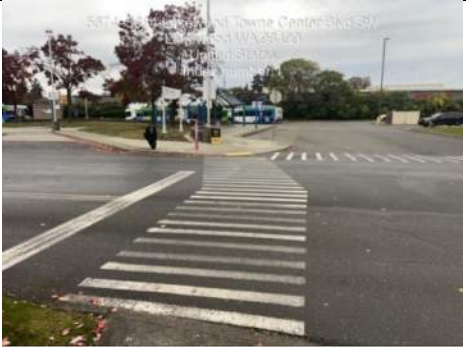
| Secondary Level | Description | Current Condition | TERM Lite Rating | Recommended Corrective Action | Estimated Cost |
|---|---|---|---|---|---|
| Pedestrian areas and associated signage, markings, and equipment | Pedestrian crosswalks, pedestrian sidewalks, and concrete around bus shelters. | Several crosswalks are faded and should be repainted<br><br>Flatwork was found in adequate condition with some minor cracking | 3.6 | Repaint (2) crosswalks that are faded<br><br>Estimated 200 SQFT (paint material) | \$3,000 |

| <p>Crosswalk should be repainted</p> | <p>Interface between ADA ramp and pavement</p> | <p>CMU walls were in good condition</p> |

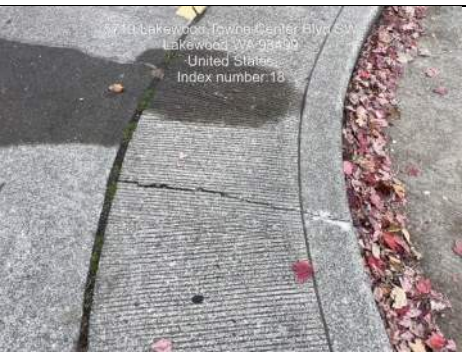
| Secondary Level | Description | Current Condition | TERM Lite Rating | Recommended Corrective Action | Estimated Cost |
|---|---|---|---|---|---|
| | | | | Pedestrian area flatwork contains cracking that should be sealed<br><br>Estimate 50LF of crack sealant | \$3,500 |

| <p>Concrete pavement and flatwork</p> | <p>Flatwork cracking in flatwork</p> | <p>Damaged Asphalt adjacent to bus concrete</p> |

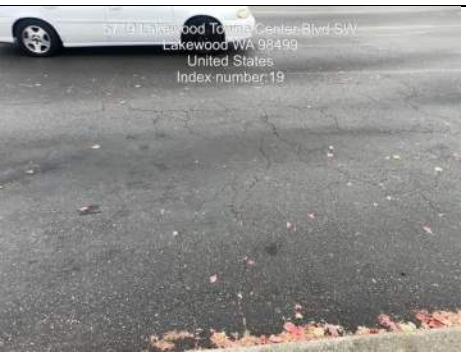
| Secondary Level | Description | Current Condition | TERM Lite Rating | Recommended Corrective Action | Estimated Cost |
|---|---|---|---|---|---|
| Roadways/driveways and associated signage, marking, and equipment | Site roadways, driveways, including concrete bus travel lanes and site asphalt | Concrete paving appears in good condition with some joints that should be sealed<br><br>Asphalt Paving contains substantial cracking adjacent to the concrete bus pad on the roadway. This asphalt should be replaced | 3.5 | Seal joints in concrete<br>Estimated 50 LF | See below |

| Secondary Level | Description | Current Condition | TERM Lite Rating | Recommended Corrective Action | Estimated Cost |
|---|---|---|---|---|---|
| | | | | Replace approximately 2000 SQFT (222 SQYD) of failing asphalt. See below for short and long-term options | |

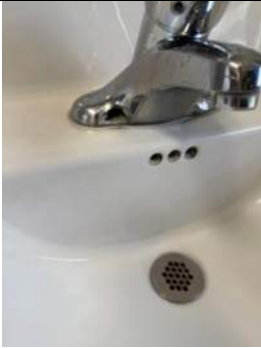
| Secondary Level | Description | Current Condition | TERM Lite Rating | Recommended Corrective Action | Estimated Cost |
|---|---|---|---|---|---|
| Fixtures | Restroom sinks, faucets, urinals, and toilets | Sinks, faucets, urinals, and toilets appear to be in good condition and are functional<br>A hole was noticed on the side of the faucet fixture in the Men's Restroom | 3.1 | Replace the faucet | \$500 |

| Men's Restroom faucet has a hole on the side | Isolation Valve leak in the utility room | Utility Room water heater potential leak |

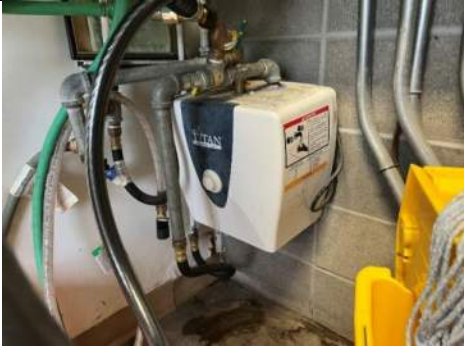
| Secondary Level | Description | Current Condition | TERM Lite Rating | Recommended Corrective Action | Estimated Cost |
|---|---|---|---|---|---|
| Water distribution | Hot and cold water supply | Hot and cold water are in working condition with no visible leaks or defects<br>The water heater is potentially leaking. A mop adjacent to the water heater was wet, possibly from a previous cleaning<br>A noticeable leak was from the isolation valve adjacent to the backflow preventer | 3.1 | Inspect the water heater for leaks<br>Replace the isolation valve, which may require replacing the backflow preventer | \$1,000 |

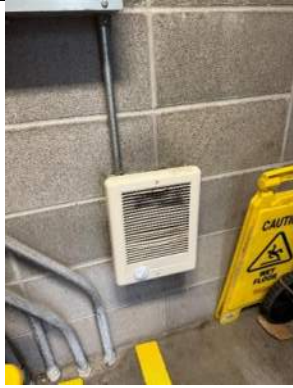
| Secondary Level | Description | Current Condition | TERM Lite Rating | Recommended Corrective Action | Estimated Cost |
|---|---|---|---|---|---|
| Heat generation and distribution systems | Heaters in restrooms and exhaust fans in utility building | Restroom heaters are missing thermostat knobs<br>Utility room wall heater is non-operational<br>Cannot confirm exhaust fans are operational. The actual equipment is located in the attic space and could not be visually observed | 2.5 | Replace the wall heater in the Utility Room<br>Inspect the exhaust fan for operability | \$500 |

| Utility room wall heater | Ceiling louver/vent in restroom | Wall heater missing knob | Men's restroom toilet |

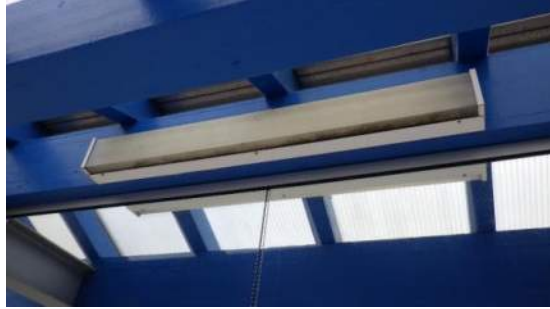
| Secondary Level | Description | Current Condition | TERM Lite Rating | Recommended Corrective Action | Estimated Cost |
|---|---|---|---|---|---|
| | Bus Shelter Interior: Fluorescent | Bus shelter fluorescent lights have cosmetic rust on the enclosures | | Replace fluorescent shelter lighting | \$700 |

| Building exterior LED lighting | | Bus shelter fluorescent lighting | |

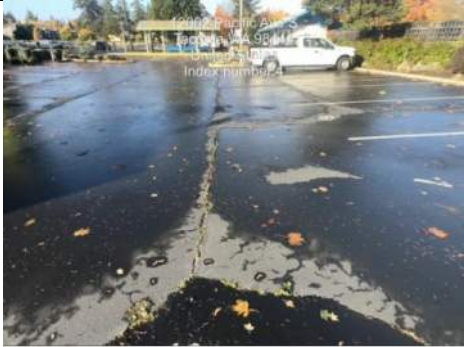
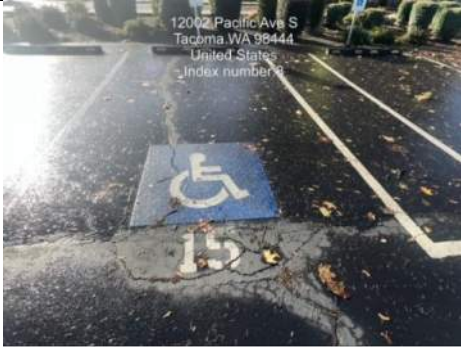
| Secondary Level | Description | Current Condition | TERM Lite Rating | Recommended Corrective Action | Estimated Cost |
|---|---|---|---|---|---|
| | | Asphalt paving in eastern parking lot contains extreme cracking and should be replaced in the future | | Short Term: Seal all joints in the asphalt<br>Estimated 300 LF | \$5,500 |

| <p>East Parking Lot is very cracked. Joints and cracks should be cleaned and resealed</p> | <p>East Parking Lot is very cracked. Joints and cracks should be cleaned and resealed</p> | <p>East parking lot curb and gutter is extremely deteriorated but still functioning</p> |

| Secondary Level | Description | Current Condition | TERM Lite Rating | Recommended Corrective Action | Estimated Cost |
|---|---|---|---|---|---|
| | | | | Long Term: Replace asphalt parking lot<br>Estimate 6500 SQFT | \$59,163 |

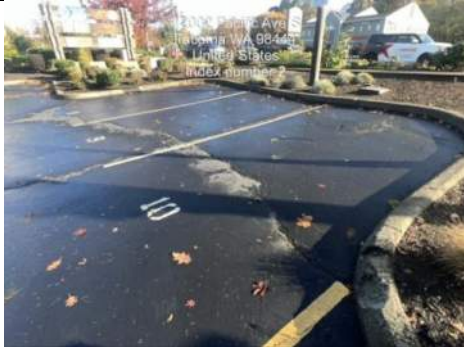
| Secondary Level | Description | Current Condition | TERM Lite Rating | Recommended Corrective Action | Estimated Cost |
|---|---|---|---|---|---|
| | | The curb in the eastern parking lot is extremely damaged and deteriorated | | 200 LF of curb replacement | \$11,000 |

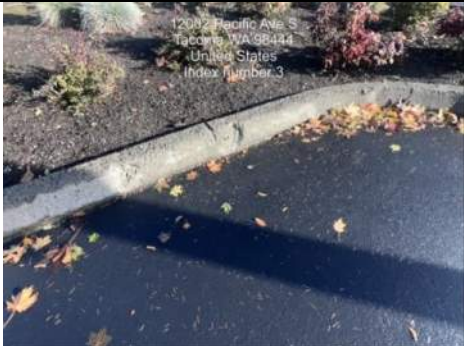
| <p>Additional curb deterioration in east parking lot</p> | <p>Concrete paving for buses requires joint sealant reapplication</p> | <p>Cracks in concrete paving</p> |

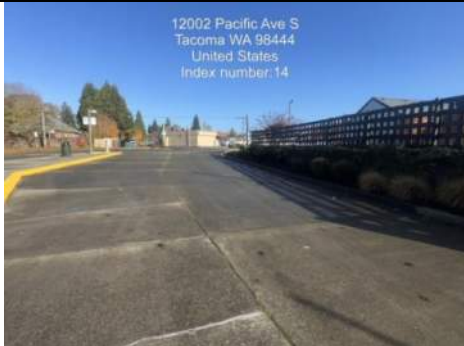
| Secondary Level | Description | Current Condition | TERM Lite Rating | Recommended Corrective Action | Estimated Cost |
|---|---|---|---|---|---|
| Roadways/driveways parking lots, and associated signage, marking, and equipment | Site roadways, driveways, parking lots, including concrete bus travel lanes and site asphalt equipment | Concrete paving appears in good condition with some cracks within the pavement that should be sealed | 2.7 | Seal all cracks in concrete pavement<br>100 LF in bus lane | \$6,000 |

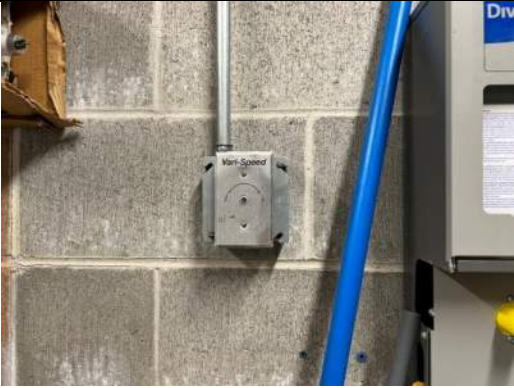
| Broken HVAC Knob in the Utility Room | Ventilation in Restroom |

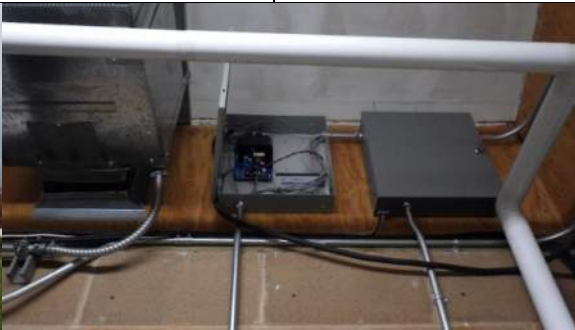
| <p>Building exterior lighting, camera, and electrical revenue meter</p> | <p>Utility room door access control box with door open and unsupported cable</p> | <p>Rider information monitor with damaged mounting bracket</p> | |

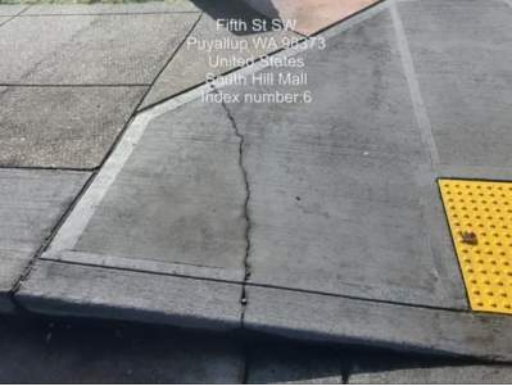
| <p>Concrete paving in the facility from the eastern driveway entrance</p> | <p>Crosswalk pattern at the facility</p> | <p>Cracked sidewalk ramp requiring caulking.</p> |

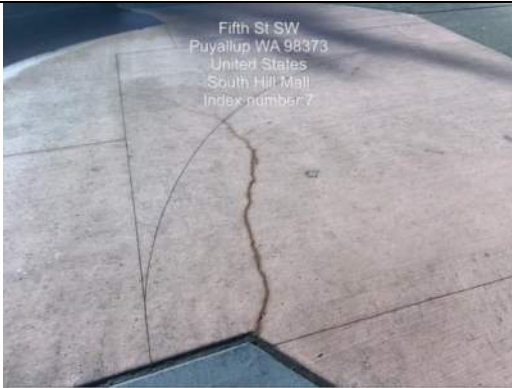
| <p>Cracked metro flatwork requiring caulking</p> | <p>Cracked concrete pavement requiring caulking.</p> | <p>Concrete flatwork in bus area</p> |

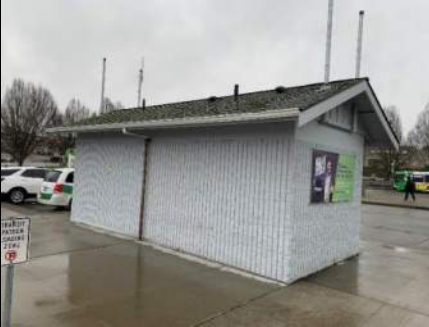
| Secondary Level | Description | Current Condition | TERM Lite Rating | Recommended Corrective Action | Estimated Cost |
|---|---|---|---|---|---|
| Roof | Utility Building<br>Shelters | Roof moss on east side<br>No problems noted | 3.5 | Clean roof. May need a new within the next few years | \$5,000 |

| Secondary Level | Description | Current Condition | TERM Lite Rating | Recommended Corrective Action | Estimated Cost |
|---|---|---|---|---|---|
| Shell appurtenances | Utility Building | Gutter damaged at northwest corner<br>Doors need repainting | 3.5 | Replace when roof is replaced | \$1,000 |

| Gutter damage and moss on the roof of the utility building | Water running off gutter near the end on the middle shelter | Sunken pavers around west downspout of the middle shelter | West shelter |

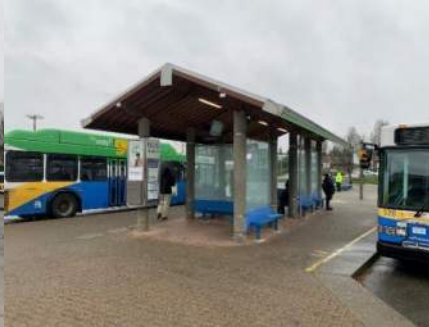
| Secondary Level | Description | Current Condition | TERM Lite Rating | Recommended Corrective Action | Estimated Cost |
|---|---|---|---|---|---|
| | Middle Shelter | Sunken area in pavers around south side downspout. Rain running off southwest corner of gutter | | Investigate; may have broken pipe under pavers. | \$2,000 |

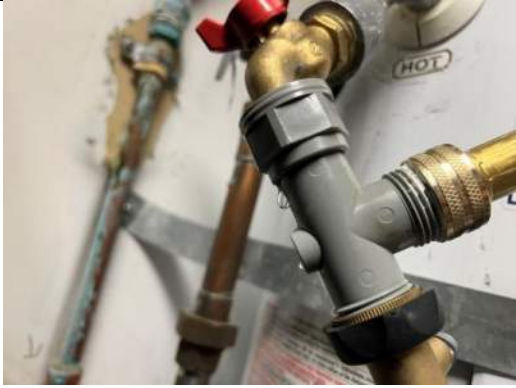
| Secondary Level | Description | Current Condition | TERM Lite Rating | Recommended Corrective Action | Estimated Cost |
|---|---|---|---|---|---|
| Fixtures, water distribution, sanitary waste | Utility building water, sewer, valves, and utility controls. Hot water tank in utility room | <p>Valves and controls in restroom are in good condition</p> <p>Sewer and drainage at utility building are in good condition</p> <p>Hot water tank in utility room is braced incorrectly based on the Uniform Plumbing Code which requires two horizontal straps for seismic restraint. Slight water leak was noted at the outlet fittings. Water heater hose had corrosion</p> <p>There is a slop sink in the women's restroom that is working and is in good condition</p> | 3.0 | <p>Install additional horizontal straps on hot water tank.</p> <p>Repair the water heater leak</p> <p>Replace the water heater hose and fittings</p> | \$1,000 |

| <p>Water heater outlet fitting leak</p> | <p>Water heater fittings corrosion noted</p> | <p>Women's restroom slop sink</p> |

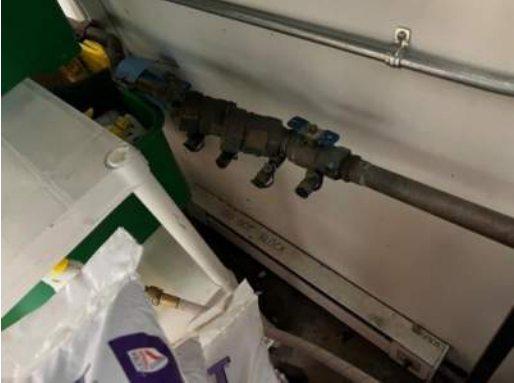
| Secondary Level | Description | Current Condition | TERM Lite Rating | Recommended Corrective Action | Estimated Cost |
|---|---|---|---|---|---|
| Heat generation and distribution systems | Electrical heaters and exhaust fans in utility building | Wall-mounted unit heater in the men's restroom is rusty and appears to have reached its expected life<br>Women's restroom heater is in good condition<br>The baseboard heater in the utility room needs to have clearance of 12 inches on all sides of the unit<br>Restroom wall heaters work as expected | 2.8 | Replace heater in Men's restroom<br>Clear/move all items from area near the heater | \$500 |

| Women's restroom toilet | Women's restroom wall heater | Items are too close to the baseboard heater in the utility room |

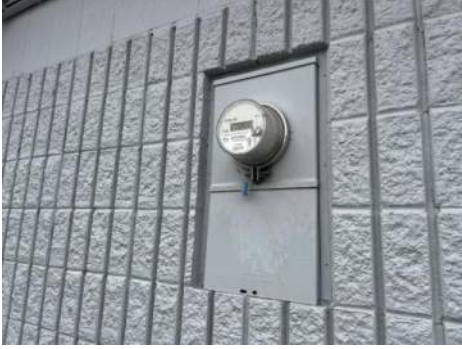
| Secondary Level | Description | Current Condition | TERM Lite Rating | Recommended Corrective Action | Estimated Cost |
|---|---|---|---|---|---|
| Electrical service & distribution | Service Entrance | The utility meter termination access panel is unsecured and accessible to the public. This is a safety hazard to the public | 1.2 | Contact Utility to provide utility security seal | N/A |

| Utility meter termination panel unsecured | Distribution panel working space obstructions | Bus information screen and associated cables open to the public |

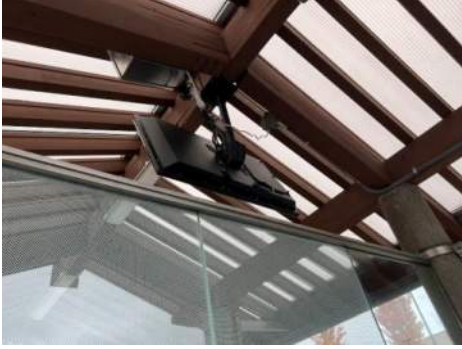
| Secondary Level | Description | Current Condition | TERM Lite Rating | Recommended Corrective Action | Estimated Cost |
|---|---|---|---|---|---|
| Communications & security | Key Card Access<br>Security Cameras<br>Bus Information Screen | Key card access was in good working order<br>Security cameras appeared to be in good working order<br>Passenger bus information screen was working properly and showed no signs of damage. The screen and associated cables are accessible to the public and risk vandalism | 3.5 | It is recommended that the bus information screen be enclosed to protect equipment and cables from vandalism | \$4,000 each |

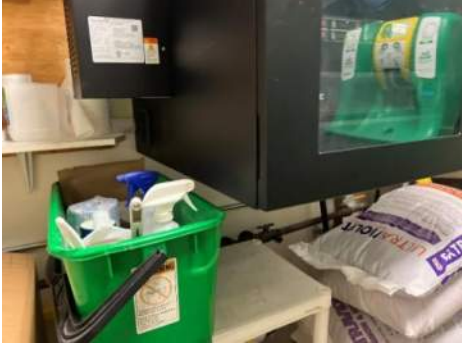
| Obstructed working space around communication equipment | Exterior lighting | Interior lighting |

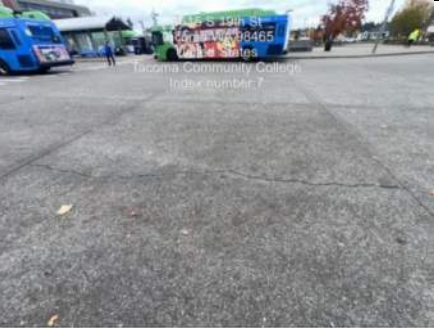
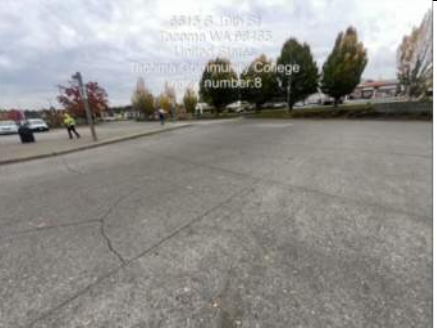
| Secondary Level | Description | Current Condition | TERM Lite Rating | Recommended Corrective Action | Estimated Cost |
|---|---|---|---|---|---|
| | | Concrete paving at the bus location was in marginal condition and contained cracking. These cracks should be sealed | | Concrete paving –<br>Approximately 150 LF of cracks should be sealed | \$8,500 |

| <p>Sidewalk near entrance to the facility</p> | <p>Paving in bus pick up area has cracking requiring sealant</p> | <p>Paving in bus pick up area has cracking requiring sealant</p> |

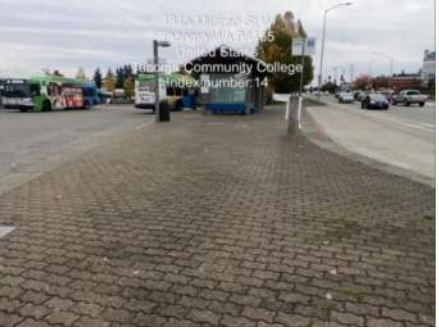
| Secondary Level | Description | Current Condition | TERM Lite Rating | Recommended Corrective Action | Estimated Cost |
|---|---|---|---|---|---|
| Pedestrian areas and associated signage, markings, and equipment | Pedestrian crossing areas, plazas, sidewalks | The brick surface located in the plaza areas was in marginal condition and is fairly faded and contains moss in some cracks. This should be cleaned up to prevent organic material from damaging the bricks | 2.8 | Brick should be cleaned of moss and organics growing in joints | N/A |

| <p>Parking area asphalt and curb</p> | <p>Brick in pedestrian areas at the bus station contains moss growing in certain location. This should be cleaned and removed</p> | <p>Damaged curb in parking lot requiring replacement. Approximately 30 LF</p> |

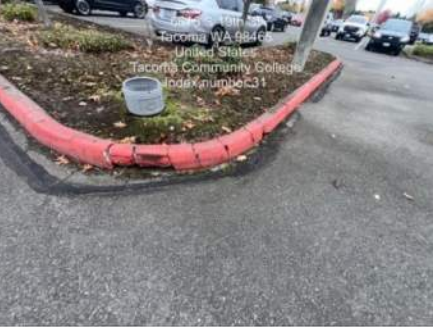
| Secondary Level | Description | Current Condition | TERM Lite Rating | Recommended Corrective Action | Estimated Cost |
|---|---|---|---|---|---|
| Parking lots and associated signage, markings, and equipment | Curb in parking lot | The asphalt parking lot was in good condition<br>There is a 30 LF segment of curb in the parking lot that requires replacement | 3.0 | Replace curb in parking lot<br>Approximately 30 LF | \$2,350 |

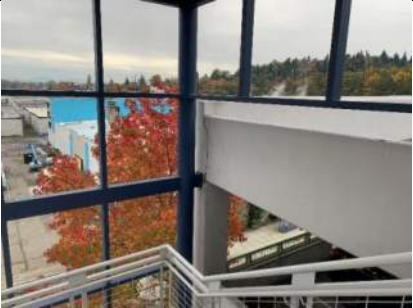
| Cracked concrete at stair tower connection to east garage | Cracked concrete at beam/column joint at the top of east garage | Crack in shear wall 1 <sup>st</sup> floor west garage | Crack in ceiling of west garage |

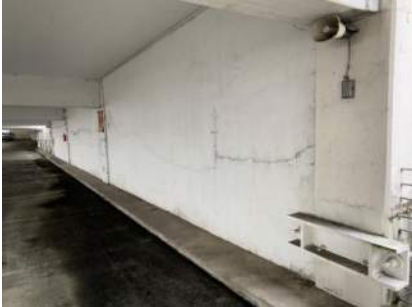
| Exposed rebar at northwest corner of west garage. | Cracked shear wall at level 6 west garage | Cracked concrete over prestressing anchorage pocket at west garage | Cracked ceiling level 1 of the west garage |

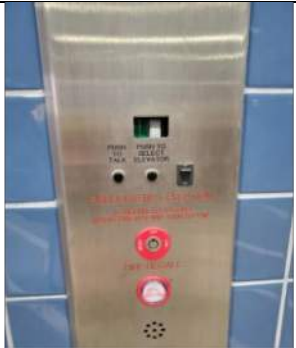
| Secondary Level | Description | Current Condition | TERM Lite Rating | Recommended Corrective Action | Estimated Cost |
|---|---|---|---|---|---|
| Elevators | <p>Hydraulic passenger elevators located in East Garage, West Garage, and Pierce Transit Island. All were manufactured around 2023</p> <p>East Garage and West Garage Elevators have rated capacities of 4,500 lbs. Pierce Transit Island elevator has a rated capacity of 3,000 lbs.</p> | <p>East Garage elevators are functioning adequately with some minor damage to the call button fixture at the Level 1/G landing and minor scratches to the cab finishes</p> <p>Pierce Transit Island elevator is functioning adequately with some dents/scratches and vandalism visible in the cab</p> <hr/> <p>West Garage elevators are out of service due to a water leak at the landing which is causing an unsafe condition in the pit. Because of this, the cabs were not accessible during the assessment. Condition of equipment appears adequate, but operation of the units could not be confirmed</p> | 3.5 | <p>Minor repairs are recommended for the fixtures and finishes for the East Garage and Pierce Transit Island elevators, though the damage is mainly cosmetic</p> <hr/> <p>West Garage elevators are out of service due to a condition not directly related to the elevator equipment. The water leakage must be repaired as soon as possible in order to return the elevators to service and prevent deterioration</p> | Varies |

| East Garage elevator landing, Level 1 | East Garage damaged hall station, Level 1 | East Garage Car 1 Cab; Car 2 Similar |

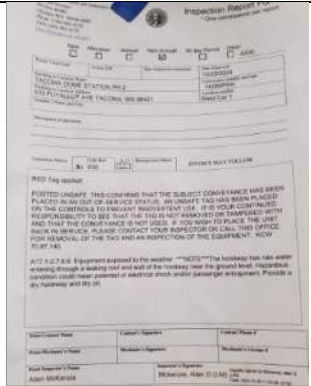
| <p>Hydraulic power unit, control cabinet and hydraulic oil cooler. East Garage Car 2 shown, other units are similar</p> | <p>West Garage elevator landing, Level 1</p> | <p>West Garage red tag notice</p> |

| Secondary Level | Description | Current Condition | TERM Lite Rating | Recommended Corrective Action | Estimated Cost |
|---|---|---|---|---|---|
| Rainwater drainage | Water drainage in the east and west parking structure | West Garage: A drainage leak by the west elevators has prevented them from permitting use. Staff is aware of this issue and are currently working to fix it<br><br>East Garage: No current issues according to staff | 2.5 | Eliminate water drainage at west elevators | Varies (this is already being worked on) |

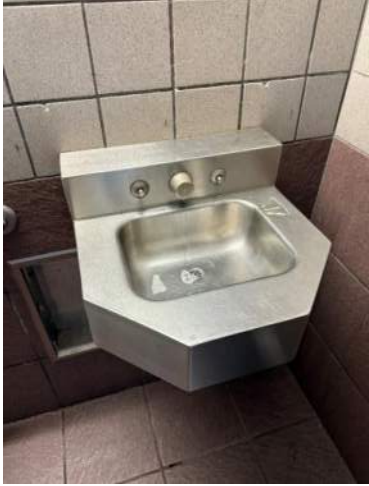
| Secondary Level | Description | Current Condition | TERM Lite Rating | Recommended Corrective Action | Estimated Cost |
|---|---|---|---|---|---|
| | | Fixtures in pick-up/drop-off area restroom are in good condition with the exception of one leaking faucet, one broken towel dispenser with integral garbage can, and one missing towel dispenser with integral garbage can | | | |

| Leaking faucet in Public Restroom | Broken towel dispenser with integral garbage | Missing towel dispenser with integral garbage |

| Secondary Level | Description | Current Condition | TERM Lite Rating | Recommended Corrective Action | Estimated Cost |
|---|---|---|---|---|---|
| Fixtures | Fixtures in the security room restroom, bus shop restrooms, and pick-up/drop-off area island restrooms. | Security room restroom fixtures appear to be in good condition with no visible leaks | 3.0 | Repair sink faucet and replace towel dispensers with integral garbage can | \$2,000 |

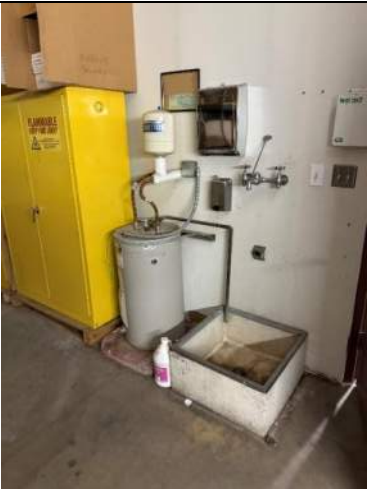
| Secondary Level | Description | Current Condition | TERM Lite Rating | Recommended Corrective Action | Estimated Cost |
|---|---|---|---|---|---|
| | | Water heater in the facilities maintenance work room is not properly braced per the Uniform Plumbing Code and has reached the end of its typical life and should be replaced | | Replace Facility Maintenance Work Room water heater | \$1,000 |

| Water heater in Facility Maintenance Work Room that should be replaced | Water heaters need two horizontal straps per seismic code requirements | Rain water drainage preventing use of west elevators |

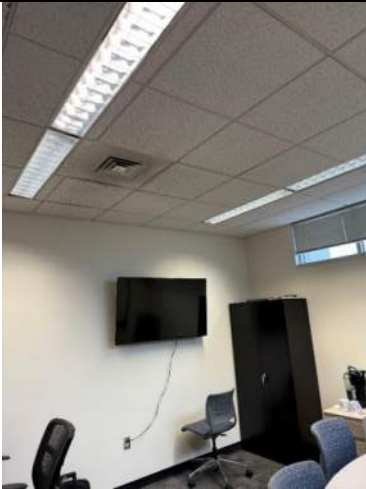
| Secondary Level | Description | Current Condition | TERM Lite Rating | Recommended Corrective Action | Estimated Cost |
|---|---|---|---|---|---|
| Heating and cooling generation and distribution systems | Security room HVAC system | Appears to be working properly during site visit, but area gets warm in summer | 3.3 | Repair or replace HVAC unit with larger unit if needed | \$25,000 |

| Security Room area gets too warm in summer | Facility Maintenance Work Room needs one radiant heater replaced | Aging water heater in Facility Maintenance Work Room should be replaced |

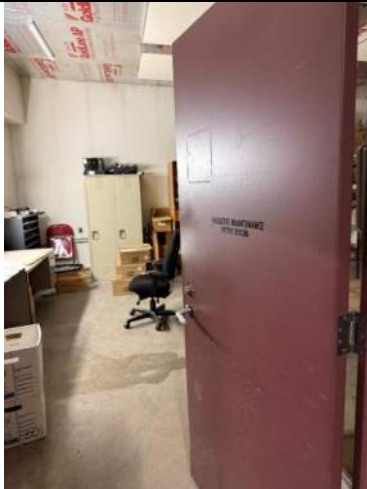
| Secondary Level | Description | Current Condition | TERM Lite Rating | Recommended Corrective Action | Estimated Cost |
|---|---|---|---|---|---|
| | Facility Maintenance Work Room | One of the radiant heaters in the Facility Maintenance Work Room was not operating and needs to be replaced | 2.0 | Replace radiant heater | \$1,000 |

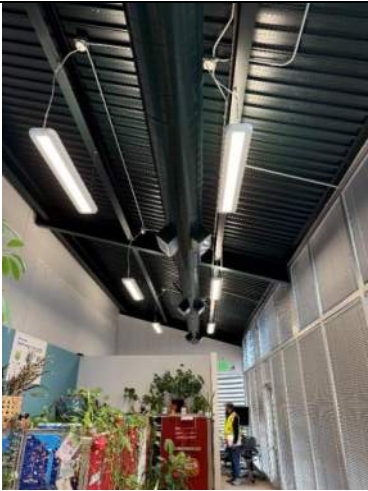
| Secondary Level | Description | Current Condition | TERM Lite Rating | Recommended Corrective Action | Estimated Cost |
|---|---|---|---|---|---|
| | Customer Service (east end) HVAC system | Staff confirmed that the cooling system was not able to keep up on warm summer days and stated that the space needed to be evacuated because of high temperatures in Summer 2024. Access to the unit was very limited and could not be visually inspected. Unit has either reached the end of its useful life or needs to be replaced with a larger unit | 2.5 | Repair/replace HVAC unit that serves the east end of Customer Service | \$50,000 |

| <p>East end of Customer Service that gets too warm in summer</p> | <p>West Elevator Room AC unit was not able to keep room at set temperature</p> | <p>Bathroom ventilation fans were all working properly</p> |

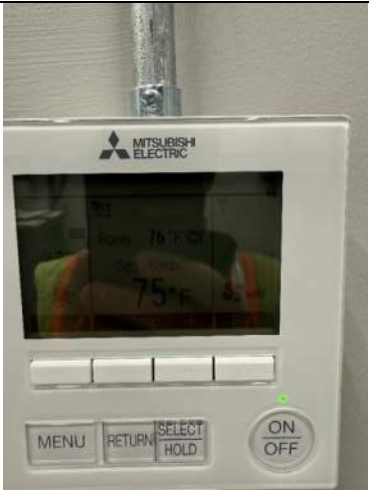
| Secondary Level | Description | Current Condition | TERM Lite Rating | Recommended Corrective Action | Estimated Cost |
|---|---|---|---|---|---|
| | West Elevator Room | The AC was not turning on while onsite and the room temperature was higher than the set temperature | 2.5 | Repair or replace HVAC/AC unit | \$20,000 |

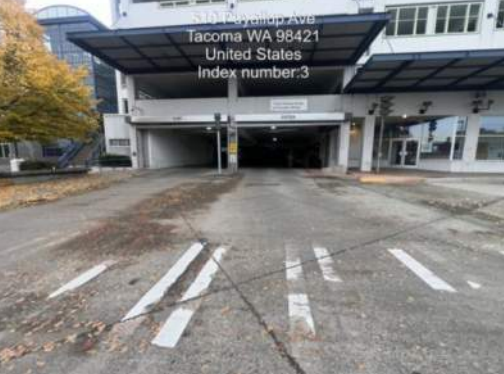
| <p>Tacoma Dome Station signage, bollards, and fencing</p> | <p>Painting in parking garage was recently painted</p> | <p>Crosswalk in front of west parking lot entrance is faded and required reinstallation (thermoplastic material)</p> |

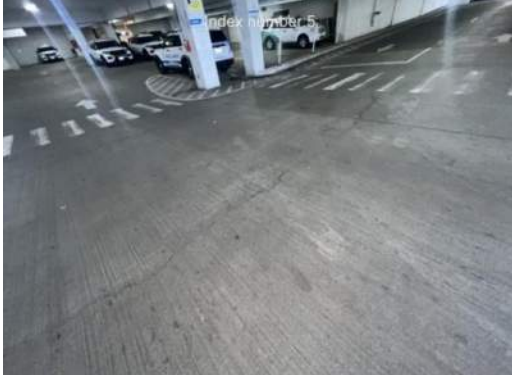
| <p>Index number:5</p> | <p>510 Puyallup Ave<br/>Tacoma WA 98421<br/>United States<br/>Index number:11</p> | <p>610 Puyallup Ave<br/>Tacoma WA 98421<br/>United States<br/>Index number:53</p> |

| <p>Crosswalks in west parking garage requires reinstallation of crosswalks (paint material)</p> | <p>Painting in parking garage was recently painted</p> | <p>Concrete pavement cracking in bus area requiring sealant</p> |

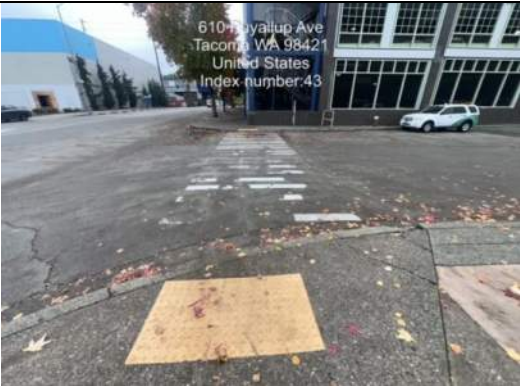
| <p>Crosswalk near bus pavement entrance requires reinstallation. (thermoplastic material)</p> | <p>Concrete pavement cracking in bus area requiring sealant</p> |

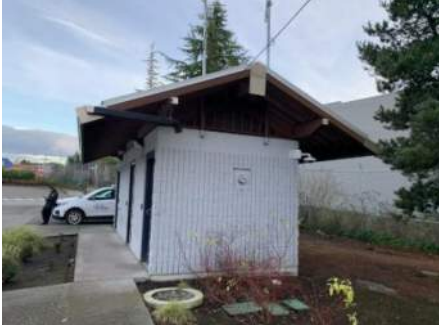
| Secondary Level | Description | Current Condition | TERM Lite Rating | Recommended Corrective Action | Estimated Cost |
|---|---|---|---|---|---|
| Shell appurtenances | Utility building | Missing downspout allows rainfall to damage landscaping | 3.0 | Add chain to downspout or reroute downspout closer to wall so that it can be supported | \$1500 |

| Utility Building, view from north | Utility Building, missing downspout on west end | East Shelter, view looking west |

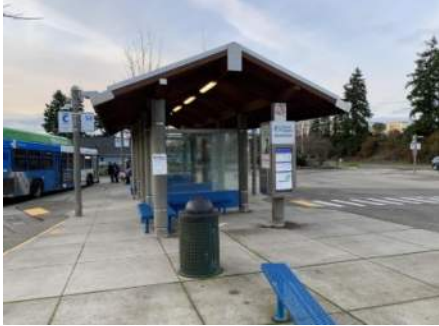
| Secondary Level | Description | Current Condition | TERM Lite Rating | Recommended Corrective Action | Estimated Cost |
|---|---|---|---|---|---|
| | Shelters: Timber roof framing, concrete columns | Shelters: West shelter, West end, protective metal cap missing on South beam end, Steel clamp repair to split on North beam end and other steel likely added to replace damaged concrete column. | 3.5 | Replace protective metal cap | \$500 |

| West Shelter, looking north | West Shelter, missing protective cap on end of south beam | West Shelter, steel clamp to repair split on north beam end |

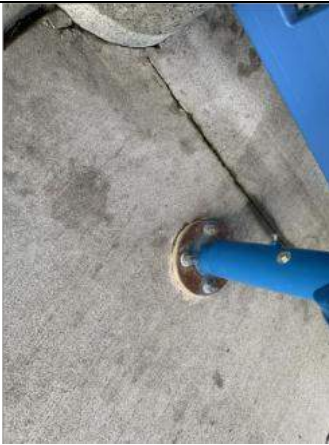
| Secondary Level | Description | Current Condition | TERM Lite Rating | Recommended Corrective Action | Estimated Cost |
|---|---|---|---|---|---|
| Passenger Areas | East Shelter | Seat at East end broken. Seat mounting flanges to concrete are rusting | 3.0 | Repair seat. Paint mounting flanges | \$1000 |

| East Shelter, broken seat | Rusted seat mounting flange | Dirt around column base |

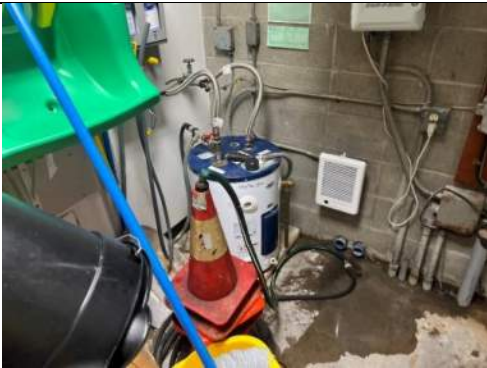
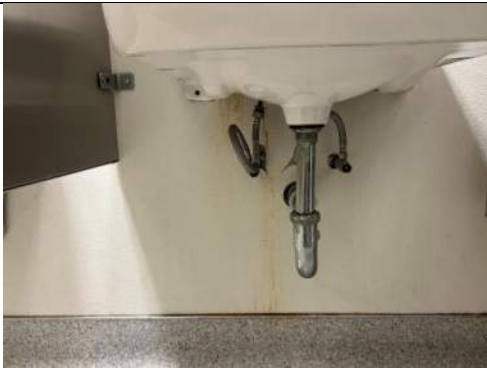
| Secondary Level | Description | Current Condition | TERM Lite Rating | Recommended Corrective Action | Estimated Cost |
|---|---|---|---|---|---|
| Water distribution | Restroom facility water distribution system | Water distribution system functioning with no apparent leaks<br><br>There may have been a past water leak near the water heater. The water heater operates normally as expected | 3.7 | Inspect the water heater for water leaks | N/A |

| Water Heater with possibly a slight leak | Water Heater with possibly a slight leak | Women's Restroom Toilet |

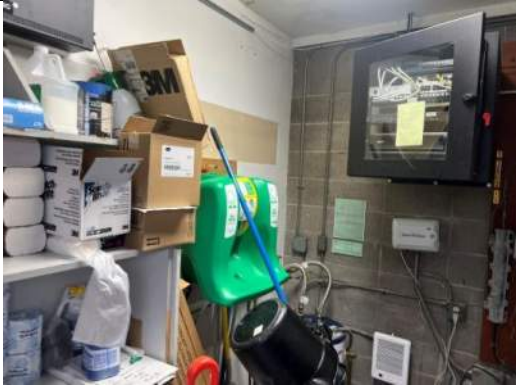
| Secondary Level | Description | Current Condition | TERM Lite Rating | Recommended Corrective Action | Estimated Cost |
|---|---|---|---|---|---|
| | | There is a note posted on the communications cabinet that states to leave the cabinet slightly open as the AC unit is broken | | Repair the AC unit for the communications cabinet in the utility room | |

| <p>Communications Cabinet with a note regarding the broken AC Unit</p> | <p>Restroom Facility Louvered Ceiling Vents</p> | <p>Women's Restroom Wall Heater</p> |

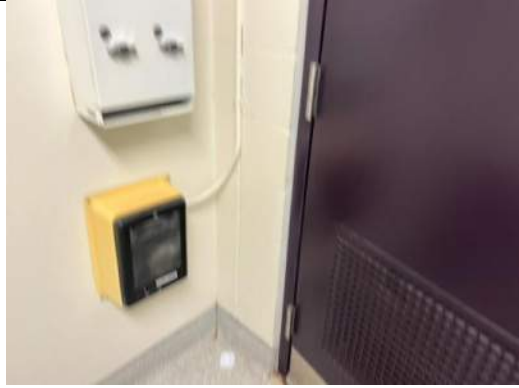
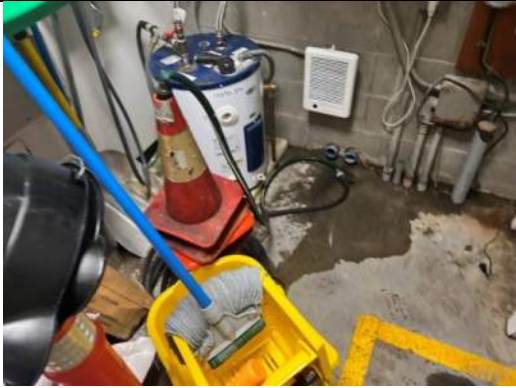
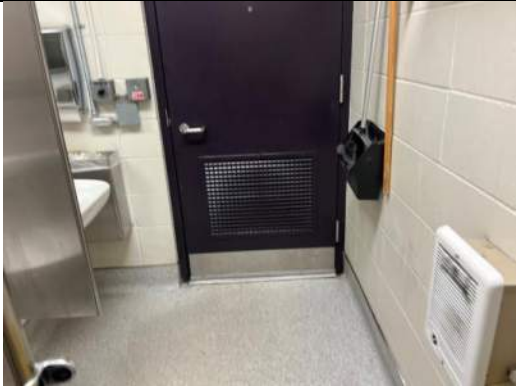
| Secondary Level | Description | Current Condition | TERM Lite Rating | Recommended Corrective Action | Estimated Cost |
|---|---|---|---|---|---|
| Heat generation and distribution systems | Restroom facility wall mounted heaters | Heating provided by electric wall mounted unit heaters. Units appear to be functional. The thermostat knob on all restroom heaters appears to be missing<br>Slight discoloration on the Wall Heater grille in the Men's Restroom | 3.0 | Replace the wall heater knob, if desired | \$1,000 |

| <p>Utility Room Wall Heater</p> | <p>Men's Restroom Wall Heater</p> | |
