# *Transit Asset Management Plan*

# Pierce Transit Facilities Condition Assessment Report: Appendices

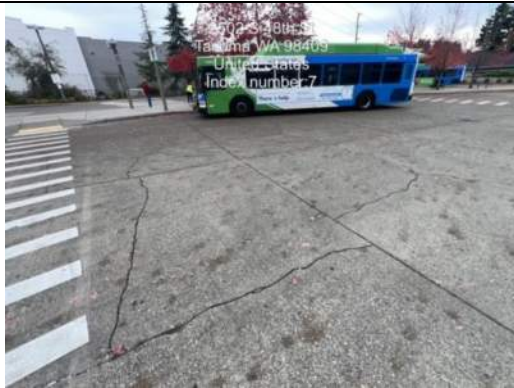
| <p>2515 S 48th St<br/>Tacoma WA 98409<br/>United States<br/>Index number:7</p> | <p>2515 S 48th St<br/>Tacoma WA 98409<br/>United States<br/>Index number:15</p> | <p>2515 S 48th St<br/>Tacoma WA 98409<br/>United States<br/>Index number:17</p> |

| <p>Cracked in concrete paving that was previously sealed</p> | <p>Cracking in concrete paving that contains moss and no sealant. This area should be sealed to prevent additional damage</p> | <p>Cracking in concrete paving that contains moss and no sealant. This area should be sealed to prevent additional damage</p> |

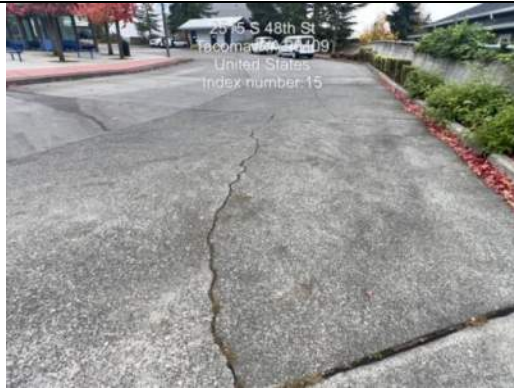
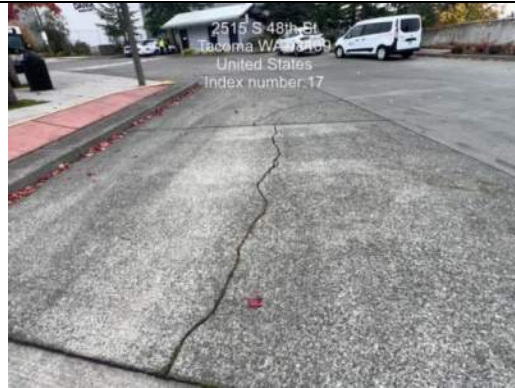
| Secondary Level | Description | Current Condition | TERM Lite Rating | Recommended Corrective Action | Estimated Cost |
|---|---|---|---|---|---|
| Roadways/driveways and associated signage, marking, and equipment | Parking garage and bus driveway area concrete panels | Concrete paving in bus area was found in adequate condition. Concrete cracks in paneling should be sealed to prevent further damage<br>Bus entrance area contains unsealed cracks | 3.3 | Seal cracks in concrete pavement in bus area<br>Estimated 150 LF | \$8,500 |

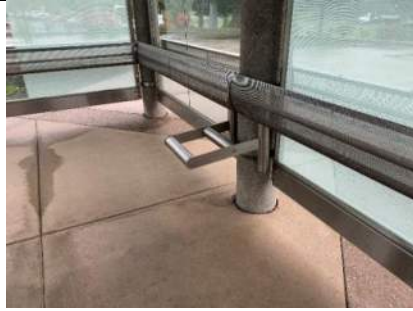
| Utility Building: Looking West | West Shelter: Looking West | Shelter: Glass panels and columns | West shelter: seat missing perforated metal cover |

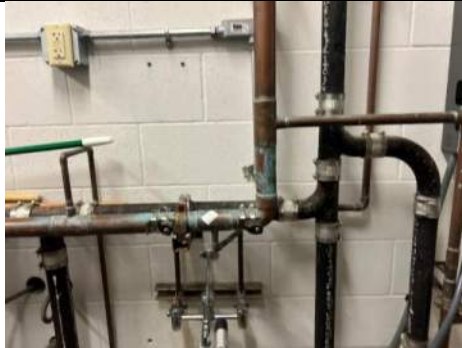
| Utility Room Photo | Utility Room Piping Corrosion | Eyewash Station in the Utility Room | |

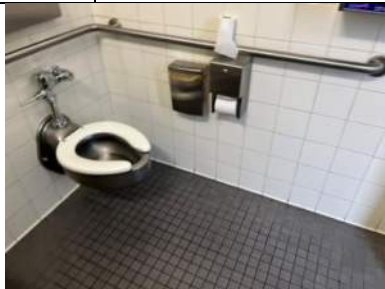
| Handsink in the Women's Restroom | Toilet in the Women's Restroom | Handsink in the Men's Restroom | Toilet in the Men's Restroom |

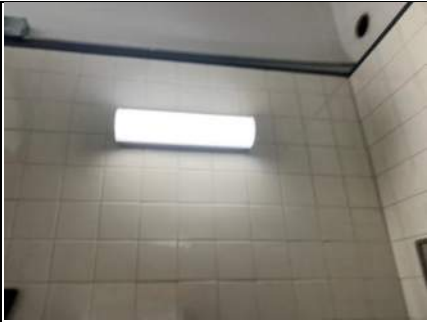
| Secondary Level | Description | Current Condition | TERM Lite Rating | Recommended Corrective Action | Estimated Cost |
|---|---|---|---|---|---|
| Chimneys and vents | Exhaust Fan (Men's and Women's Room) | Exhaust fan was out of reach and could not confirm operability | 2.5 | Confirm operability | N/A |

| Women's Restroom Exhaust Fan | Men's Restroom Heater | Exhaust Fan Assembly in the Utility Room | Heater in the Utility Room |

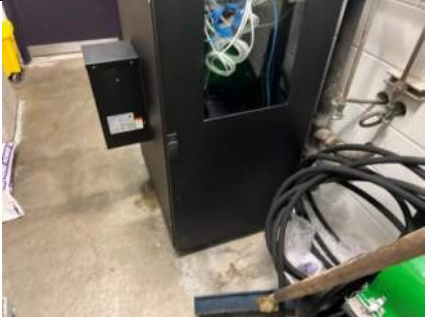
| Secondary Level | Description | Current Condition | TERM Lite Rating | Recommended Corrective Action | Estimated Cost |
|---|---|---|---|---|---|
| Communications & security | Key Card Access<br>Security Cameras | Key card access was in good working order<br>Security cameras appeared to be in good working order<br>There is equipment stored in the working space in front of the communication cabinet | 4.5 | Clear the area around the communication equipment inside the utility room | \$225 |

| Distribution Equipment | Obstructed Communication Equipment Working Space | Interior Lighting | Exterior Lighting |

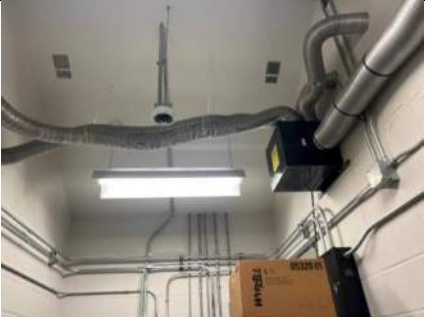
| Secondary Level | Description | Current Condition | TERM Lite Rating | Recommended Corrective Action | Estimated Cost |
|---|---|---|---|---|---|
| Lighting & branch wiring (interior and exterior) | Exterior Lighting: LED<br>Interior Lighting: Fluorescent | Exterior lighting appeared to be in good working order and well-spaced throughout the facility. Interior lighting was adequate and functioning properly<br>Assessment was conducted during daylight hours, and the exterior lights were not in operation | 4.5 | Assess the exterior lights for functionality during non-daylight hours. Replace bulbs and ballast as required | \$100 |

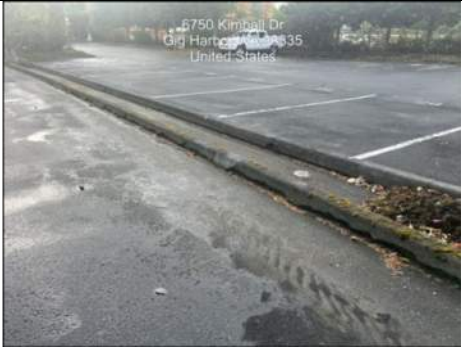
| <p>Damage concrete curb in north parking lot</p> | <p>Cracking in asphalt in north parking lot</p> | <p>Cracking in asphalt in north parking lot</p> |

| Secondary Level | Description | Current Condition | TERM Lite Rating | Recommended Corrective Action | Estimated Cost |
|---|---|---|---|---|---|
| | | Replace 100 LF of curb in north parking lot | | Replace curb | \$5,500 |

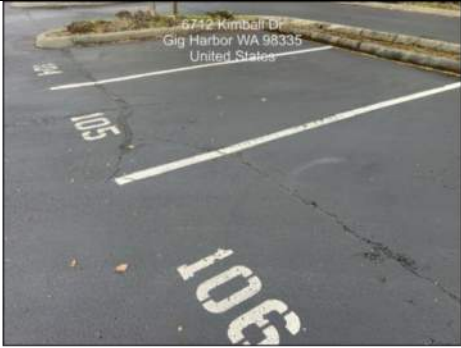
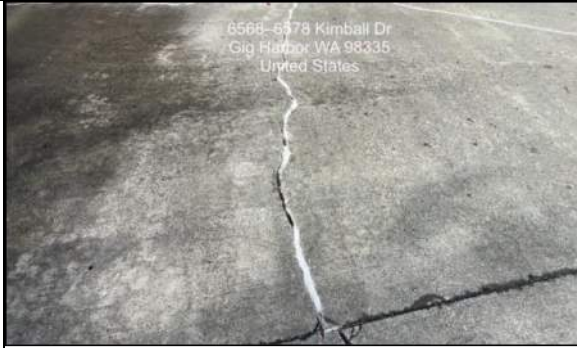
| Secondary Level | Description | Current Condition | TERM Lite Rating | Recommended Corrective Action | Estimated Cost |
|---|---|---|---|---|---|
| Parking lots and associated signage, markings, and equipment | Site roadways, driveways, parking lots, including concrete bus travel lanes and site asphalt | Asphalt pavement in north parking lot was found in adequate condition but contains cracking that should be sealed to prevent further damage<br>Estimated 100LF of cracks | 2.5 | Seal all joints in the asphalt<br>Estimated 100 LF | \$2,500 |

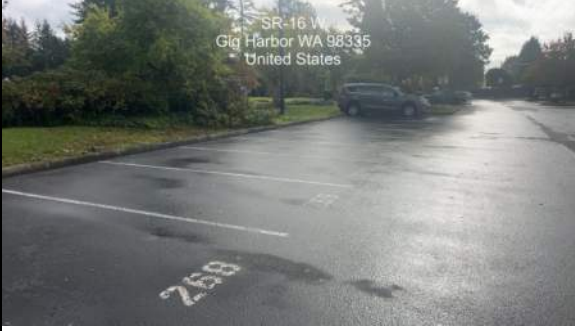
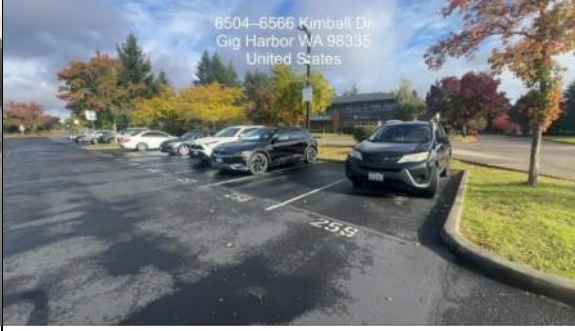
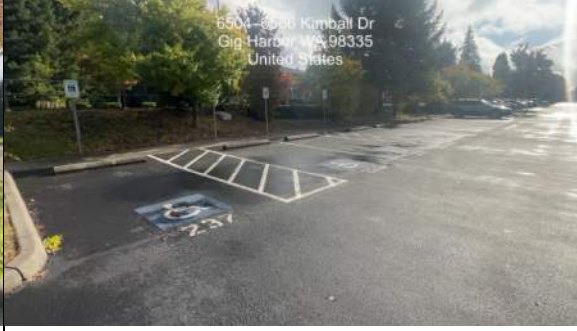
| <p>South parking lot asphalt condition</p> | <p>South parking lot general conditions</p> | <p>Parking lot asphalt general condition</p> |

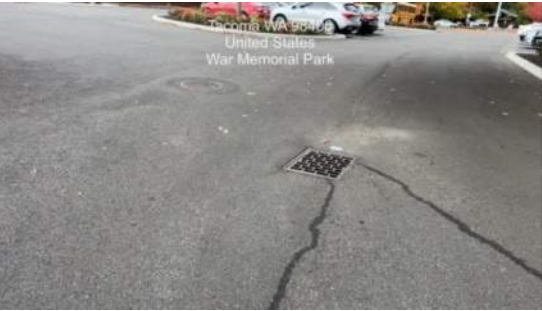
| <p>New concrete sidewalks were observed</p> | <p>Condition of pavement as well as newly installed curb connecting to existing old curb</p> | <p>Condition of pavement adjacent to utility structure lids</p> |

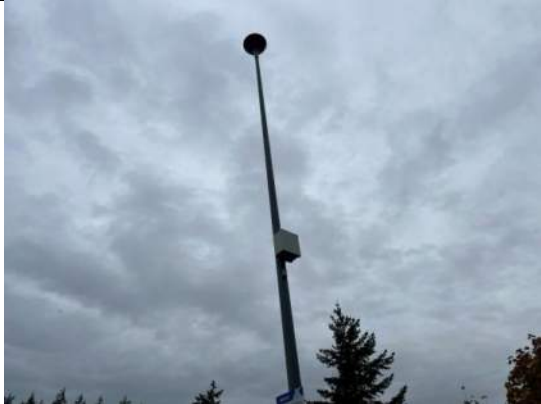
| Secondary Level | Description | Current Condition | TERM Lite Rating | Recommended Corrective Action | Estimated Cost |
|---|---|---|---|---|---|
| Lighting & branch wiring (interior and exterior) | Exterior lighting | Assessment was conducted during daylight hours, and some of the exterior lights were not in operation | 3.5 | It is recommended that the exterior lights be assessed for functionality during non-daylight hours. Replace bulbs and ballast as required | N/A |

| Service Entrance and Distribution Equipment | Area Lighting | Security Camera |

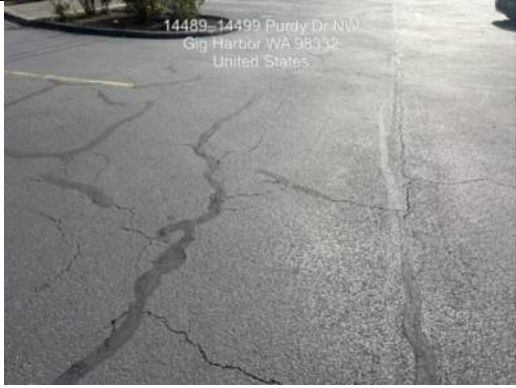
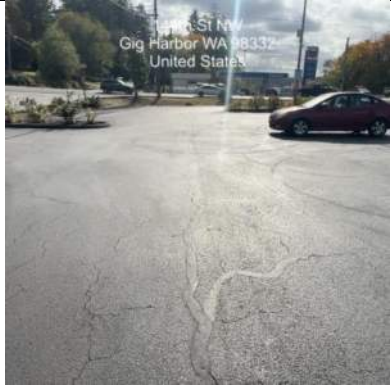
| Secondary Level | Description | Current Condition | TERM Lite Rating | Recommended Corrective Action | Estimated Cost |
|---|---|---|---|---|---|
| Parking lots and associated signage, markings, and equipment | Parking lots and associated signage, markings, and equipment | The asphalt parking lot was observed in marginal condition and contained substantial cracking that should be sealed in the short term | 2.3 | Short term: Seal 500 LF of cracks in pavement | \$8,500 |

| <p>Heavily cracked location within parking lot. These cracks should be sealed before they are worsened by water intrusions</p> | <p>Heavily cracked location within parking lot. These cracks should be sealed before they get worse from water intrusions</p> | <p>Cracking in asphalt at project entrance off the right-of-way</p> |

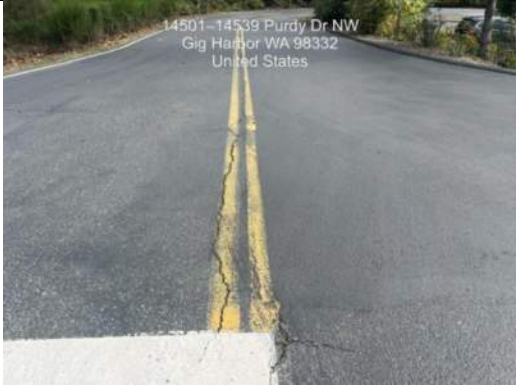
| Secondary Level | Description | Current Condition | TERM Lite Rating | Recommended Corrective Action | Estimated Cost |
|---|---|---|---|---|---|
| Roadways, driveways, including concrete bus travel lanes and site asphalt | Driveway and asphalt at bus area | The asphalt roadway was observed in adequate condition but contained cracks that should be sealed | 3.0 | Seal cracks in asphalt pavement<br>Estimated 250 LF | \$5,750 |

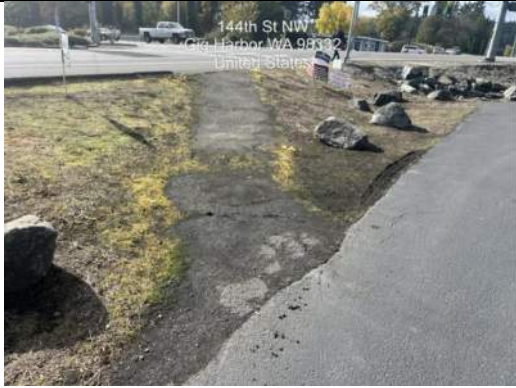
| <p>~120 LF of Curb and Gutter is missing here. Boulders are being used to disallow cars from traversing into this area</p> | <p>Damage asphalt pavement in parking lot</p> | <p>Damage asphalt pavement in parking lot</p> |

| Secondary Level | Description | Current Condition | TERM Lite Rating | Recommended Corrective Action | Estimated Cost |
|---|---|---|---|---|---|
| | | | | Curb replacement at southern entrance<br>Estimated 30 LF | \$3,350 |

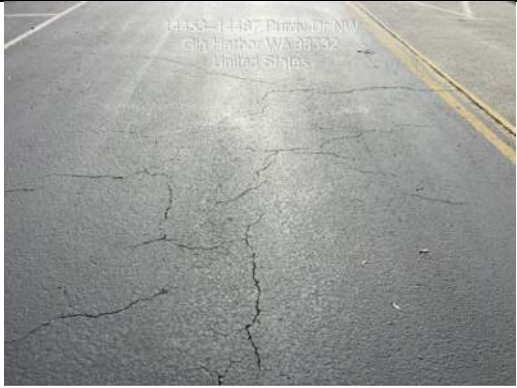
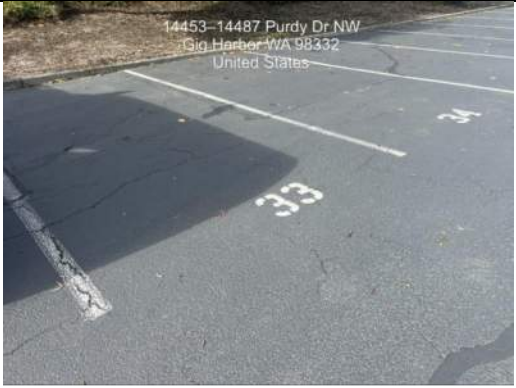
| Secondary Level | Description | Current Condition | TERM Lite Rating | Recommended Corrective Action | Estimated Cost |
|---|---|---|---|---|---|
| | | The asphalt parking lot should be replaced in the future and is reaching the end of its usable life | | Long term: Replace Asphalt Parking Lot<br>Estimate 56,500 SQFT (6,277 SQYD) | \$433,198.43 |

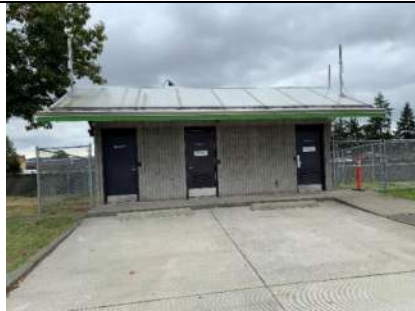
| Utility Building: West Side | Utility Building: rust at door frame bottoms. | Shelter: Damaged paint on wood panels. | West Shelter: Damaged downspout. |

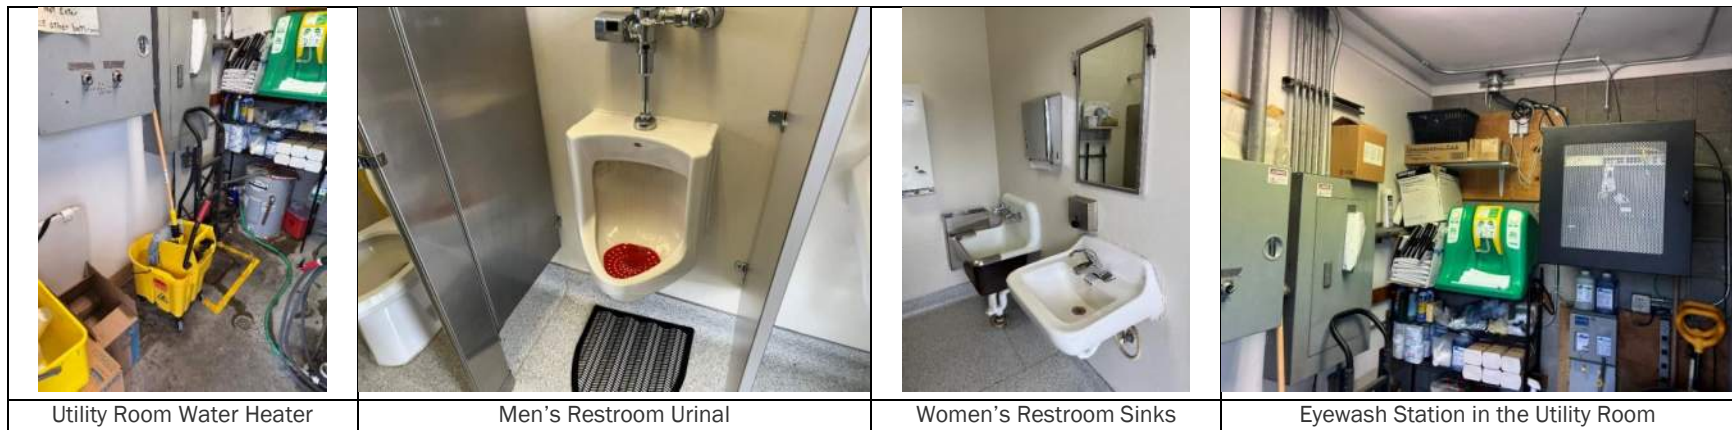
| Secondary Level | Description | Current Condition | TERM Lite Rating | Recommended Corrective Action | Estimated Cost |
|---|---|---|---|---|---|
| | | It was noted that the gauge needle is broken on the pressure gauge | | Replace pressure gauge on backflow preventer | |
| | | Hose bib connection in utility room appears to be leaking and needs to be repaired | | Repair hose bib connection leak | |
| | | Hot water tank in utility room appears to be leaking and is braced incorrectly based on the Uniform Plumbing Code which requires two horizontal straps for seismic restraint | | Repair or replace leaking hot water tank. Install two horizontal bracing straps. | |
| | | Possible leak can be seen surrounding the backflow preventer or the area may be wet from a previous cleaning | | Inspect the backflow preventer to confirm leak | |

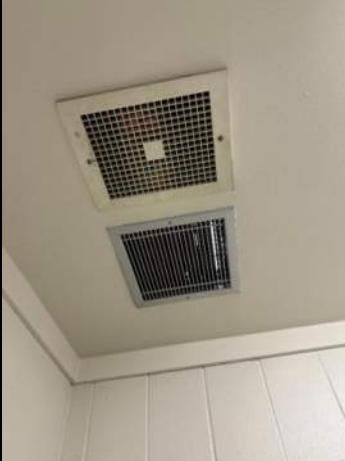
| Secondary Level | Description | Current Condition | TERM Lite Rating | Recommended Corrective Action | Estimated Cost |
|---|---|---|---|---|---|
| Heat generation and distribution systems | Electrical heaters and exhaust fans in utility building | Restroom exhaust fans in both the Men's and Women's Restrooms are not operational. The actual equipment is located in the attic space and could not be visually observed | 2.5 | Confirm reason for non-functional restroom exhaust fans and replace if needed | \$500 |

| Men's Restroom Exhaust Fan Grating | Wall Heater in the Utility Room | Exhaust Fan in the Utility Room | Men's Restroom Wall Heater | Men's Restroom Exhaust Fan Switch |

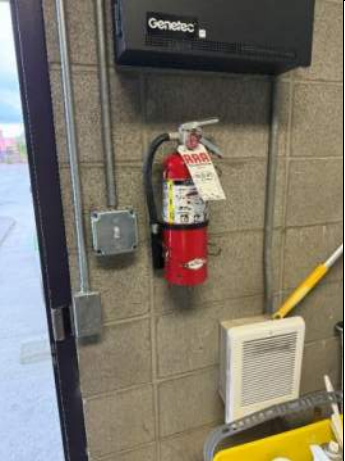
| Secondary Level | Description | Current Condition | TERM Lite Rating | Recommended Corrective Action | Estimated Cost |
|---|---|---|---|---|---|
| | | Wall heaters in the restrooms operate. The heater in the storage/utility room is non-operational | | Replace electric non-operational heater in storage utility/room | |

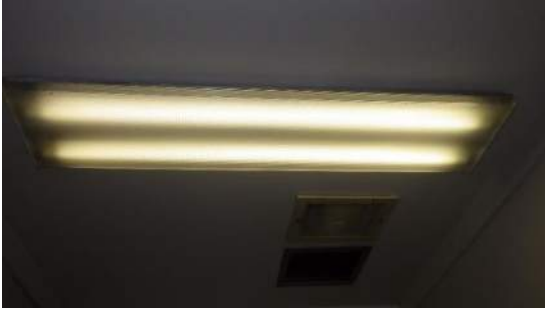
| Secondary Level | Description | Current Condition | TERM Lite Rating | Recommended Corrective Action | Estimated Cost |
|---|---|---|---|---|---|
| Electrical service & distribution | Utility power | Site electrical power appears to be adequate for the electrical needs of the facility<br><br>Equipment was found stored in front of the electrical panel within the marked dedicated working space | 3.8 | Relocate stored equipment away from the electrical panel, outside of the marked space on the floor | \$225 |

| <p>Equipment stored in front of the electrical panel</p> | <p>Fluorescent lighting in restrooms</p> | <p>Security camera in utility room with room occupancy sensor</p> |

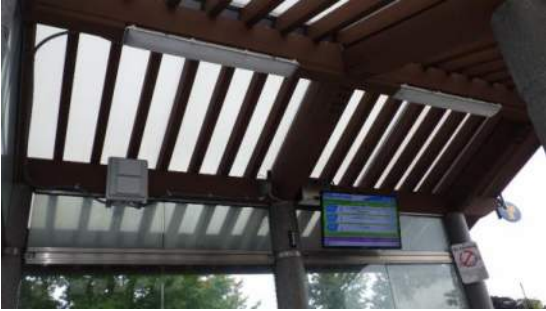
| <p>Bus shelter lighting and schedule display</p> | <p>Area pole lighting with security camera</p> | <p>Crumbling light pole base grout</p> |

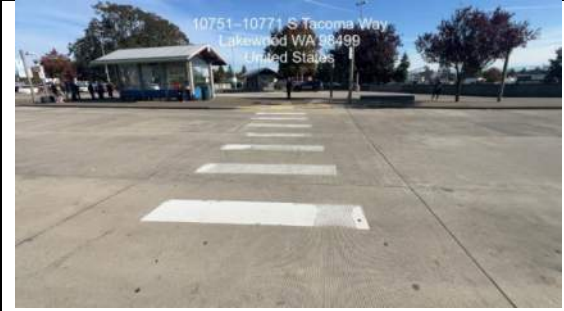
| Secondary Level | Description | Current Condition | TERM Lite Rating | Recommended Corrective Action | Estimated Cost |
|---|---|---|---|---|---|
| Roadways/driveways and associated signage, marking, and equipment | Concrete pavement at bus station | The concrete pavement at the bus area is in adequate condition<br>There are two crosswalks that require restriping<br>Estimated 400 SQFT | 3.6 | Restripe crosswalks<br>Estimated 240 SQFT | \$3,400 |

| <p>Crosswalks should be repainted</p> | <p>Concrete around CB in the middle of roadway is heavily cracked</p> | <p>Concrete is sticking up in the sidewalk. Replace the panels to be flush</p> |

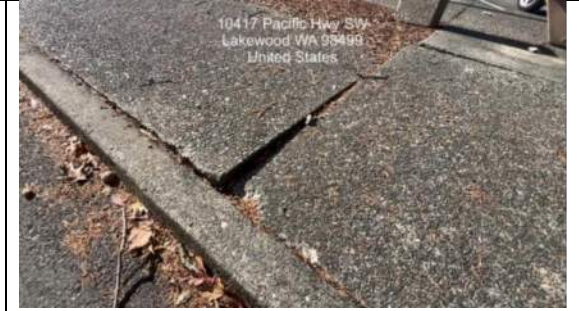
| Secondary Level | Description | Current Condition | TERM Lite Rating | Recommended Corrective Action | Estimated Cost |
|---|---|---|---|---|---|
| | | Sidewalk in bus area contains a sidewalk panel that is sticking up and is a trip hazard. Replace both panels | | Replace Sidewalk<br>Estimated 32 SQFT | \$3,460 |

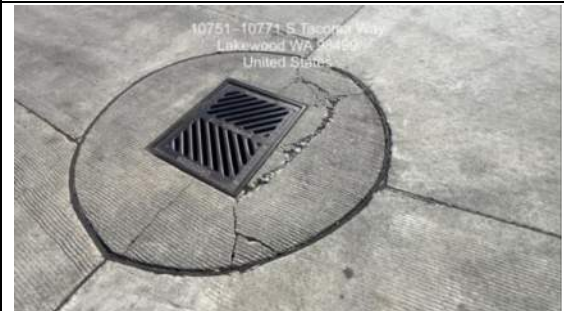
| <p>Concrete around CB in the middle of roadway is heavily cracked</p> | <p>Cracked concrete in Sidewalk in parking lot</p> | <p>Cracked concrete in Sidewalk in parking lot</p> |

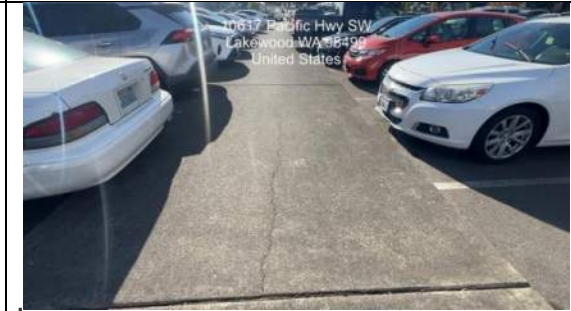
| Secondary Level | Description | Current Condition | TERM Lite Rating | Recommended Corrective Action | Estimated Cost |
|---|---|---|---|---|---|
| Parking lots and associated signage, markings, and equipment | Asphalt parking lot including concrete pedestrian sidewalks in middle of parking lot | The asphalt parking lot was observed in adequate condition with minimal cracking observed in the asphalt<br>The sidewalk that runs through the center of the parking lot contained cracks that should be sealed with caulking<br>Estimated at 200 LF | 3.5 | Seal cracks in concrete sidewalk<br>200 LF | \$5,000 |
