Pacific Avenue || SR 7 Corridor

FEASIBILITY STUDY

First/Last Mile Access Improvements Technical Report – Task 8.5

September 27, 2018

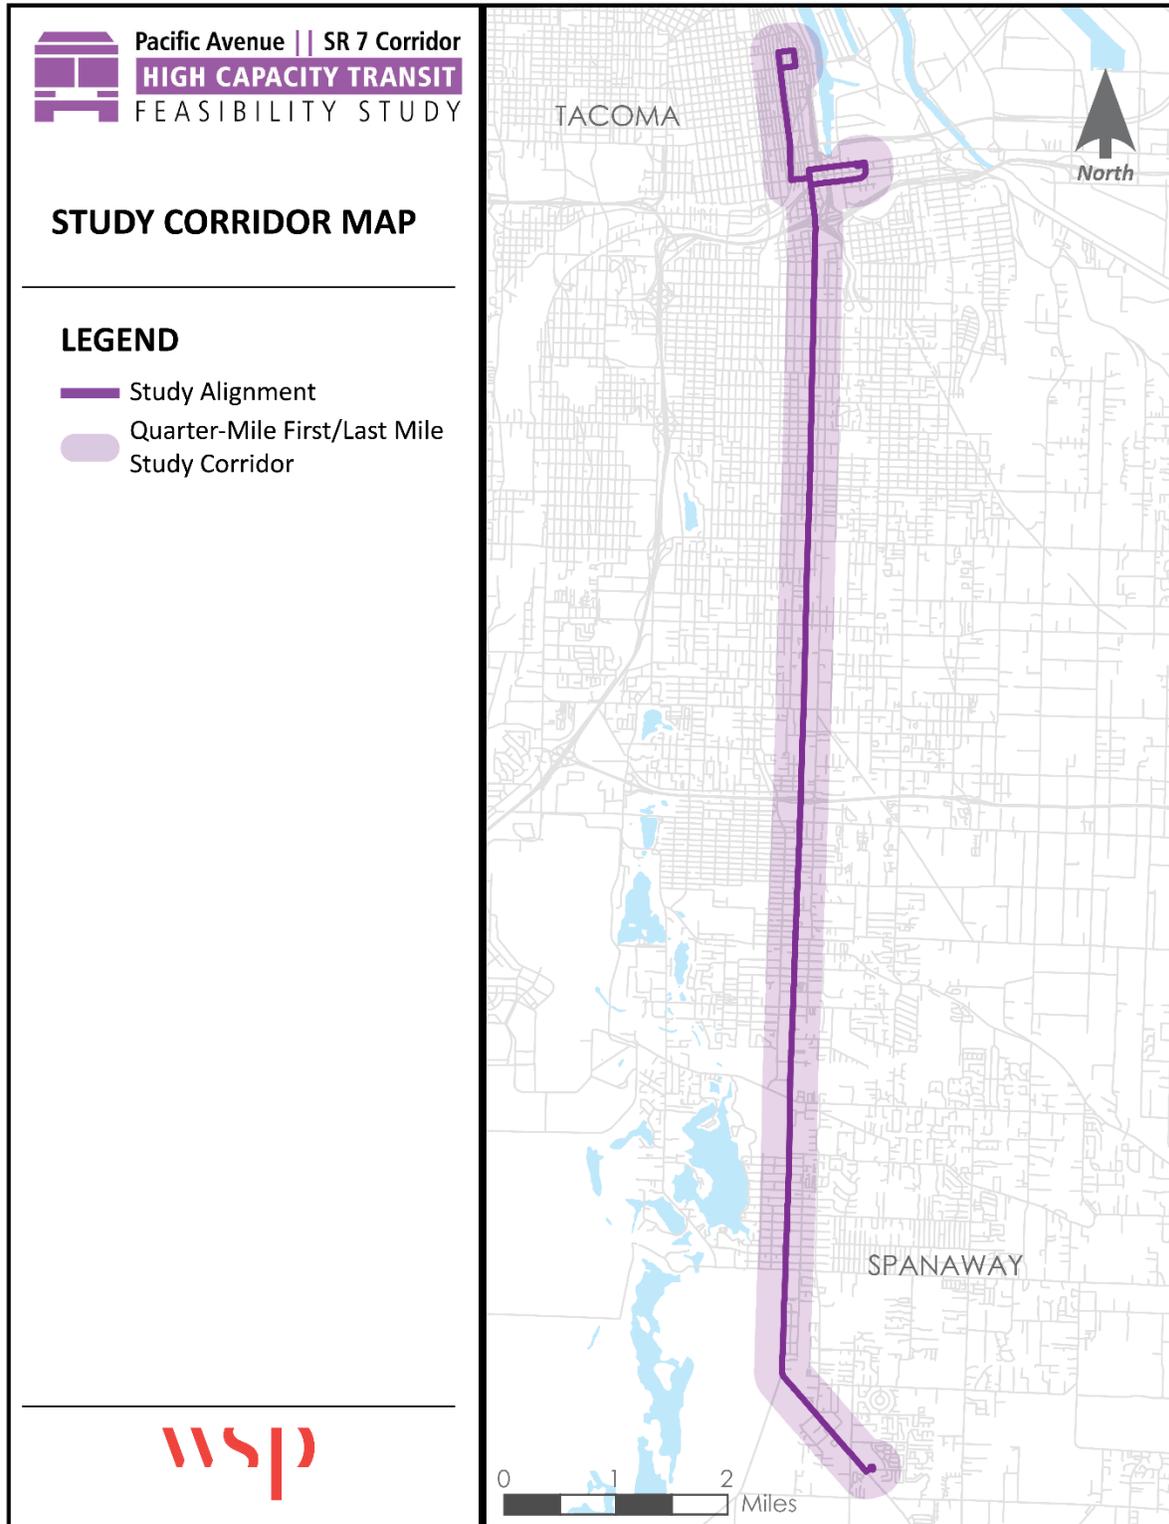
Figure 1: Study Corridor and Alignment

The Pacific Avenue S/SR7 HCT Study Corridor is a 14-mile segment of Pacific Avenue S/SR 7 between the Commerce Street Transfer Center in Downtown Tacoma and 204th Street E in Spanaway, entirely within Pierce County (Figure 1). The Corridor is currently served by the majority Route 1, one of Pierce Transit's four trunk routes. This is the highest ridership route in the system, carrying almost 1.7 million passengers in 2016, nearly 20 percent of Pierce Transit's fixed route ridership. Pierce Transit's Destination 2040 Long Range Plan, Sound Transit's ST3 Plan, and Puget Sound Regional Council's (PSRC) Transportation 2040 Long Range Plan all identify this Corridor for potential HCT service.

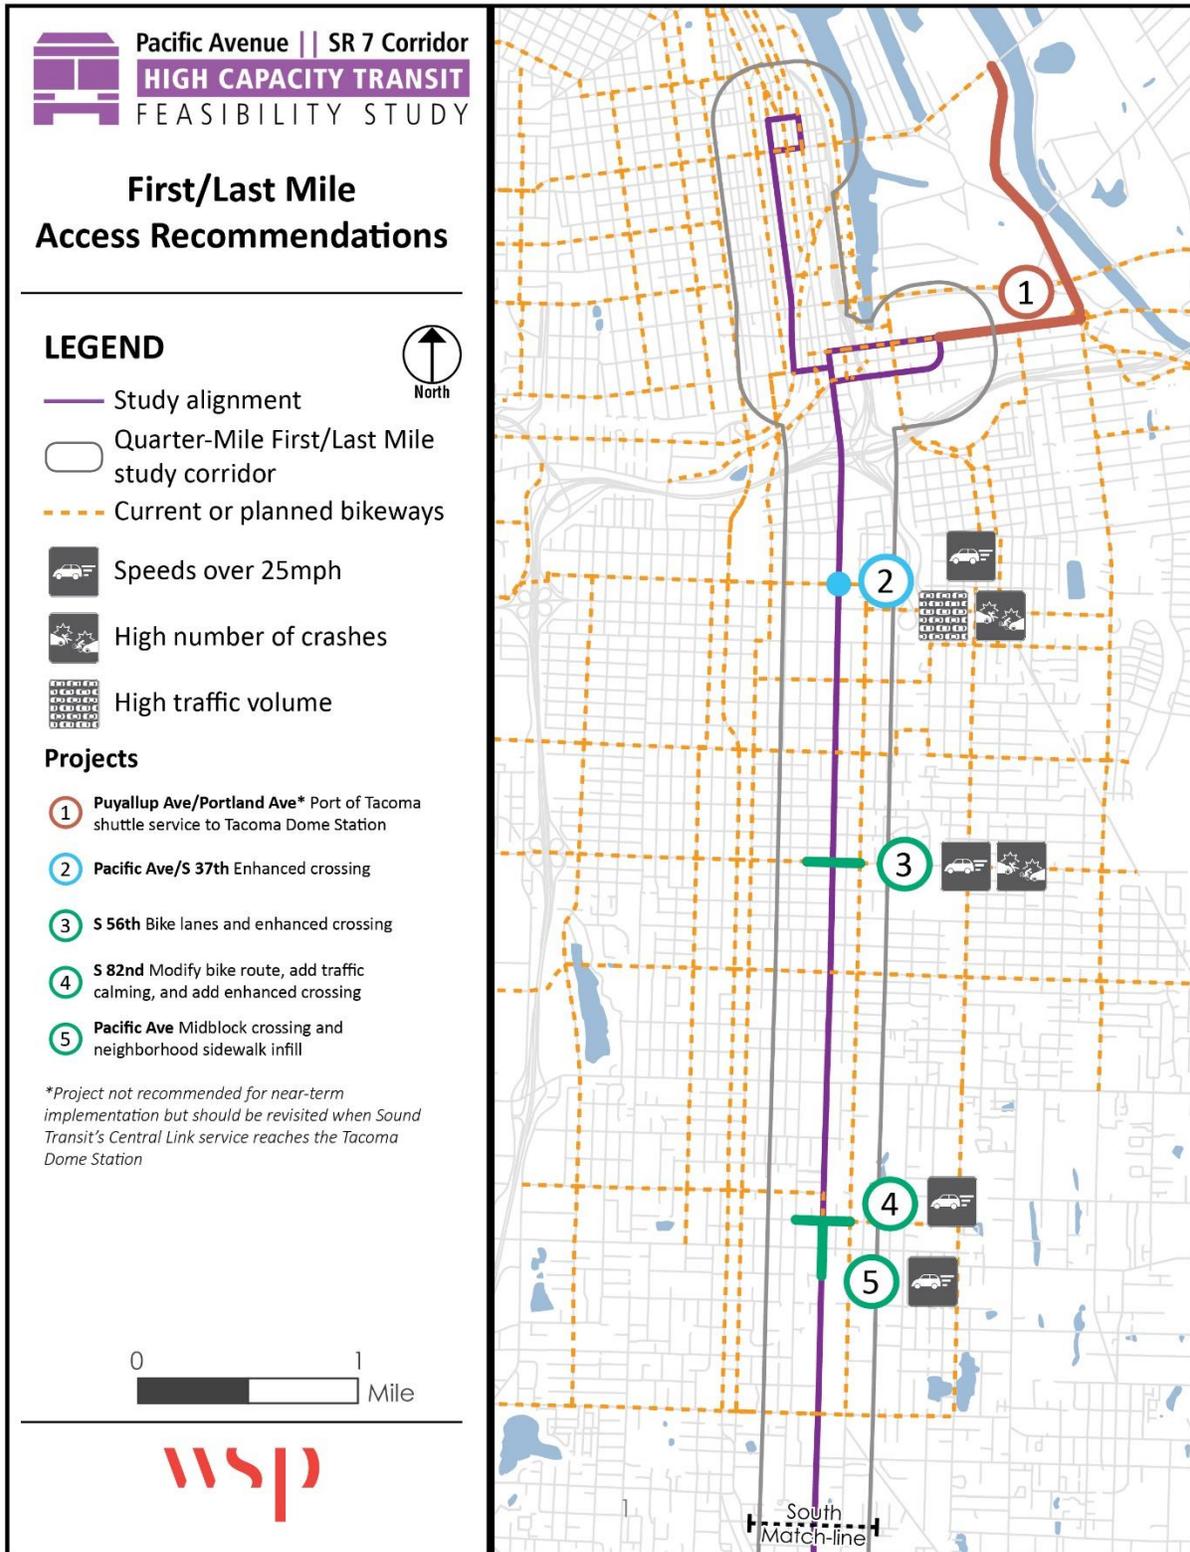
Figure 2: North Corridor Access Concerns

The following metrics (Table 3-1) were used to aid in the identification of transit access improvement areas within the study area. For safety concerns, the areas in proximity to proposed stations with “high” and “very high” rankings across these metrics were used to prioritize improvements. The maps below indicate some of the access concerns at each of the selected project areas.

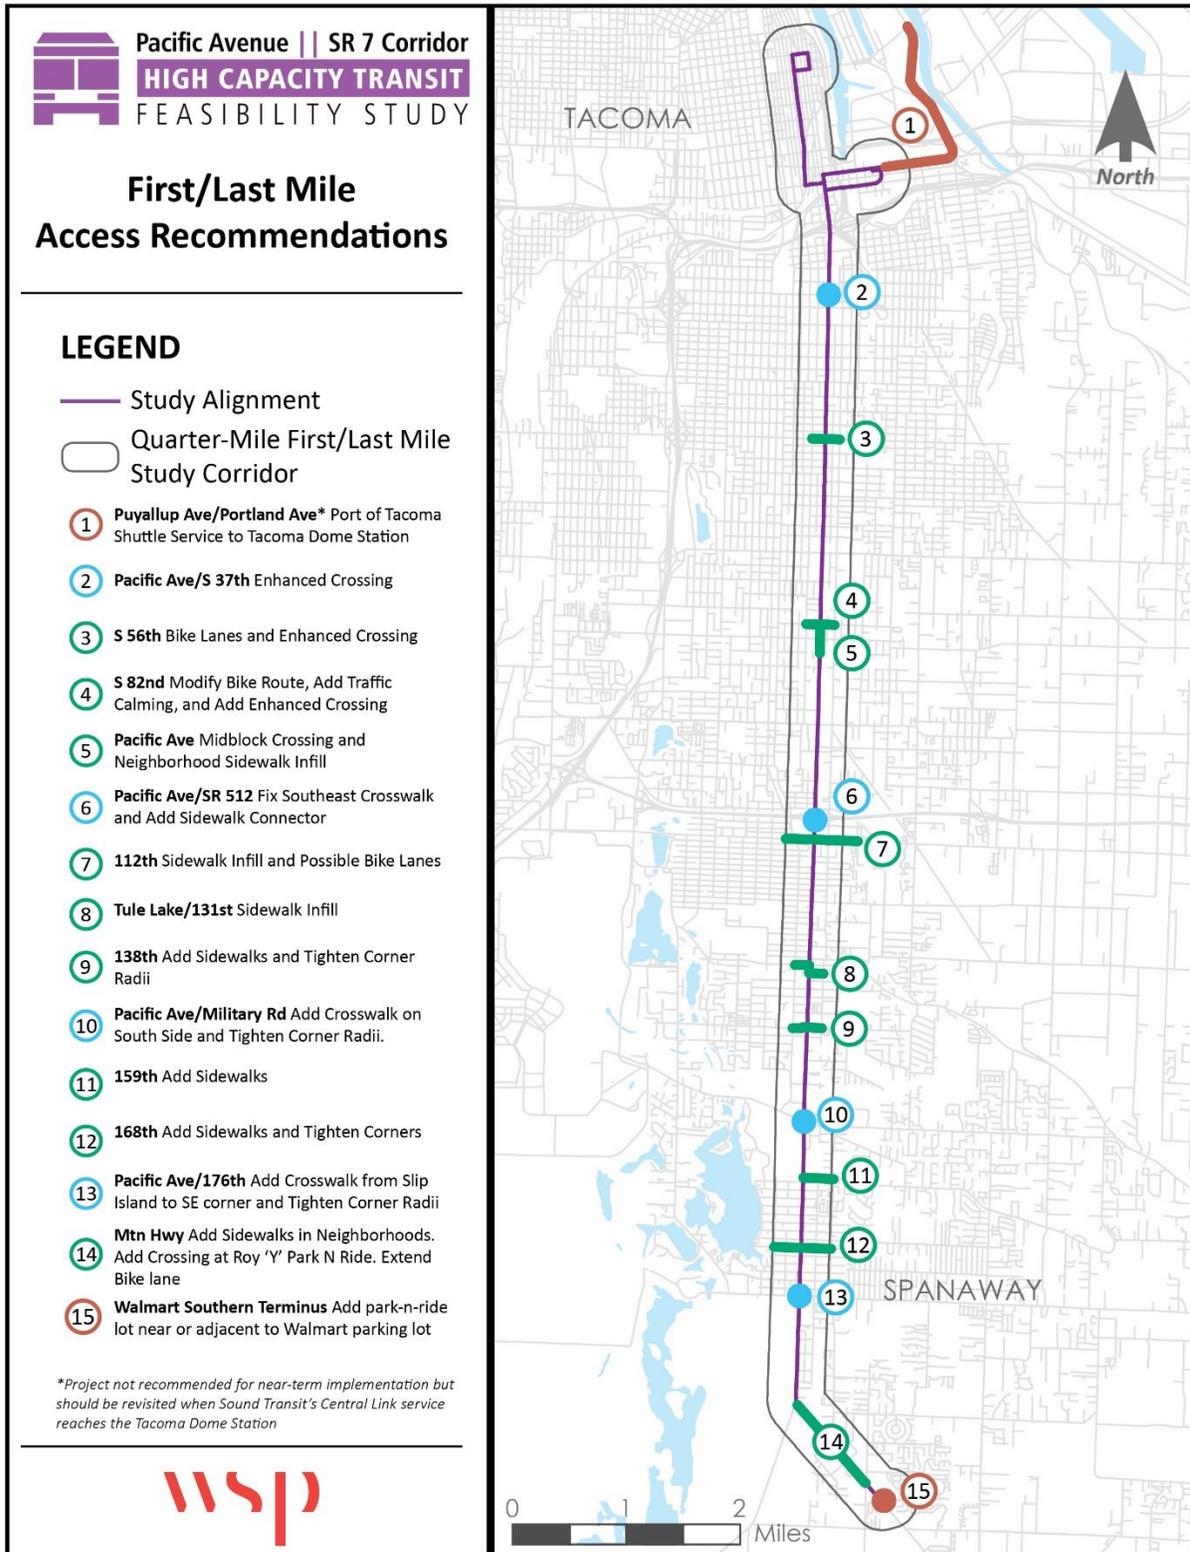
Figure 4: Potential Transit Access Projects Along the Corridor

Based on the data and observation of existing conditions for people walking the proposed BRT corridor, a list of projects was developed to improve access to transit in the areas deemed as having the highest need. These projects offer solutions for getting people to, from and around the proposed stations, as well as connecting them to destinations and services, including other transit services. The proposed first/last mile access improvements are organized from north to south. High level “order of magnitude” costs have been identified for the improvements, and are indicated in ranges as shown in Table 5-1 for each improvement.

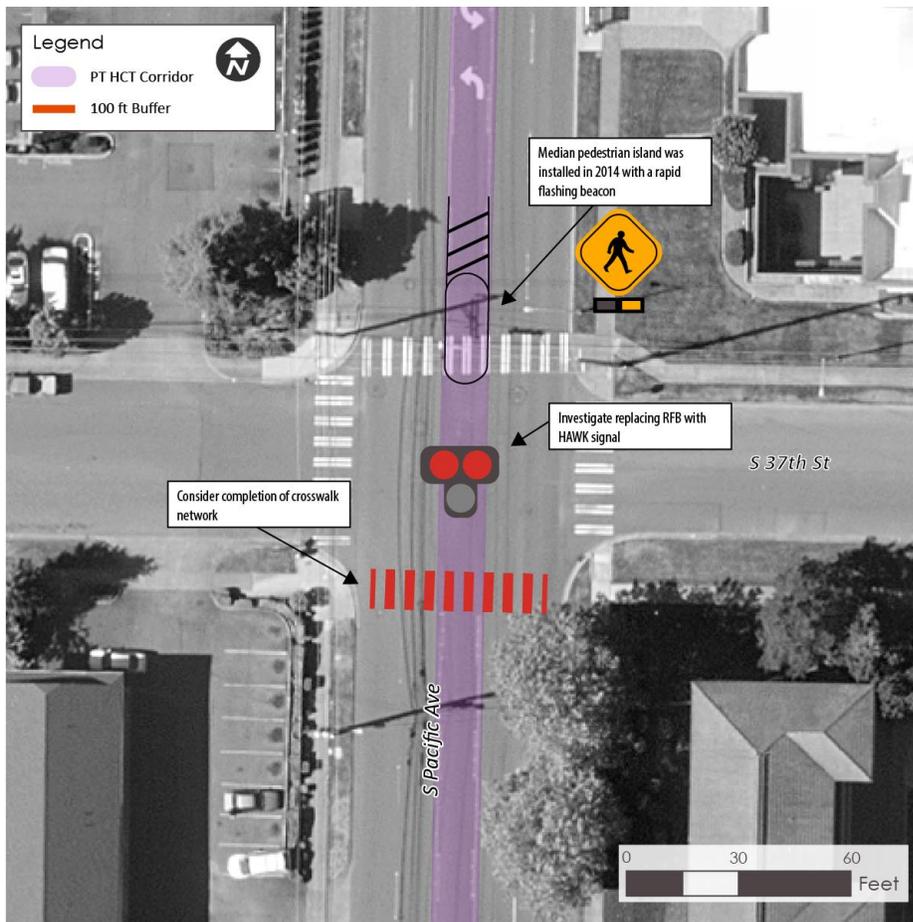
Figure 5: Pacific Avenue at S 37th Street

A high number of crashes (2012-2016) were reported by WSDOT at the intersection of Pacific Avenue and S 37th Street. As of 2014, a median crossing island has been installed with a rapid flashing beacon that alerts drivers to a pedestrian or bicyclist crossing. However, there is only a crosswalk on the north side of the intersection, which may require pedestrians to cross three times to cross Pacific Avenue on the south side. Enhancements (see Figure 5) could include a pedestrian-only signal or a pedestrian-hybrid beacon³, including actuation buttons for pedestrians and cyclists, which would allow users to cross more visibly. The assessment summary is shown in Table 5-2.

Access Mode	Problem	Potential Solution	Implementation Challenge	Cost Estimate
Pedestrian	High amount of pedestrian crashes.	Enhance current rapid flashing beacon crossing.	New median island already installed (2014).	\$

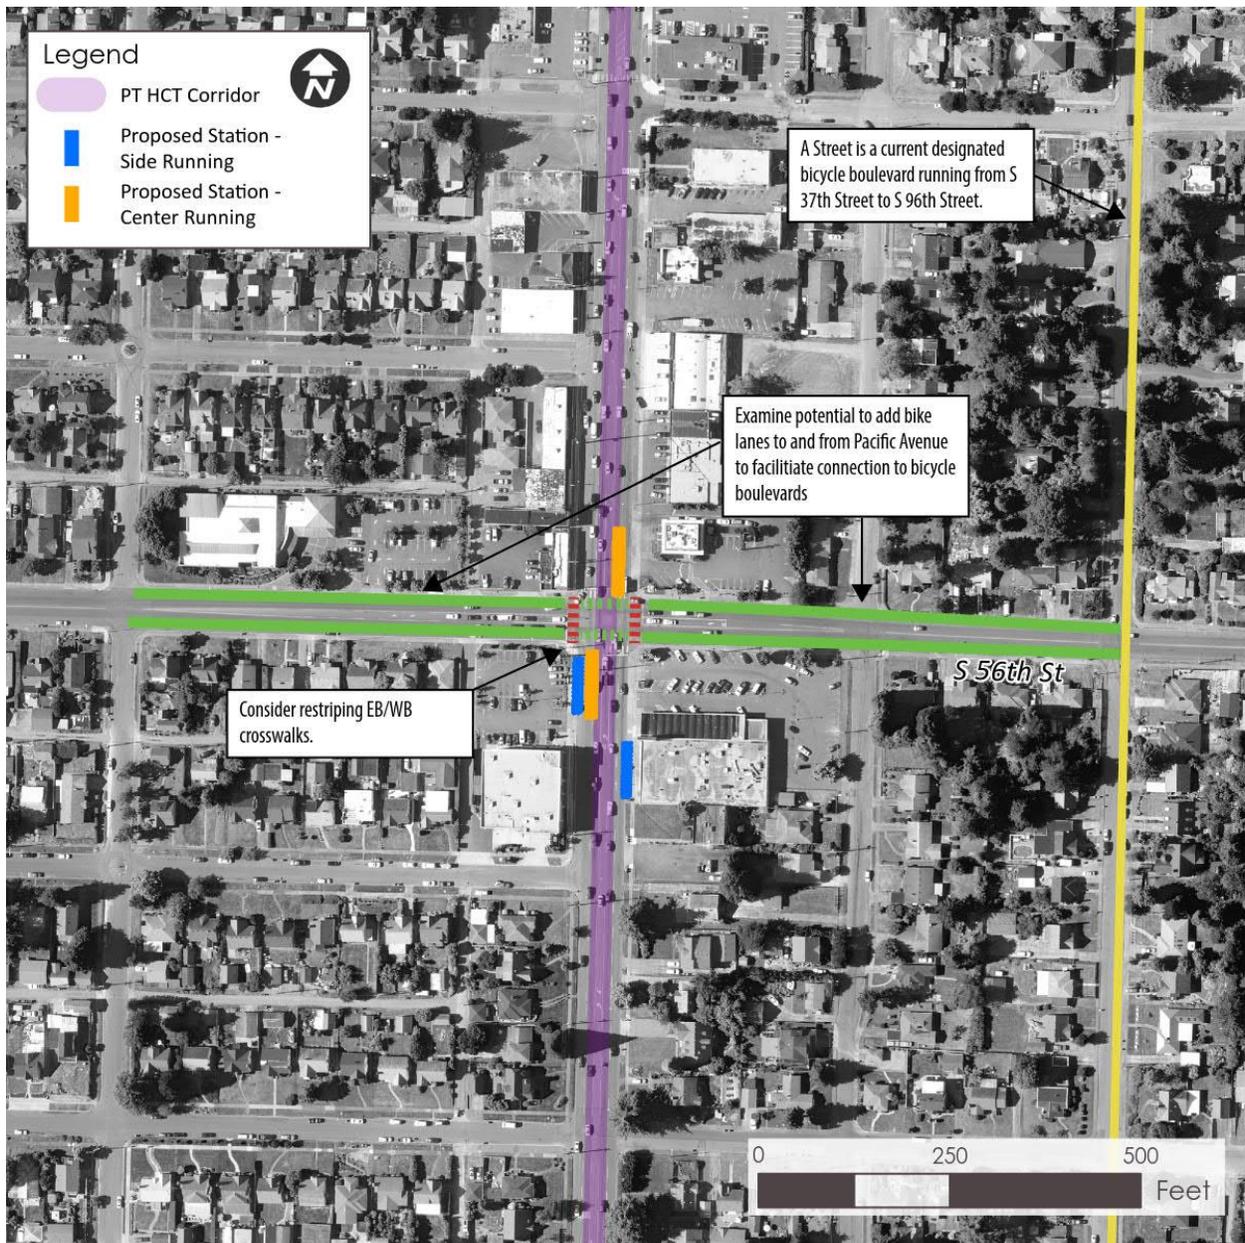
Figure 6: Pacific Avenue at S 56th Street

For pedestrians using the proposed 56th Street BRT station, the intersection of S 56th Street and Pacific Avenue would benefit from a marked crosswalk along the west side to match the other three crosswalks. Additional ADA amenities are suggested on three of the four corners as they currently lack curb cuts and tactile paving to meet ADA standards as shown in Figure 6. Additionally, due to the higher speeds on 56th Street, providing bike lanes to connect to adjacent parallel streets, in particular the A Street bicycle boulevard, would enhance the safety and convenience of bicycle access to the BRT station. The assessment summary for these improvements is documented in Table 5-3 and Table 5-4.

Access Mode	Problem	Potential Solution	Implementation Challenge	Cost Estimate
Pedestrian	High amount of pedestrian crashes.	Enhance current rapid flashing beacon crossing.	New median island already installed (2014).	\$

Access Mode	Problem	Potential Solution	Implementation Challenge	Cost Estimate
Bicycle and pedestrian	High speeds and high amount of bike/pedestrian crashes.	Striped or buffered bike lane along S 56 th Street. Safe crossing at Pacific Avenue/S 56 th Street intersection.	Narrow ROW east of A Street.	\$

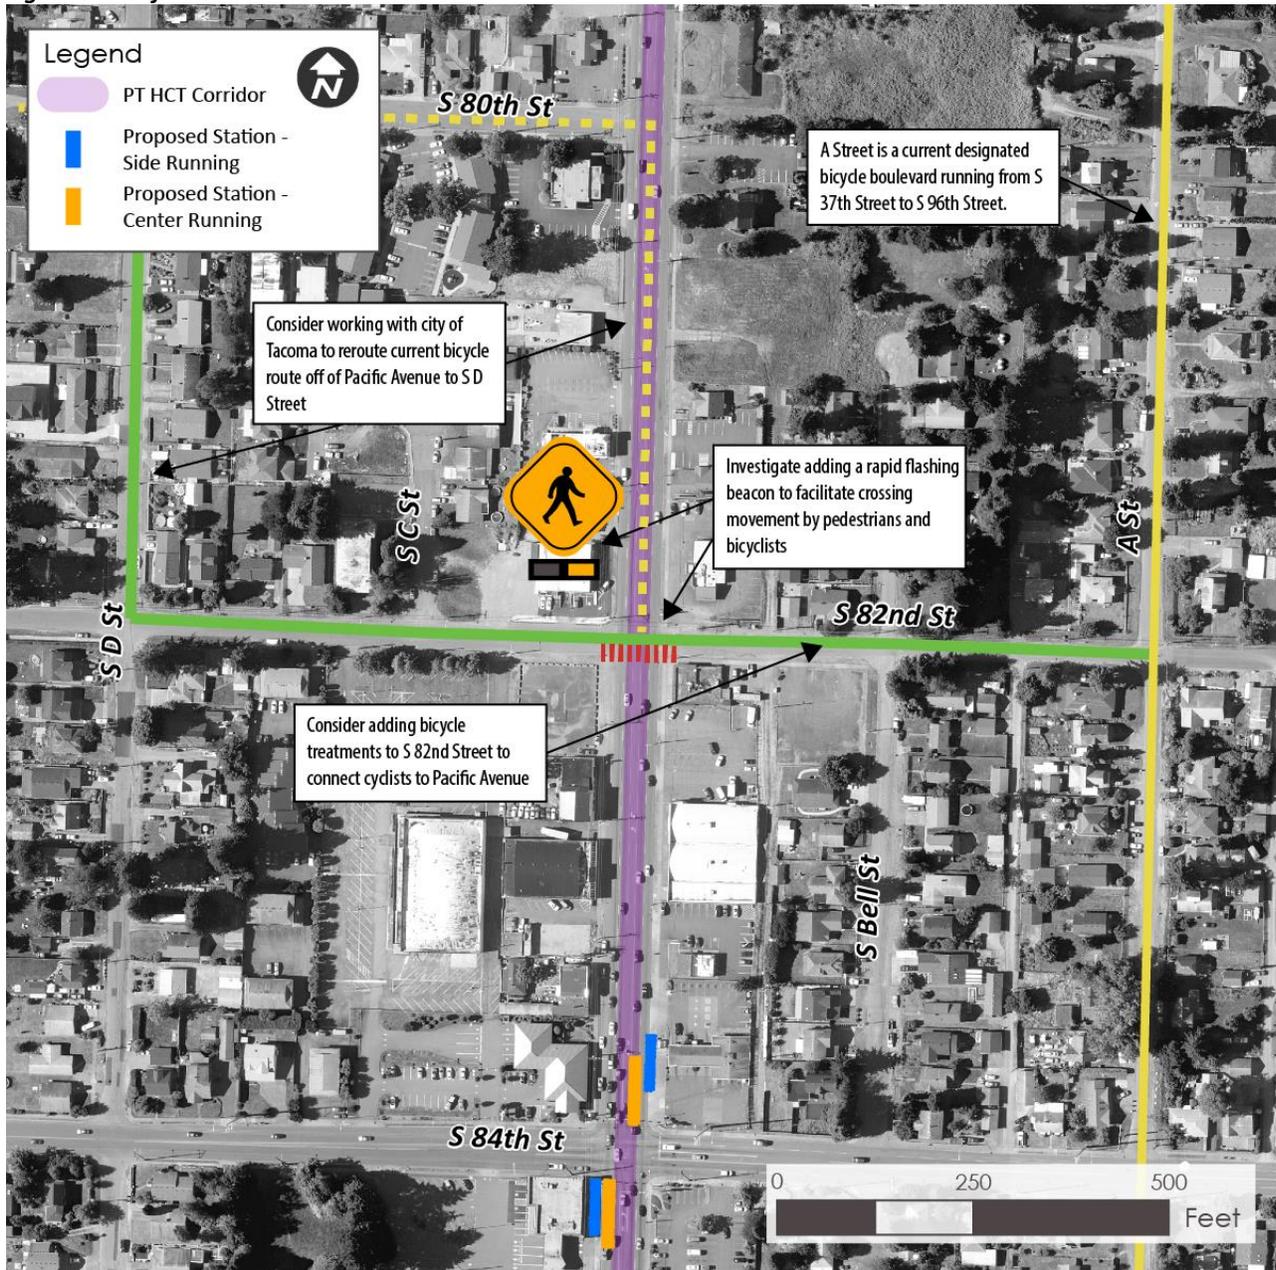
Figure 7: Pacific Avenue at S 82nd Street

Pacific Avenue between S 80th Street and S 86th Street had a high number of bicycle and pedestrian crashes reported between 2012 and 2016. With the exception of one intersection, this commercial district segment lacks crosswalks, requiring pedestrians to cross five lanes of traffic without any markings. While there is a marked crosswalk and signal at S 84th Street (the large cross-street arterial in this section), elsewhere there are no facilities or amenities to facilitate bicycle and pedestrian crossing movements. The construction of a crosswalk with a median island or refuge with a rapid flashing beacon or a HAWK signal on S 82nd Avenue is a potential solution (see Figure 7). The assessment summary for these improvements is documented in Table 5-5.

Access Mode	Problem	Potential Solution	Implementation Challenge	Cost Estimate
Pedestrian	High number of bike/pedestrian crashes. High speeds. Sidewalk/crossing gaps in surrounding areas.	Add midblock crossing along this stretch of the corridor. Sidewalk infill in surrounding neighborhood. (See Table 5-8)	None	\$

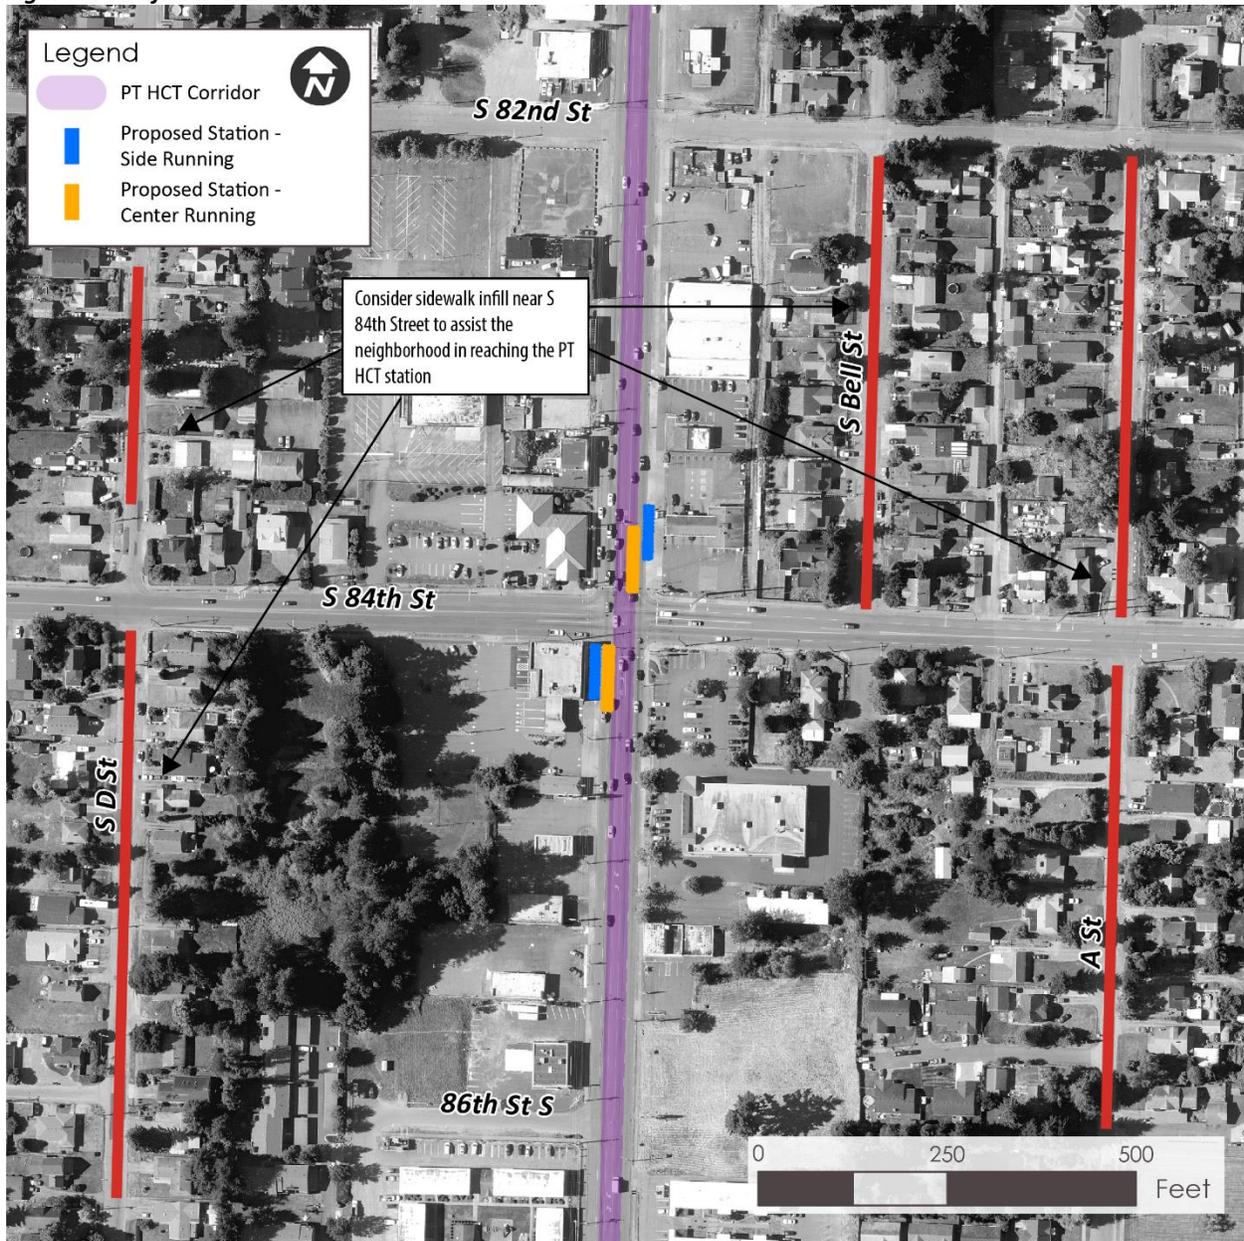
Figure 8: Pacific Avenue at 84th Street

This segment would also benefit from an additional midblock crossing, including rapid flashing beacons, at S 80th Street or S 86th Street. The surrounding residential streets also lack sidewalks making the trip to the proposed station at S 84th Street difficult. Some potential infill sidewalk improvements are shown in Figure 8. The assessment summary for these improvements is documented in Table 5-6.

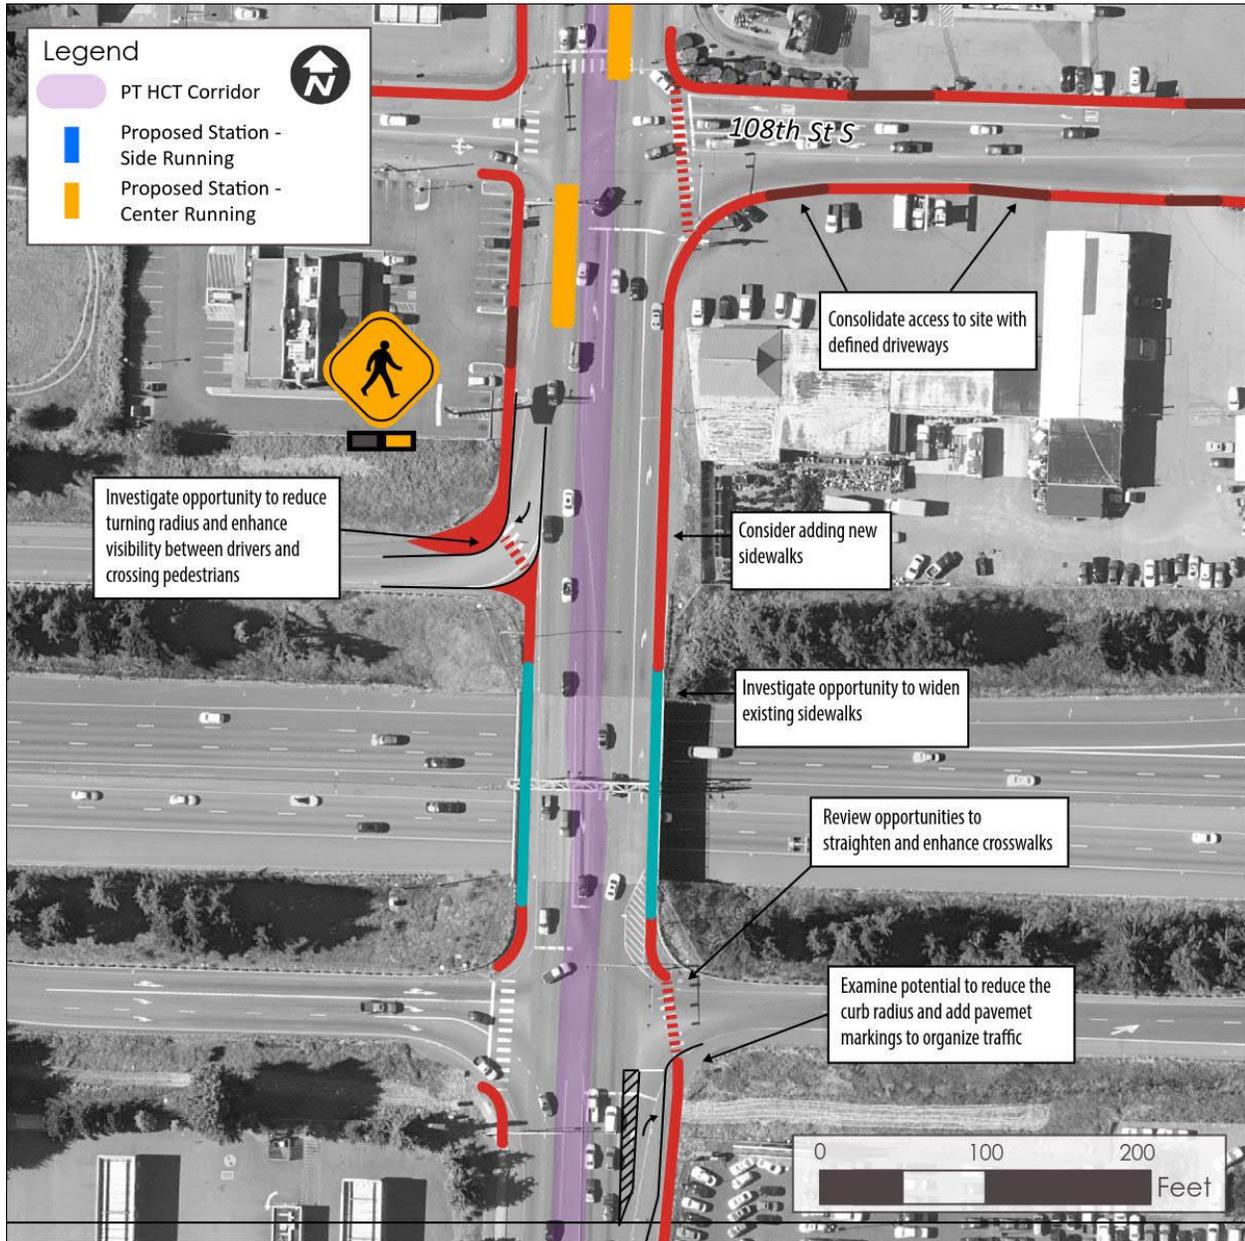
Figure 9: Pacific Avenue at State Route 512

The Pacific Avenue overpass over SR 512 features sidewalks on both sides. However, the sidewalk exists only on the structure itself and most of the connecting links on both sides of the overpass lack sidewalks. Additionally, the roadway geometry and striping at the southbound SR 7 to westbound SR 512 ramp, and the northbound SR 7 to eastbound SR 512 ramp encourage high motor vehicle speeds and reduce visibility between motorists and crossing pedestrians. It is recommended that the gaps in the surrounding sidewalk network are filled as shown in Figure 9, and that the sidewalks on the overpass

itself are widened if possible. Additionally, reducing the curb radii at the SR 512 on-ramp intersections with SR 7 would slow traffic and help improve pedestrian mobility and safety at this interchange. If this is not incorporated into the Pacific Avenue/SR 7 BRT Project, as this is a relatively expensive treatment, then other funding options should be investigated for implementing this recommendation. The assessment summary for these improvements is documented in Table 5-7.

Access Mode	Problem	Potential Solution	Implementation Challenge	Cost Estimate
Pedestrian	Area around interchange lacks sidewalk, narrow sidewalks on interchange, large curb radii at SB-WB and NB-EB ramp approaches	Tighten corner radii, shorten crosswalks, add sidewalks	Acquiring ROW might be difficult due to auto center nearby.	\$\$\$\$

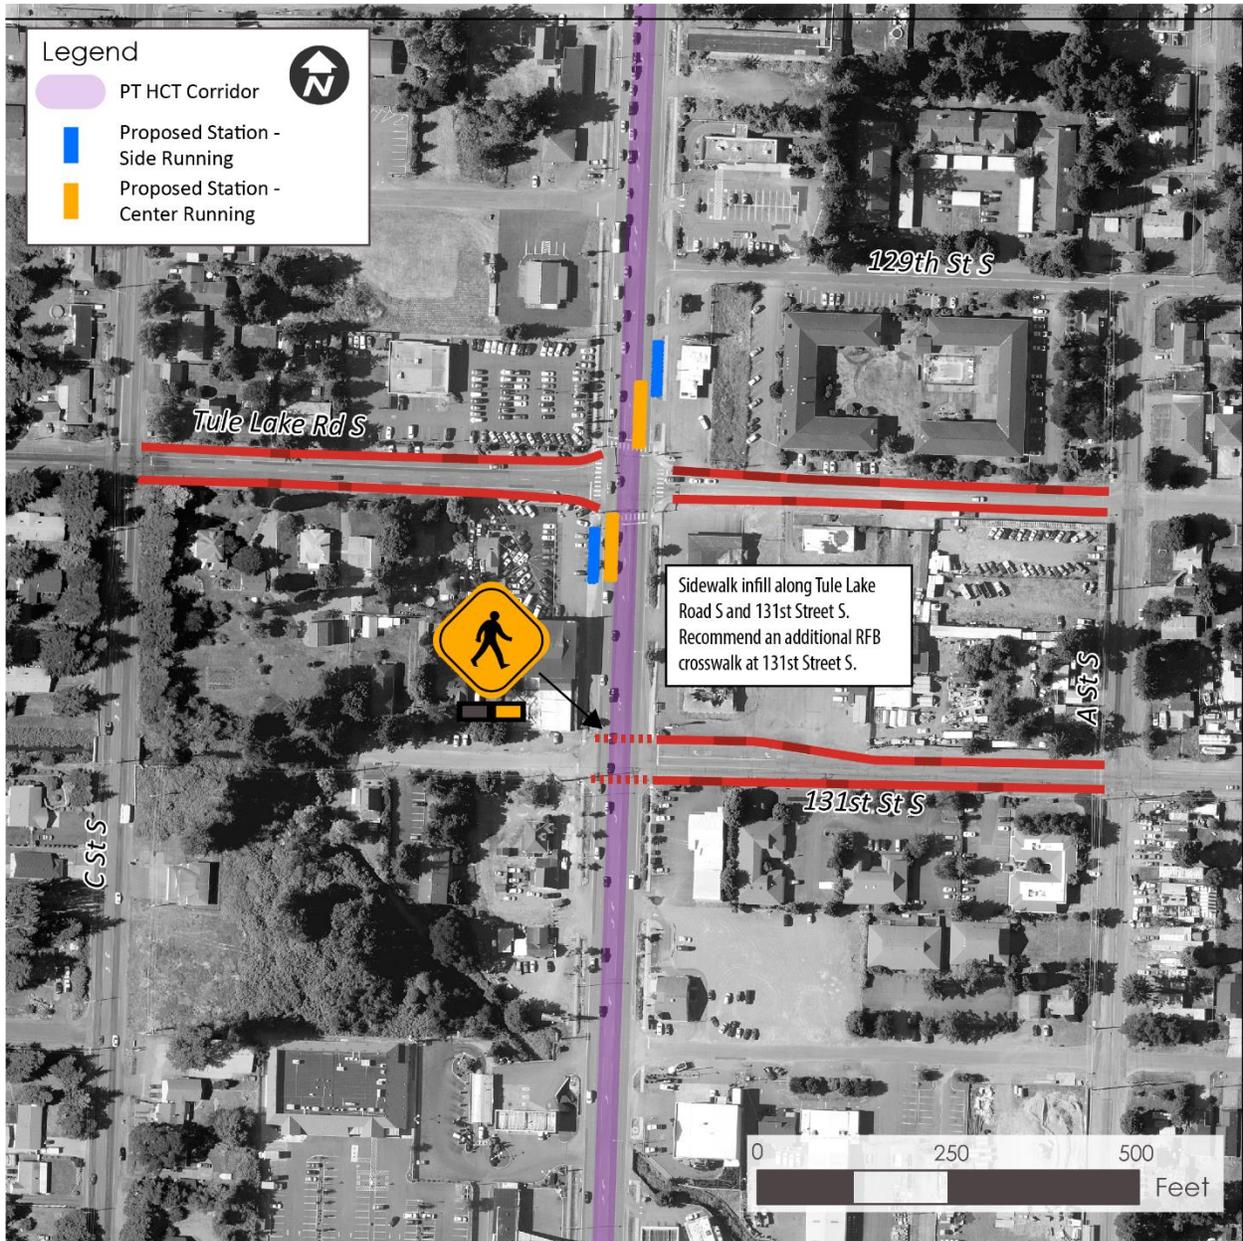
Figure 11: Pacific Avenue at Tule Lake Road S

Pacific Avenue at Tule Lake Road S is proposed to have an BRT station; however, the current nearest cross streets (Tule Lake Road and 131st Street S) do not have sidewalks to facilitate pedestrian movement from nearby neighborhoods to Pacific Avenue and the proposed station. Moreover, both Tule Lake Road S and 131st Street S are higher speed roads making the trip potentially unsafe for pedestrians. It is recommended that sidewalks be constructed along 131st Street east of Pacific Avenue to A Street, and to the west of Pacific Avenue along Tule Lake Road to C Street S to allow for residents to walk from their neighborhood streets with lower speeds (though still no sidewalks) to their primary intersecting arterials that would bring them to the proposed BRT station (see Figure 11). The assessment summary for these improvements is documented in Table 5-9.

Access Mode	Problem	Potential Solution	Implementation Challenge	Cost Estimate
Pedestrian	No sidewalks along road with higher motor vehicle speeds. Bike/pedestrian crash history. Sidewalk network gap.	Add sidewalks on Tule Rd from Park Avenue to Pacific Avenue, and along 131 st Street from B Street to Pacific Avenue. Add protected pedestrian crossing at 131 st St S (RRFB)	Acquiring ROW might be difficult due to auto center nearby.	\$\$\$

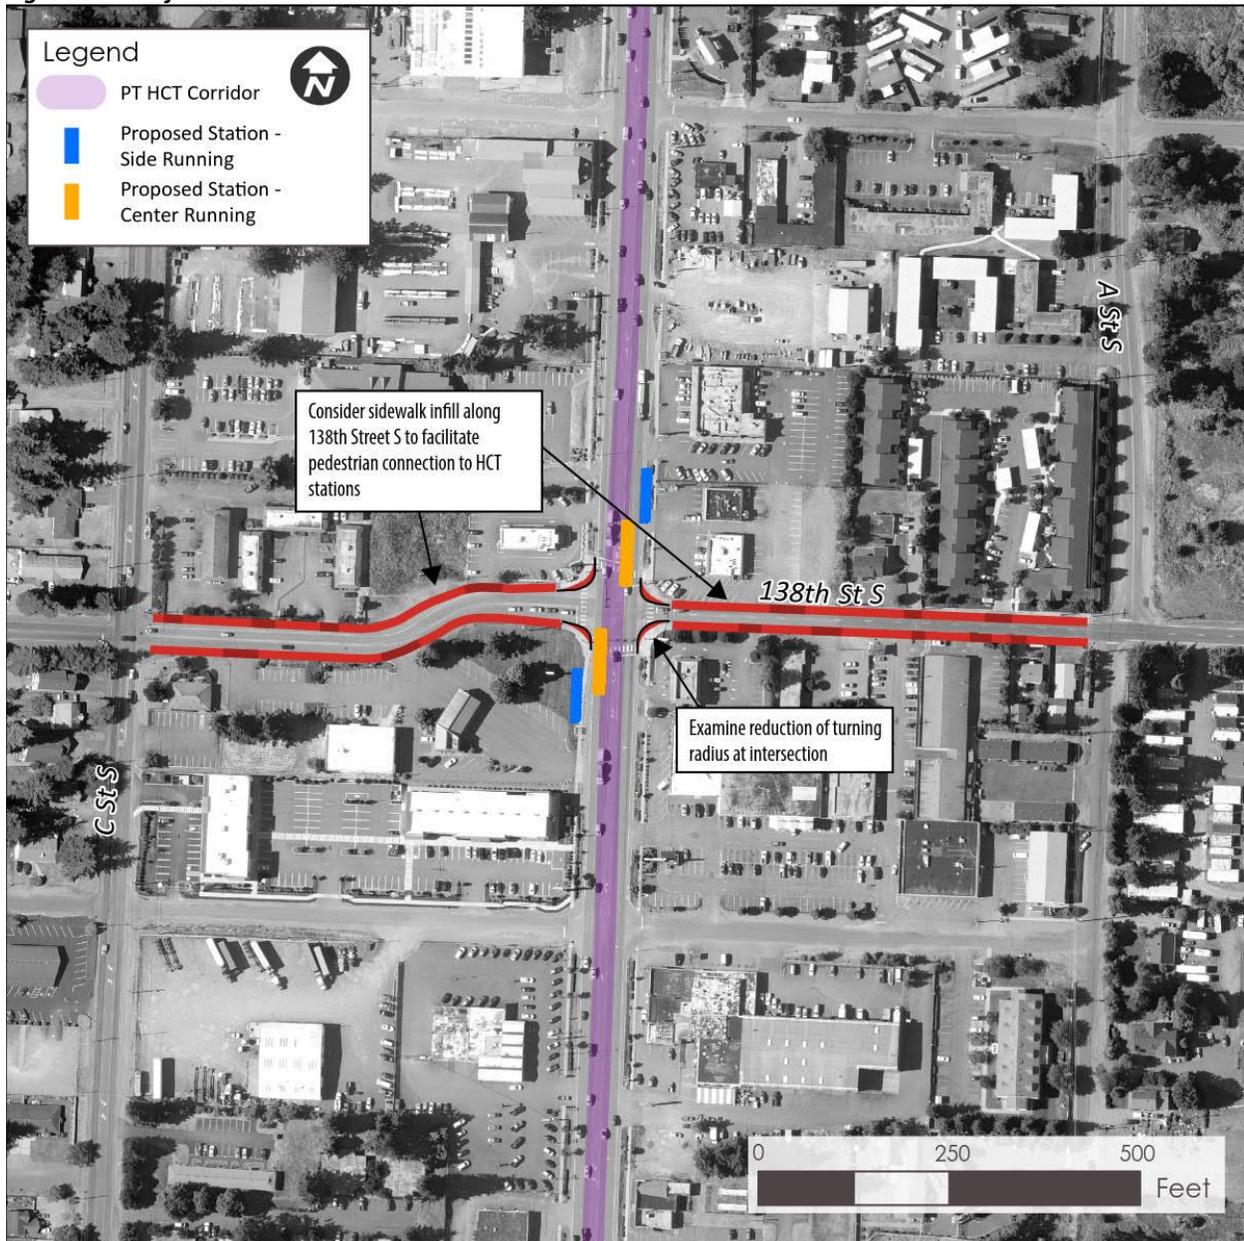
Figure 12: Pacific Avenue at 138th Street S

138th Street S, which does not have sidewalks, provides a primary road linkage to a proposed BRT station on Pacific Avenue. Vehicular speeds on this road are relatively high, creating an unfavorable environment for pedestrians. Additionally, the west side of 138th Street S contains an S-curve that limits visibility of pedestrians walking along that section of road. It is recommended that sidewalks be added along this stretch of road between 2nd Avenue Ct E and Park Avenue S, as shown in Figure 12. Furthermore, the corners at the Pacific Avenue intersection are not well designed for pedestrians. The existing large curb radius lengthens pedestrian crossing distances and encourages higher speed turns. Reducing curb radii would mitigate both issues. The assessment summary for these improvements is documented in Table 5-10.

Access Mode	Problem	Potential Improvement	Implementation Challenge	Cost Estimate
Pedestrian	No sidewalks along higher speed road. Intersection encourages high speed turns.	Add sidewalks from 2 nd Ave to Park Ave. Tighten corner radii at each corner of the Pacific Avenue /138 th Street S intersection.	None	\$\$\$\$

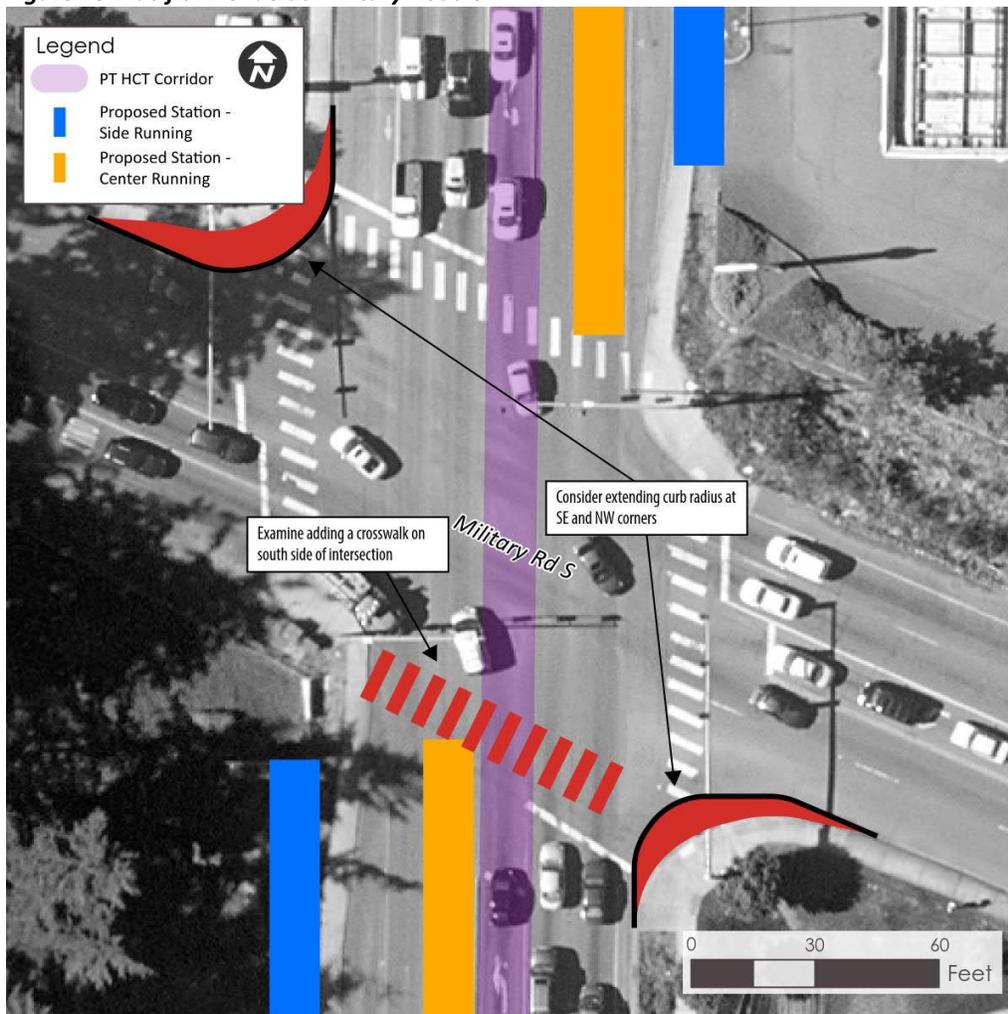
Figure 13: Pacific Avenue at Military Road S

The Pacific Avenue/Military Road intersection does not have a crosswalk on the south side, thus limiting pedestrian access to three crossings. A new crosswalk and pedestrian signal added to the south side of this intersection would allow pedestrians to access this corner of the intersection with only a single crossing rather than three crossings (Figure 13). There is a large shopping center with a grocery store and other amenities on the southeast corner. Additionally, the large radii on the southeast and northwest corners allow for faster turning movement speeds by vehicles. These corners could be tightened to shorten the crosswalk distance and encourage drivers to slow down before turning. The assessment summary for these improvements is documented in Table 5-11.

Access Mode	Problem	Potential Solutions	Implementation Challenge	Cost Estimate
Pedestrian	Lack of marked crossing on the south side of Pacific Avenue.	Add signalized crosswalk on south side of intersection. Tighten corner radii in northwest and southeast corners.	None	\$

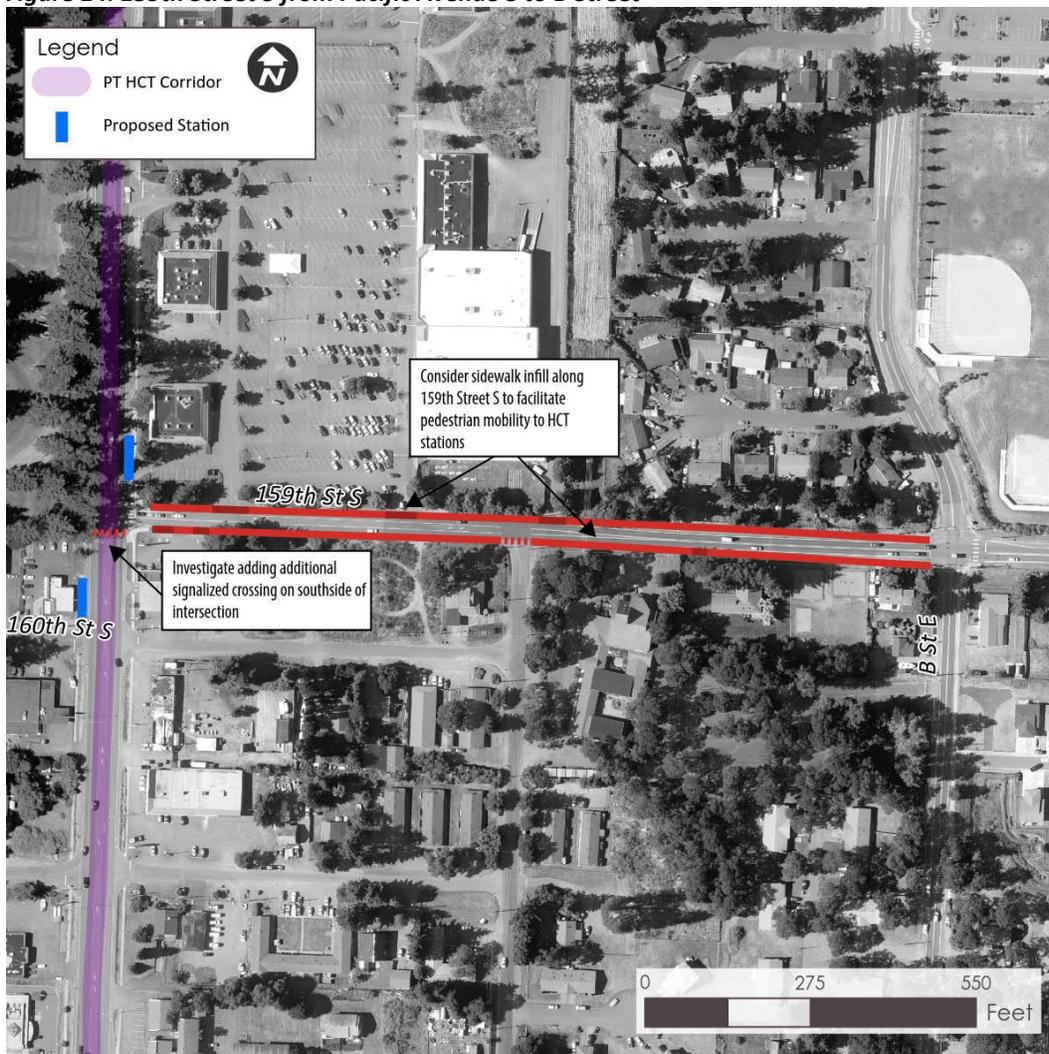
Figure 14: 159th Street S from Pacific Avenue S to B Street

159th Street S currently does not have sidewalks connecting the surrounding neighborhood to Pacific Avenue and the proposed BRT station. Furthermore, 159th Street S is a higher speed road making the walk to Pacific Avenue on the shoulder potentially unsafe. The construction of a new sidewalk from B Street (where sidewalks currently do exist) to Pacific Avenue would provide connectivity to the pedestrian network (Figure 14). Not only would it give residents a walkable path to the BRT station, it would also add linkage to the nearby Safeway/Rite Aid shopping center. The assessment summary for these improvements is documented in Table 5-12.

Access Mode	Problem	Potential Solution	Implementation Challenge	Cost Estimate
Pedestrian	Higher speeds with no sidewalks. No marked crossing on south side of 159 th at Pacific Avenue.	Add sidewalks along 159 th Street S from B Street to Pacific Avenue.	None	\$\$\$

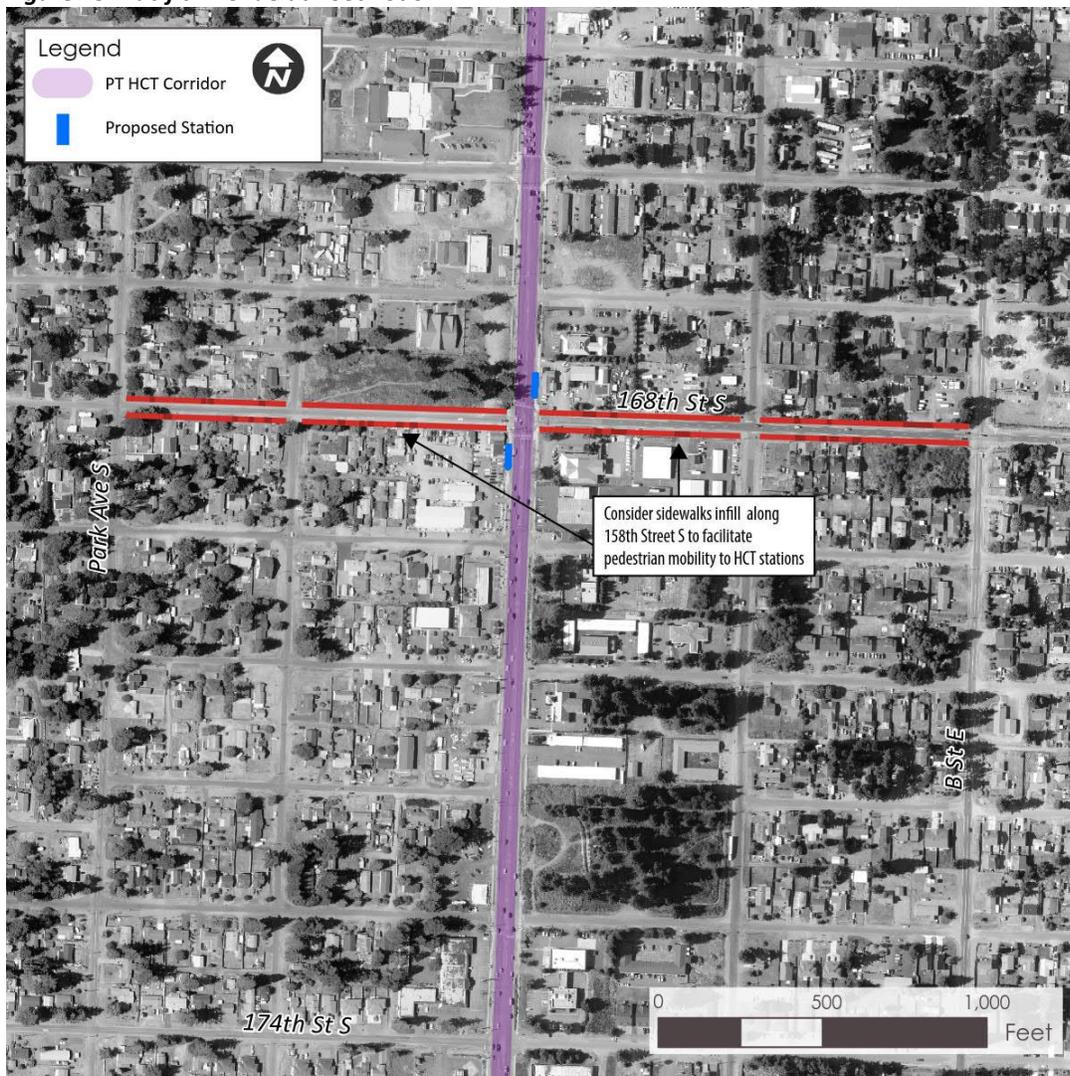
Figure 15: Pacific Avenue at 168th St S

168th Street S is lacking in consistent sidewalk linkages to Pacific Avenue, requiring pedestrians to walk alongside a narrow shoulder to the proposed BRT station as well as nearby amenities such as the Post Office. Adding sidewalks between B Street and Park Avenue would address this issue (Figure 15). Further safety enhancements may be necessary due to the high number of bicycle and pedestrian crashes at this intersection. One possibility is the corner radii at each of the four corners could be rebuilt and tightened to ensure that turning vehicles speeds are reduced and pedestrians have shorter crossing distances. The assessment summary for these improvements is documented in Table 5-13).

Access Mode	Problem	Potential Solution	Implementation Challenge	Cost Estimate
Pedestrian	Complete lack of sidewalk network in surrounding neighborhood. Higher amount of bike/pedestrian crashes.	Add sidewalks from B Street to Park Avenue S. Rebuild intersection corners to have tighter corner radii.	None	\$\$\$\$
