Pacific Avenue || SR 7 Corridor

FEASIBILITY STUDY

First/Last Mile Access Improvements Technical Report – Task 8.5

September 27, 2018

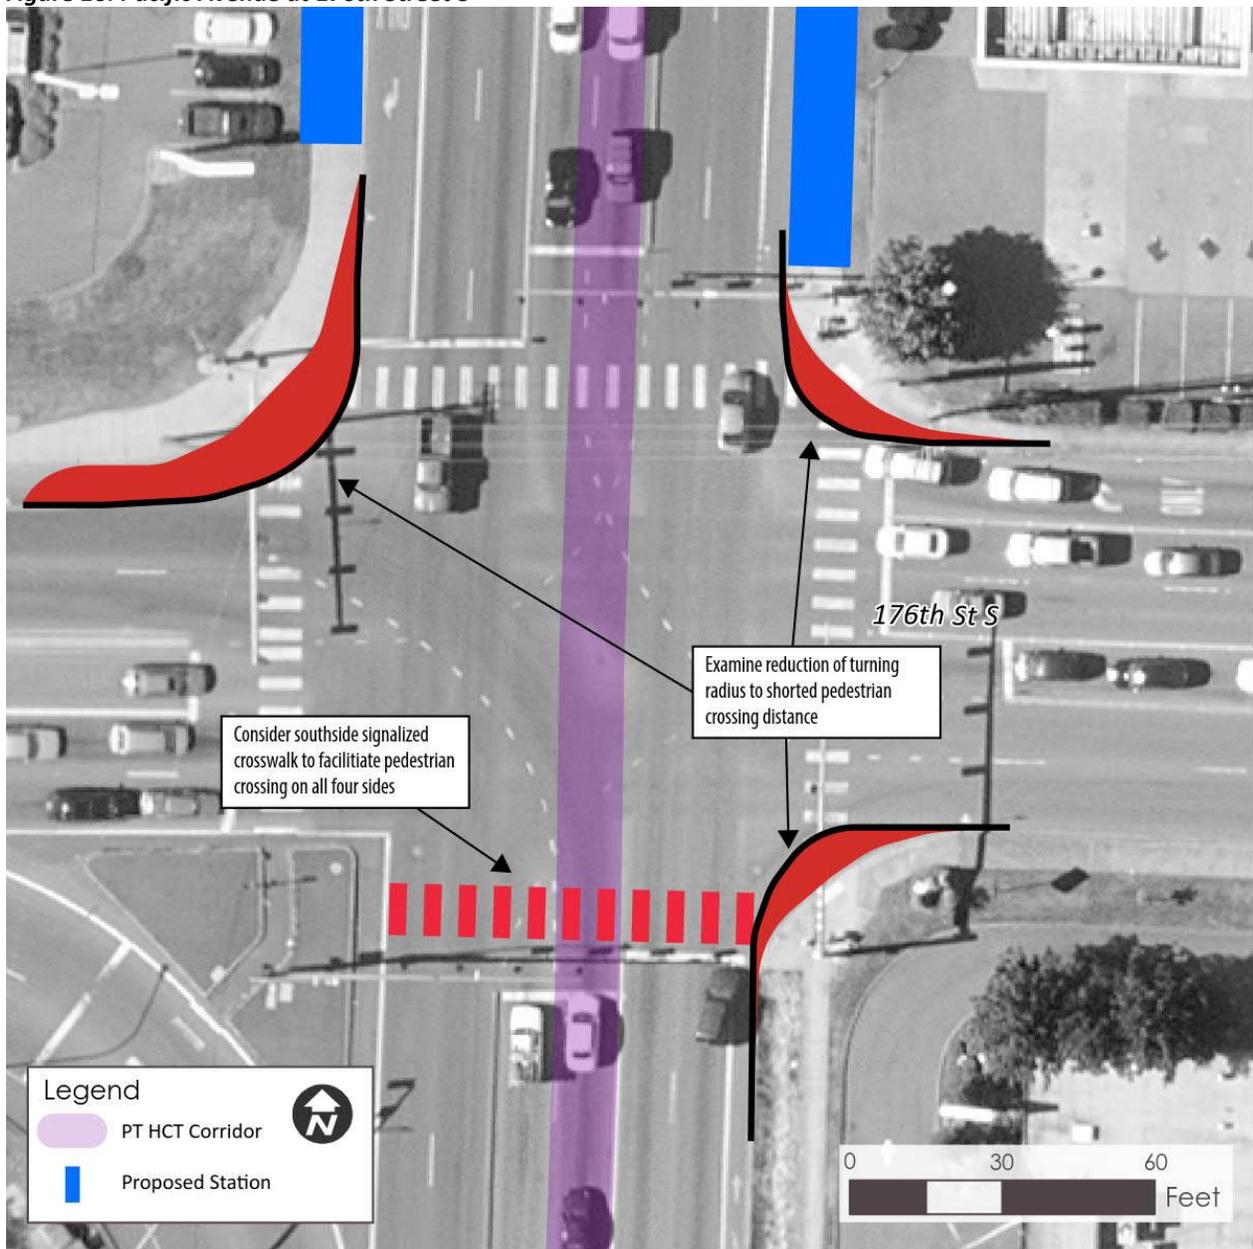
Figure 16: Pacific Avenue at 176th Street S

Access Mode	Problem	Potential Solution	Implementation Challenge	Cost Estimate
Bicycle and pedestrian	Lack of sidewalk and crossing on southern end of the intersection. Slip lane could pose comfortability issues. Lack of appropriate bicycle connection through intersection.	Provide marked crossing from slip lane to southeast corner. Tighten corner radii on NW, NE, and SE corners. Southbound bicycle lane improvements.	Signal timing issues for cyclists and adding the crosswalk.	\$\$

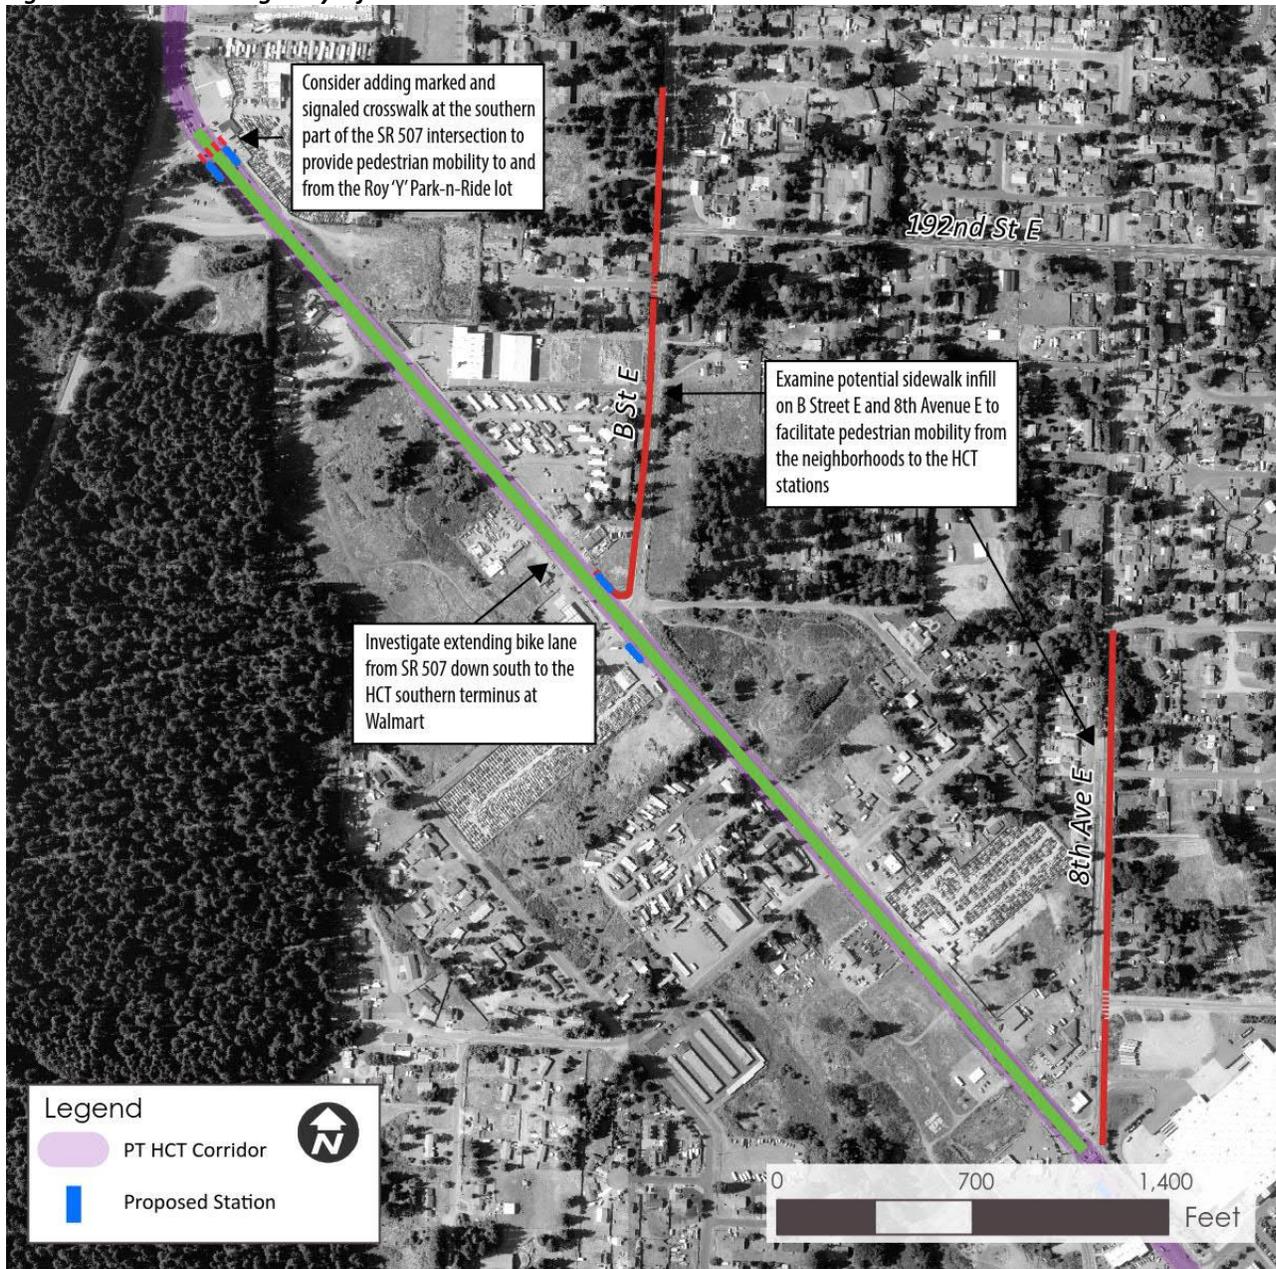
Figure 17: Mountain Highway E from State Route 507 to 8th Avenue E

The final segment of the corridor, along Mountain Highway between SR 507 and 8th Avenue E poses many BRT stations mobility issues for both bicyclists and pedestrians – including the low density of land uses and rural characteristics that reduce the overall walkability of the area.

Additionally, access to and from the Roy “Y” Park-and-Ride could be improved with the addition of a new crosswalk at the northbound approach to the intersection. The assessment summary for these improvements is documented in Table 5-15.

Access Mode	Problem	Potential Solution	Implementation Challenge	Cost Estimate
Bicycle and pedestrian	Higher speeds and no sidewalks anywhere. Lack of safe crossings. Bike/pedestrians crashes present through corridor.	Add sidewalks along adjoining streets to connect neighborhoods to Pacific Avenue. Add safe crossing at Roy 'Y' Park N Ride. Extend striped bike lane to the Walmart Supercenter.	ROW constraints.	\$\$

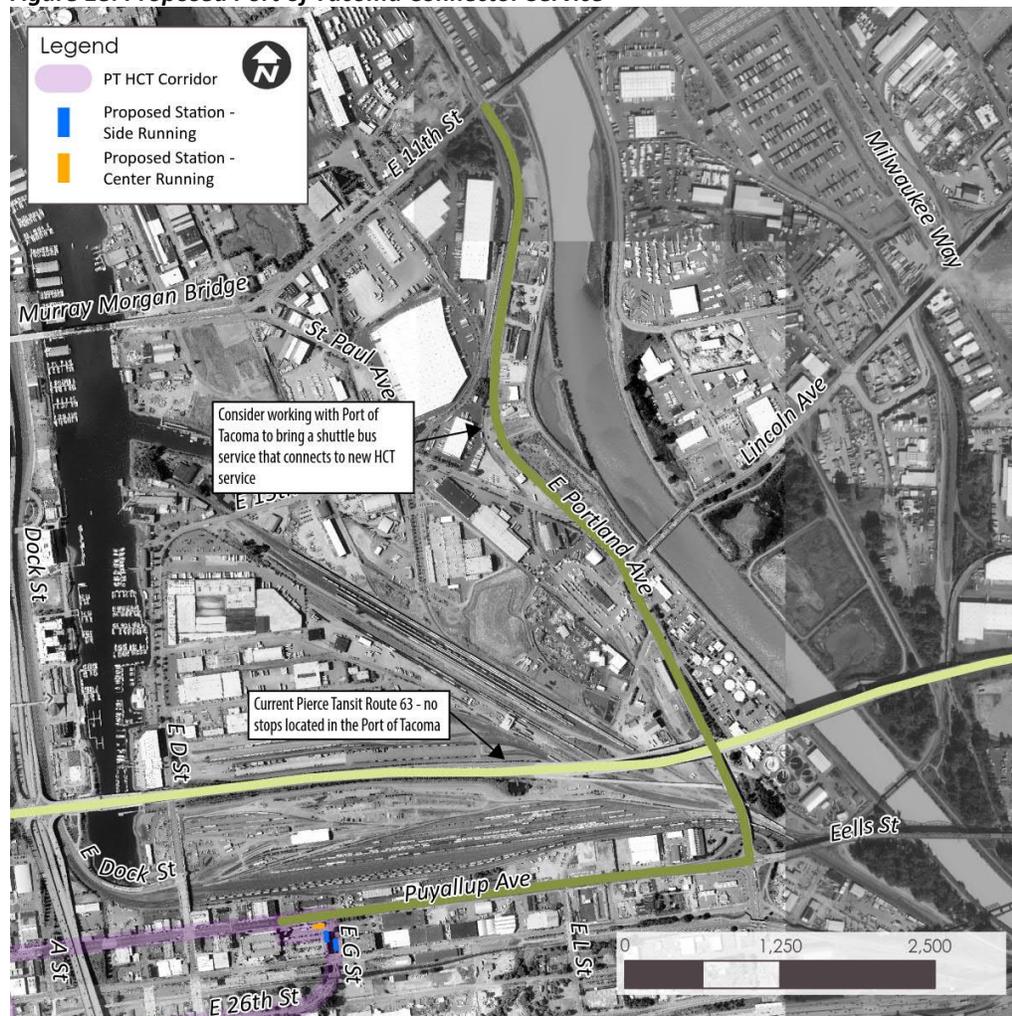
Figure 18: Proposed Port of Tacoma Connector Service

Currently, there is only one bus route that runs from downtown Tacoma into the Port of Tacoma, which employs 29,000 people over 2,400 acres⁵. This gives Pierce Transit and the Port of Tacoma the opportunity to add an additional bus or connector service into the Port connecting to the proposed BRT service and the Tacoma Dome Station by way of Puyallup Avenue and Portland Avenue E and into the Port of Tacoma (Figure 18). Such a plan would likely require a partnership with the port. As a shuttle service, it would be logistically challenging as determining where to drop off passengers given the port’s relative sprawl. The assessment summary for these improvements is documented in Table 7-1. However, Pierce Transit has attempted previous fixed routes in the past to serve this purpose with marginal success because the spread-out nature of the jobs as well as the varying shifts make it challenging to serve. Currently no additional routes are shown or proposed in the Pierce Transit Long-Range Plan. Therefore, it is recommended that this strategy not be implemented in the near-term, but be revisited when Sound Transit’s Central Link service reaches the Tacoma Dome Station.
